# TREE CONSERVATION REPORT V2.0

**109-115 Dalhousie**

Tree Conservation Report submitted as Partial  
Requirements for a Site Plan Control Application,  
February 16, 2022

**Date:** February 16, 2022

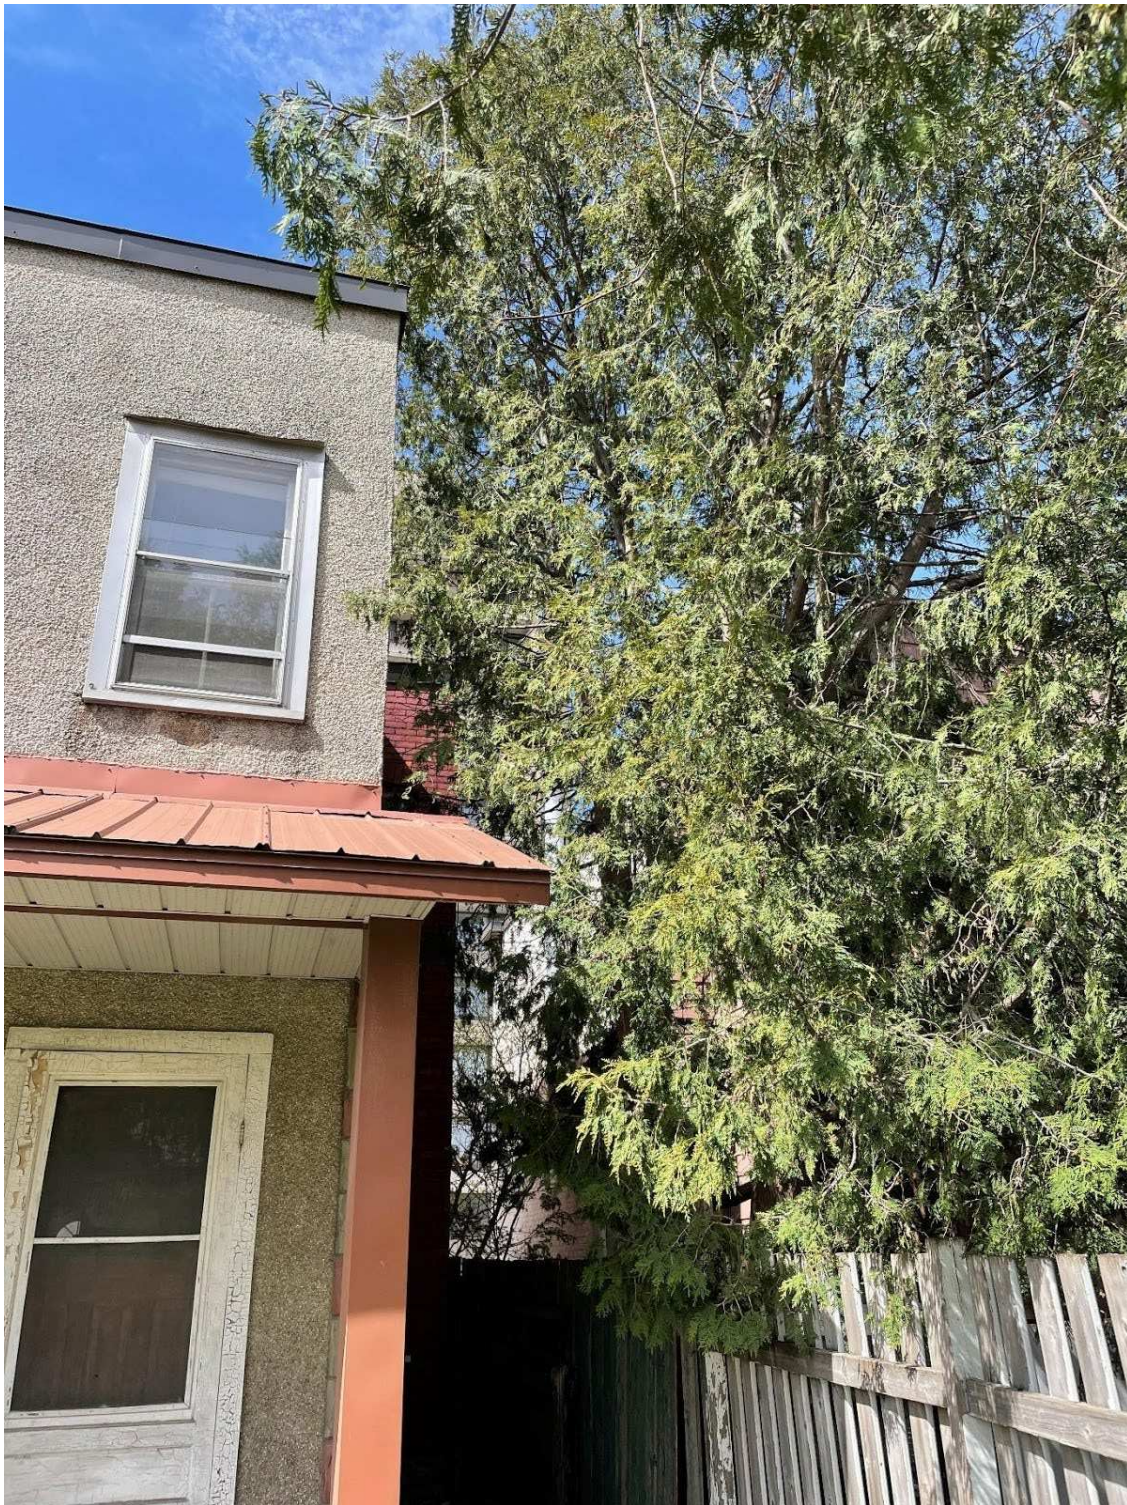
Tree 1, an eastern white cedar, located on adjacent property is in good health. However, the proposed development will involve severing some of the roots, possibly impacting the structural integrity of the tree. If the excavation in this area cannot be limited to at least 1 m from the edge of the tree, then removal is recommended. The two trunks are situated 25 and 40 cm from the current fence. If the tree is retained, an onsite inspection by an arborist to assess stability during excavation is recommended. Alternatively, the roots can be severed prior to excavation by an arborist using an airspade, at which time, an assessment on potential stability can be made. Pruning of the crown is also required to

Figure 1: Tree 1, eastern white cedar on adjacent property to be retained

accommodate the scaffolding while the new building is under construction. If excavation cannot be reduced to 1 m from the tree trunk, then removal is the recommended option. Since this tree is entirely on adjacent property, permission from the neighbour would be required for removal.

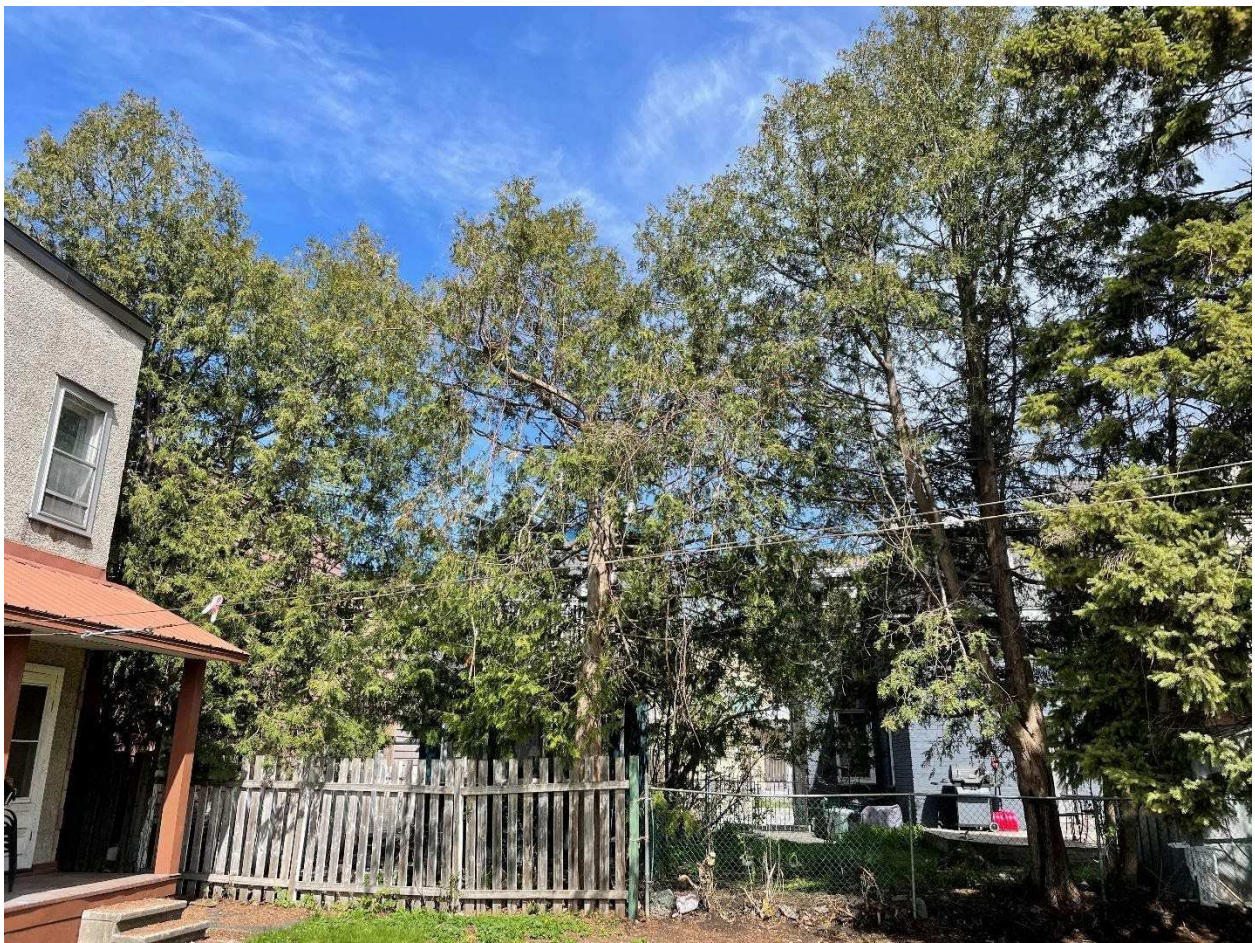
Tree 2 is in fair health due to the loss of its tops and will be within the area of excavation – removal is recommended. Although tree 3 is slightly further away, there will be some impact to the tree through severing of the roots from the excavation. The main stem of this tree has a large stem attached to the base of the trunk that is at risk of failure. The preferred option by the client is to retain this tree, but it should be monitored through construction for signs of failure. Some of the smaller stems close to this tree may be retained, but they are being suppressed by tree 4, and combined with the stress of the excavation, are not ideal candidates for retention.

Figure 2: Trees 1 (left), 2 (middle), 3 (right), all eastern white cedar

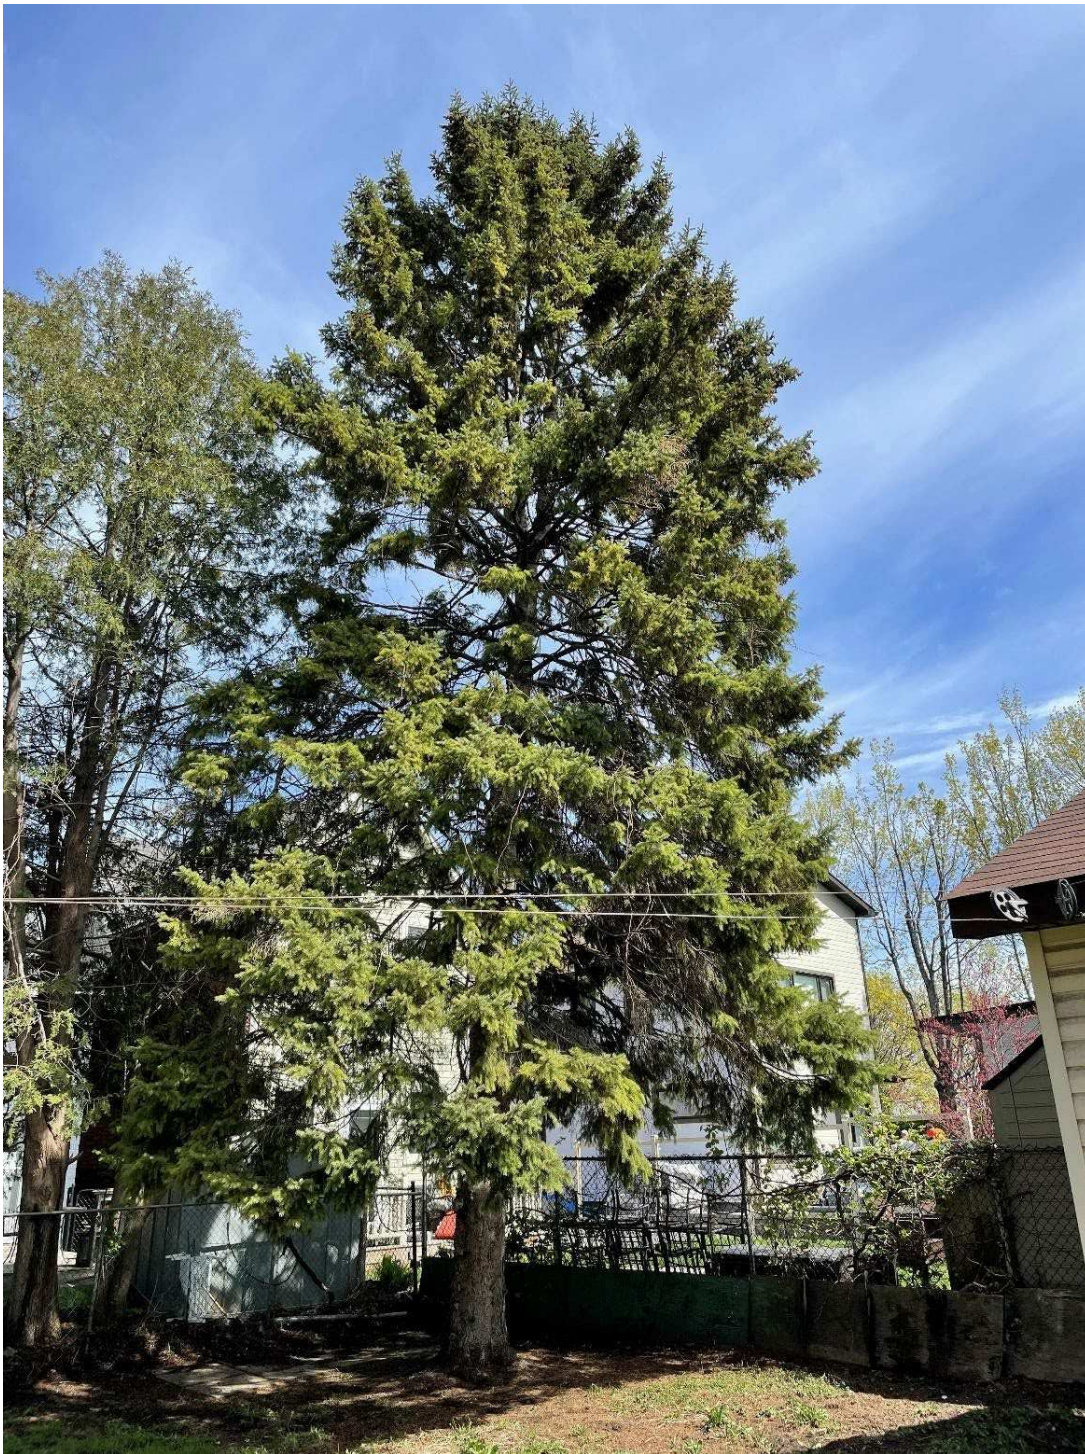
Figure 3: Tree 4, white spruce to be retained

Tree 4 is a healthy spruce that should be retainable if the area can be well protected throughout site works as per the tree protected specifications below. Tree 5 is on adjacent property and the roots will likely be impacted by the proposed excavation. This tree is set back far enough that stability should not be severely compromised by the excavation, however, root cutting/pruning by an arborist is recommended.

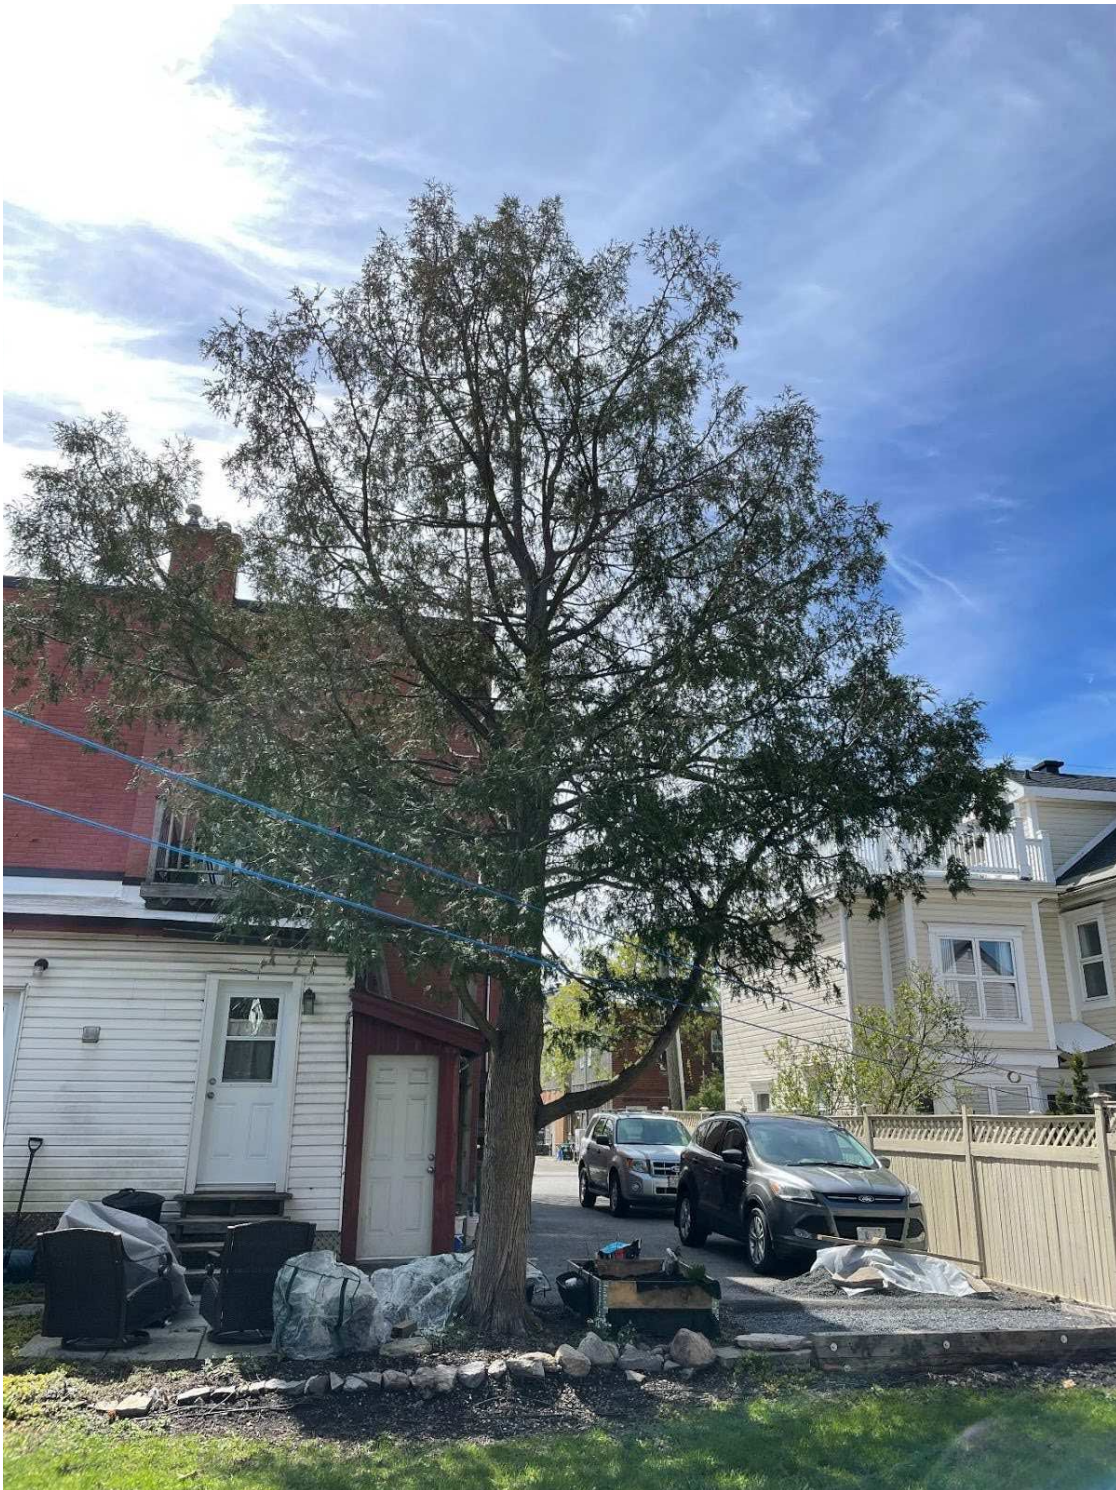
Figure 4: Tree 5, eastern white cedar on adjacent property to be retained
