December 15, 2022

RE: TREE CONSERVATION REPORT FOR 1209 ST. LAURENT BOULEVARD, OTTAWA

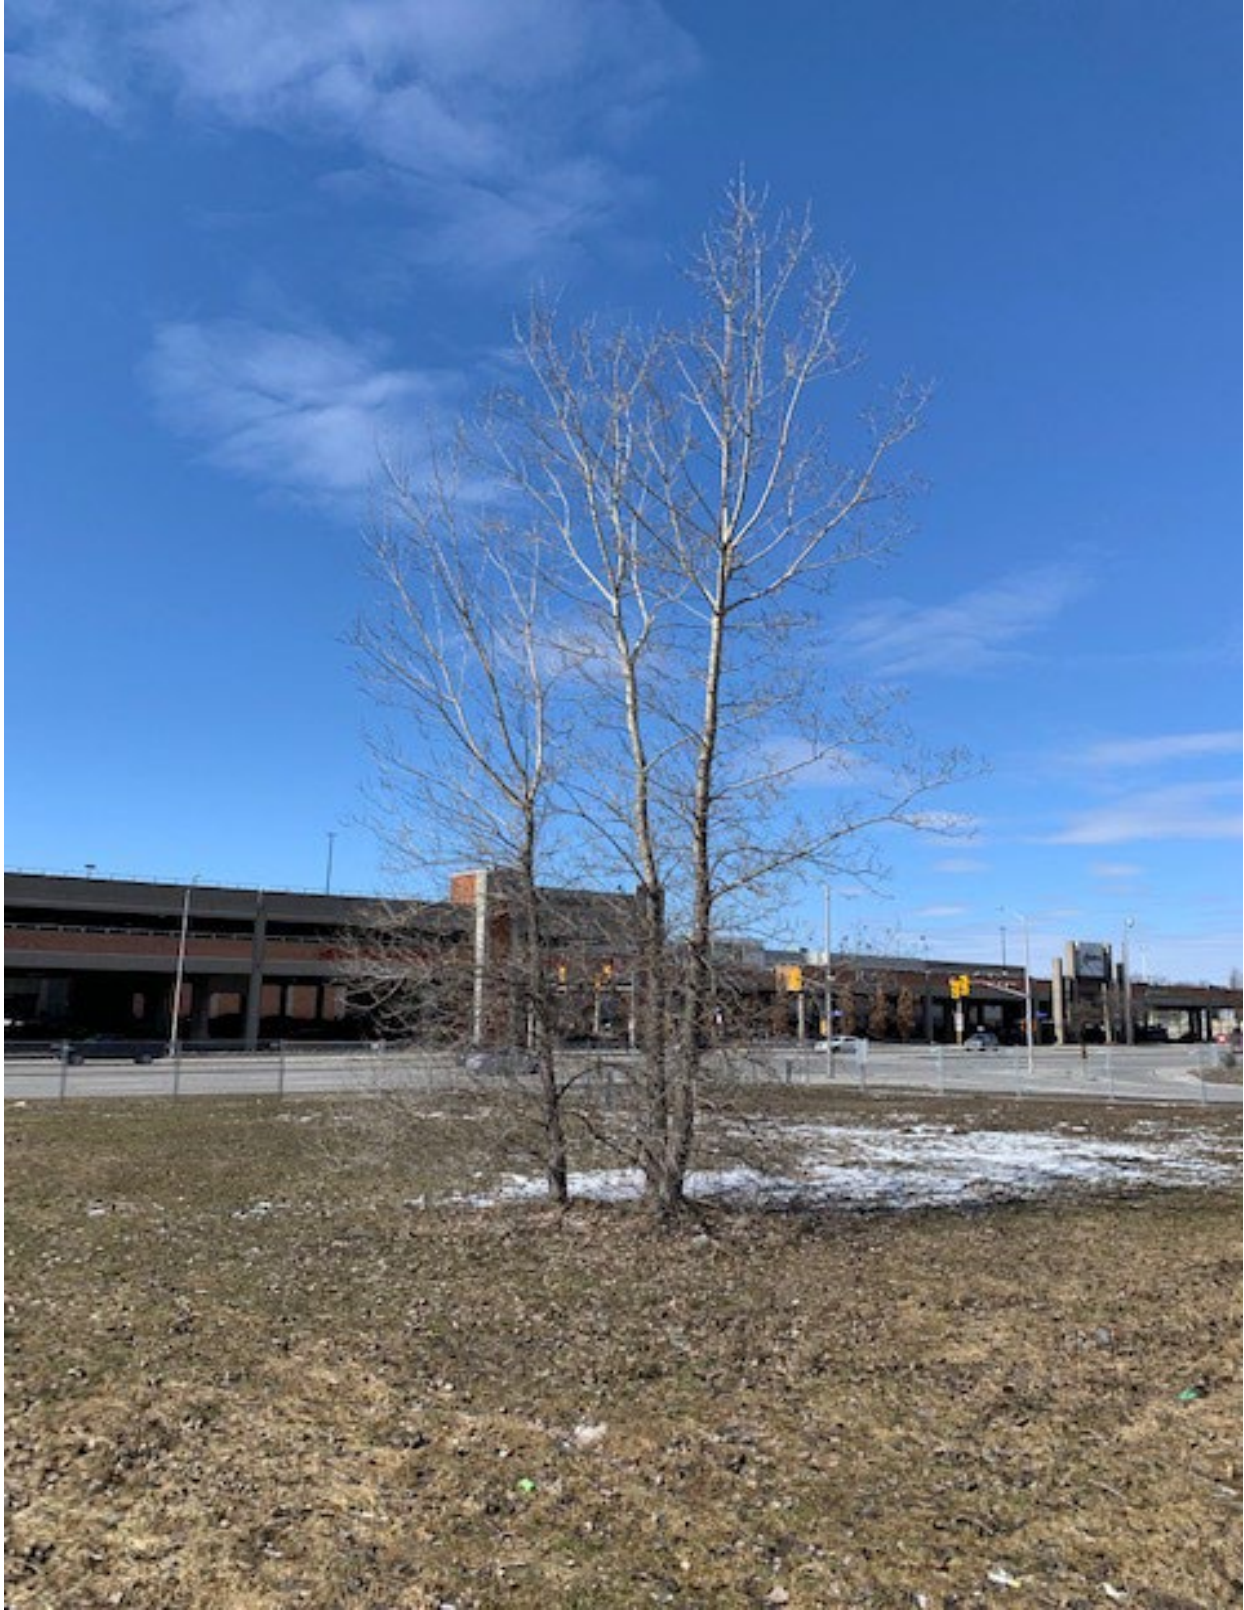
| Tree No. | Tree species /Tolerance to Construction ¹ | DBH ² (cm) | CRZ ³ | Condition, age class, tree condition notes & preservation status (to be removed or preserved and protected) |
|---|---|---|---|--|
| 1 | Cottonwood (<i>Populus deltoides</i>)/ Moderate-Good | 20 avg. | - | Good; three maturing trees; likely originated from wind-borne seed; native species; to be removed (conflicts with proposed development) |

Picture 1. Tree #1, poplar at 1209 St. Laurent Boulevard

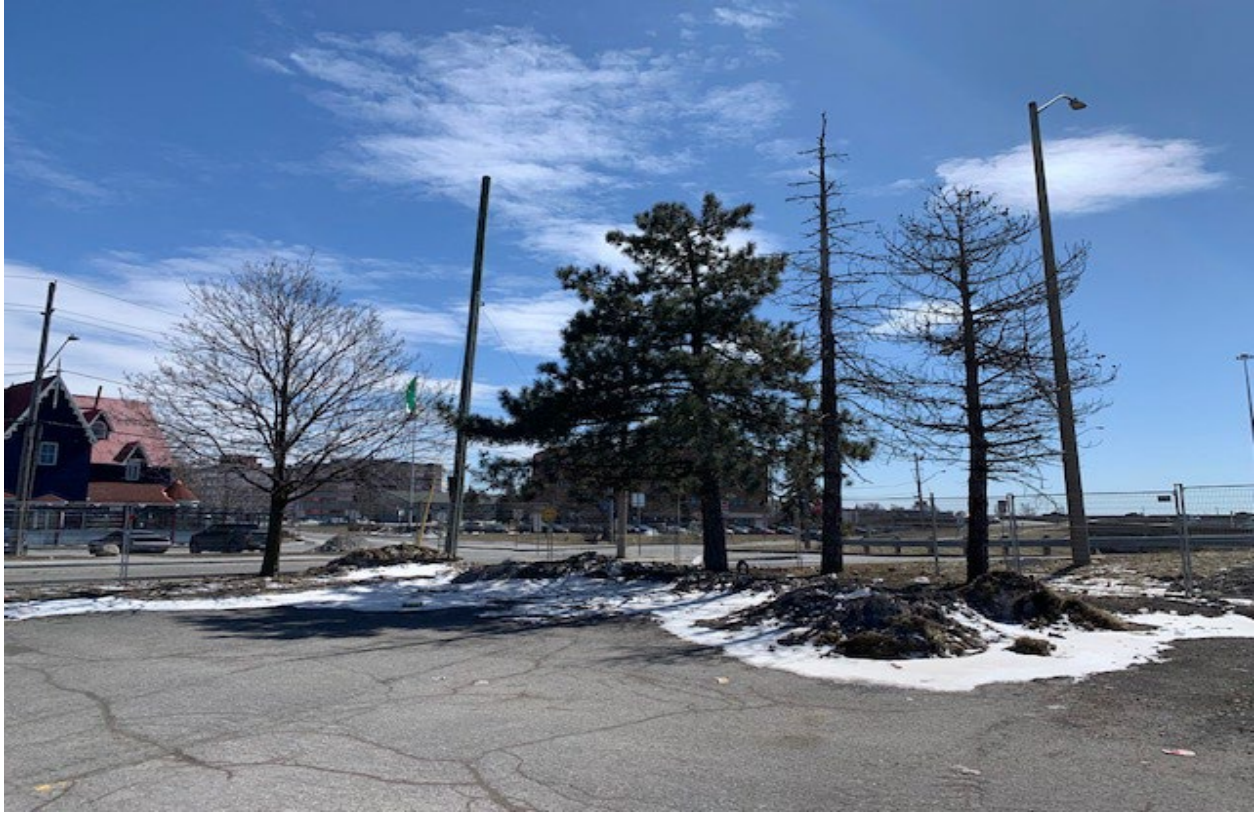
| Tree No. | Tree species /Tolerance to Construction ¹ | DBH ² (cm) | CRZ ³ | Condition, age class, tree condition notes & preservation status (to be removed or preserved and protected) |
|---|---|---|---|--|
| 3 | Austrian pine (<i>Pinus nigra</i>) | 28 | - | Standing dead; mature; to be removed (dead) |
| 4 | Austrian pine (<i>Pinus nigra</i>) | 31 | - | Standing dead; mature; to be removed (dead) |
| 5 | Austrian pine (<i>Pinus nigra</i>)/ Moderate-Good | 38 | - | Fair; mature; crown asymmetric towards north due to influence of adjacent trees; fair crown density, growth increment and needle colour; no distinct dominant leader; introduced species; to be removed (conflicts with proposed development) |
| 6 | Norway maple (<i>Acer platanoides</i>)/ Moderate-Good | 25 | 2.5 | Good; mature; central dominant stem with competing leaders at 4m from grade; suppressed laterals starting at 1.5m; dense, compact crown; introduced invasive species; to be removed (conflicts with site access) |

Picture 2. Trees #3-6 (right to left) at 1209 St. Laurent Boulevard

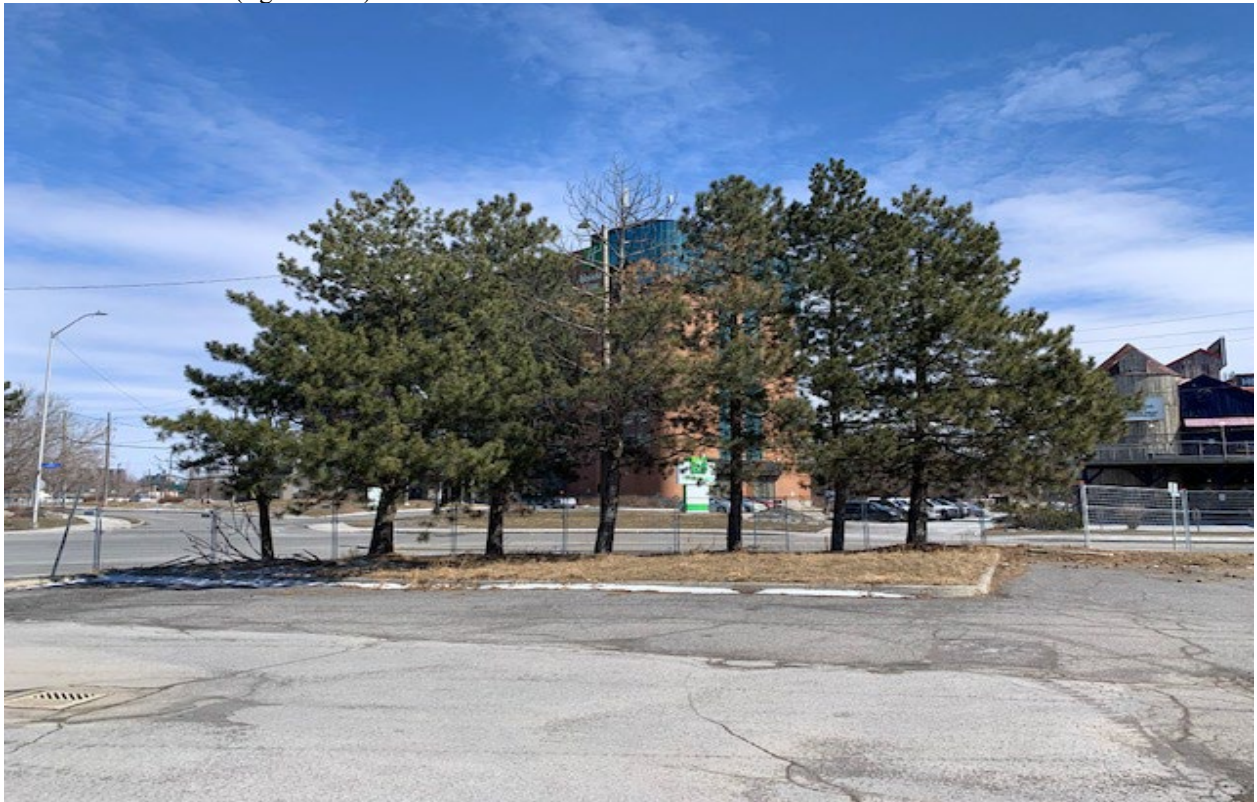
| Tree No. | Tree species /Tolerance to Construction ¹ | DBH ² (cm) | CRZ ³ | Condition, age class, tree condition notes & preservation status (to be removed or preserved and protected) |
|---|---|---|---|--|
| 7 | Austrian pine (<i>Pinus nigra</i>)/ Moderate-Good | 41 | - | Good; mature; dominant central stem; crown asymmetric due to influence of nearby trees; good crown density, growth increment and needle colour; introduced species; to be removed (will not survive root loss) |
| 8 | Austrian pine (<i>Pinus nigra</i>)/ Moderate-Good | 26 | - | Fair; mature; dominant central stem; crown asymmetric due to influence of nearby trees; good crown density, growth increment and needle colour; introduced species; to be removed (will not survive root loss) |
| 9 | Austrian pine (<i>Pinus nigra</i>)/ Moderate-Good | 31 | - | Fair; mature; dominant central stem; crown asymmetric due to influence of nearby trees; good crown density, growth increment and needle colour; introduced species; to be removed (will not survive root loss) |

| Tree No. | Tree species /Tolerance to Construction ¹ | DBH ² (cm) | CRZ ³ | Condition, age class, tree condition notes & preservation status (to be removed or preserved and protected) |
|---|--|---|---|--|
| 10 | Austrian pine (<i>Pinus nigra</i>)/ Moderate-Good | 31 | - | Very poor; mature; top half of crown dead, bottom with poor crown density, growth increment and needle colour; introduced species; to be removed (very poor condition and will not survive root loss) |
| 11 | Austrian pine (<i>Pinus nigra</i>)/ Moderate-Good | 33 | - | Fair; mature; crown moderately asymmetric due to influence of nearby trees; good crown density, growth increment and needle colour; introduced species; to be removed (will not survive root loss) |
| 12 | Austrian pine (<i>Pinus nigra</i>)/ Moderate-Good | 43 | - | Fair; mature; lower crown dead due to influence of nearby pine and maple trees; good crown density, growth increment and needle colour; introduced species; to be removed (will not survive root loss) |
| 13 | Norway maple (<i>Acer platanoides</i>) | 22 | - | Dead; mature; broken in two; to be removed (dead) |

Picture 3. Trees #7-13 (right to left) at 1209 St. Laurent Boulevard

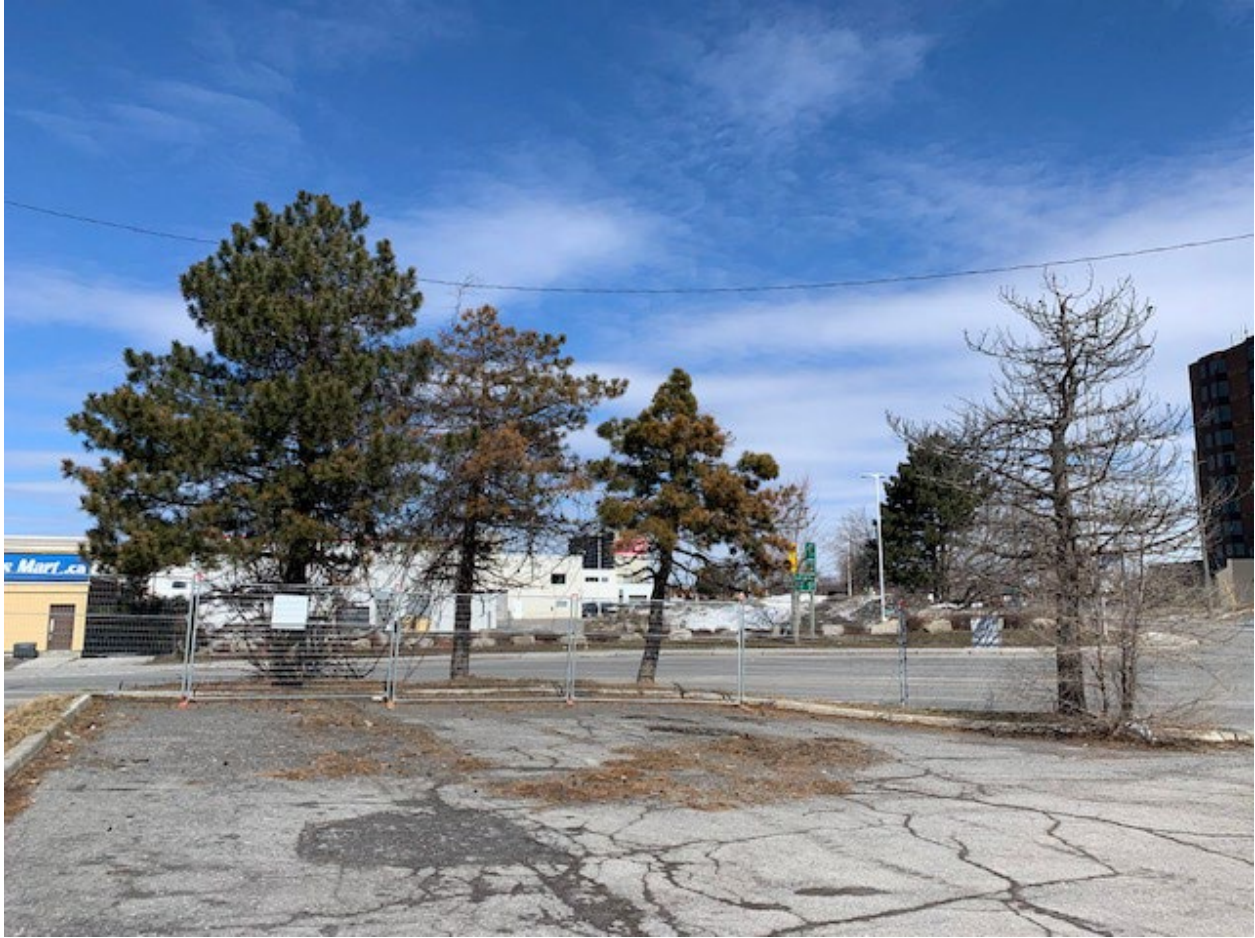
| Tree No. | Tree species /Tolerance to Construction ¹ | DBH ² (cm) | CRZ ³ | Condition, age class, tree condition notes & preservation status (to be removed or preserved and protected) |
|---|--|---|---|--|
| 14 | Austrian pine (<i>Pinus nigra</i>) | 33 | - | Dead; mature; seeded Siberian elm (<i>Ulmus pumila</i>) growing at base; to be removed (dead) |
| 15 | Austrian pine (<i>Pinus nigra</i>)/ Moderate-Good | 26 | - | Poor; mature; stunted growth form; poor crown density, growth increment and needle colour; introduced species; to be removed (poor condition) |
| 16 | Austrian pine (<i>Pinus nigra</i>)/ Moderate-Good | 29 | - | Poor; mature; stunted growth form; heavy vine (<i>Vitis</i> spp.) growth into crown; very poor crown density, growth increment and needle colour; introduced species; to be removed (poor condition) |
| 17 | Austrian pine (<i>Pinus nigra</i>)/ Moderate-Good | 34 | 3.4 | Fair; mature; crown asymmetric due to influence of nearby trees; vine (<i>Vitis</i> spp.) growth into crown; fair crown density and needle colour, good growth increment; hydro line runs through crown apex; introduced species; to be removed (conflicts with site access) |

Picture 4. Trees #14-17 (right to left) at 1209 St. Laurent Boulevard
