May 18, 2022

RE: TREE CONSERVATION REPORT FOR 1209 ST. LAURENT BOULEVARD, OTTAWA

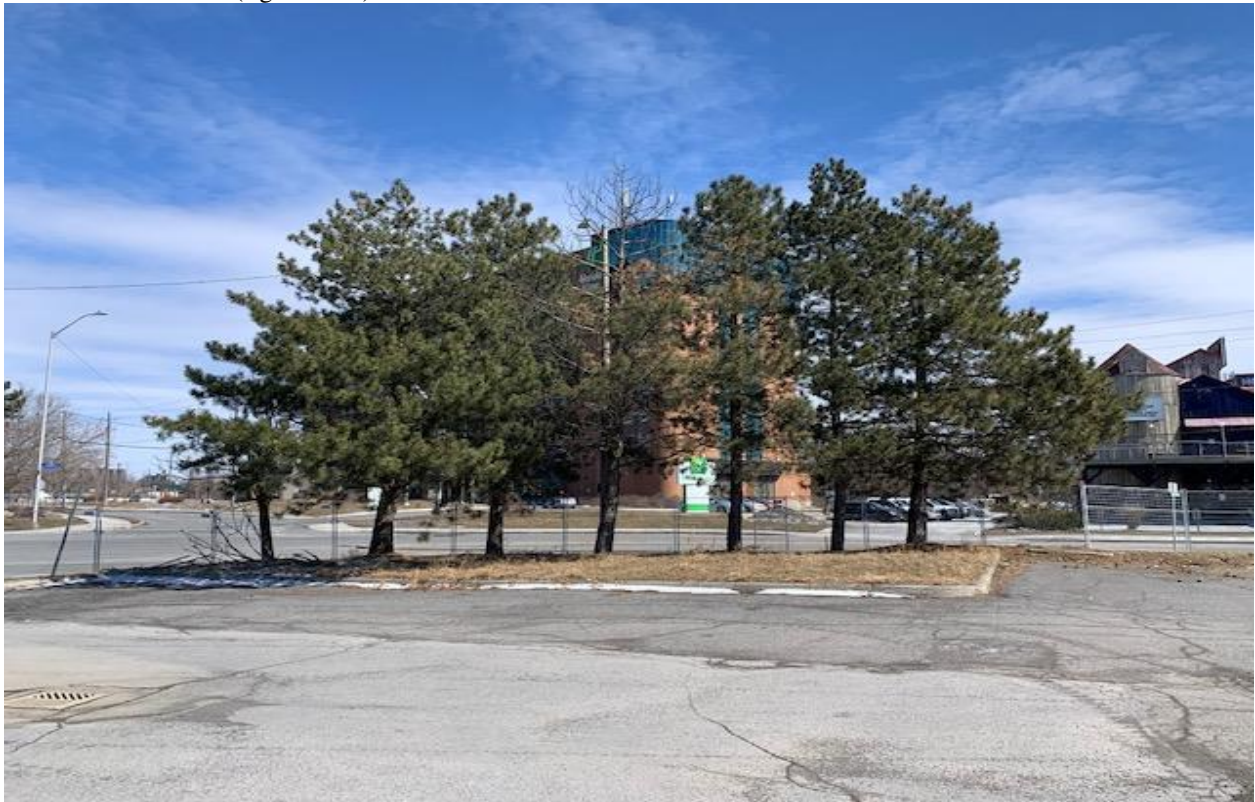
6	Norway maple (<i>Acer platanoides</i>) / Moderate-Good	25	2.5	Good; mature; central dominant stem with competing leaders at 4m from grade; suppressed laterals starting at 1.5m; dense, compact crown; introduced invasive species; to be preserved and protected
7	Austrian pine (<i>Pinus nigra</i>) / Moderate-Good	41	-	Good; mature; dominant central stem; crown asymmetric due to influence of nearby trees; good crown density, growth increment and needle colour; introduced species; to be removed (will not survive root loss)
8	Austrian pine (<i>Pinus nigra</i>) / Moderate-Good	26	-	Fair; mature; dominant central stem; crown asymmetric due to influence of nearby trees; good crown density, growth increment and needle colour; introduced species; to be removed (will not survive root loss)
9	Austrian pine (<i>Pinus nigra</i>) / Moderate-Good	31	-	Fair; mature; dominant central stem; crown asymmetric due to influence of nearby trees; good crown density, growth increment and needle colour; introduced species; to be removed (will not survive root loss)

Tree No.	Tree species /Tolerance to Construction ¹	DBH ² (cm)	CRZ ³	Condition, age class, tree condition notes & preservation status (to be removed or preserved and protected)
10	Austrian pine (<i>Pinus nigra</i>)/ Moderate-Good	31	-	Very poor; mature; top half of crown dead, bottom with poor crown density, growth increment and needle colour; introduced species; to be removed (very poor condition and will not survive root loss)
11	Austrian pine (<i>Pinus nigra</i>)/ Moderate-Good	33	-	Fair; mature; crown moderately asymmetric due to influence of nearby trees; good crown density, growth increment and needle colour; introduced species; to be removed (will not survive root loss)
12	Austrian pine (<i>Pinus nigra</i>)/ Moderate-Good	43	-	Fair; mature; lower crown dead due to influence of nearby pine and maple trees; good crown density, growth increment and needle colour; introduced species; to be removed (will not survive root loss)

13	Norway maple (<i>Acer platanoides</i>)	22	-	Dead; mature; broken in two; to be removed (dead)
14	Austrian pine (<i>Pinus nigra</i>)	33	-	Dead; mature; seeded Siberian elm (<i>Ulmus pumila</i>) growing at base; to be removed (dead)
15	Austrian pine (<i>Pinus nigra</i>)/ Moderate-Good	26	-	Poor; mature; stunted growth form; poor crown density, growth increment and needle colour; introduced species; to be removed (poor condition)
16	Austrian pine (<i>Pinus nigra</i>)/ Moderate-Good	29	-	Poor; mature; stunted growth form; heavy vine (<i>Vitis</i> spp.) growth into crown; very poor crown density, growth increment and needle colour; introduced species; to be removed (poor condition)
17	Austrian pine (<i>Pinus nigra</i>)/ Moderate-Good	34	3.4	Fair; mature; crown asymmetric due to influence of nearby trees; vine (<i>Vitis</i> spp.) growth into crown; fair crown density and needle colour, good growth increment; hydro line runs through crown apex; introduced species; to be preserved and protected

Picture 3. Trees #7-13 (right to left) at 1209 St. Laurent Boulevard
