Claridge Homes 2559 Mer Bleue Road Subdivision

Headwaters Report

Prepared by: Bowfin Environmental Consulting Inc. 168 Montreal Road Cornwall, Ontario K6H 1B3

November 2020

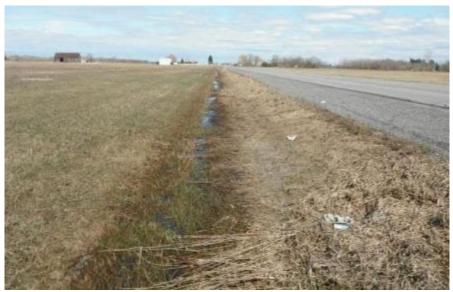
The substrate was composed of fines. The entire channel was choked with vegetation (reed canary grass, and purple loosestrife). There were no signs of erosion.

Photo 1: Drain 6 (Station 8) looking upstream from the downstream end (April 28, 2014)

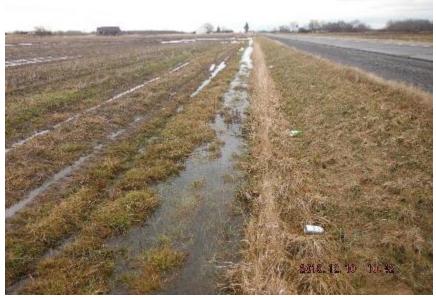
Photo 2: Drain 6 (Station 8) looking upstream from the downstream end (December 10, 2019)

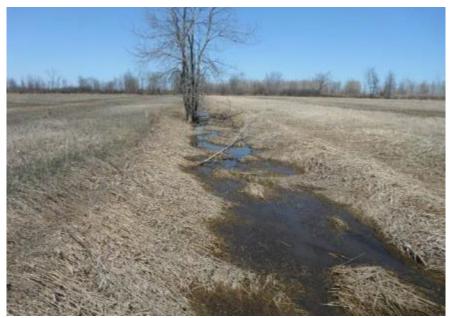
The substrate was composed of fines. The in-stream cover consisted of aquatic vegetation (reed canary grass, narrow-leaved cattail, and purple loosestrife. There were no signs of erosion.

Photo 3: Drain 7 (Station 9) looking upstream from the downstream end (April 28, 2014)

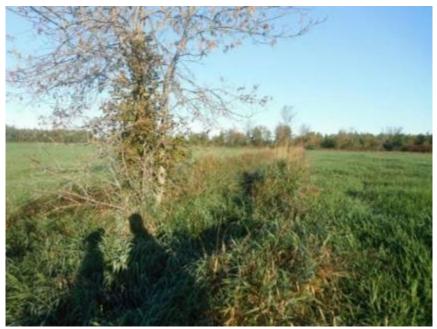
Photo 4: Drain 7 (Station 9) looking upstream from the downstream end (September 17, 2013)

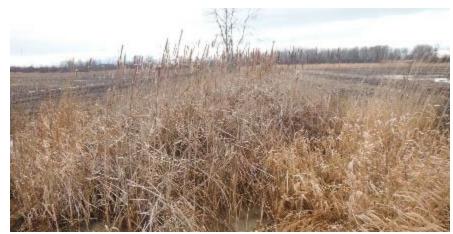
Photo 5: Drain 7 (Station 9) looking upstream from the downstream end (December 10, 2019)

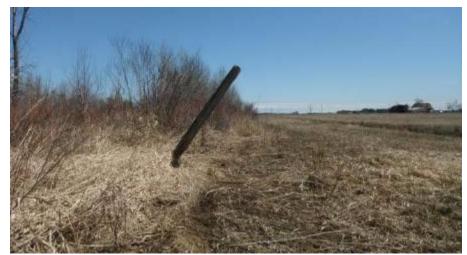
The substrate was composed of fines. The channel was heavily chocked with vegetation (purple loosestrife, narrow-leaved cattail, and reed canary grass). There were no signs of erosion.

Photo 6: Drain 8 (Station 10) looking upstream from the downstream end (April 28, 2014)

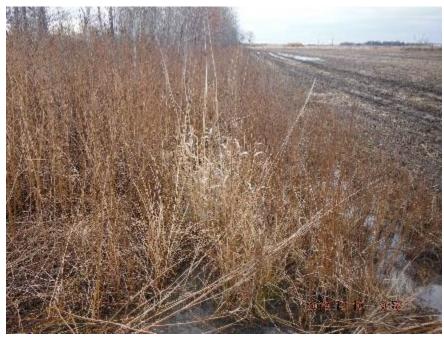
Photo 7: Drain 8 (Station 10) looking upstream from the downstream end (December 10, 2019)

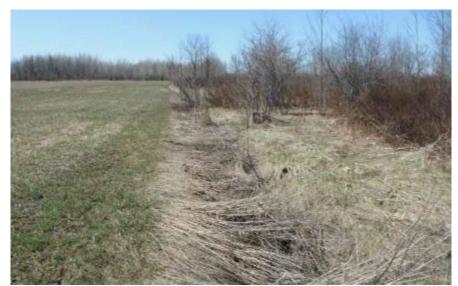
The substrate was composed of fines. The channel was entirely choked with aquatic vegetation (reed canary grass, black bulrush, and purple loosestrife). There were no signs of erosion.

Photo 8: Drain 9 (Station 11) looking upstream from the downstream end (April 28, 2014)

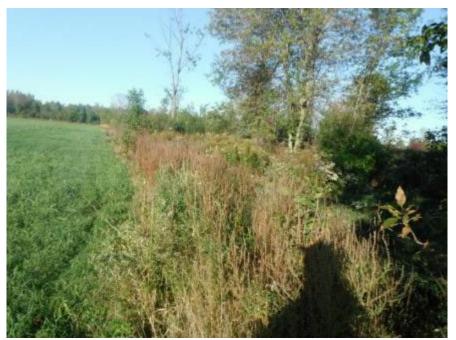
Photo 9: Drain 9 (Station 11) looking upstream from the downstream end (September 17, 2013)

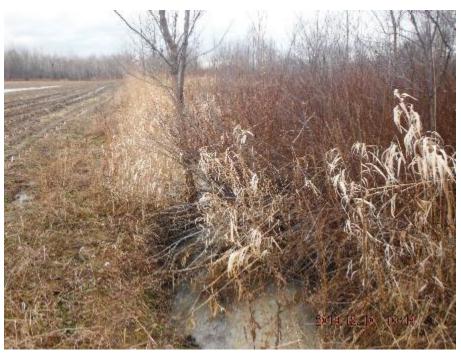
Photo 10: Drain 9 (Station 11) looking upstream from the downstream end (December 10, 2019)

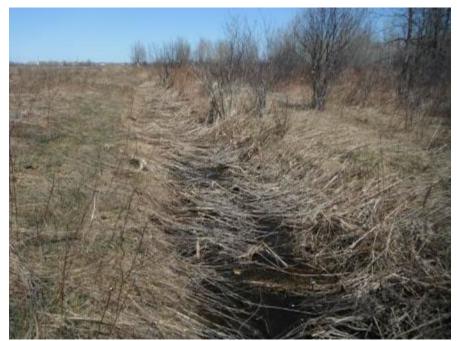
The substrate was composed of fines. The channel was entirely vegetated with purple loosestrife, reed canary grass, and narrow-leaved cattail. There were no signs of erosion.

Photo 11: Drain 10 (Station 12) looking upstream from the downstream end (April 28, 2014)

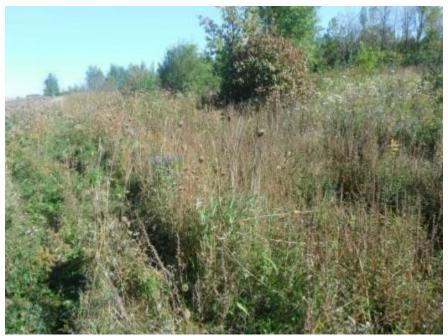
Photo 12: Drain 10 (Station 12) looking upstream from the downstream end (September 17, 2013)

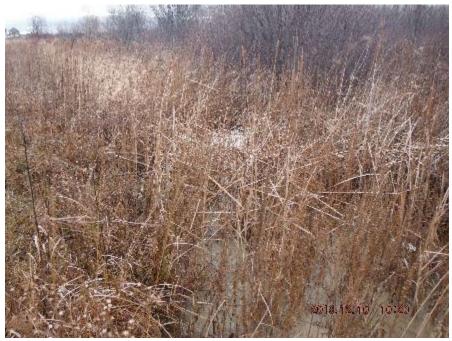
Photo 13: Drain 10 (Station 12) looking upstream from the downstream end (December 10, 2019)

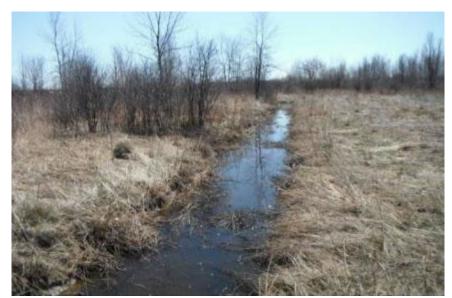
The substrate was composed of fines. The channel was choked by aquatic vegetation (purple loosestrife, narrow-leaved cattail, and reed canary grass). There were no signs of erosion.

Photo 14: Drain 11 (Station 13) looking upstream from the downstream end (April 28, 2014)

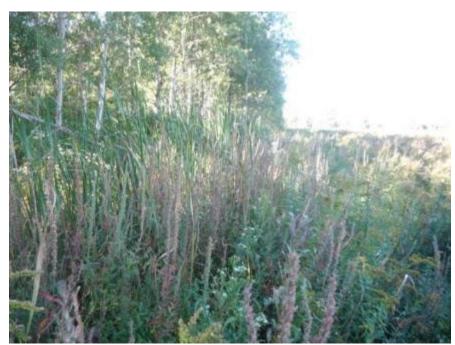
Photo 15: Drain 11 (Station 13) looking upstream from the downstream end (September 17, 2013)

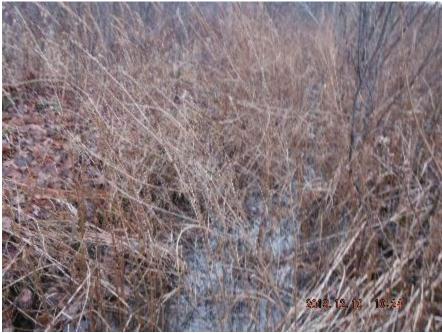
Photo 16: Drain 11 (Station 13) looking upstream from the downstream end (December 10, 2019)

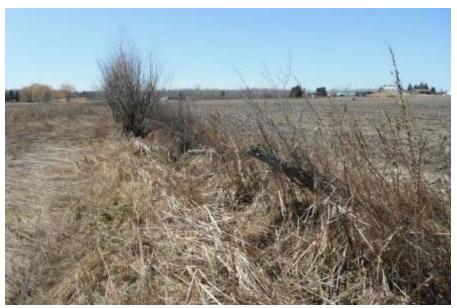
The substrate was composed of fines. The channel was entirely choked by aquatic vegetation (purple loosestrife, broad-leaved cattail, and reed canary grass). There were no signs of erosion.

Photo 17: Drain 12 (Station 14) looking upstream from the downstream end (April 28, 2014)

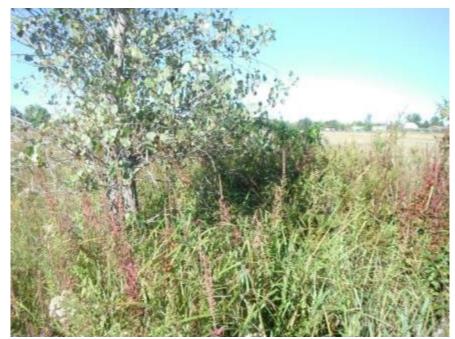
Photo 18: Drain 12 (Station 14) looking upstream from the downstream end (September 17, 2013)

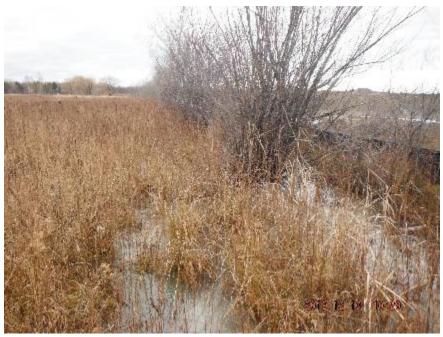
Photo 19: Drain 12 (Station 14) looking upstream from the downstream end (December 10, 2019)

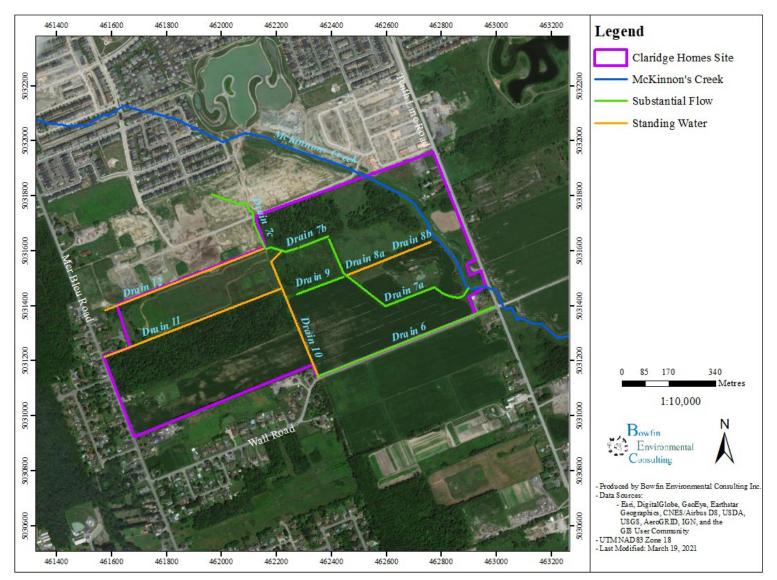
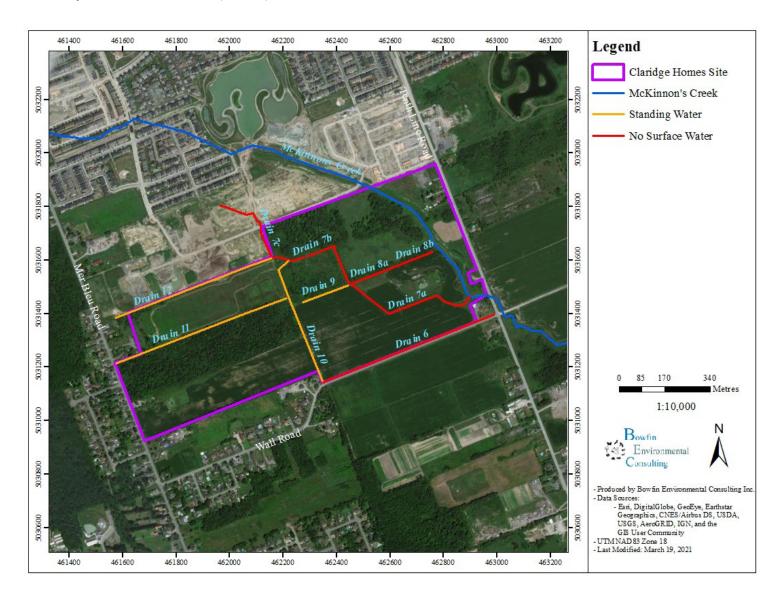
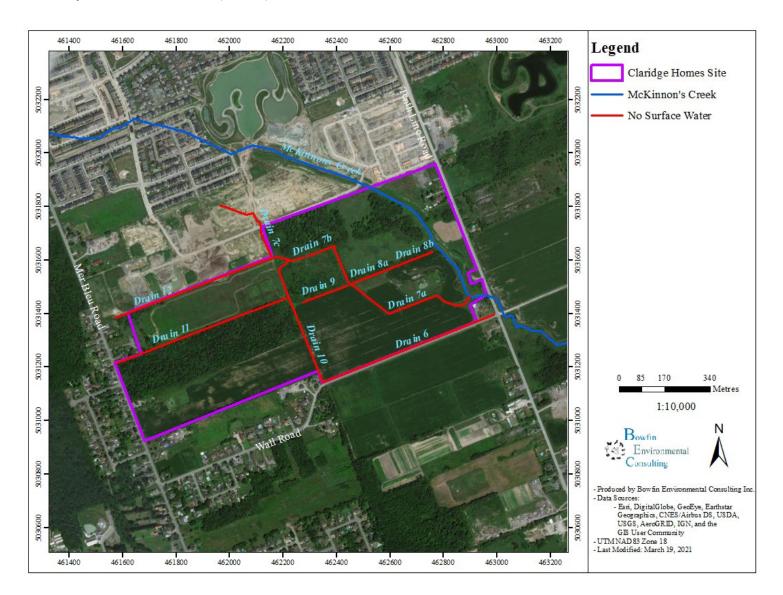
Four features had standing water during the spring freshet (Drains 8, and 10-12). All of the others contained substantial surface water flow during this visit. By the second visit most features had standing water only with the exception of one (Drains 6) which was dry. All features were dry come summer (note that there was little rainfall in the general area in the summer of 2016). Figures 3-5 depict the flow conditions during the three visits.
