URBAN FORESTRY & FOREST MANAGEMENT CONSULTING

March 15, 2023

RE: TREE CONSERVATION REPORT FOR 3055 RICHMOND ROAD, OTTAWA

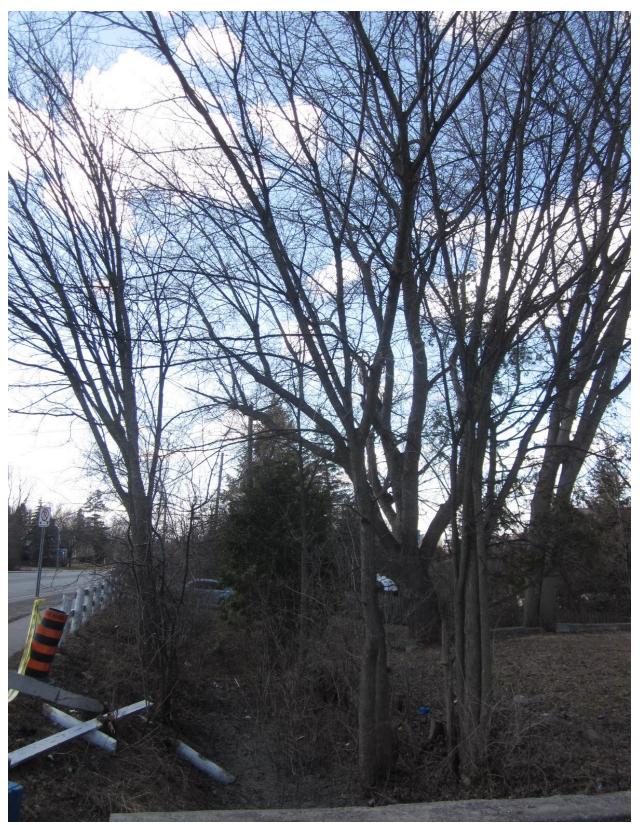
Picture 1. Trees #4, 5 and 6 (right to left), white elms on city property adjacent to 3055 Richmond Road

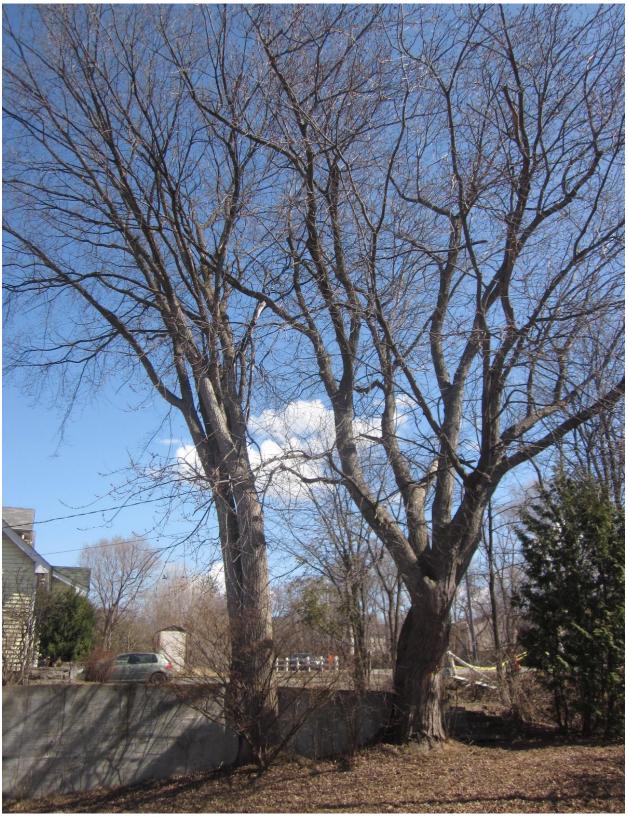
2.5m)		bisect at 5-5.5m - crown
			2.0111)		broadens above this height;
					growing into retaining wall
					(grade change of +/-1.5m); no
					outward signs of DED; native
					species; to be removed (will not
					survive root loss due to nearby
					excavation)
8	Silver maple	Fair	93.1	Private	Very mature; co-dominant stems
	(Acer		(at		at 3m – both bisect at 5.5m; very
	saccharinum)		0.2m		broad crown; asymmetric
	,,,,,,,,,,,,,,,,,,,,,,,,,,,,,,,,,,,,,,,				towards south due to influence
					of tree #7; pockets of decay and
					major deadwood in upper crown;
					growing into retaining wall;
					native species; to be removed
					(will not survive future grade
					change)
9	Crab apple	Poor	17	Private	Overmature; five stemmed from
	(Malus spp.)		avg.		grade; central stem dead, hollow;
	11 /				heavily asymmetric towards
					south due to influence of tree #8;
					cultivar; recommended for
					removal due to condition

Picture 2. Trees #7 and 8 (left to right) private white elm and silver maple at 3055 Richmond Road (note existing grade change/retaining wall)

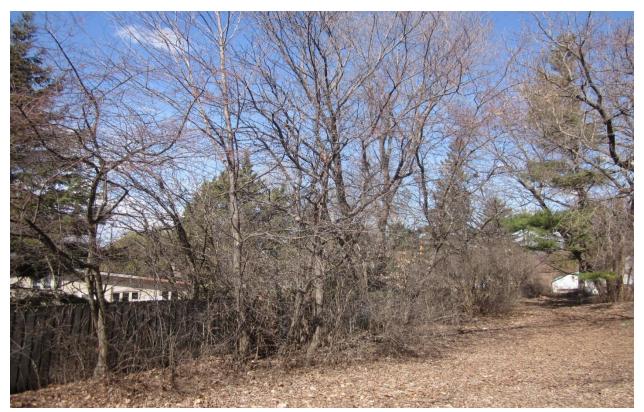
Picture 3. Trees #14-18 (left to right), private crab apples, Norway maple and mountain-ash at 3055 Richmond Road

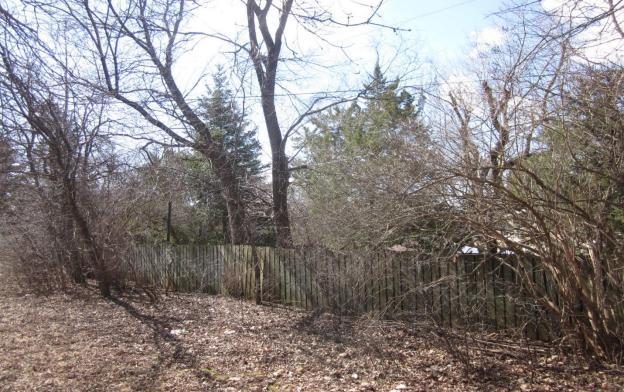
Picture 4. Trees #20 and 21 (centre, left to right), neighbouring Manitoba maple and Siberian elm adjacent to 3055 Richmond Road

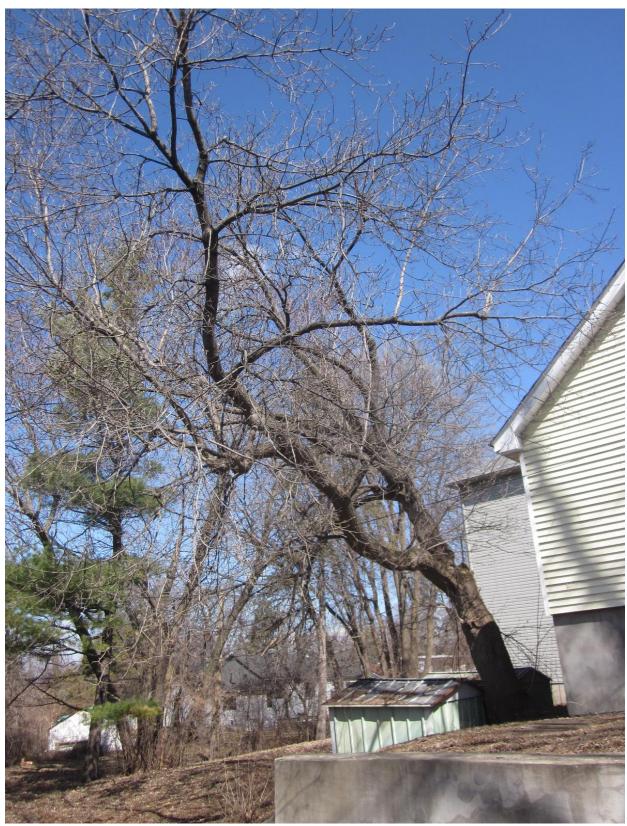
Picture 5. Tree #19, private Manitoba maple at 3055 Richmond Road

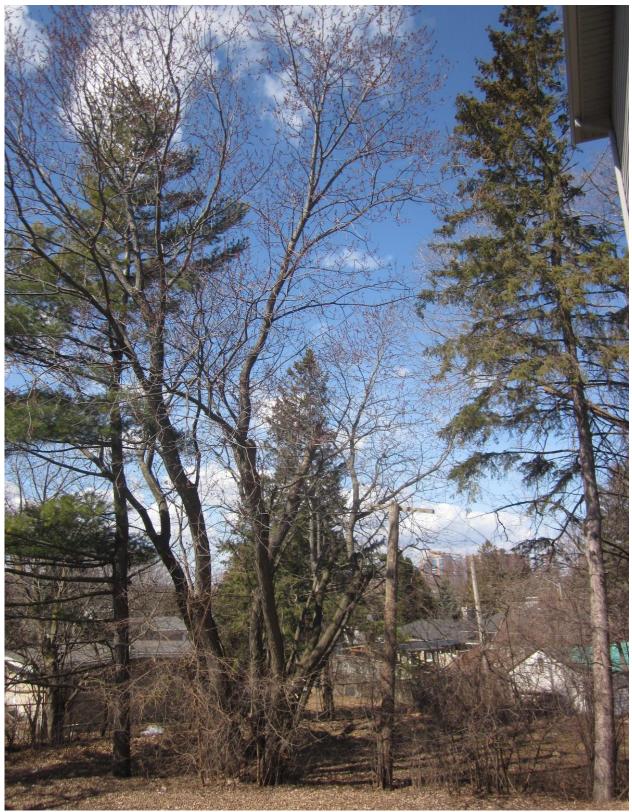
#26; fair crown density, annual
					increment and needle colour;
					native species; to be removed
					(will not survive root loss due to
					nearby excavation)
26	Silver maple	Fair	41	Private	Mature; five stemmed at grade;
	(Acer		avg.		central stem broken at 9m, all
	saccharinum)				other stems all moderately
					divergent; native species; to be
					preserved and protected
27	White spruce	Fair	+/-40	Neighbour	Mature; living crown held at half
	(Picea glauca)				height due to influence of
					surrounding trees; some vine
					(Vitis spp.) growth into crown;
					fair crown density, annual
					increment and needle colour;
					native species; to be preserved
					and protected

Picture 6. Trees #25, 26 and 27 (left to right), private white pine, silver maple and neighbouring white spruce at 3055 Richmond Road

As excavation will be within the CRZs of several trees, in particular tree #26, the following measures will be taken:

- 1. Hydro excavation along the line of excavation in closest proximity to the trees to carefully expose roots. Exposed roots will then be cleanly cut and sealed before being reburied. Excavation can then resume using traditional mechanical means. Sealing the cleanly cut root ends with a beeswax product will help prevent the loss of moisture and facilitate healing.
- 2. If the excavation is to be left open for any time a covering of at least three layers of moistened burlap is to be draped over the exposed face of excavation closest to the tree. This will help reduce the loss of soil moisture (as soil dries the roots contained within die).
