2510 St. Laurent Blvd – Tree Conservation Report

Claridge Homes

October 3, 2023

CLIENT:	Claridge Homes
PROJECT NAME:	Walkley Conroy
REPORT TITLE:	2510 St Laurent Blvd - Tree Conservation Report
IBI REFERENCE:	140253
VERSION:	2.0
DIGITAL MASTER:	J:\140253_Walkley_Conr
ORIGINATOR:	Brittany Semmler, Ecologist
REVIEWER:	Alex Zeller, Associate – Manager, Natural Systems

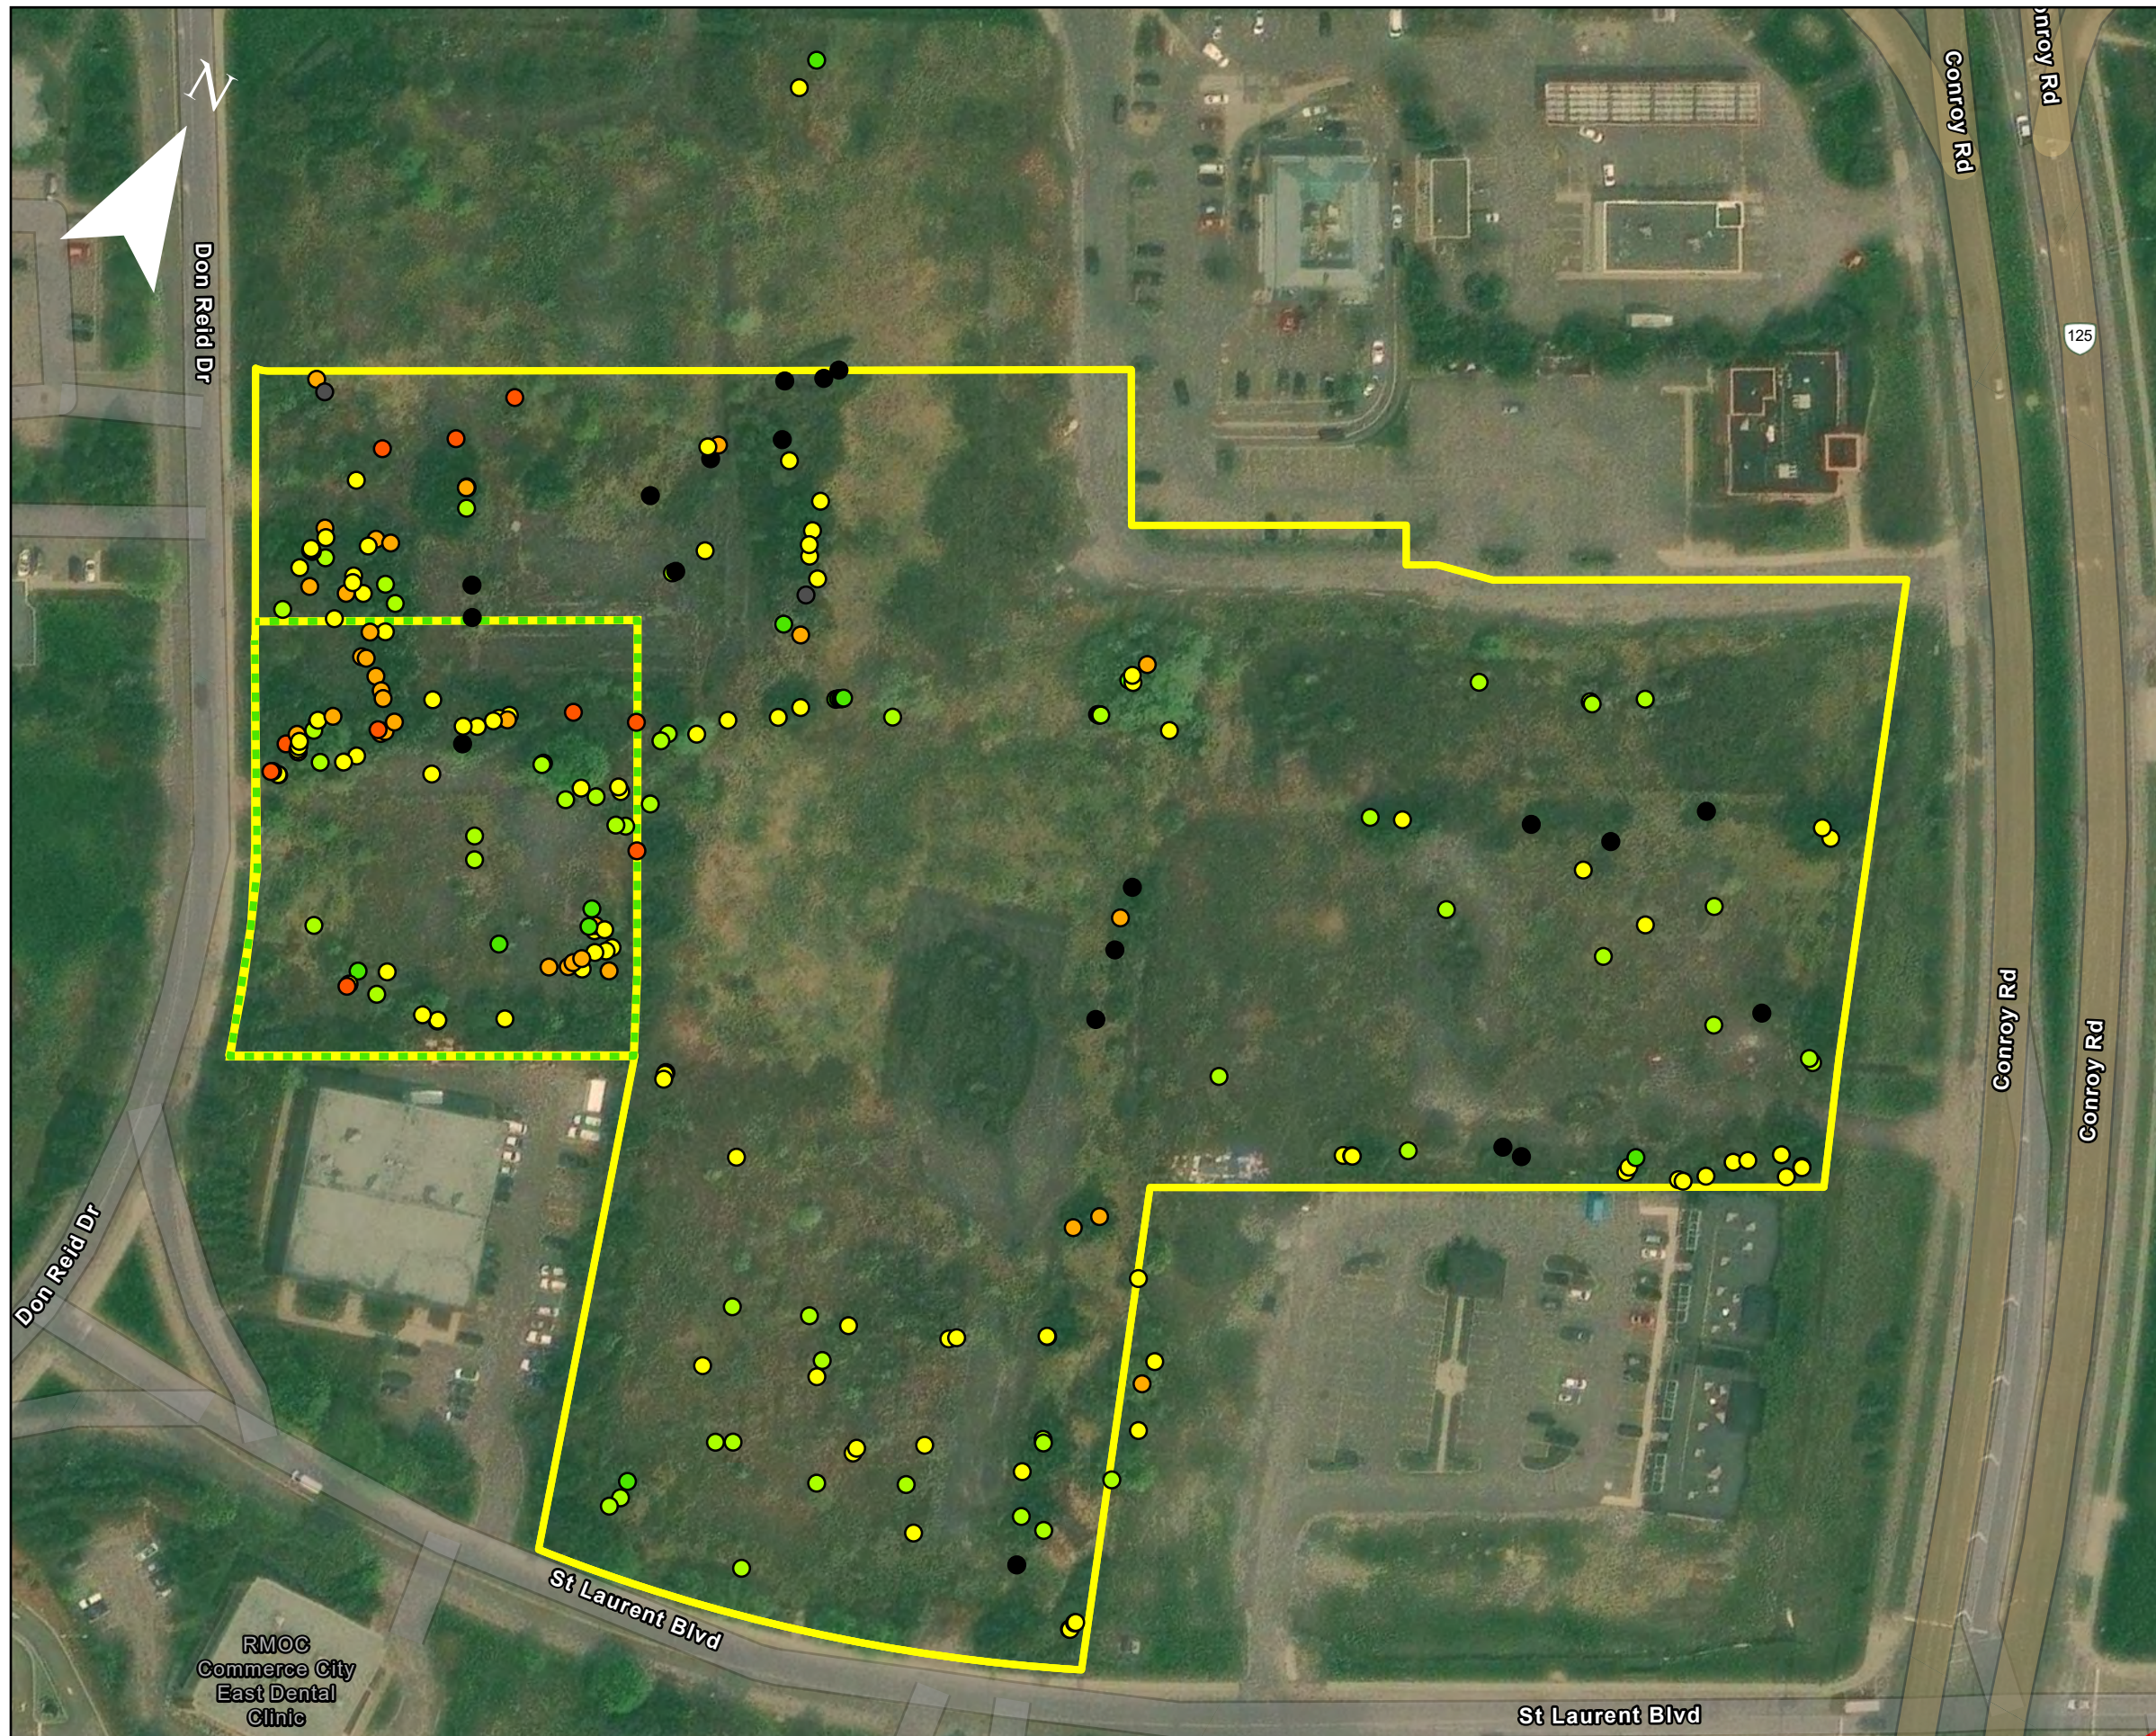
Figure: 1

The vegetation on this vacant commercial property (**Figure 1**) can be described as a disturbed urban tree stand composed of several non-native and invasive tree species of various sizes and stages of development. The trees within the tree stand may provide cover and nesting habitat services for birds and other wildlife. However, none of the inventoried trees possessed cavities that would be suitable for any significant wildlife habitat.

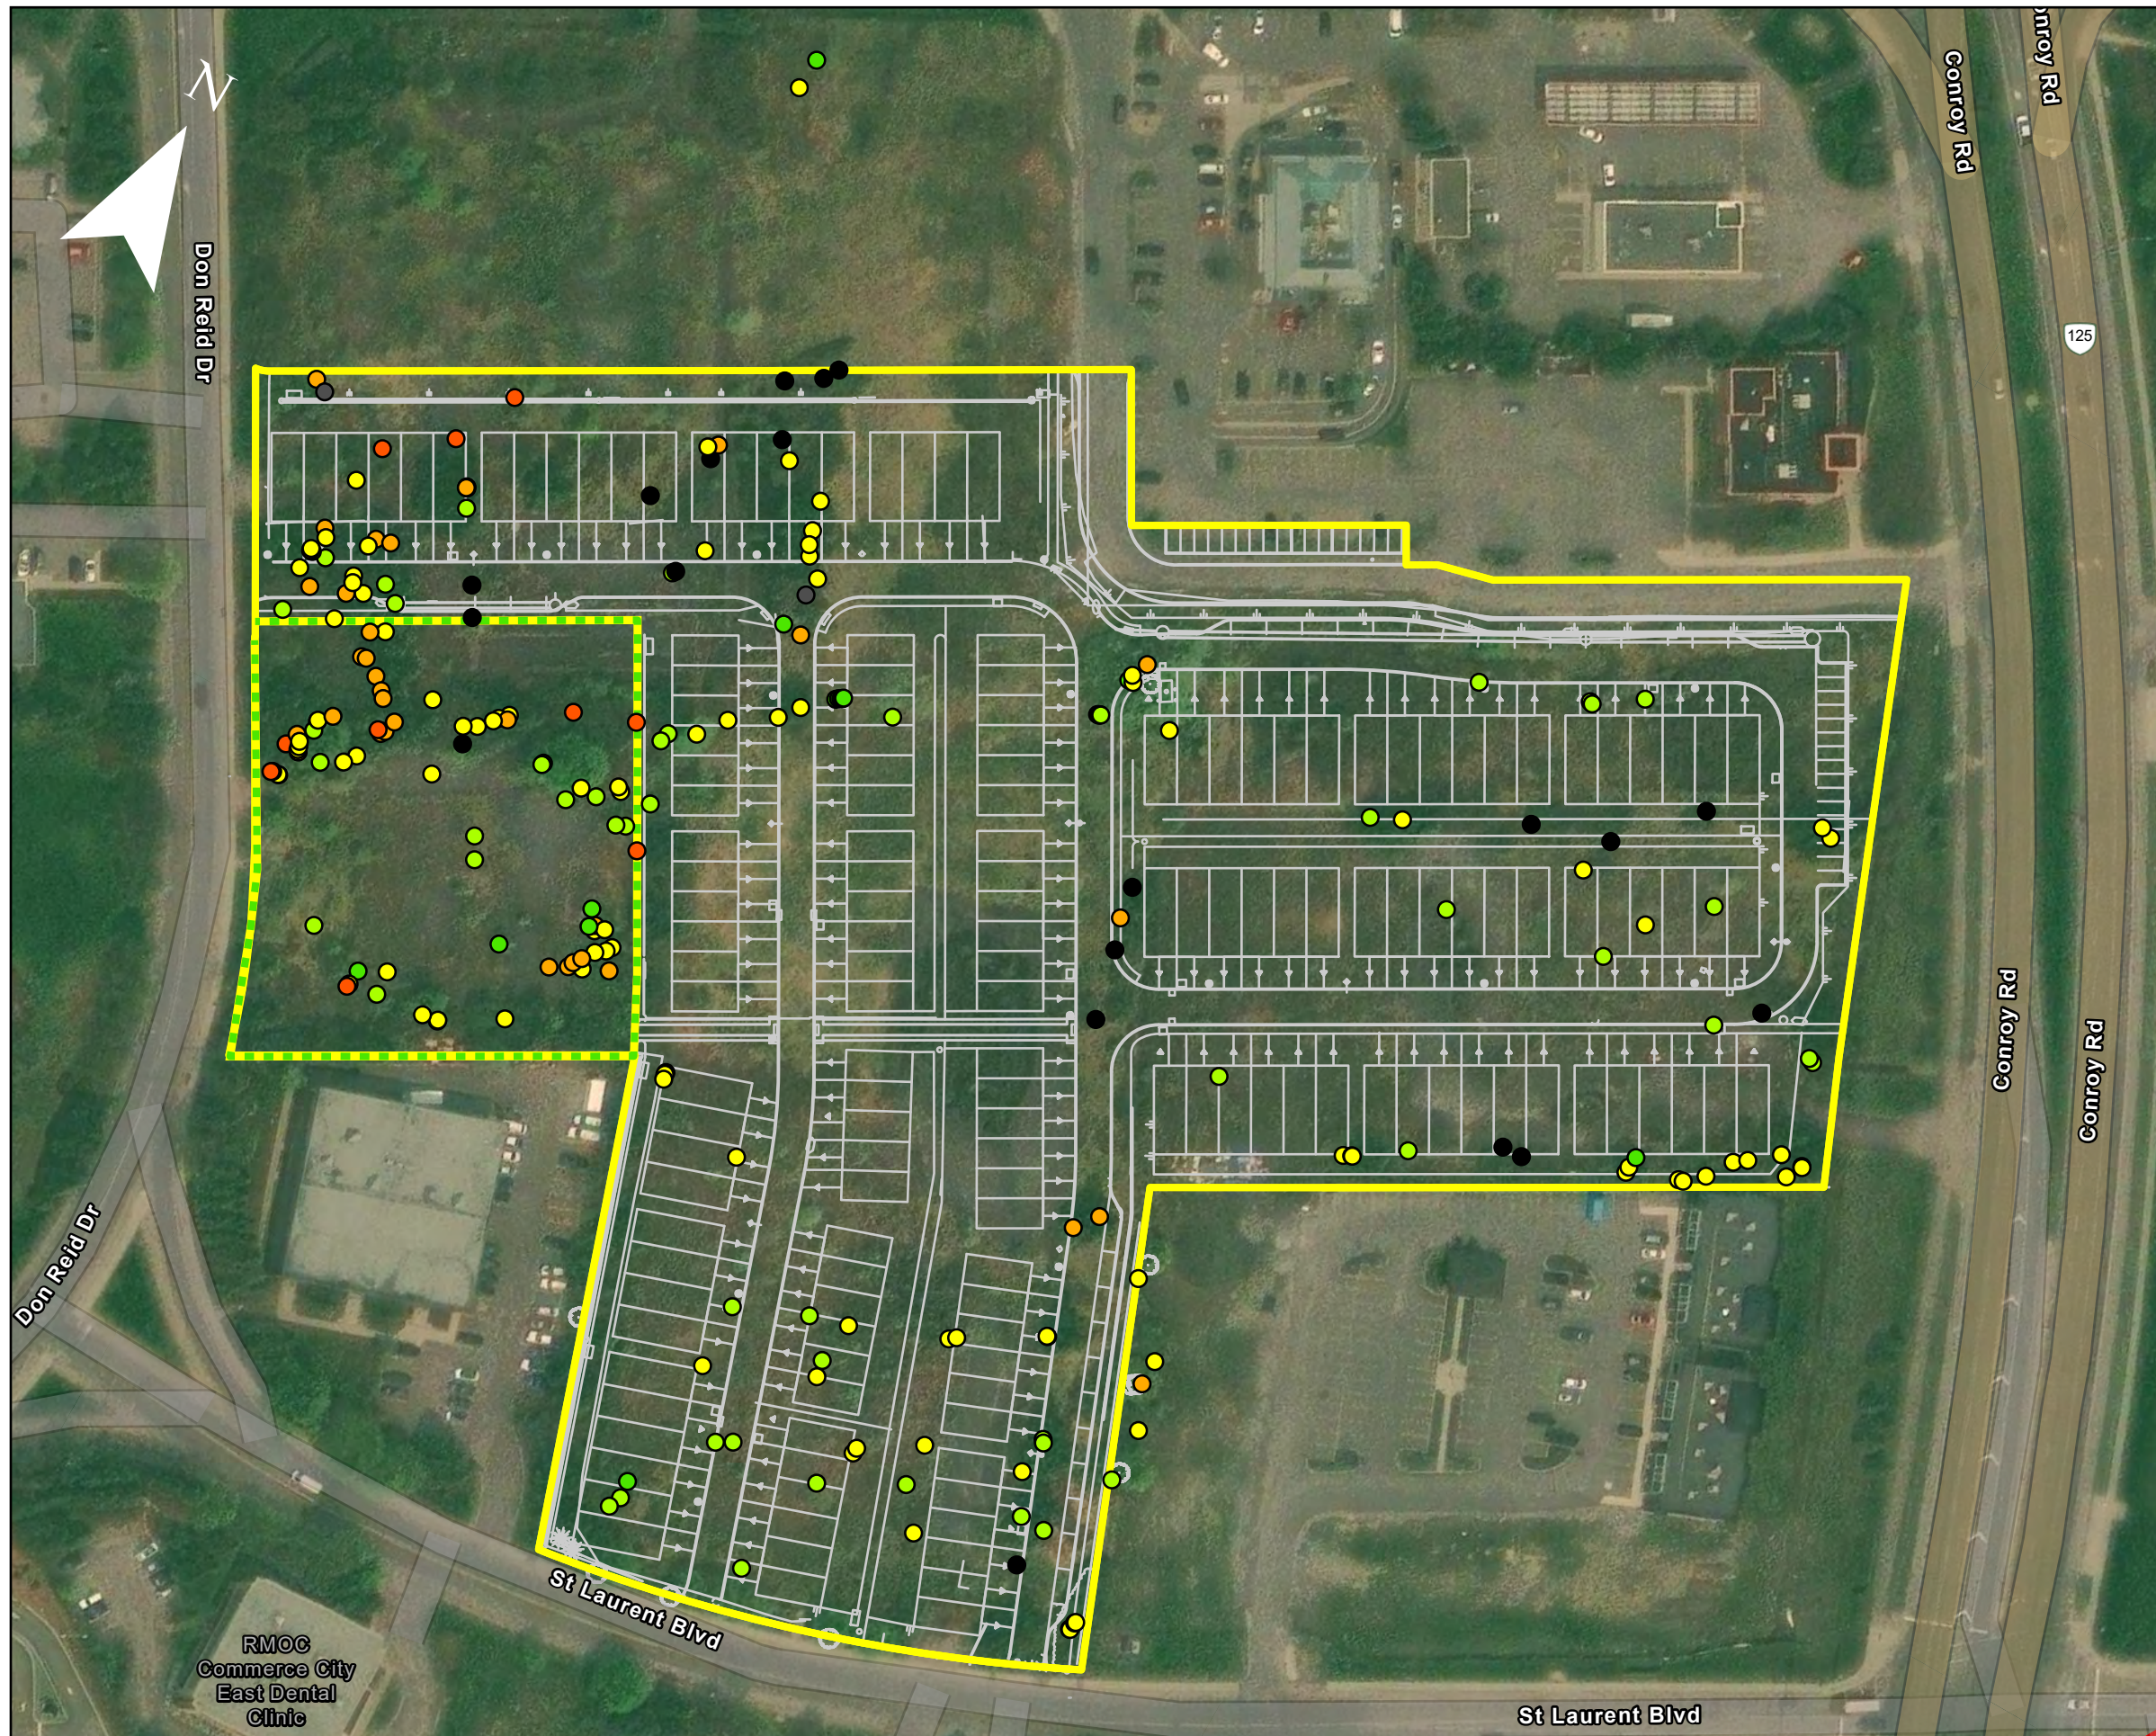
Figure: 2

The Critical Root Zone (CRZ) of 143 trees located within the Subject Property are in direct conflict with the proposed site plan (**Figure 2**) and will require removal. Physical impacts on the CRZ by construction activities rapidly deteriorates the overall health, quality, and ecological service of the tree.
