Fluvial Geomorphological and Erosion Threshold Assessment, Tributary of Cardinal Creek

1296 and 1400 Old Montreal Road
City of Ottawa, Ontario

Submitted:
November 11, 2024

GEO Morphix Project No. 23076

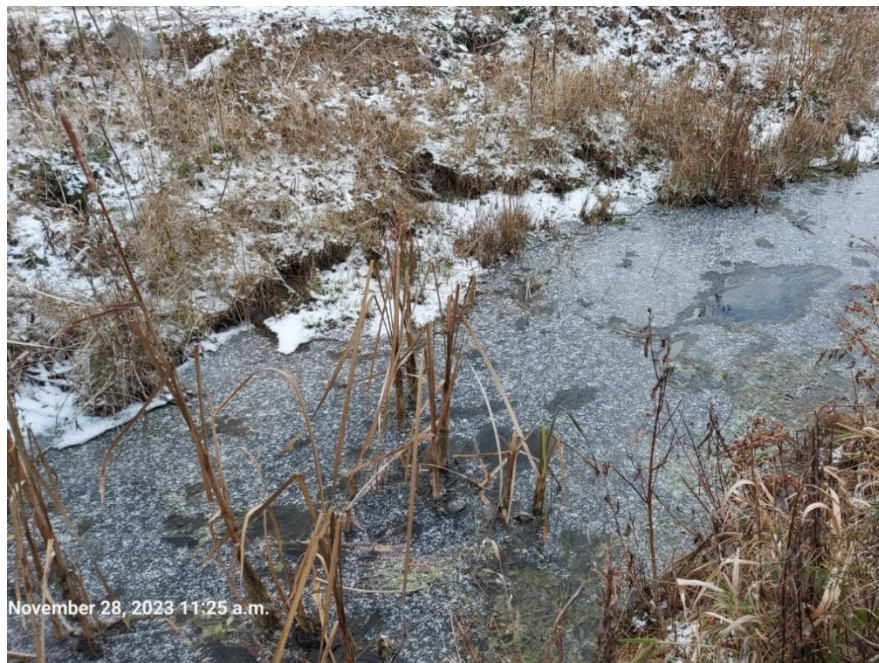
Photo 4
Tributary of Cardinal Creek
Reach: R1

Photograph taken facing the left bank at the downstream extent of **R1**. Minor scour was observed along both banks.

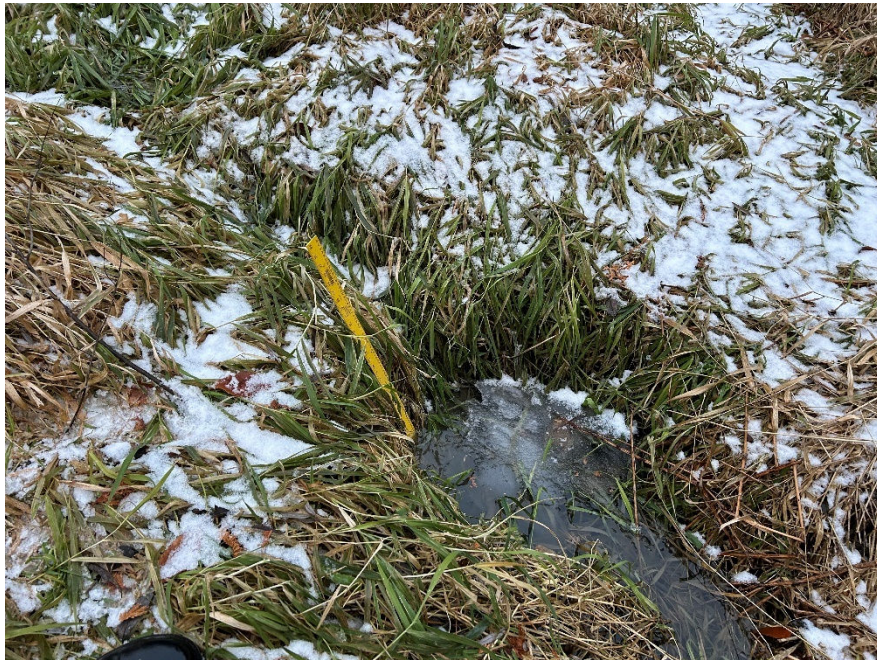
Photo 20
Tributary of Cardinal Creek
Reach: R2A

Photograph taken facing upstream along **R2A**. a knickpoint (0.65m) was observed.

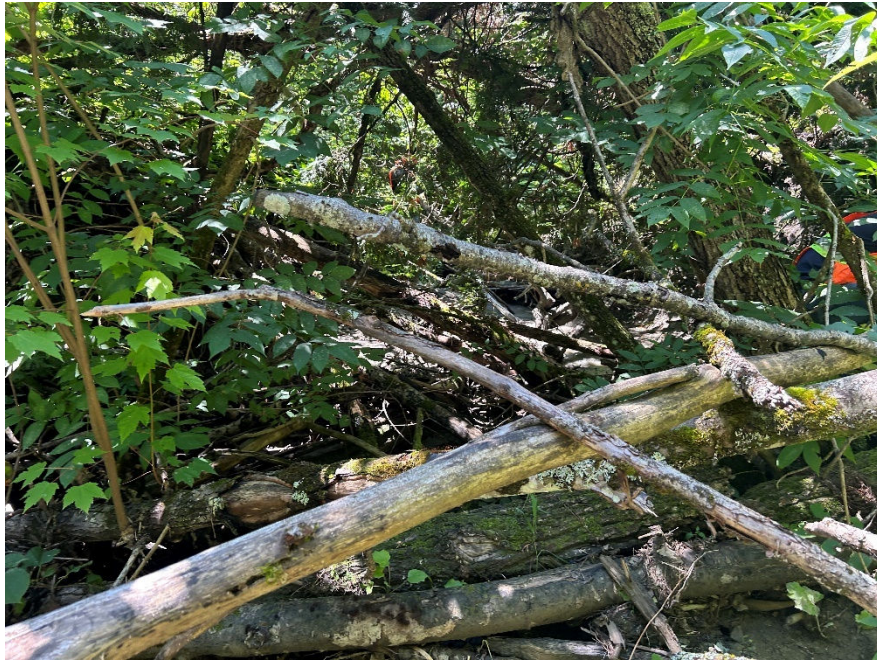
Photo 21
Tributary of Cardinal Creek
Reach: R3

Photograph taken facing downstream at the upstream extent of **R3** Riparian vegetation was primarily composed of mature trees and herbaceous vegetation. Instream woody debris jams were extreme and frequently observed.

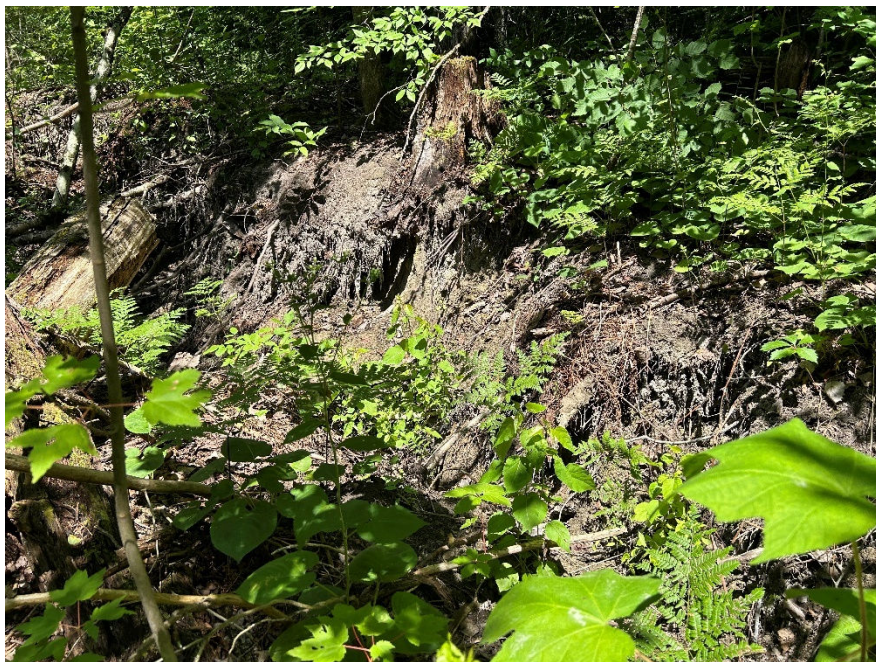
Photograph taken at the downstream extent of **R3** facing the top of a large slump. The slump was located on the right bank and carried debris over the channel.

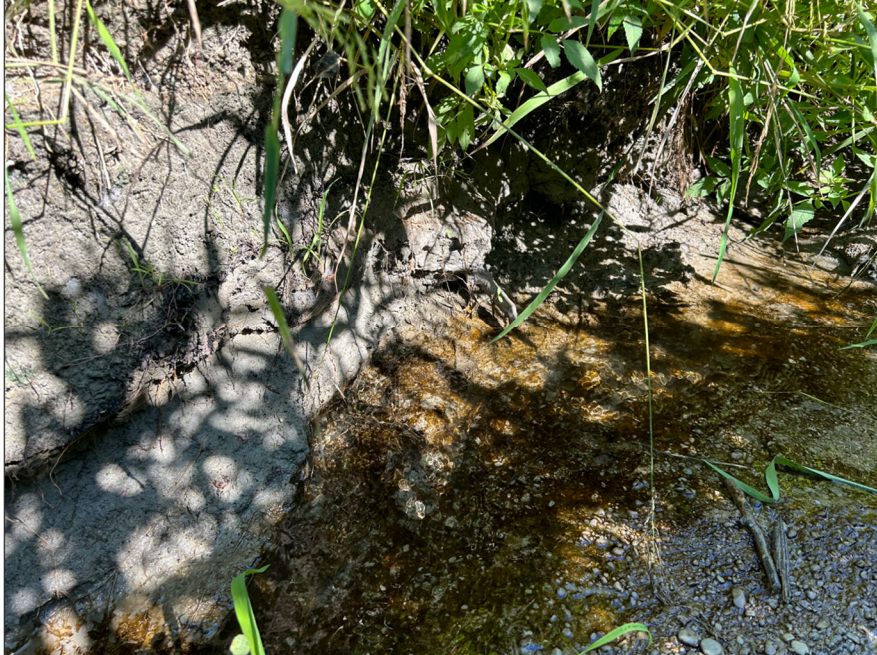
Photograph taken facing the right bank. Bank materials were composed of thick and loose clay deposits. Undercutting of up to 15 cm was observed along the right bank.

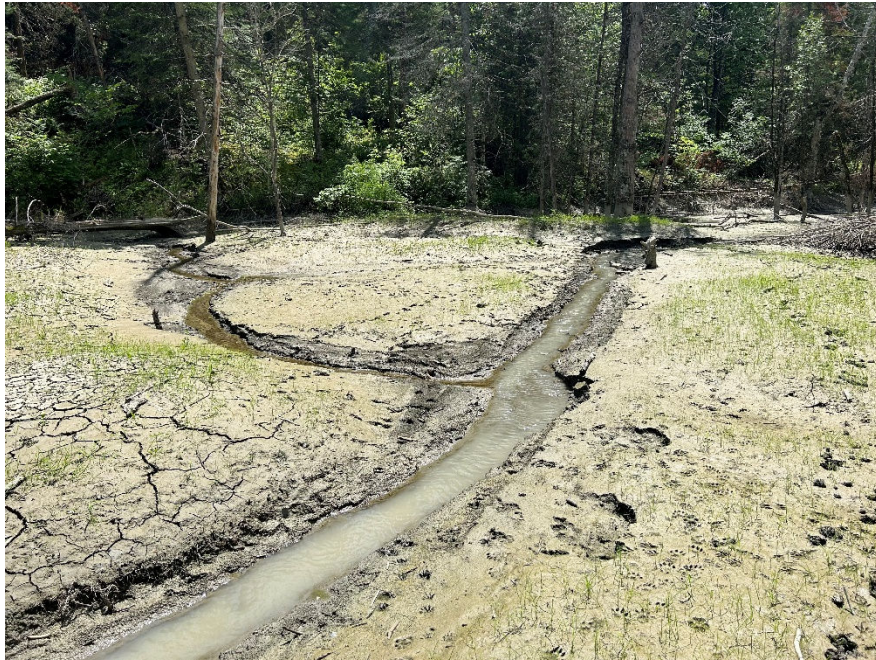
Photograph taken facing downstream along **R4** (summer 2023). The upstream portion of the reach exhibited signs of recent de-watering including dry cracked sediments and the channel carving a path through exposed sediments.

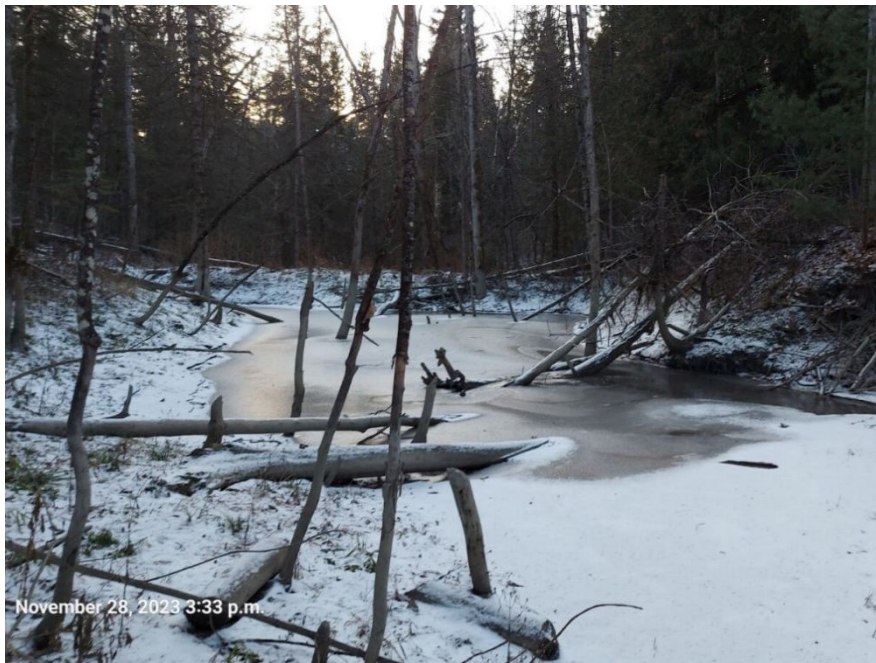
Photograph taken facing downstream along **R4** (fall 2023). A large beaver pond was still observed directly upstream of the beaver dam.

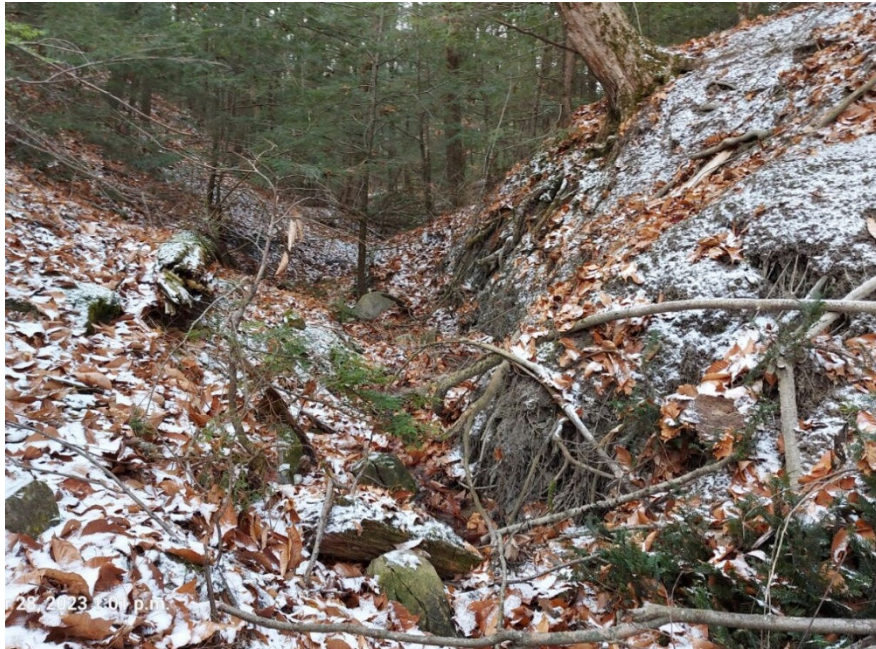
Photograph taken facing downstream from the upstream extent of **T1**. The channel had a high gradient as it travelled through a ravine. Riparian vegetation was composed of trees.

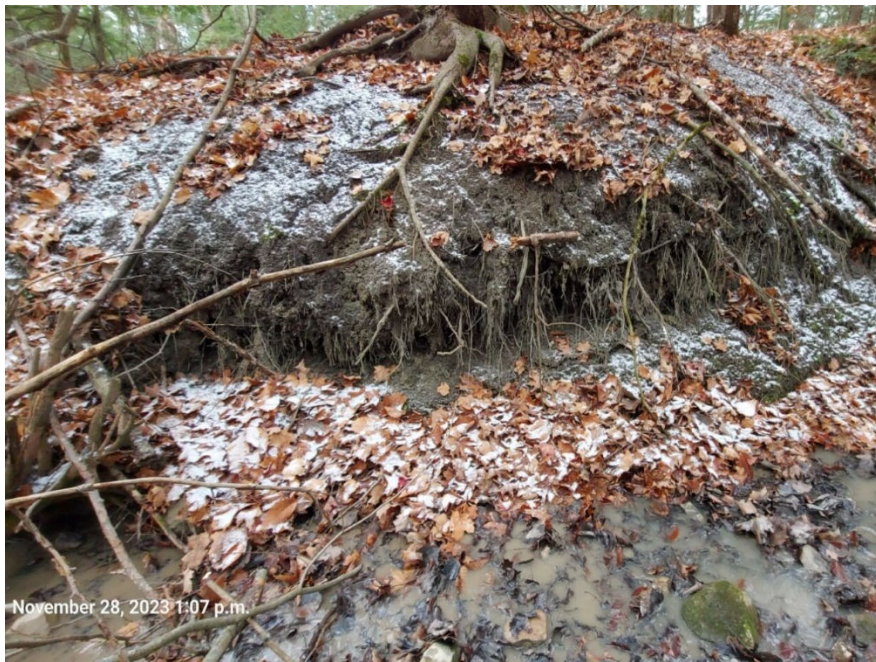
Photograph taken facing the right bank along **T1**. Undercutting, exposed roots and woody debris jams were commonly observed.

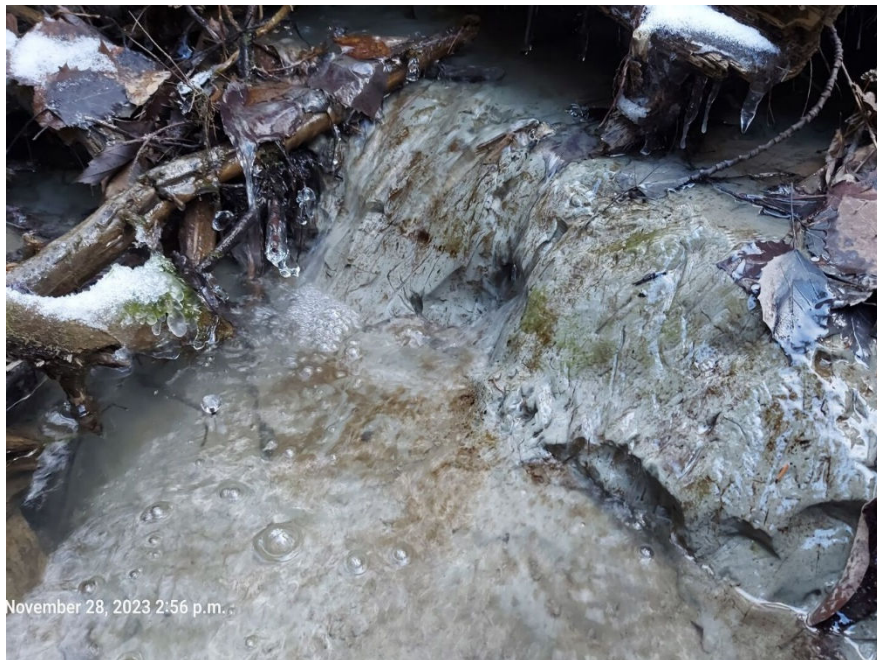
Photograph taken facing upstream along **T4**. Several forced knickpoints were observed as well as knickpoints in exposed clay-till.

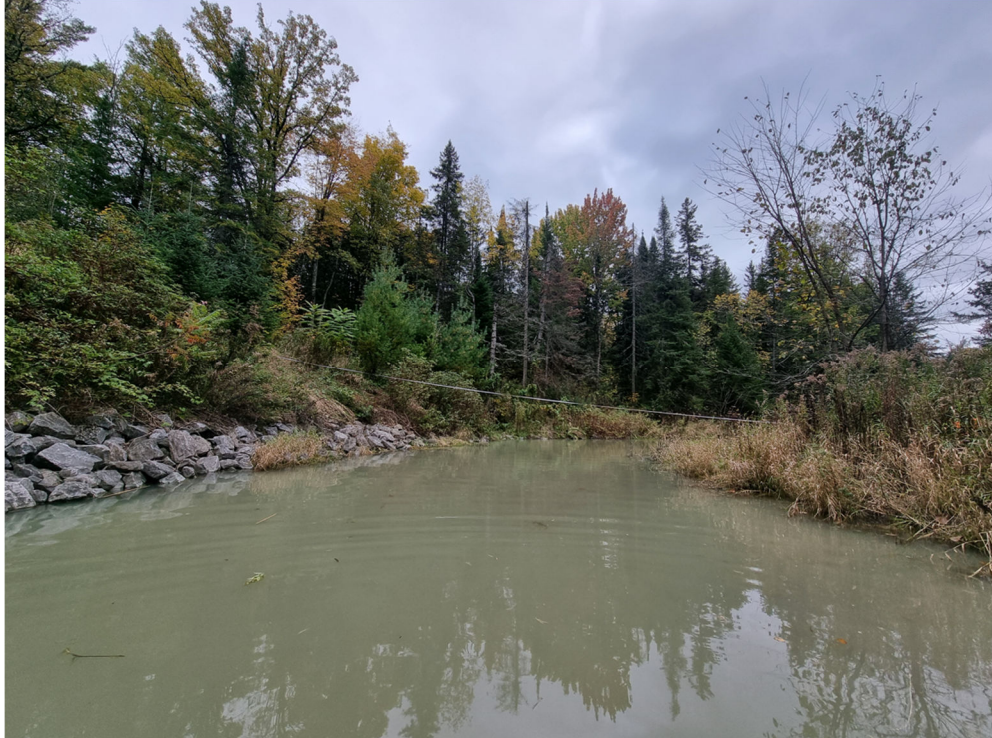
Photograph taken facing upstream at cross-section 5; located upstream of one of three beaver dams observed. Slope stabilization works comprise the right bank around the meander bend for erosion protection.
