Geotechnical Investigation

Proposed Residential Development

4386 Rideau Valley Drive
Ottawa, Ontario

Report PG5828-1 Revision 5 dated July 19, 2024

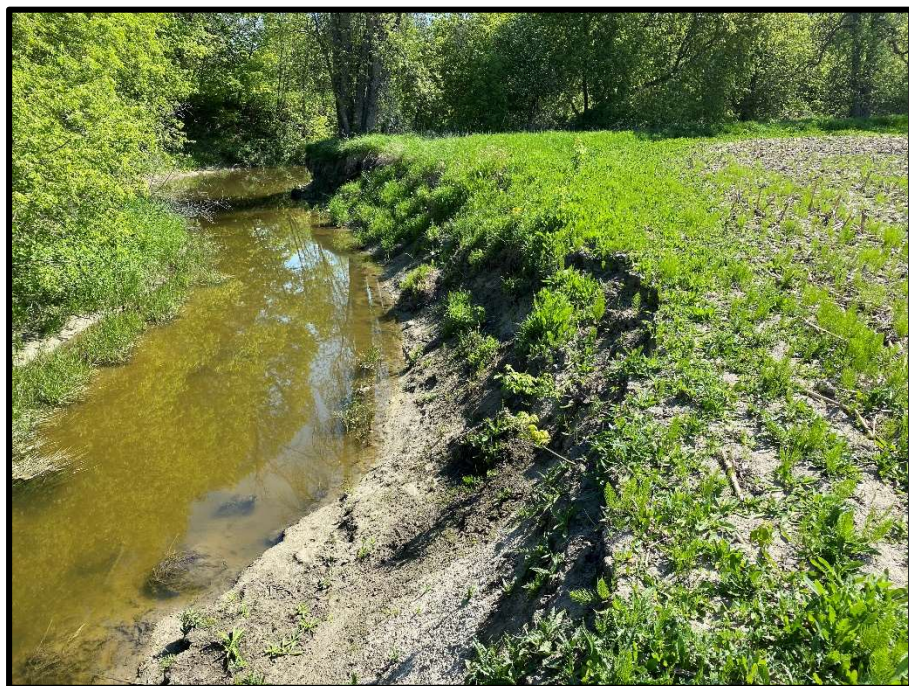
Photo 12: Area of Mud Creek along north-west portion of subject site. Area appeared to have banks exposed to streams flow and along with slumping and oversteepening of banks at the time of our site visit.
