FLUVIAL GEOMORPHIC AND EROSION HAZARD ASSESSMENT
STINSON LANDS
OTTAWA, ONTARIO

Prepared for:
NOVATECH ENGINEERING AND CONSULTANTS LTD.

Prepared by:
MATRIX SOLUTIONS INC.

Version 1.0
November 2022
Guelph, Ontario

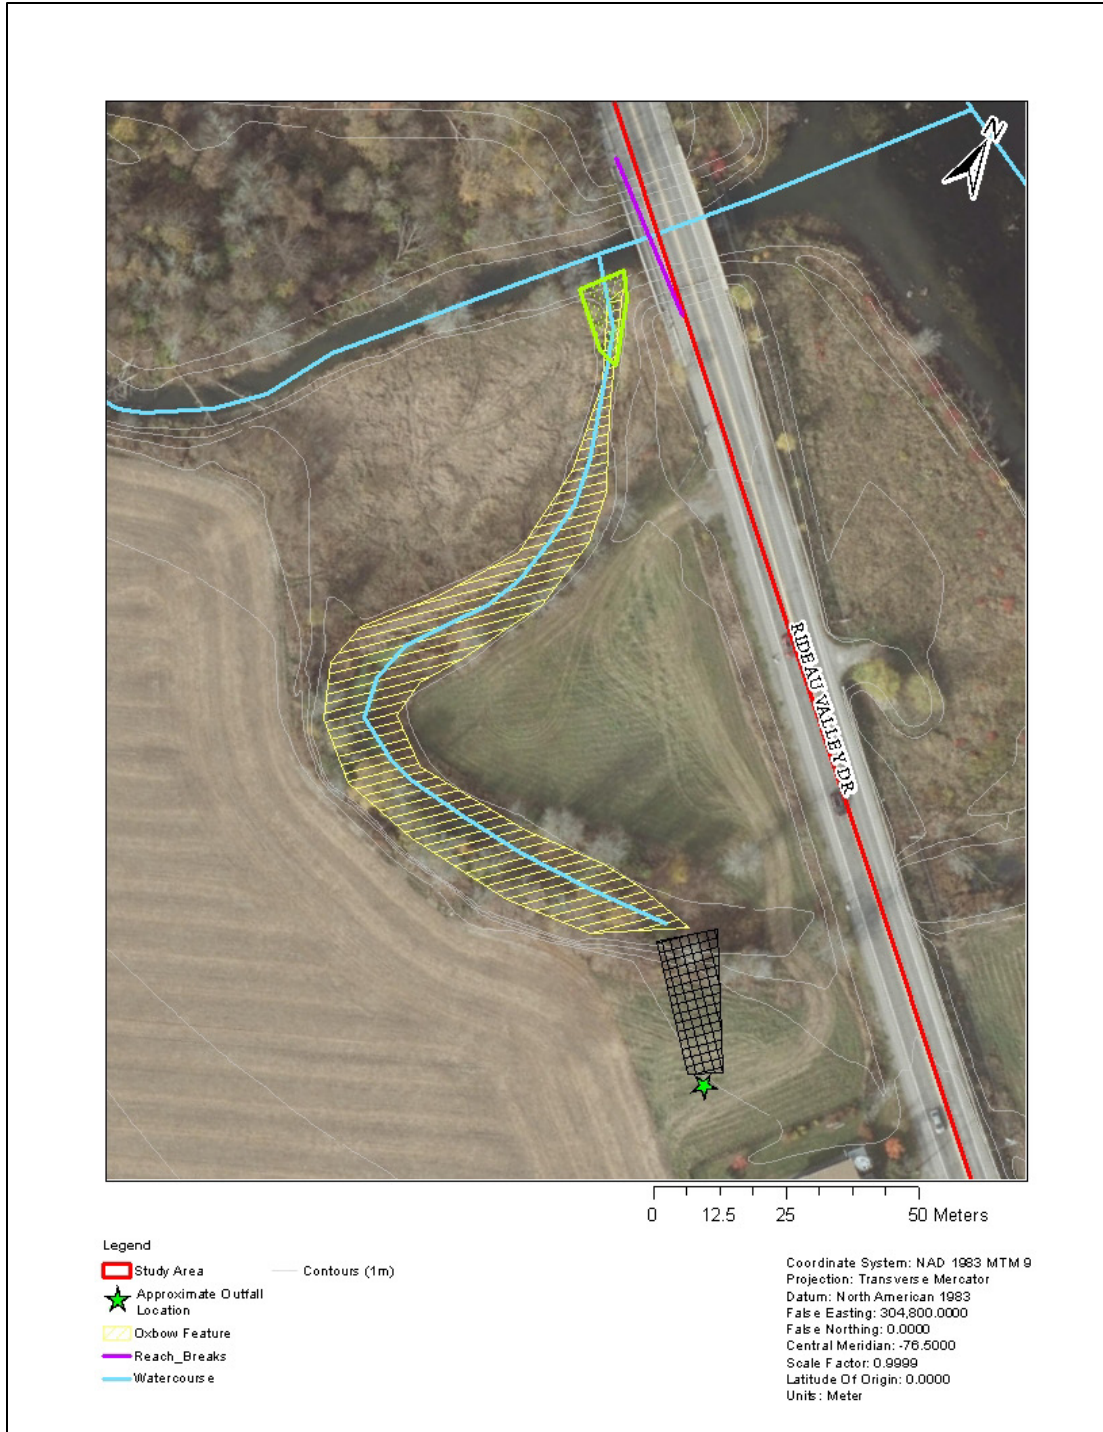
FIGURE 8 Recommended Design Opportunities for Stormwater Management Outflows

With velocities at the connection to Mud Creek being four times the permissible velocity under the 2-year, it is recommended that a connection to Mud Creek be formalized (Figure 8) with a gentler slope, design cross-section, and appropriately sized/selected lining materials to avoid headcutting into the floodplain, towards the oxbow feature. This would have to consider changes in the water level of Mud Creek for sustained stability.

Figure 8 provides the approximate location and extent of required stabilization works for a formalized Mud Creek connection to be developed through detailed design. Furthermore, at the detailed design stage, Matrix recommends the confirmation of stability of the oxbow under future scenarios through detailed hydraulic modelling (e.g., HEC-RAS) and any potential mitigation or alternate design options to convey flows from the development to Mud Creek that may be required pending the result of detailed design analysis. As mentioned earlier in this section, it is understood that further analysis will be completed at the detailed design stage to ensure that there will be no negative impacts to the oxbow feature, Mud Creek, or the Rideau River that may result from increased peak flows (Novatech 2022). The formalization of a connection down the bank of Mud Creek, the outflow channel design, and other floodplain modifications (if required) should be designed by or in collaboration with practitioners in fluvial geomorphology.

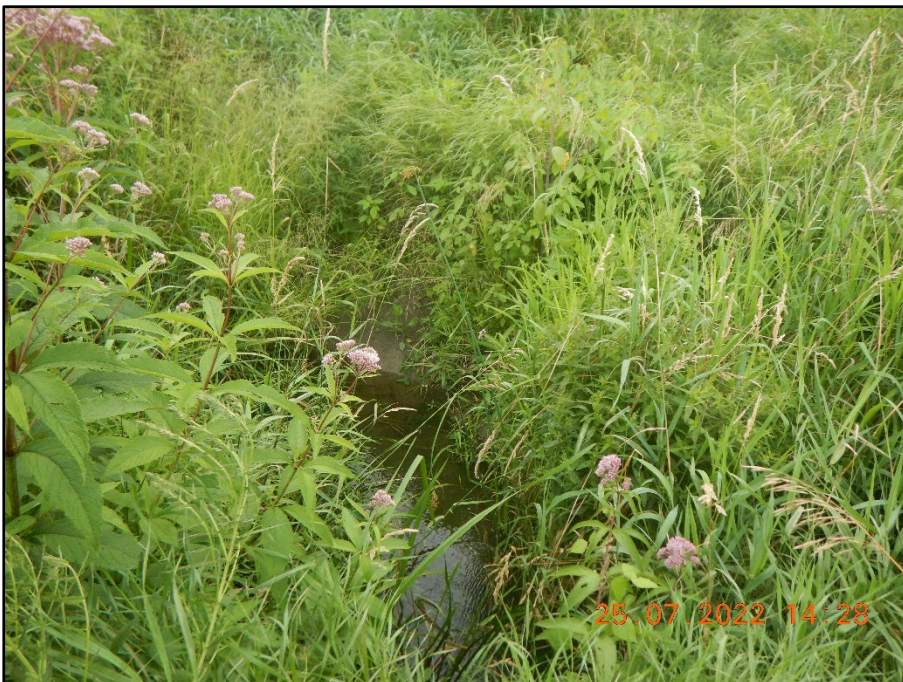
6. Wilson Cowan Drain - Facing downstream, the reach showed consistent signs of erosion in the form of steep outside meander banks, slumped banks, and failed banks

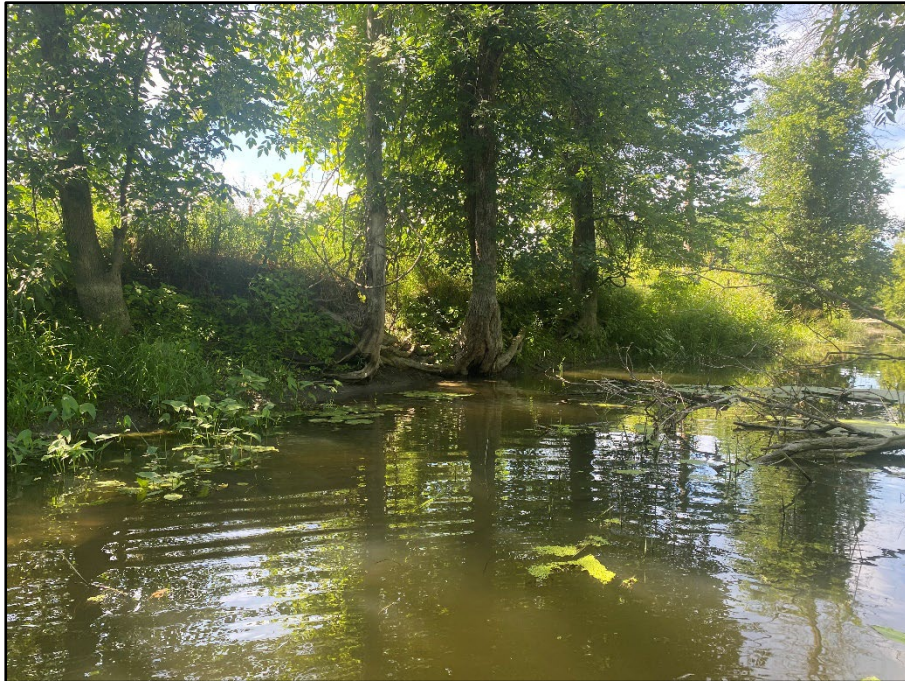
9. Mud Creek – Facing upstream, creek banks commonly show exposed tree roots

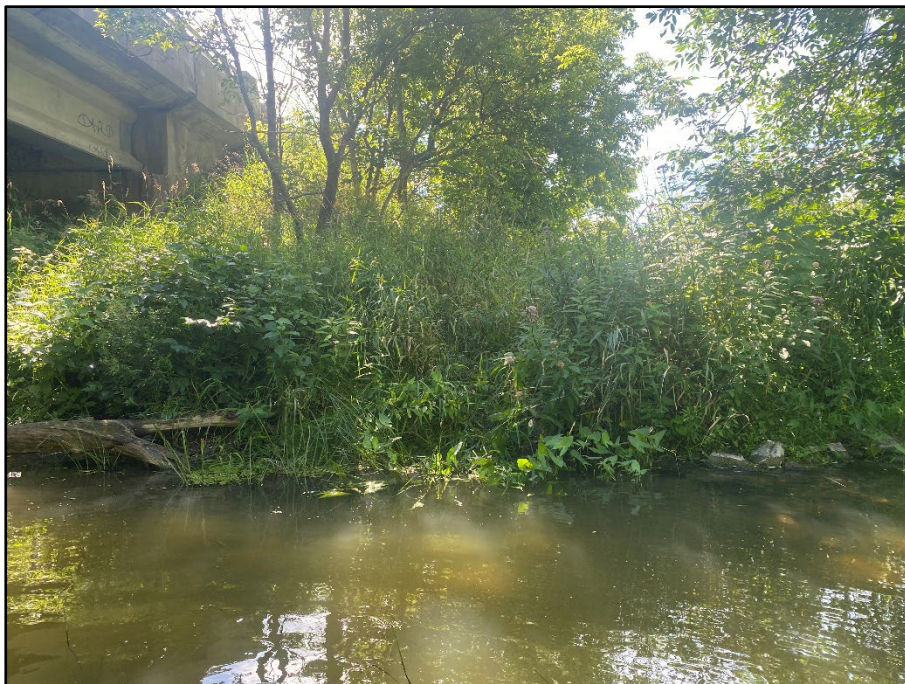
10. Mud Creek – Facing parallel to Rideau Valley Drive N, inlet location from the Oxbow feature into Mud Creek with an approximate 1 – 1.5 m elevation change

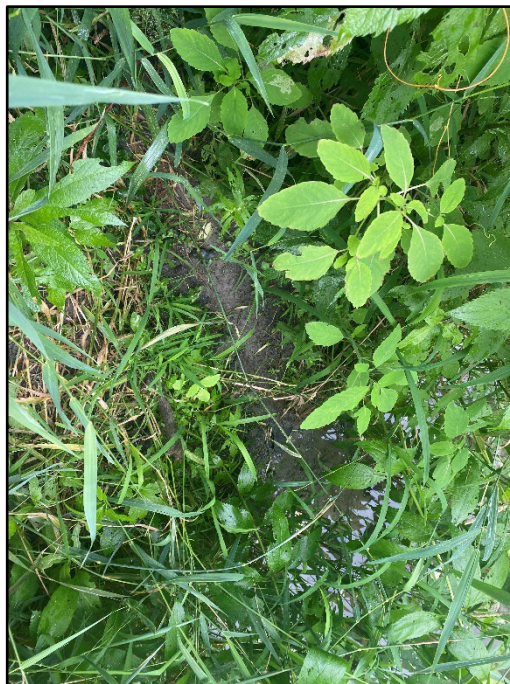
12. Oxbow Feature – Facing down, elevated area separating the standing water in the Oxbow and Mud Creek has a clear and define flow path but was above the water level at the time of the field visit

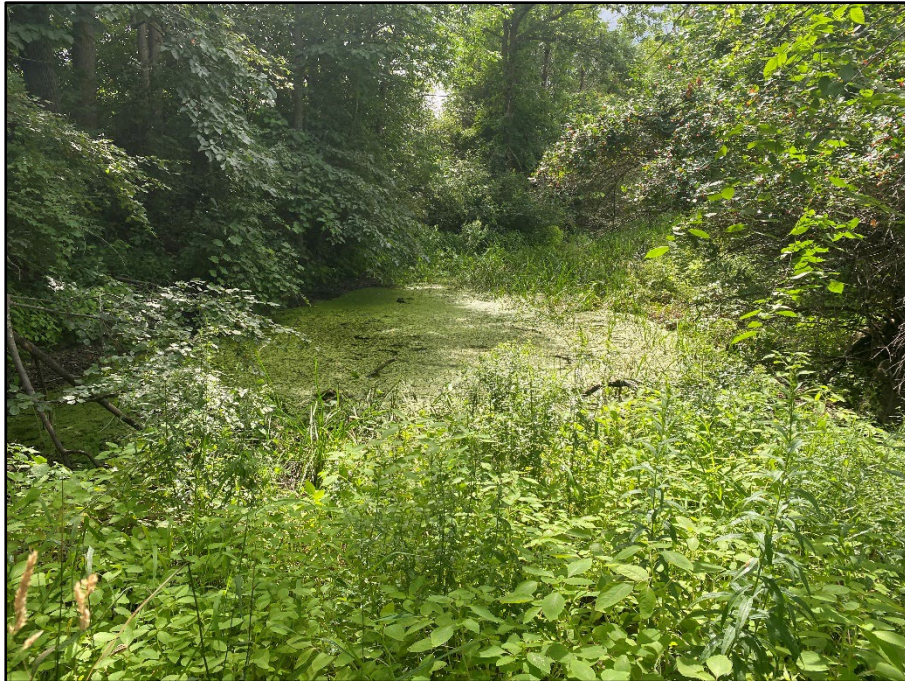
13. Oxbow Feature – Facing downstream, the depression maintained standing water at the time of the site visit, with saturated and unconsolidated soil underneath

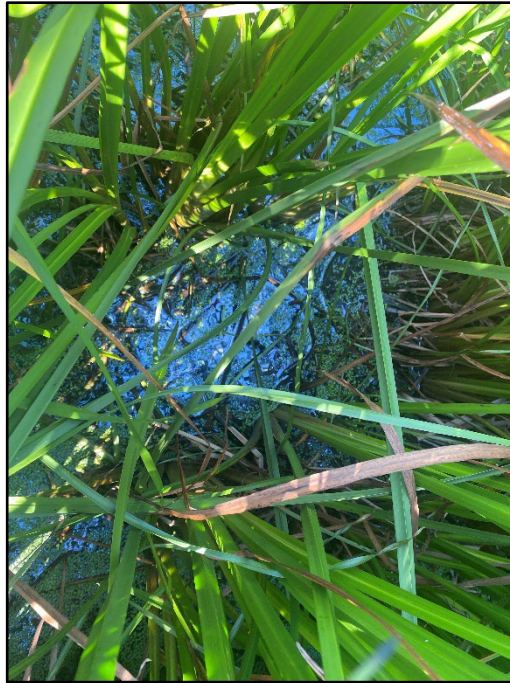
15. Oxbow Feature – Facing down, water surfaces in parts of the oxbow show pollution in the form of mineral staining
