April 18, 2023

1900 and 2000 CITYPARK DRIVE TREE INVENTORY AND RETENTION REVIEW

project
1900 & 2000 CITY PARK DRIVE

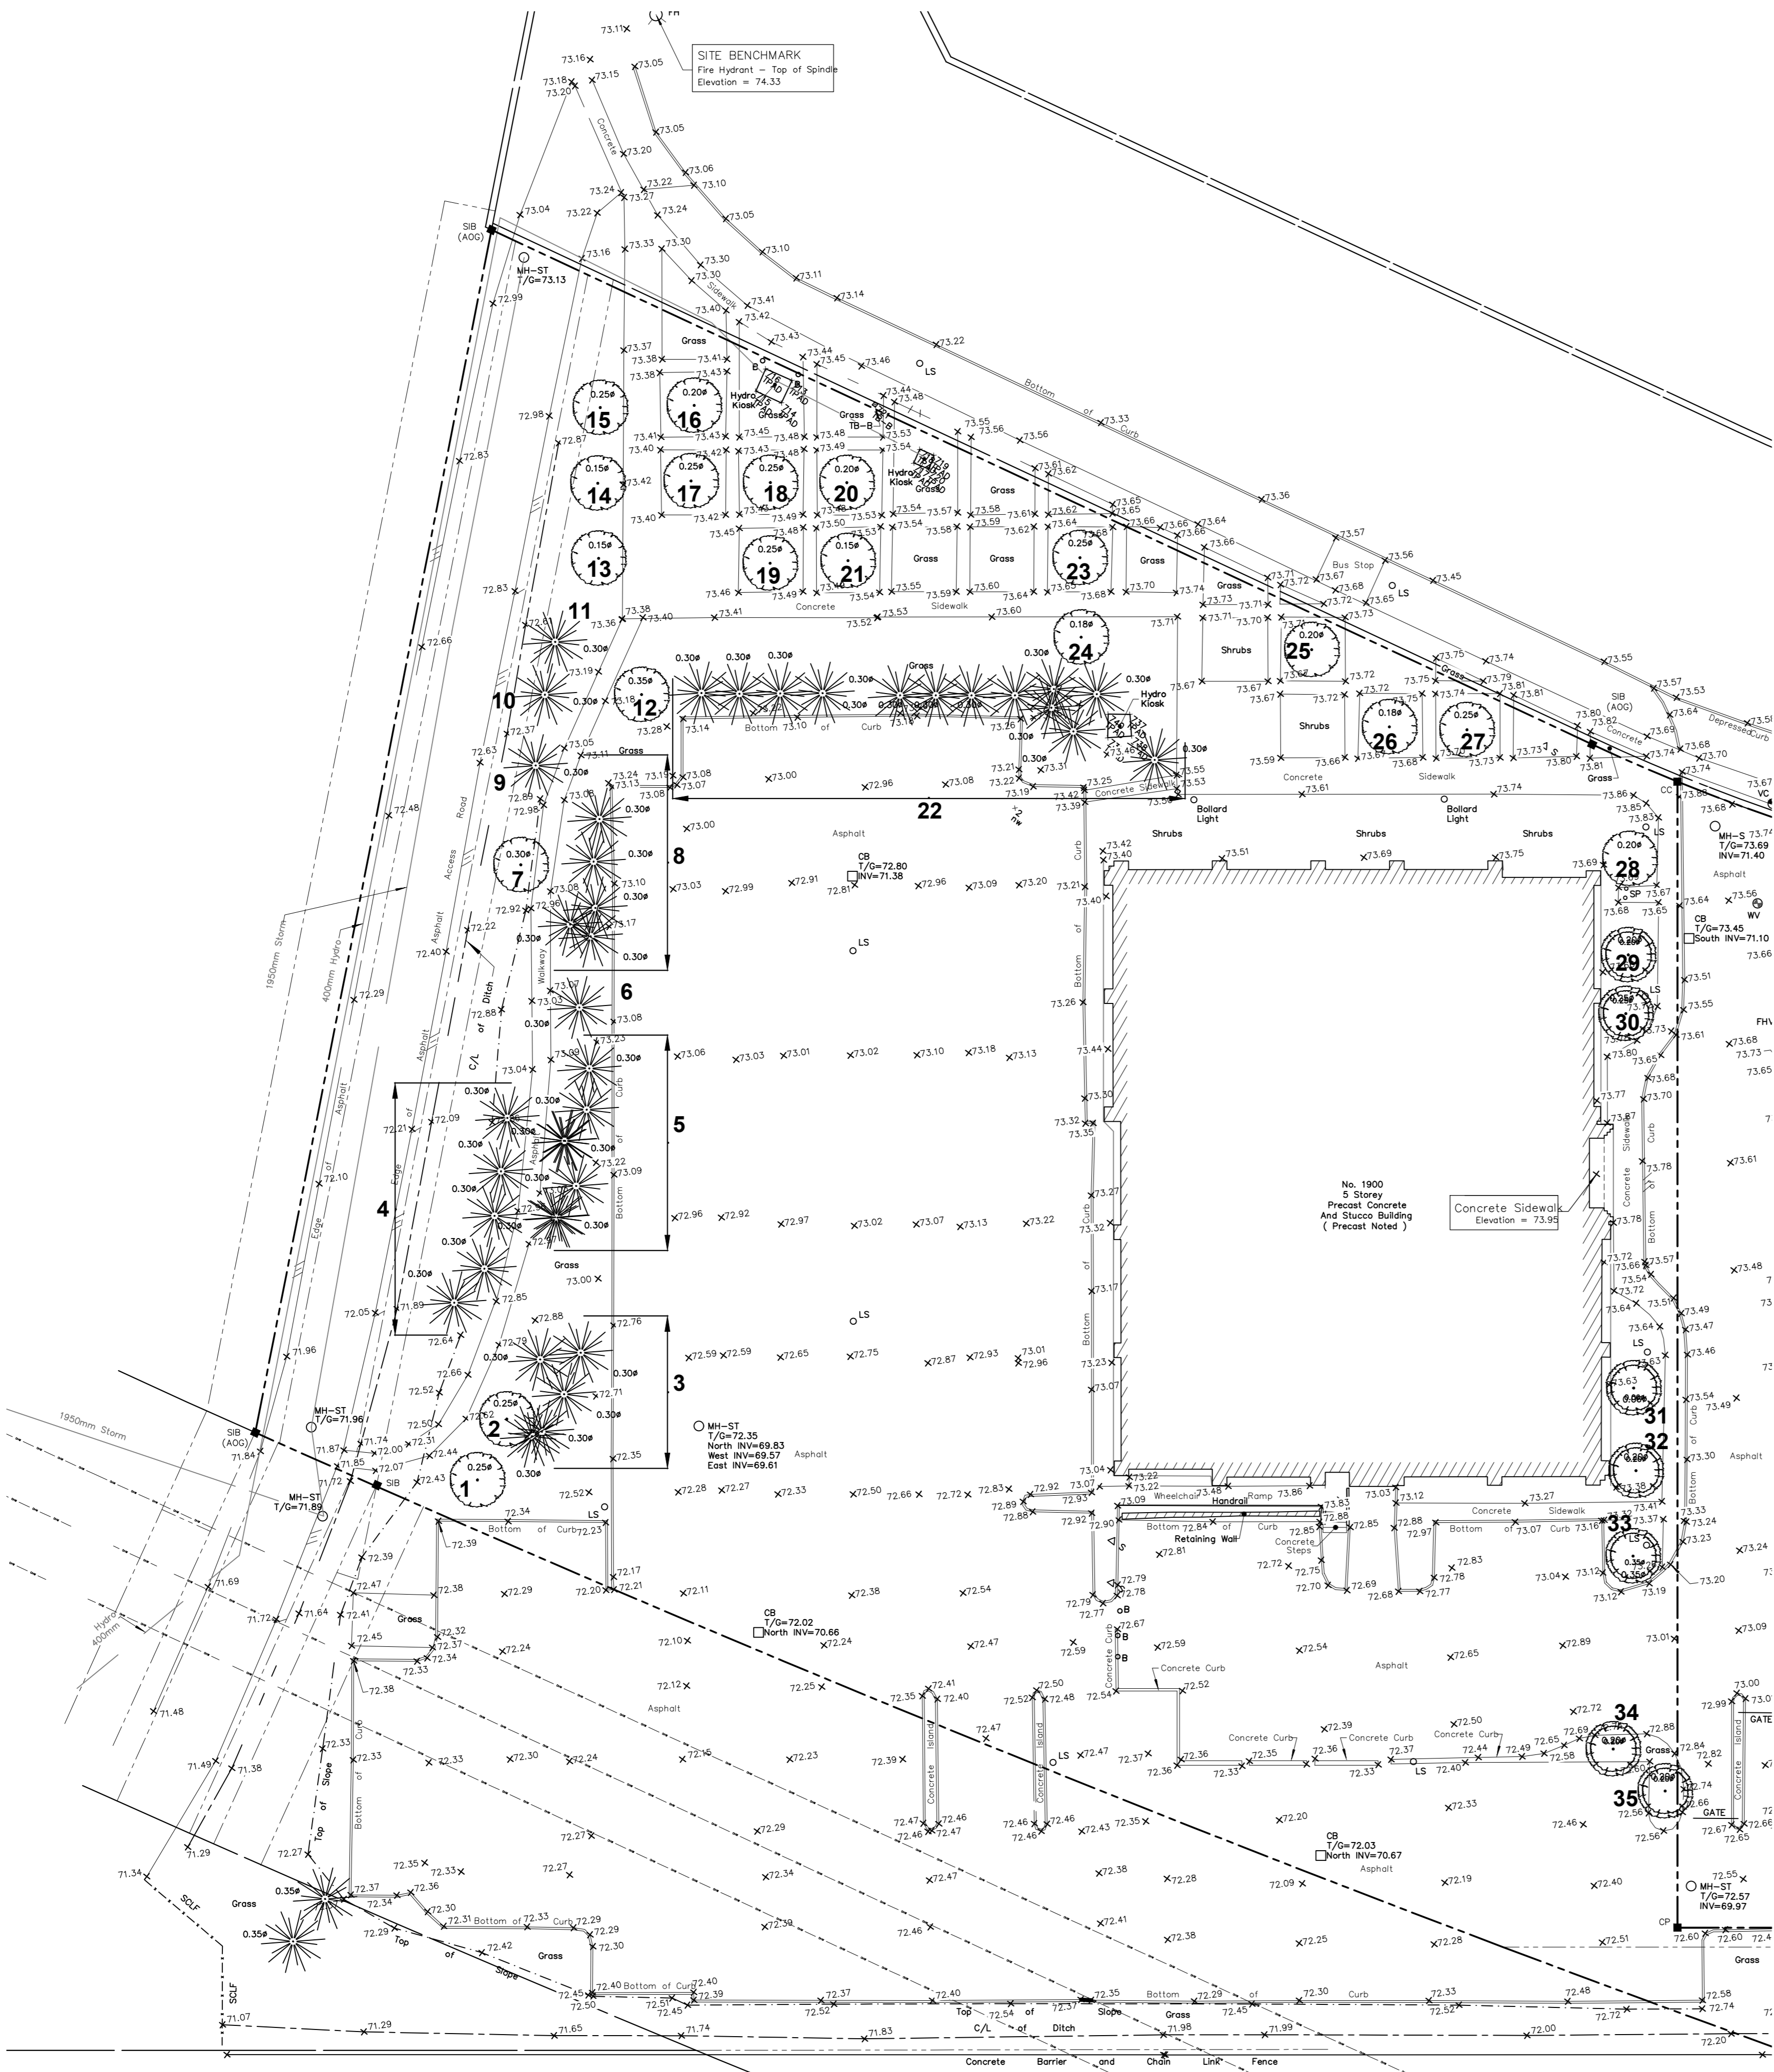
drawing title
1900 CITY PARK DRIVE EXISTING VEGETATION

This block consists of an existing 5 storey building, parking and built landscape with semi mature trees. The majority of the species here are Norway Maple, Colorado Spruce and Japanese Tree Lilac, semi-mature to mature size, from poor to good condition, refer to chart.

Tree Retention: Preservation opportunities exist in the north west corner (parkland dedication) (trees #8-21), depending on the future use. The remainder of the trees would be removed. A final review of retention possibilities will be undertaken during the site plan control process with a final site plan layout. Refer to attached tree retention areas.

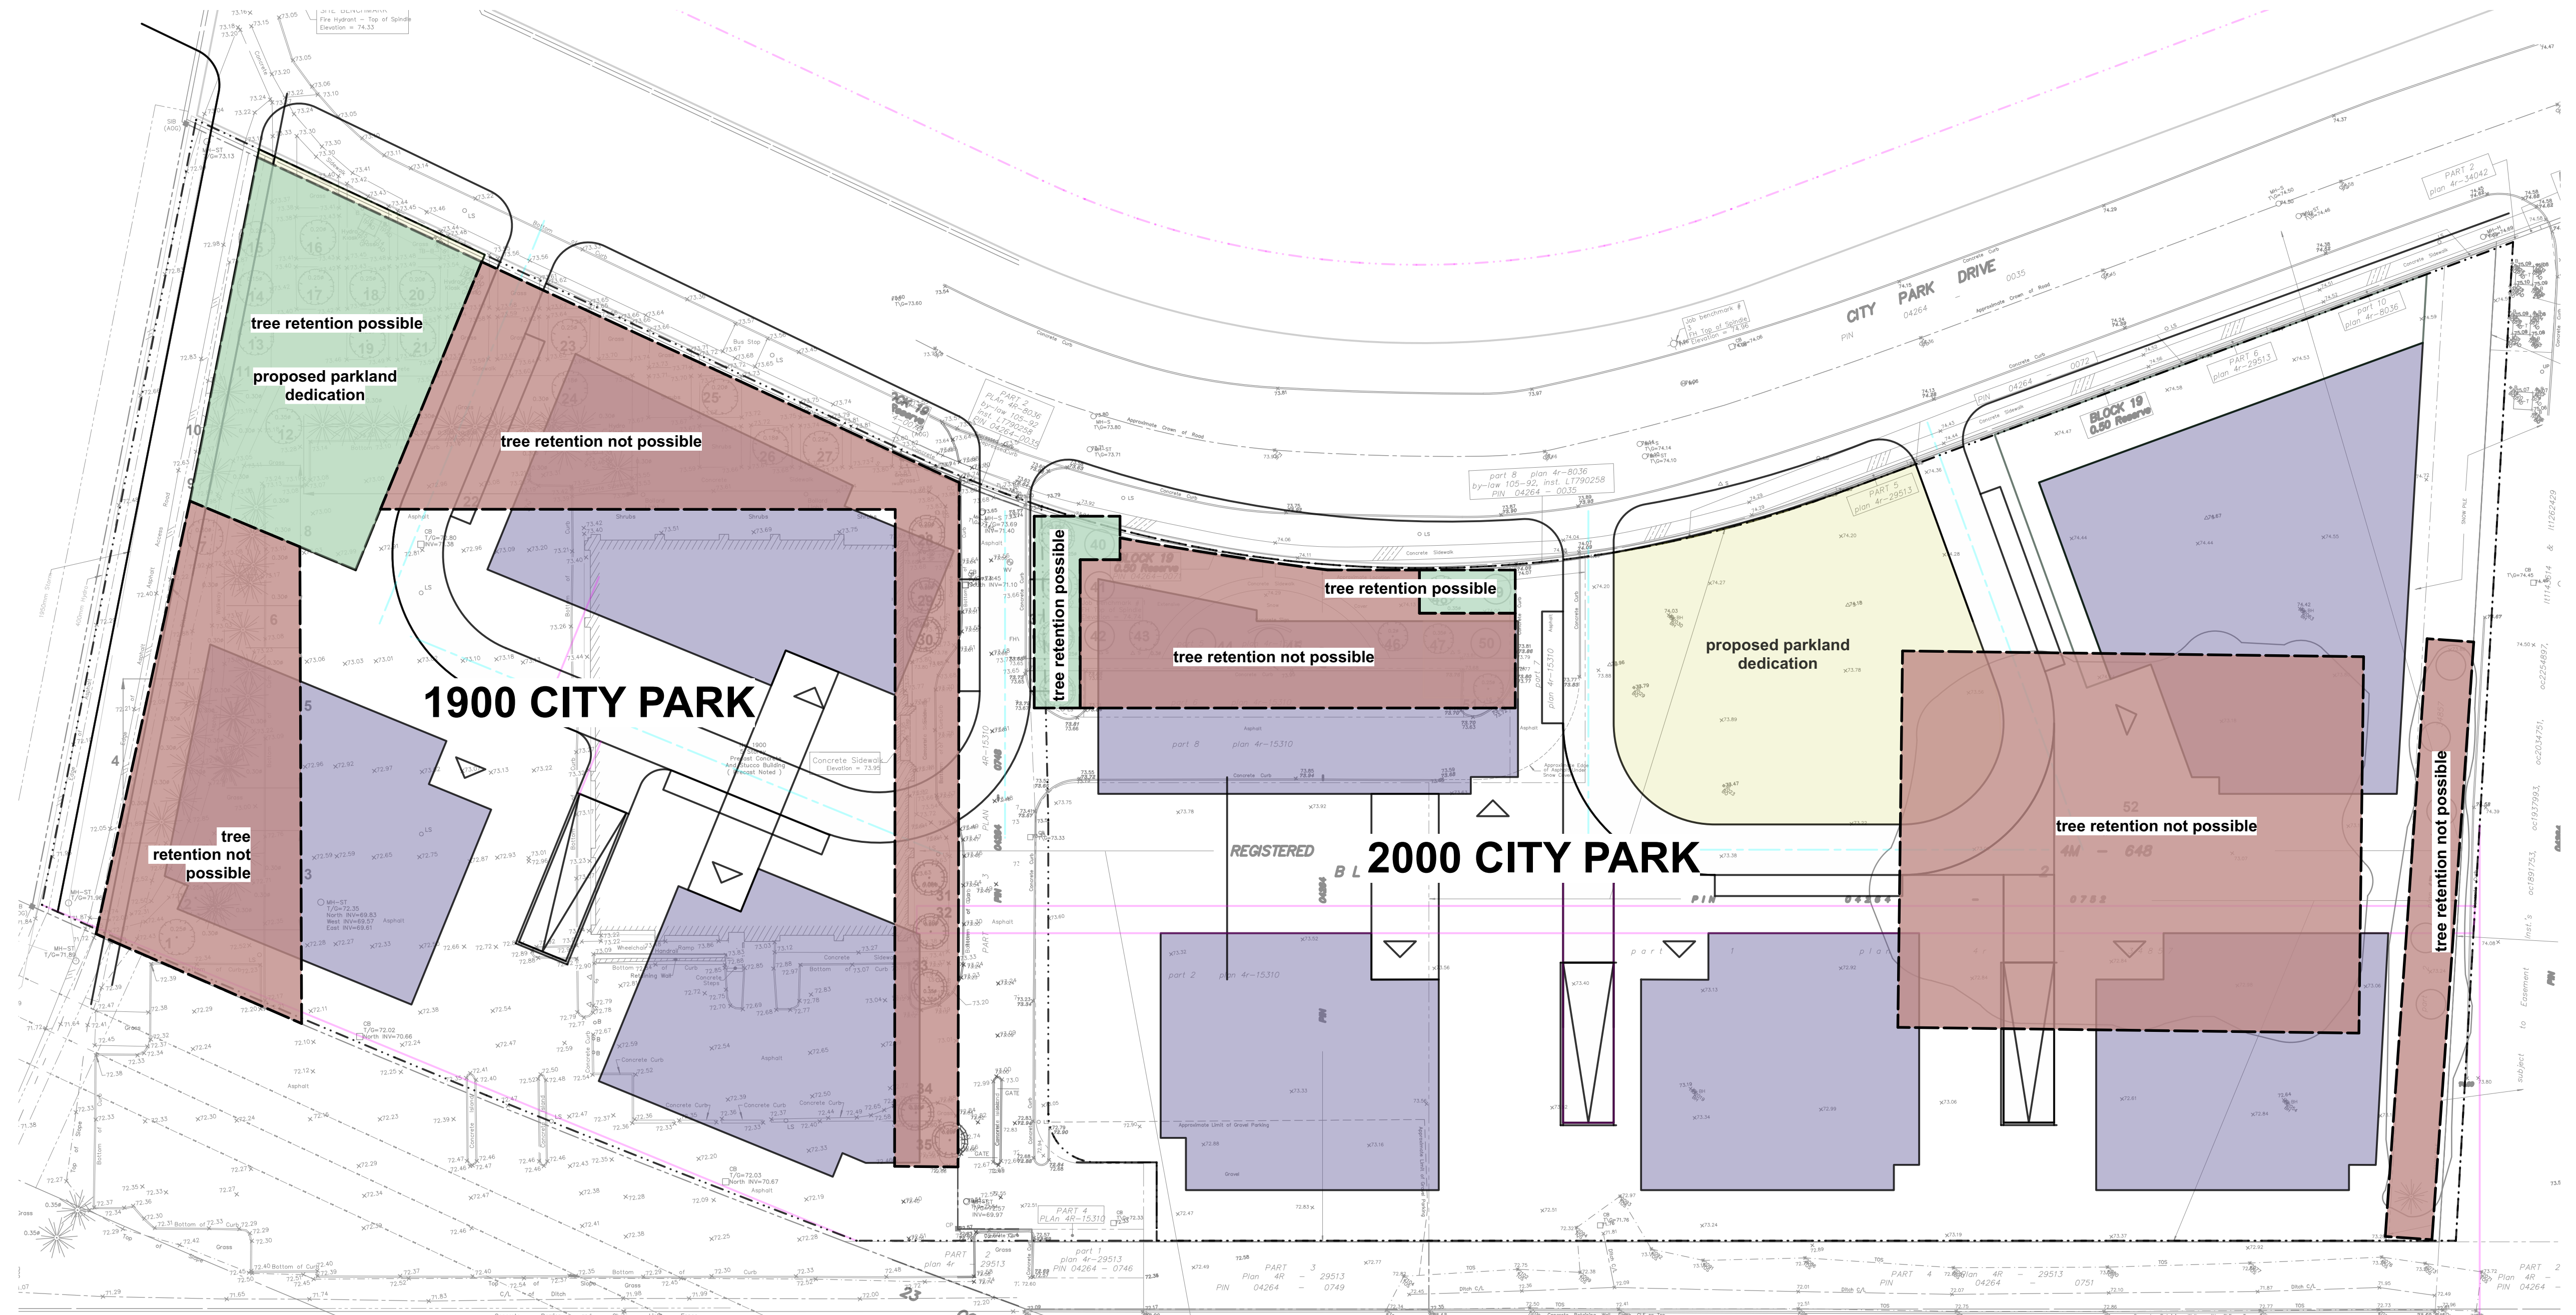
RETENTION SCHEMATIC

A high level desktop review of possible tree retention areas was undertaken using the existing schematic building layout for 1900 and 2000 City Park Drive. A retention plan is provided which is based on the existing surveys and proposed schematic site plan, refer to Retention Plan, R1 prepared by Ruhland & Associates.

Tree Retention: based on the current schematic site plan, preservation opportunities exist in the north west corner in the r.o.w. adjacent to the proposed entrance drive (trees #36-40, 48 & 49). The remainder of the trees would be removed. A final review of retention possibilities will be undertaken during the site plan control process with a final site plan layout. Refer to attached tree retention areas.
