**110394936 CANADA INC.**

**TREE CONSERVATION REPORT**

1299 Richmond Road

CIMA+ file number: A001359  
May 29, 2023 – Review 000

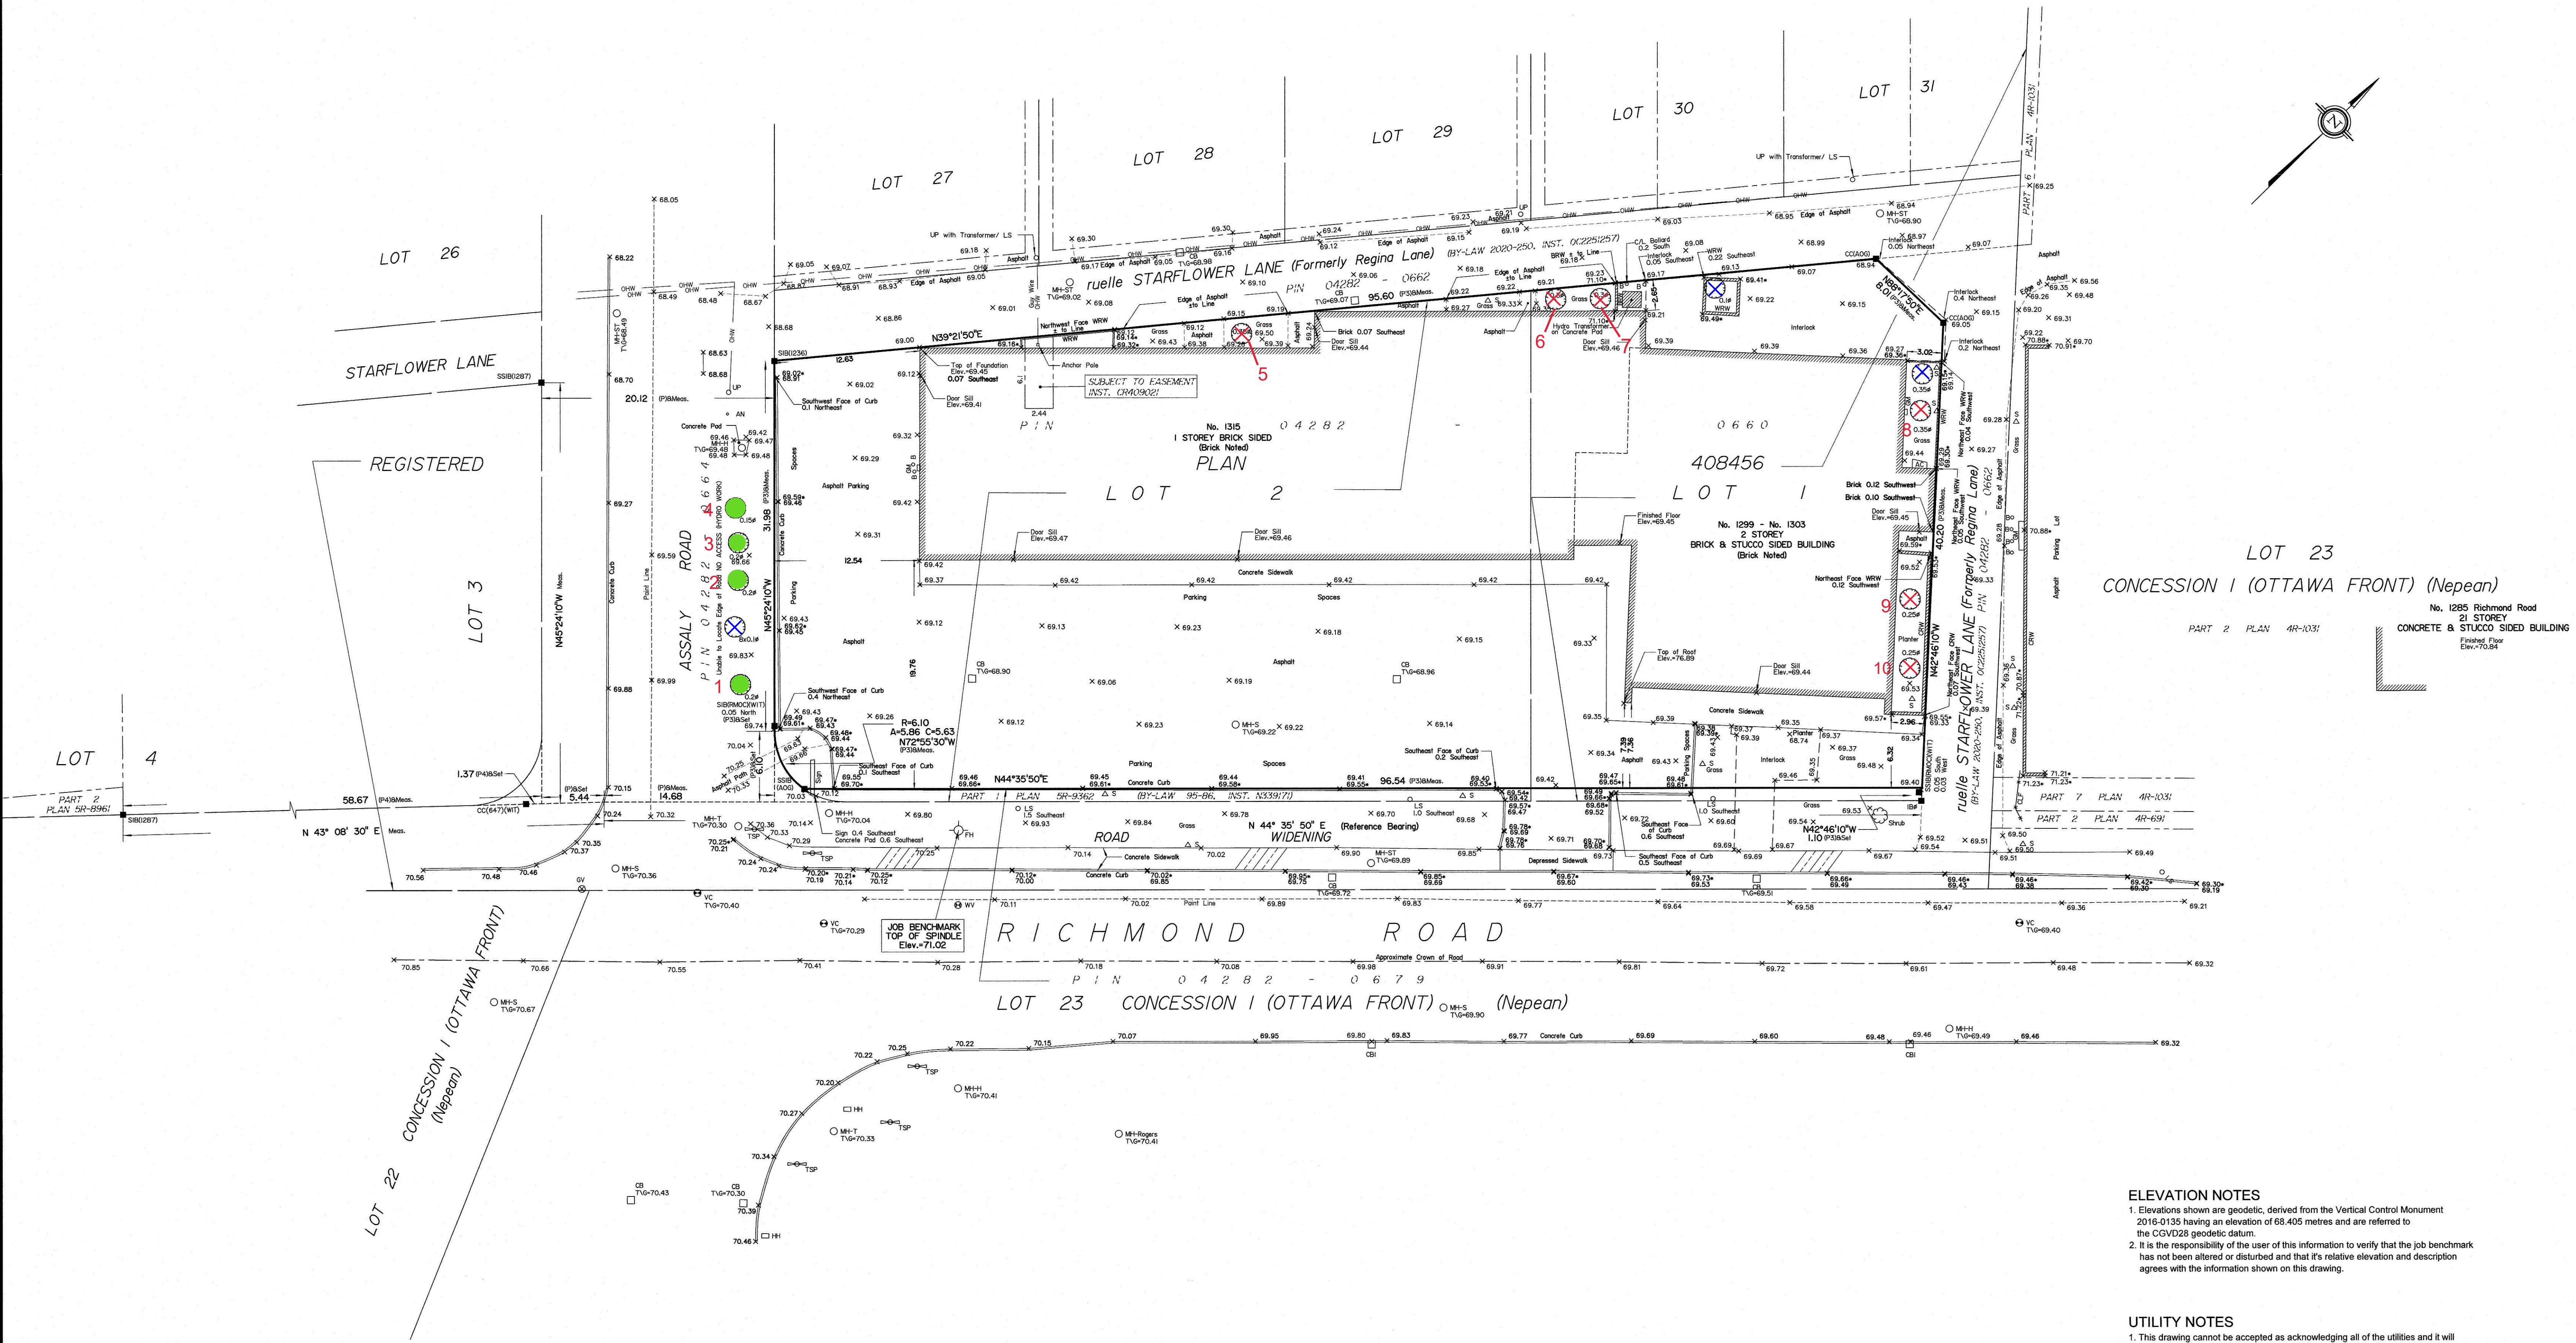
TOPOGRAPHICAL PLAN OF SURVEY OF  
**PART OF LOTS 1 and 2**  
**REGISTERED PLAN 408456**  
**CITY OF OTTAWA**  
 Surveyed by Annis, O'Sullivan, Vollebek Ltd.

A total of 10 trees were assessed as part of this inventory, all of which were alive. The only species observed on site was small-leaved linden. The condition of the trees on site ranged from Excellent to Poor.

Based on the species and conditions of the trees located within the site and the extent of the grading limits of the proposed project design it has been decided to retain 4 trees and remove 6 trees on site.
