TREE CONSERVATION REPORT

1299 Richmond Road

CIMA+ file number: A001359
August 27, 2024 – Review 002

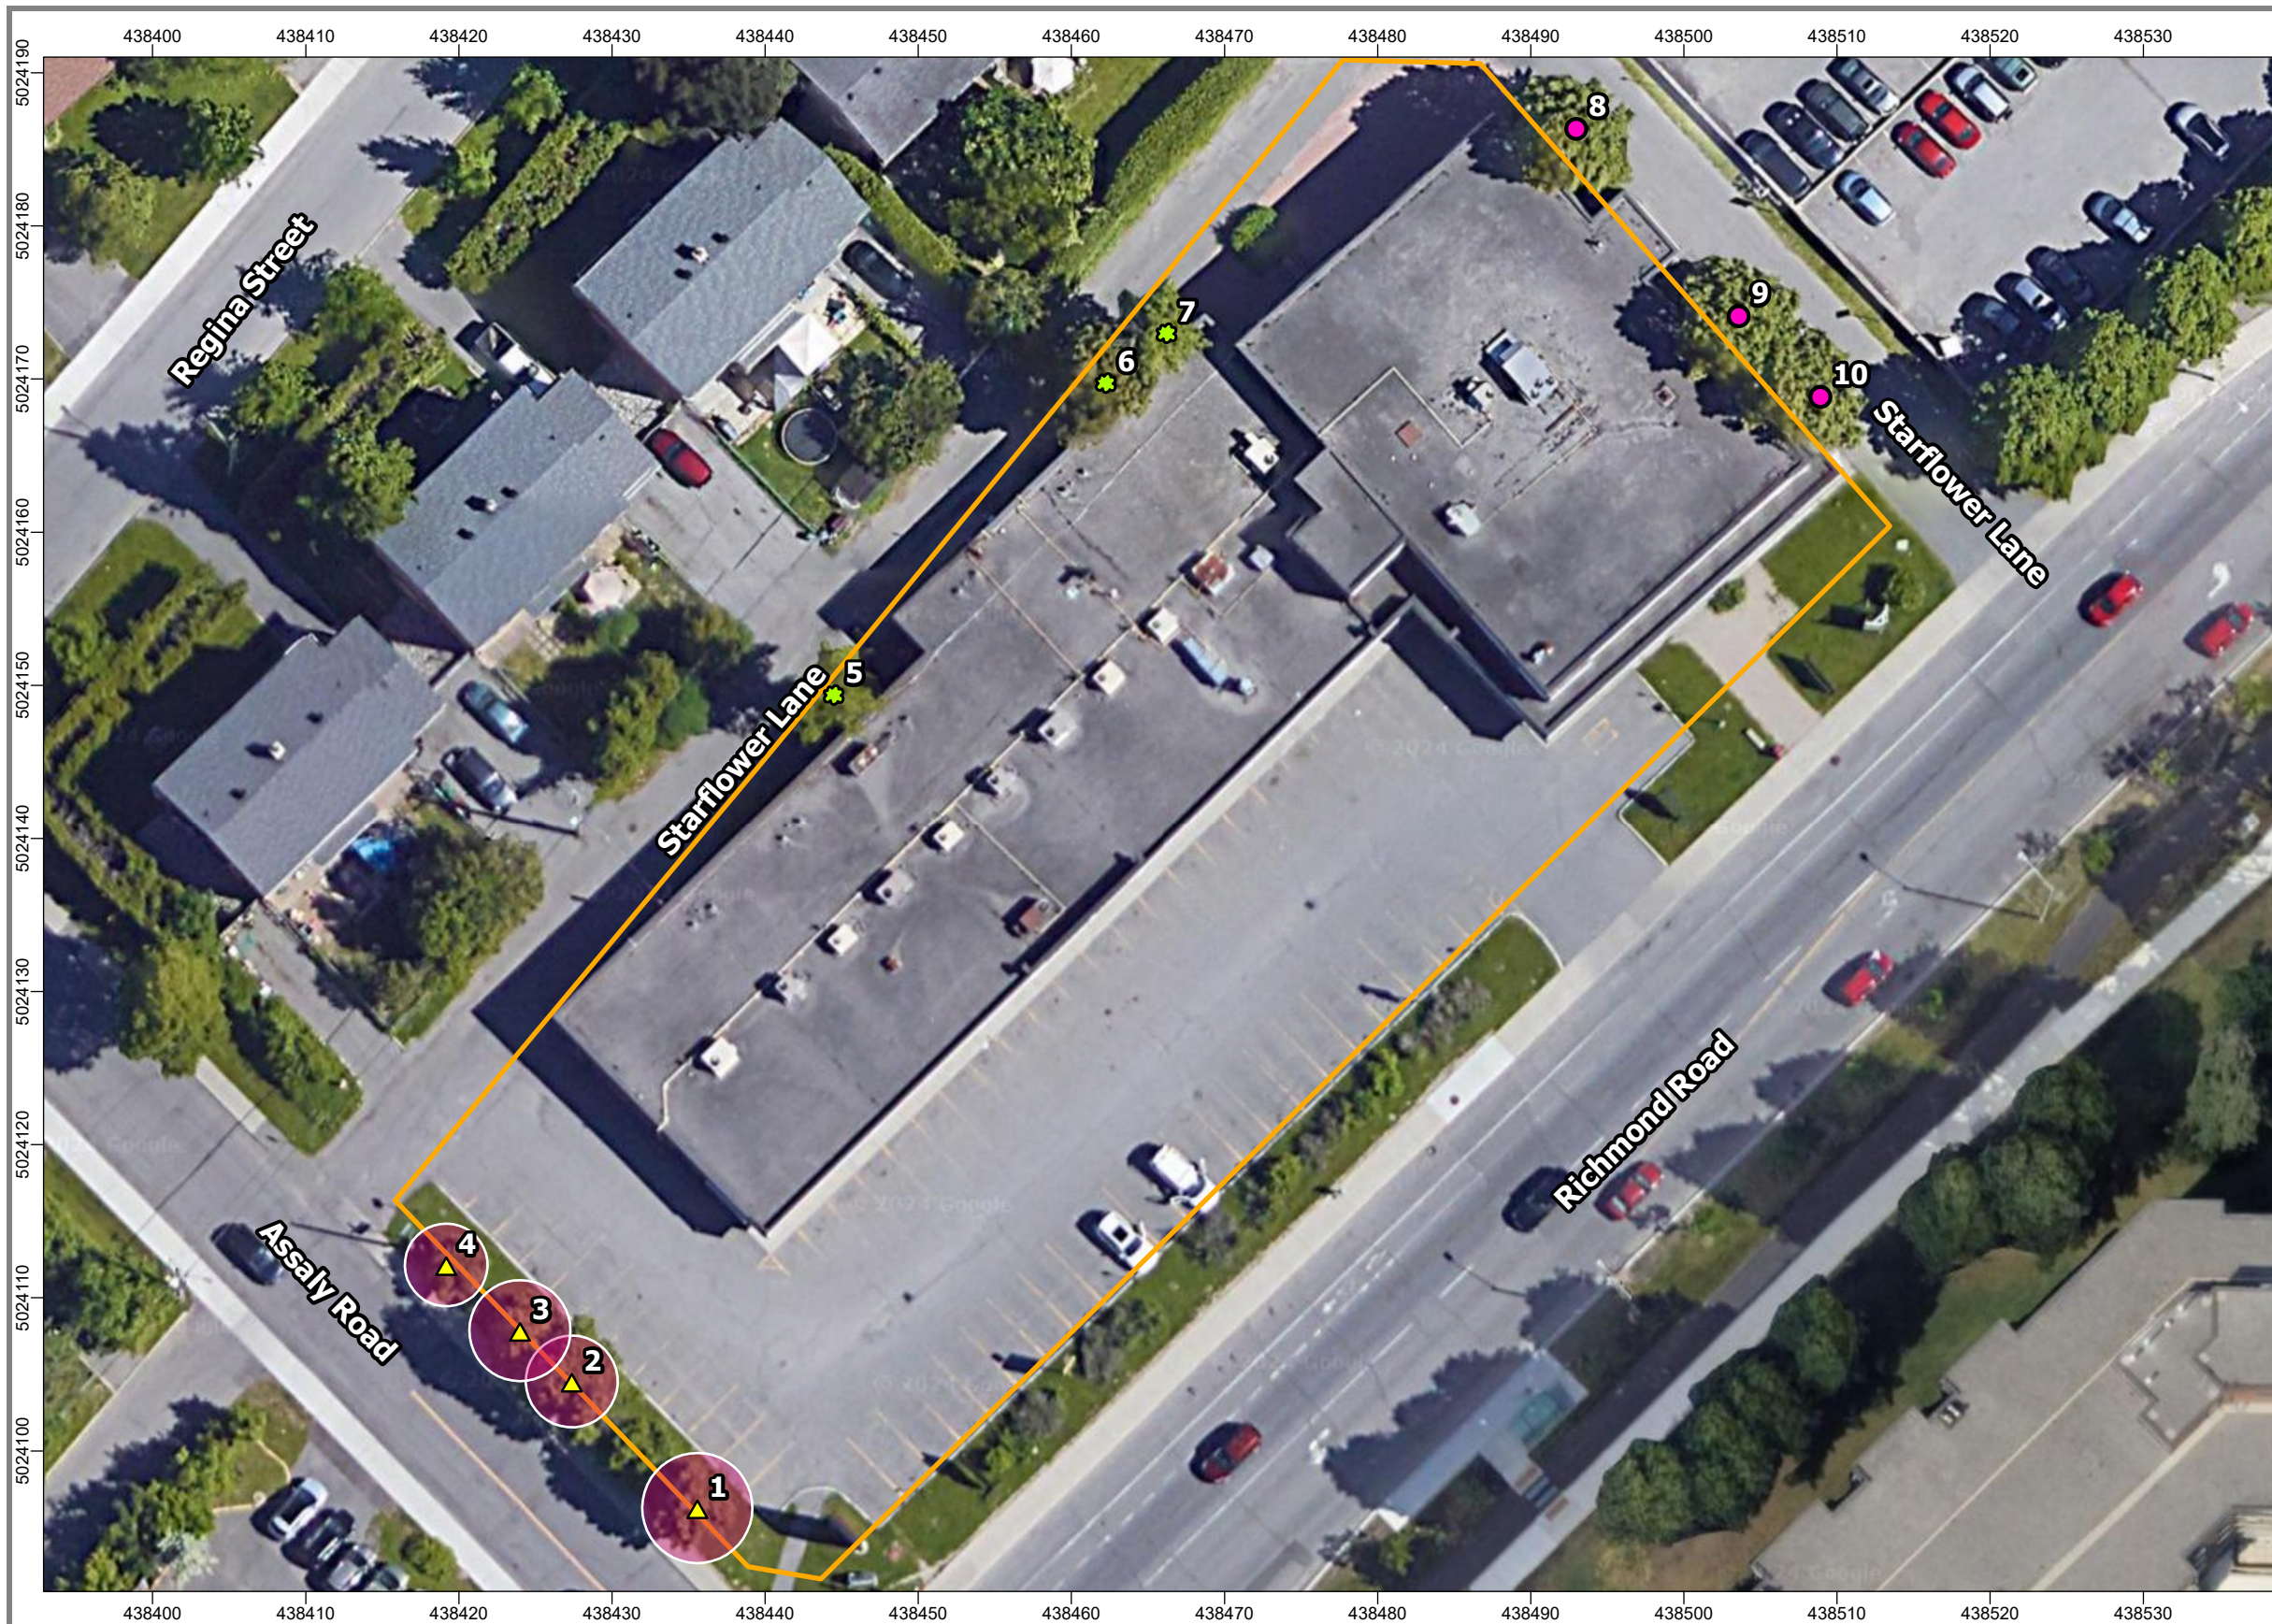
Map 1 - Current Vegetation

A total of 10 trees were assessed as part of this inventory, all of which were alive. The only species observed on site was small-leaved linden, *Tilia cordata*. The condition of the trees on site ranged from Excellent to Poor.

Tree No.	Common Name / Scientific Name	No. Stems	DBH (cm)	Height (m)	Crown Spread (m)	Structural Defects								Overall Condition	Comments	Ownership	Recommendation	CRZ (m)
						CA	MBR	SMD	ADV	INC	FC	COD	SC					
1	Small-leaved linden / <i>Tilia cordata</i>	1	36	12-15	6	<input type="checkbox"/>	<input type="checkbox"/>	<input type="checkbox"/>	<input checked="" type="checkbox"/>	<input checked="" type="checkbox"/>	<input checked="" type="checkbox"/>	<input type="checkbox"/>	<input type="checkbox"/>	Good		Shared (City/Private)	Retain	3.6
2	Small-leaved linden / <i>Tilia cordata</i>	1	30	8-11	3	<input type="checkbox"/>	<input type="checkbox"/>	<input checked="" type="checkbox"/>	<input type="checkbox"/>	<input checked="" type="checkbox"/>	<input checked="" type="checkbox"/>	<input type="checkbox"/>	<input checked="" type="checkbox"/>	Poor	Scarring on majority of trunk	Shared (City/Private)	Retain	3.0

3	Small-leaved linden / <i>Tilia cordata</i>	1	33	12-15	6	<input type="checkbox"/>	<input type="checkbox"/>	<input type="checkbox"/>	<input type="checkbox"/>	<input type="checkbox"/>	<input checked="" type="checkbox"/>	<input type="checkbox"/>	<input type="checkbox"/>	Good		Shared (City/Private)	Retain	3.3
4	Small-leaved linden / <i>Tilia cordata</i>	1	27	12-15	6	<input type="checkbox"/>	<input type="checkbox"/>	<input type="checkbox"/>	<input type="checkbox"/>	<input type="checkbox"/>	<input checked="" type="checkbox"/>	<input type="checkbox"/>	<input type="checkbox"/>	Good		Shared (City/Private)	Retain	2.7
5	Small-leaved linden / <i>Tilia cordata</i>	1	41	16-20	6	<input type="checkbox"/>	<input type="checkbox"/>	<input checked="" type="checkbox"/>	<input type="checkbox"/>	<input type="checkbox"/>	<input checked="" type="checkbox"/>	<input type="checkbox"/>	<input type="checkbox"/>	Fair	Dying / dead leader	Private	Remove	n/a

6	Small-leaved linden / <i>Tilia cordata</i>	1	36	16-20	8	<input type="checkbox"/>	<input type="checkbox"/>	<input checked="" type="checkbox"/>	<input type="checkbox"/>	<input type="checkbox"/>	<input checked="" type="checkbox"/>	<input type="checkbox"/>	<input type="checkbox"/>	Good		Private	Remove	
7	Small-leaved linden / <i>Tilia cordata</i>	1	35	16-20	5	<input type="checkbox"/>	<input type="checkbox"/>	<input checked="" type="checkbox"/>	<input type="checkbox"/>	<input checked="" type="checkbox"/>	<input checked="" type="checkbox"/>	<input checked="" type="checkbox"/>	<input checked="" type="checkbox"/>	Poor	Scarring on majority of trunk	Private	Remove	
8	Small-leaved linden / <i>Tilia cordata</i>	1	43	16-20	10	<input checked="" type="checkbox"/>	<input type="checkbox"/>	<input type="checkbox"/>	<input type="checkbox"/>	<input checked="" type="checkbox"/>	<input type="checkbox"/>	<input type="checkbox"/>	<input type="checkbox"/>	Good		City	Remove

9	Small-leaved linden / <i>Tilia cordata</i>	1	36	16-20	10	<input type="checkbox"/>	<input checked="" type="checkbox"/>	<input type="checkbox"/>	<input type="checkbox"/>	<input type="checkbox"/>	<input type="checkbox"/>	<input type="checkbox"/>	<input type="checkbox"/>	Good		City	Remove	
10	Small-leaved linden / <i>Tilia cordata</i>	1	35	16-20	10	<input checked="" type="checkbox"/>	<input checked="" type="checkbox"/>	<input checked="" type="checkbox"/>	<input type="checkbox"/>	<input type="checkbox"/>	<input type="checkbox"/>	<input type="checkbox"/>	<input type="checkbox"/>	Good		City	Remove

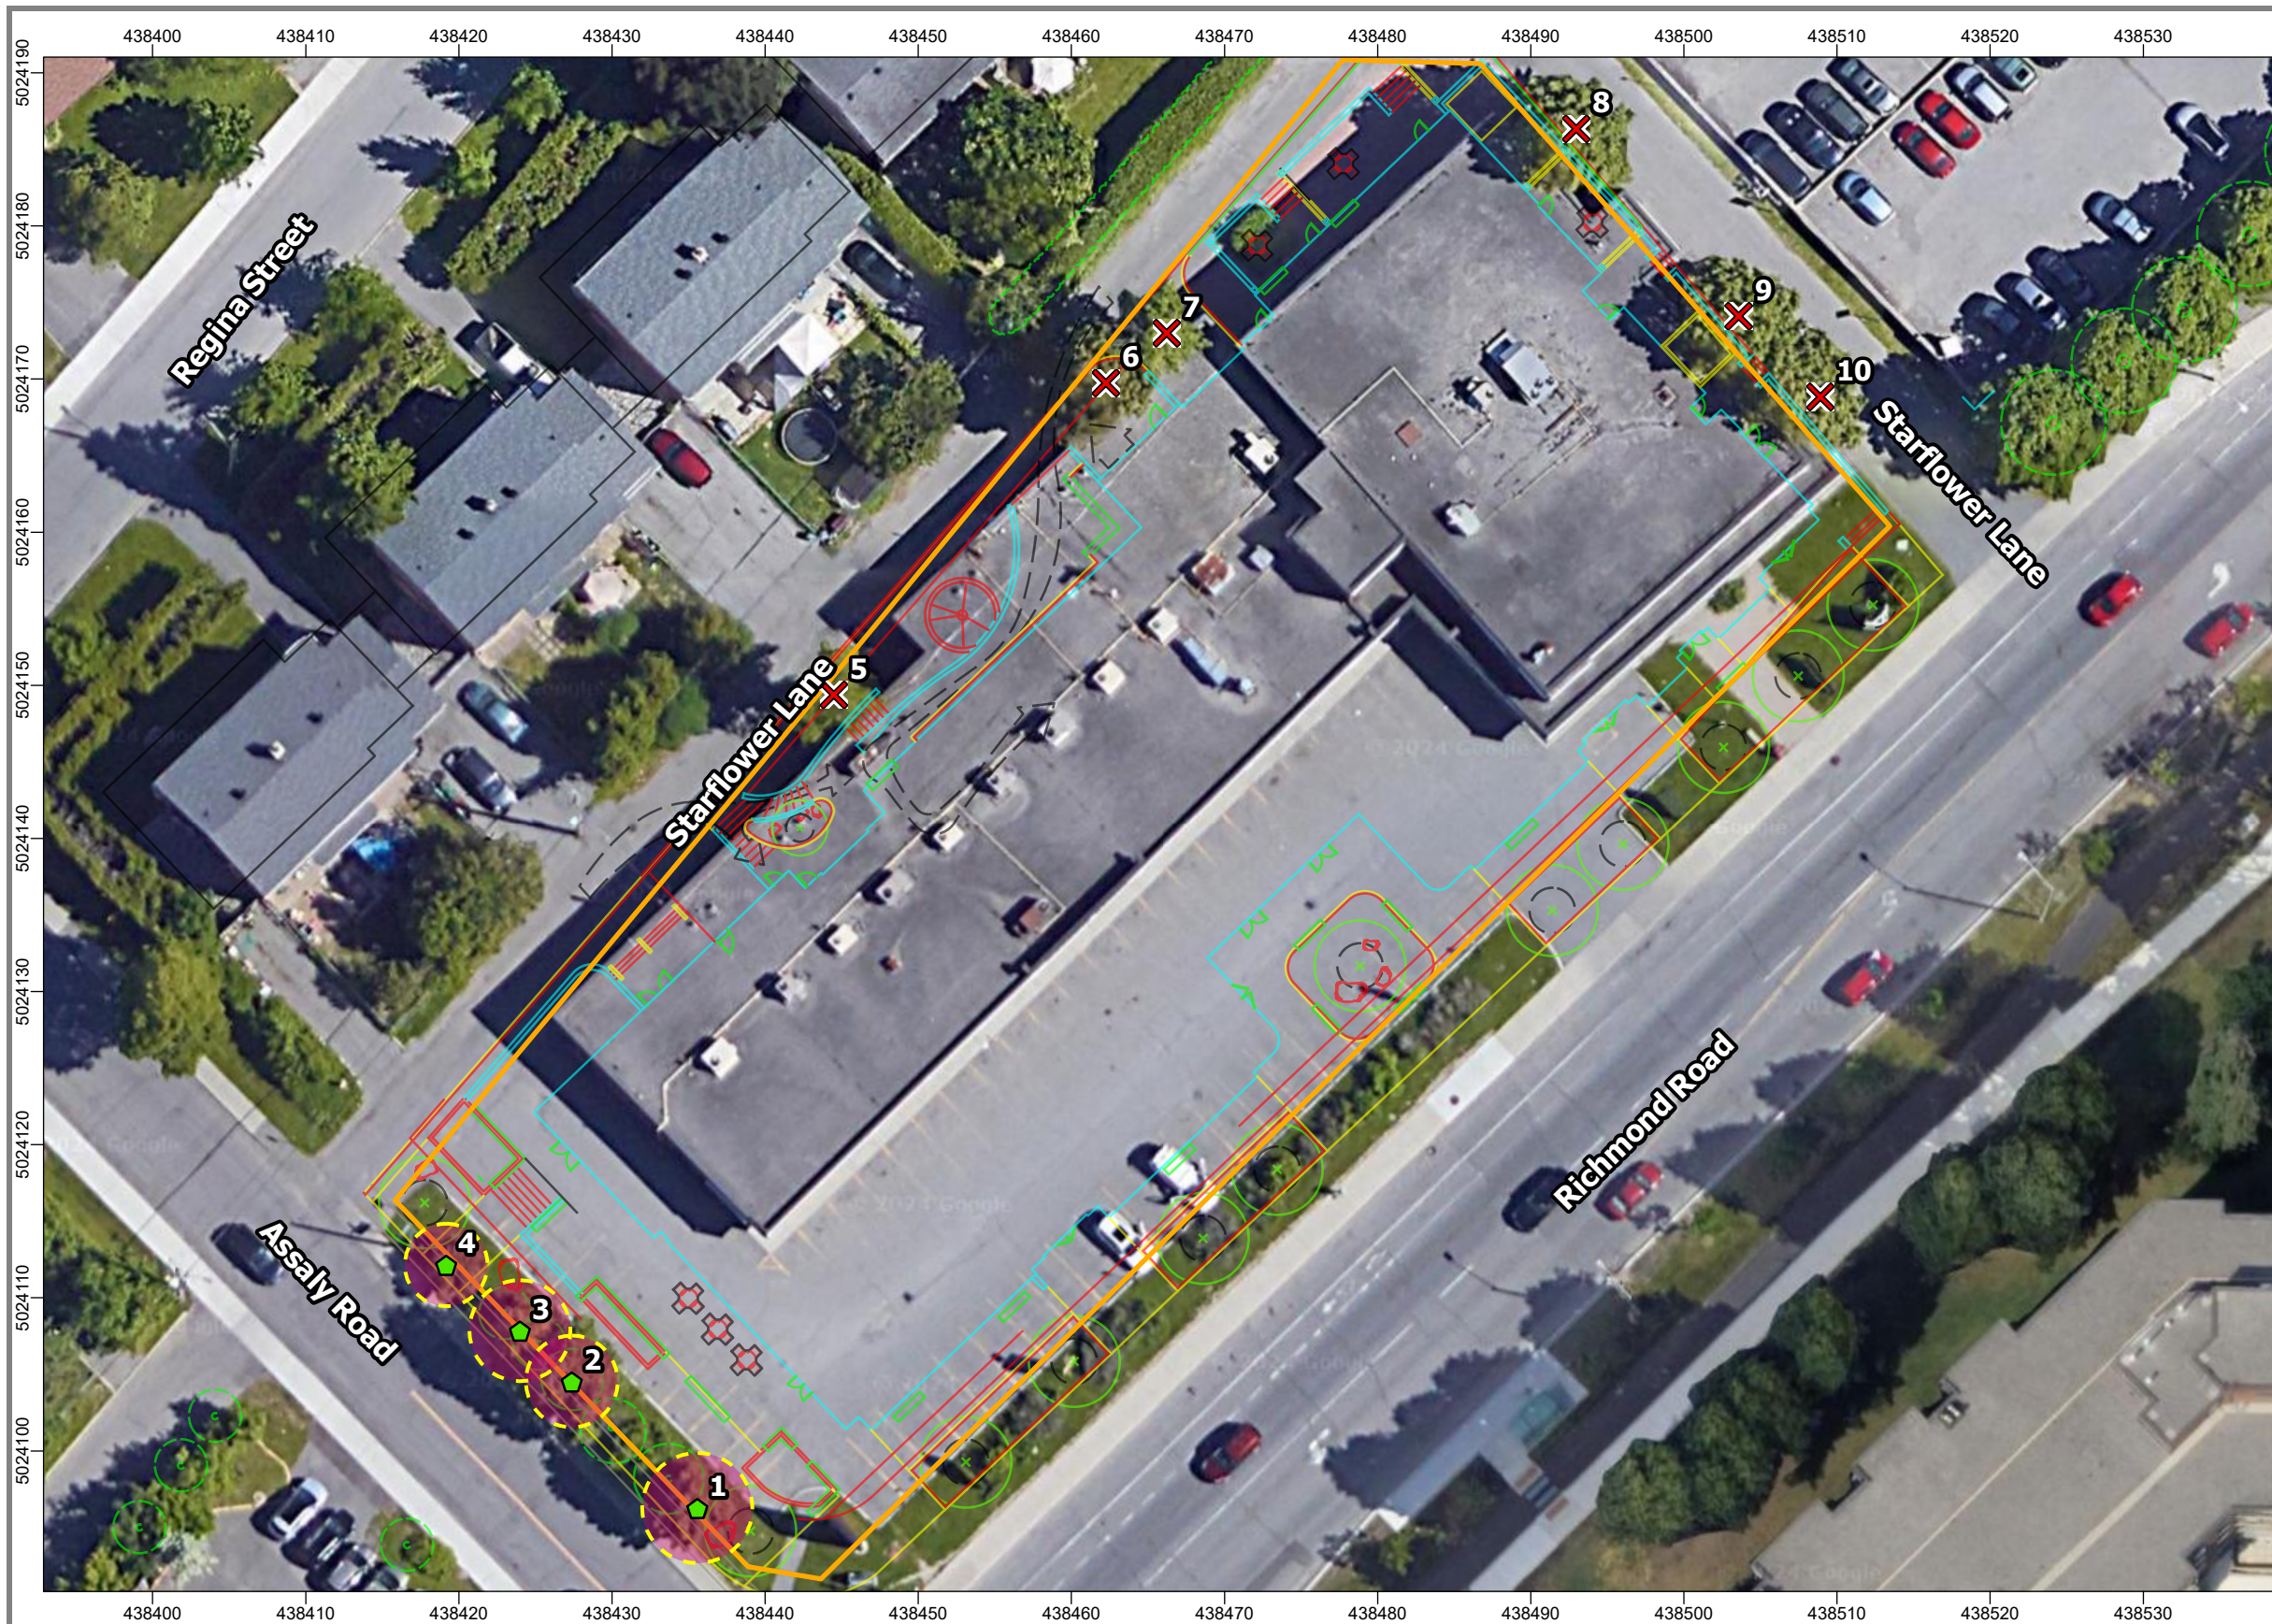
Map 2 - Proposed Development & Conserved Vegetation

Based on the species and conditions of the trees located within the site and the extent of the grading limits of the proposed project design it has been decided to retain 4 trees and remove 6 trees on the Site.

Trees to be Removed	Trees to be Injured	Trees to be Retained
6	0	4

In order to successfully preserve trees that are recommended for on-site retention, the following series of mitigation measures is recommended. These recommended measures largely center on the minimum CRZ of trees (The CRZ is calculated as DBH x 10 cm), as defined by the City’s Tree Conservation Report Guidelines. The following measures are being recommended to protect the CRZ of all trees slated for retention and/or impact:

- + Delineation of the disturbance limits within work areas will be clearly defined on drawings and on the site prior to construction;
- + Install Tree Protection Fencing prior to commencement of construction activities, and retain fencing until construction activities have been completed, as per City of Ottawa’s Tree Protection (By-law No. 2020-340), Part VI:

- Tree protection fencing shall be at least 1.2 metres in height (or as per the approved Tree Conservation or Tree Information Report) and installed in such a way that the fence cannot be altered. It is to be installed no closer than the outer edge of the CRZ. Other such measures as required by the General Manager shall be implemented to protect the tree.
