TREE CONSERVATION REPORT

121 Brae Crescent, Ottawa

Tree Conservation Report submitted as Partial
Requirements for a Site Plan Control Application,
April 24, 2023

Tree Conservation Report v2.0

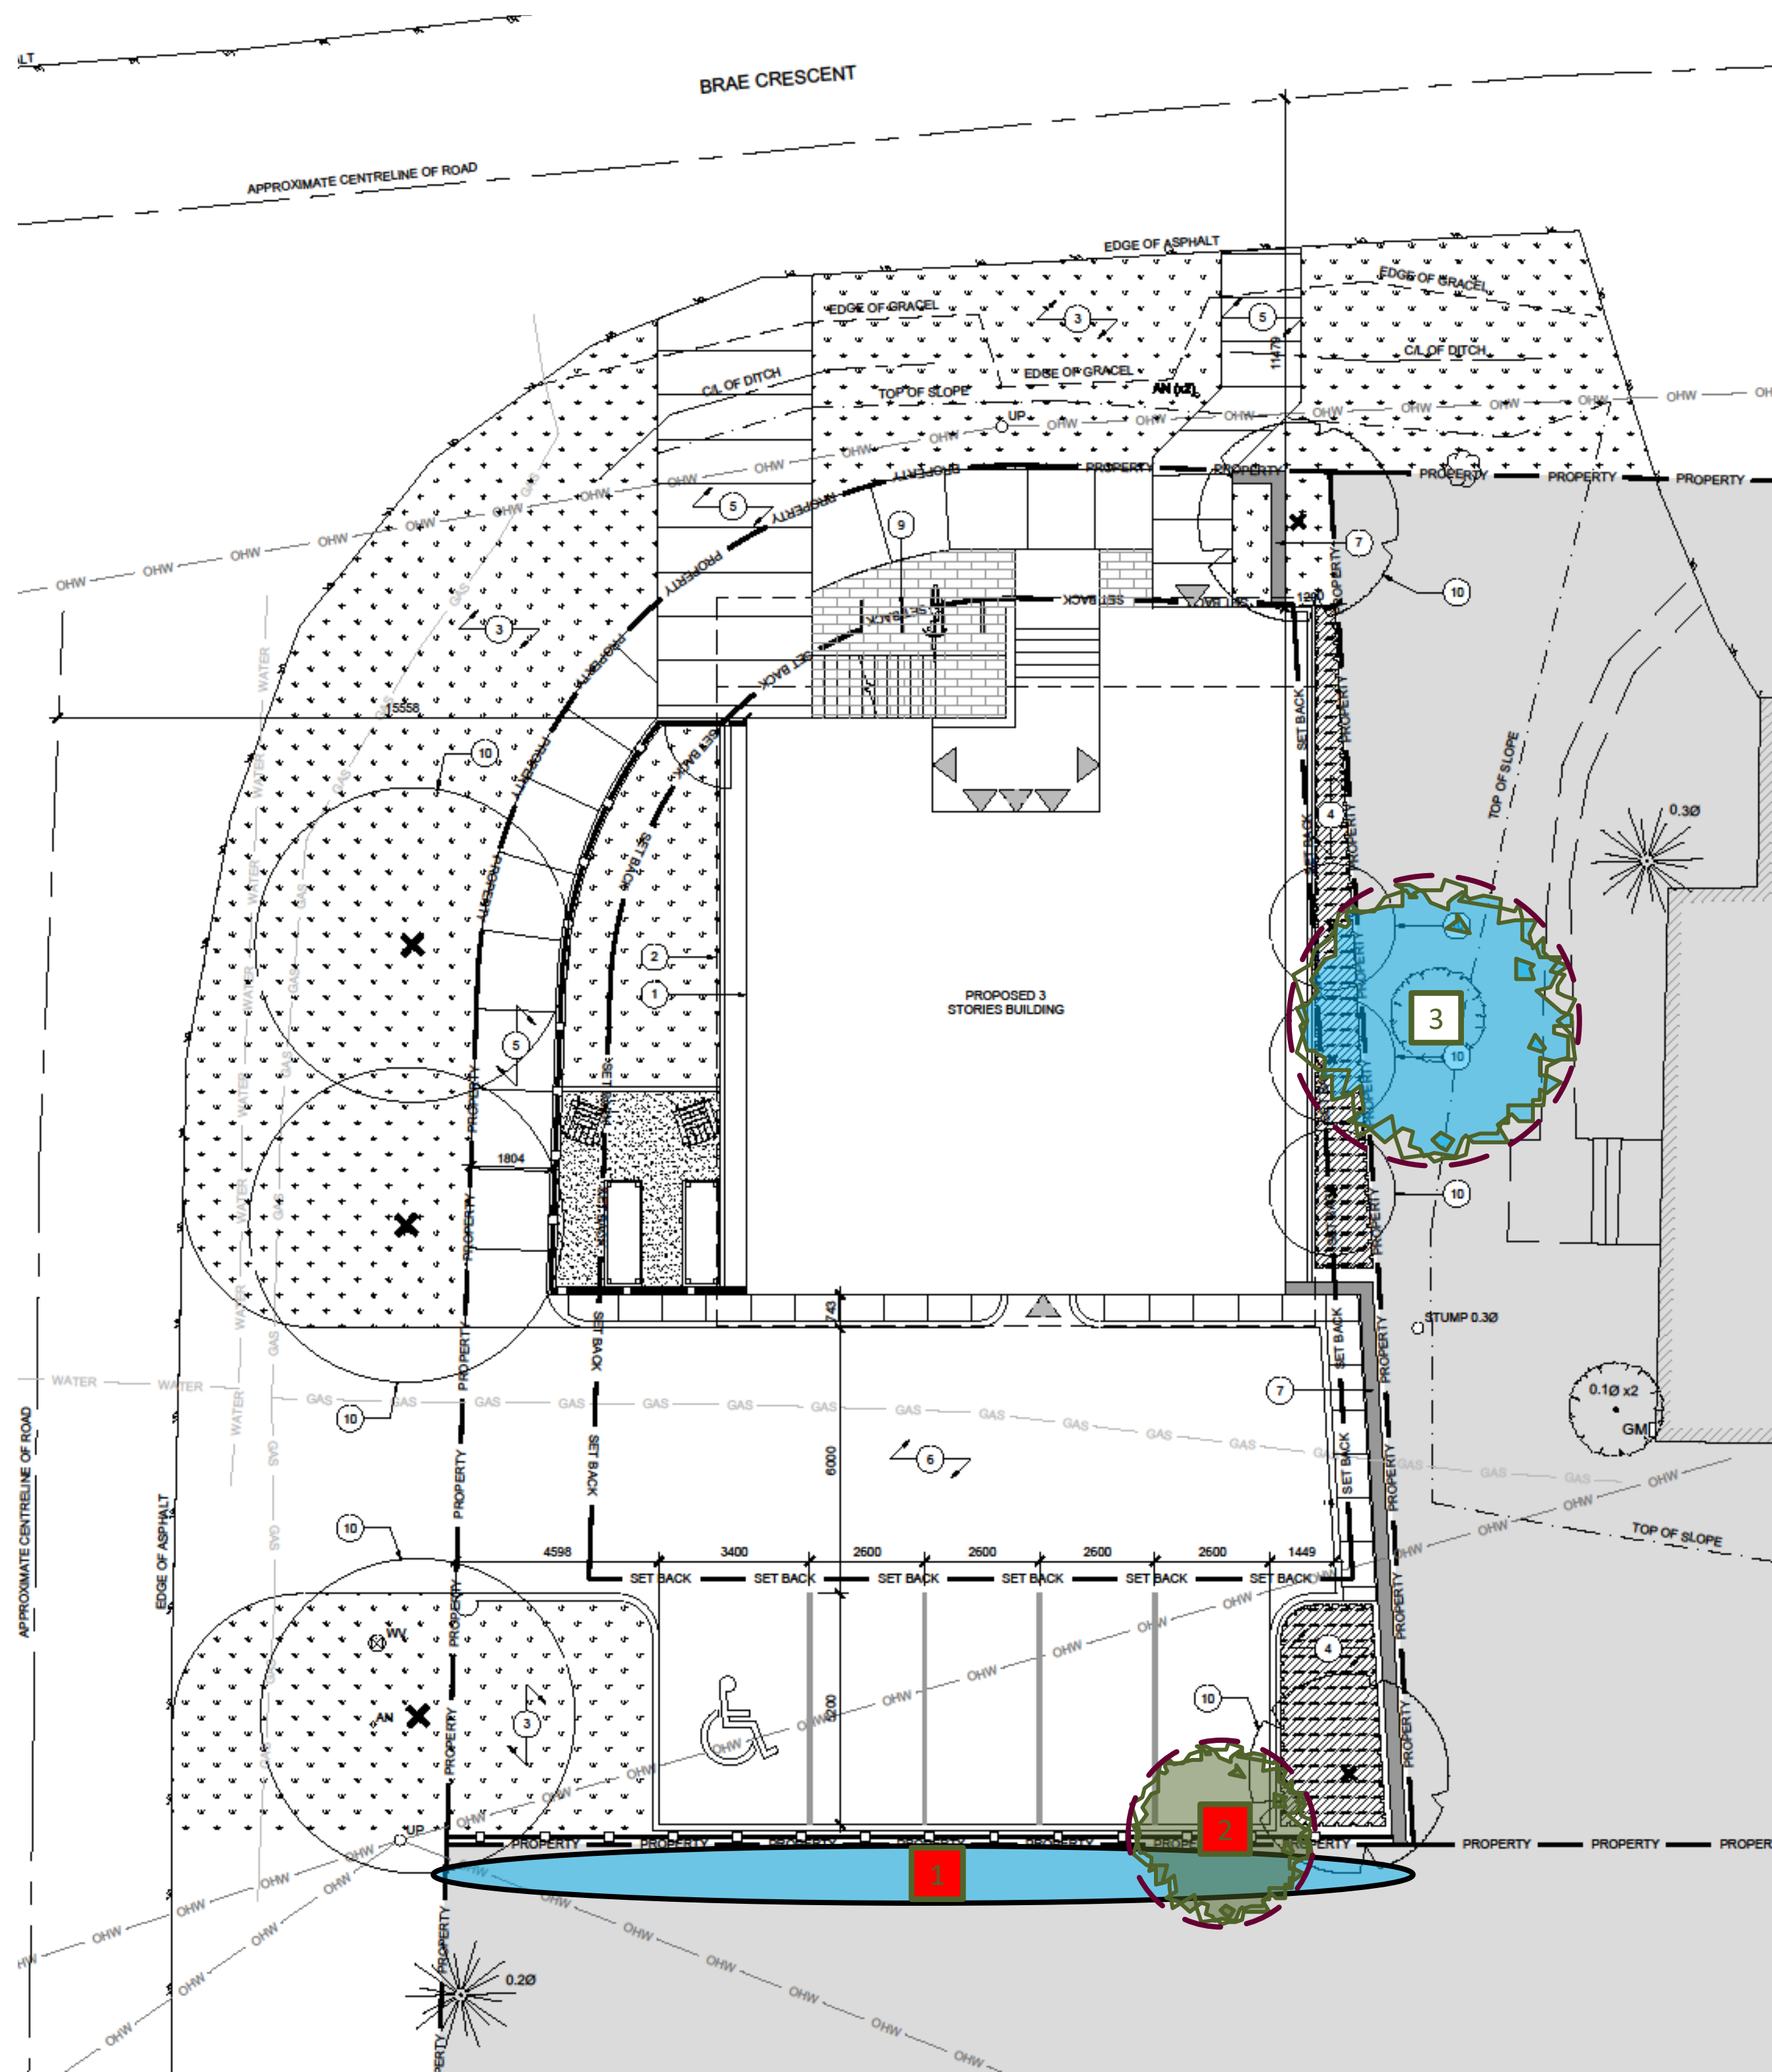
Tree Conservation Report – 121 Brae
 Proposed Development and Conserved Vegetation
 Tree layer prepared by Dendron Forestry Services
 Version 2.0, April 24, 2023
 For more information, please contact info@dendronforestry.ca

Tree ¹	Species	Diameter at breast height (dbh)	Ownership ^{2,3}	Condition	Action
1	Eastern white cedar (<i>Thuja occidentalis</i>)	5-15 cm	Jointly owned, mostly on adjacent property at 3 Norway Spruce; approximately 6-8 m in height	Fair; has not been maintained on the subject property side recently	Remove due to design of parking area and installation of retaining wall; permission from adjacent property owner required; Tree Permit required
2 ⁴	Manitoba maple (<i>Acer negundo</i>)	Multi-stemmed, 5-15	Jointly owned with adjacent property at 3 Norway Spruce	Good/fair; good vigour, poor form	Remove; conflict with proposed parking area
3	Crabapple (<i>Malus spp</i>)	30 cm (estimate)	Adjacent property at 123 Brae	Good	Retain and protect; light pruning of branches may be required for clearance, if significant root damage occurs during excavation for the new building, consider a deep root fertilizer one year after construction
