Tree Conservation Report

30 Cleary Avenue

CIMA+ file number: A001443
November 17, 2023 – Review 002

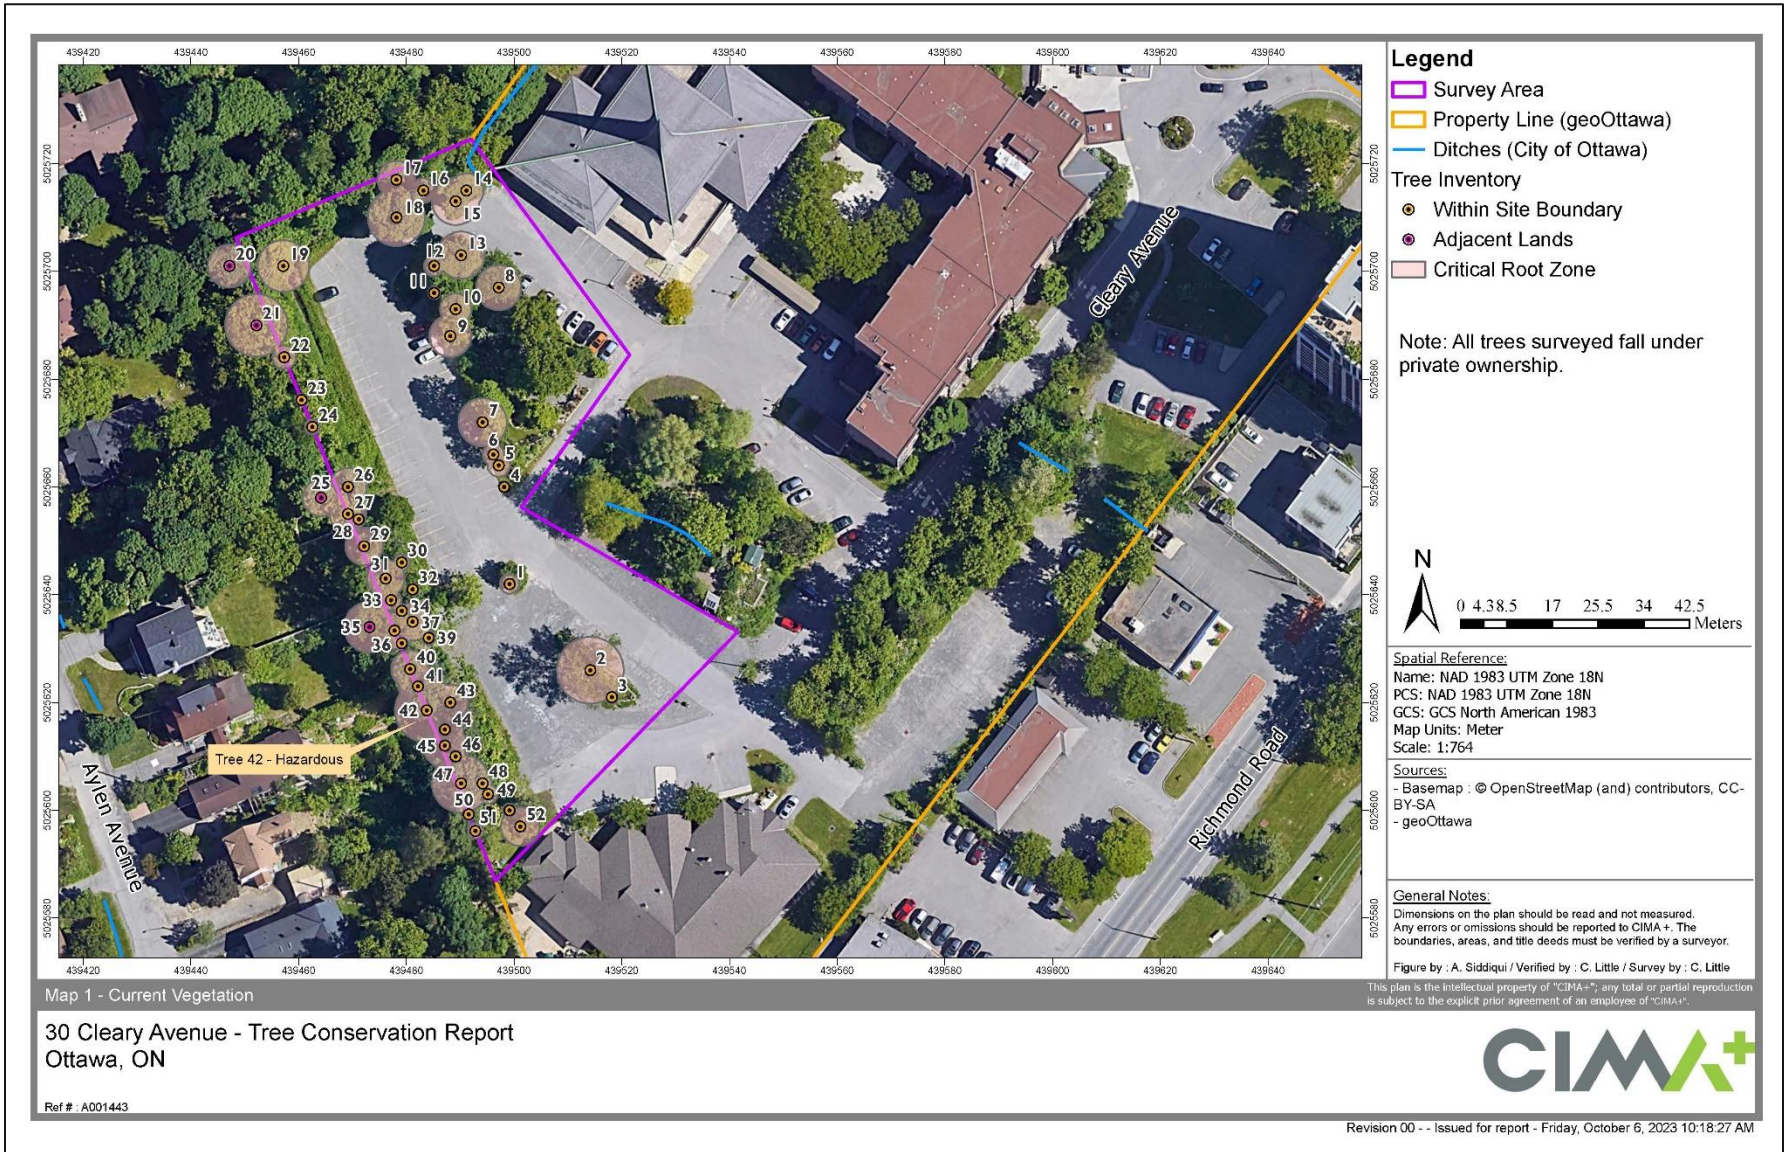
Figure 2 : Current Vegetation (Map 1 as per City Guidelines)

A total of 53 individual trees were assessed as part of this inventory. The condition of the trees on Site ranged from Good to Poor, 75% of which were in Good condition. The most common species were Norway maple (33%), red pine (26%), and Manitoba maple (9%). There are 28 trees that meet the definition of a ‘Distinctive Tree’ as per Tree Protection By-law No. 2020-340 (any tree located on private property with a DBH of 30 cm or greater, within the inner urban area).
