TREE CONSERVATION REPORT

1887 St Joseph Boulevard, Ottawa, ON

Tree Conservation Report submitted as Partial
Requirements for a Rezoning Application, July
13, 2023

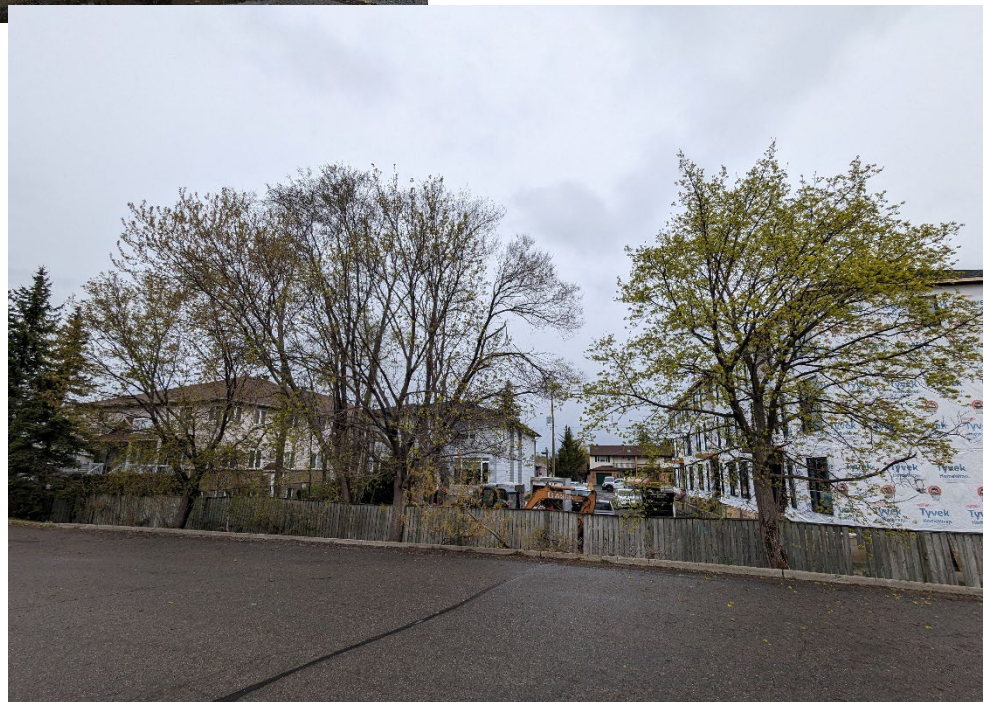
Trees 18-22 (right to left)

Tree 20 is a group of 14 Siberian elms (*Ulmus pumila*) on the adjacent property but growing quite close to the fence. Many of these trees will likely suffer deleterious effects from the changes in grade on the subject property and from the installation of the proposed landscaping wall along the eastern property line, so it is possible they will need to be removed in the future. At this time, they are recommended for retention with the following mitigations recommended: prior to excavation for the proposed landscape wall, a certified arborist should expose the roots by air spade and sever them cleanly by hand. This will promote faster sealing after construction. The arborist can then make a determination about tree stability and health based on the size of roots severed.

beginning; cracks in branches; lost limb	
20	Siberian elm (<i>Ulmus pulmila</i>)	14 stems: 10-40	Adjacent – 1250/1252 Marenger	14 stems between 10 and 40cm	Retain. Certified arborist to expose roots and sever roots by hand prior to excavation for proposed landscape wall
21	Norway maple (<i>Acer platanoides</i>)	40	Subject property	Poor; poor union; Center of stem decayed away; possible canker	Remove due to health
22	Norway maple (<i>Acer platanoides</i>)	25 (est)	Boundary - 1250/1252 Marenger	Poor: leaning heavily on, and growing over, fence	Remove due to impacts of development
23	Norway spruce (<i>Picea abies</i>)	25	Subject property	Fair: thin crown	Remove due to impacts of development
24	Norway spruce (<i>Picea abies</i>)	38	Subject property	Fair/Good: minor defoliation	Remove due to impacts of development
25	Norway spruce (<i>Picea abies</i>)	34	Subject property	Fair: crown thin at top	Remove due to impacts of development

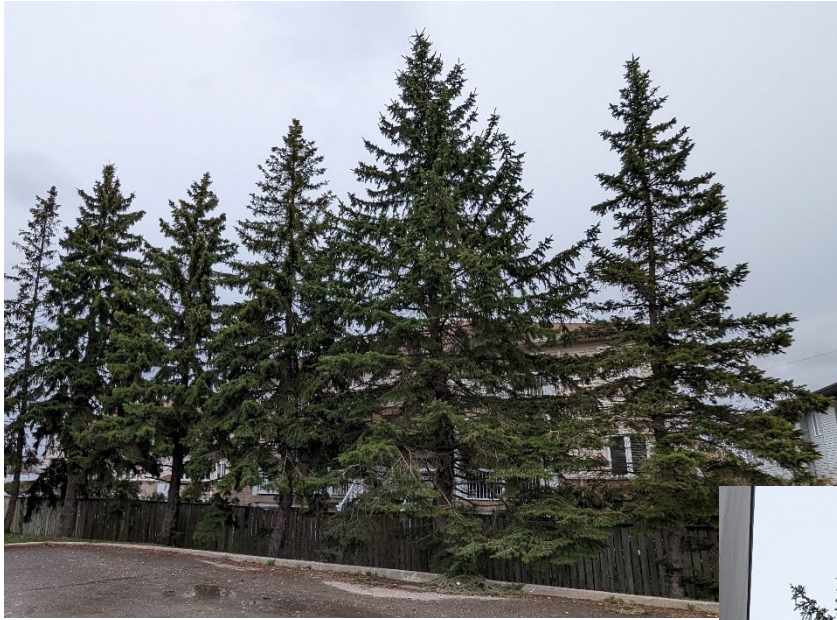
Above - Trees 23-28 (right to left)

26	Norway spruce (<i>Picea abies</i>)	38	Subject property	Fair/Good: minor defoliation	Remove due to impacts of development
27	Norway spruce (<i>Picea abies</i>)	36	Subject property	Good	Remove due to impacts of development
28 ⁴	White spruce (<i>Picea glauca</i>)	22	Subject property	Poor: major defoliation/dead branches	Remove due to health
29	White spruce (<i>Picea glauca</i>)	23	Subject property	Poor: major defoliation/dead branches	Remove due to health
30	Norway maple (<i>Acer platanoides</i>)	41	Subject property	F: exposed roots with damage; large wound with decay (canker?)	Remove due to impacts of development
31	Norway spruce (<i>Picea abies</i>)	29	Subject property	Fair/Good: asymmetrical crown, minor defoliation	Retain and protect
32	White spruce (<i>Picea glauca</i>)	31, 32	Subject property	Fair: Codominant stems at 40cm; minor defoliation	Retain and protect
33	Colorado spruce (<i>Picea pungens</i>)	35	Subject property	Good: asymmetrical crown	Remove due to impacts of development
