McKinnon's Creek Erosion Hazard Assessment

930 Smith Road, Navan, Ontario

December 8, 2023 (Revised March 22 and June 18, 2024)
PN23106

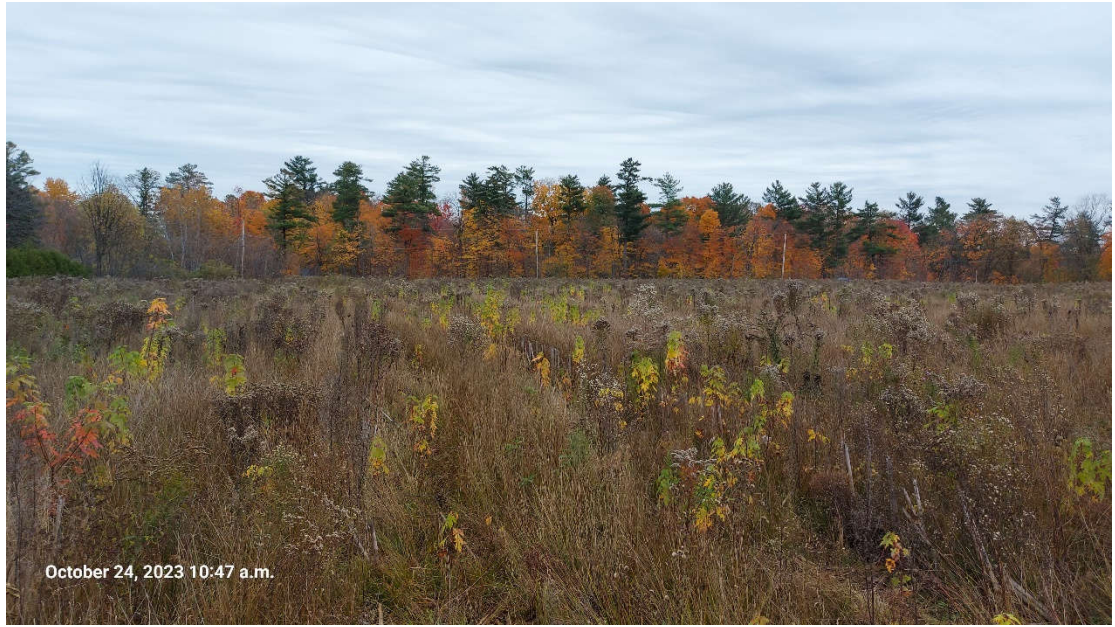
Photo 1
McKinnon's Creek
930 Smith Road, Navan

Photograph taken facing east towards Smith Road from the center of the subject site. No established drainage features were observed within the site.

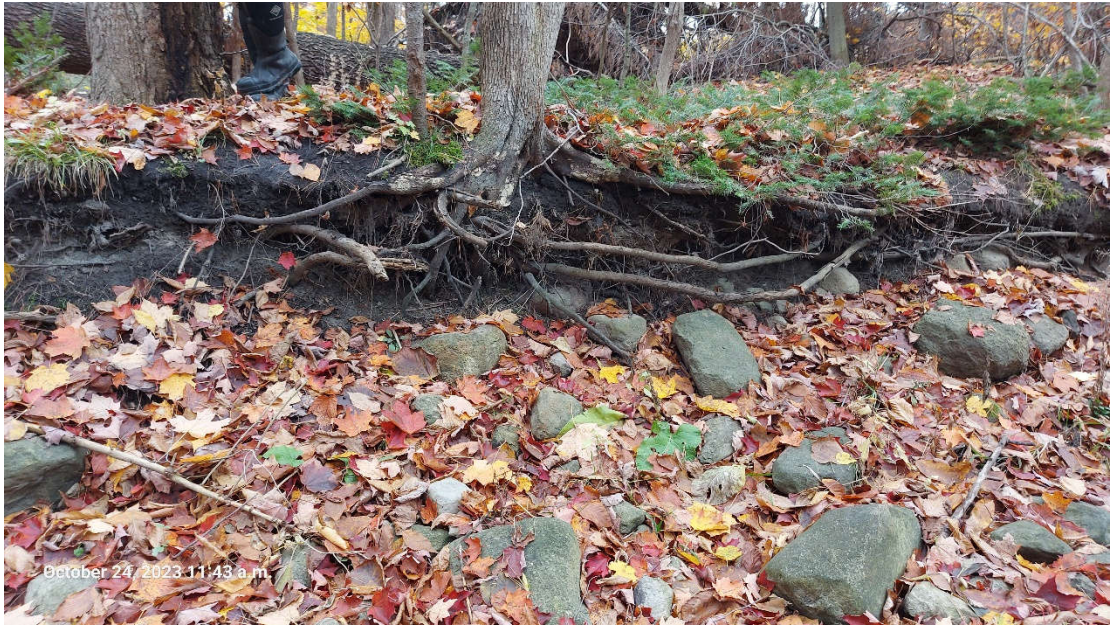
Photo 5
McKinnon's Creek
930 Smith Road, Navan

Photograph taken facing the left bank along the center of the reach. Exposed roots were commonly observed. Large boulders and cobbles were observed along the channel banks.

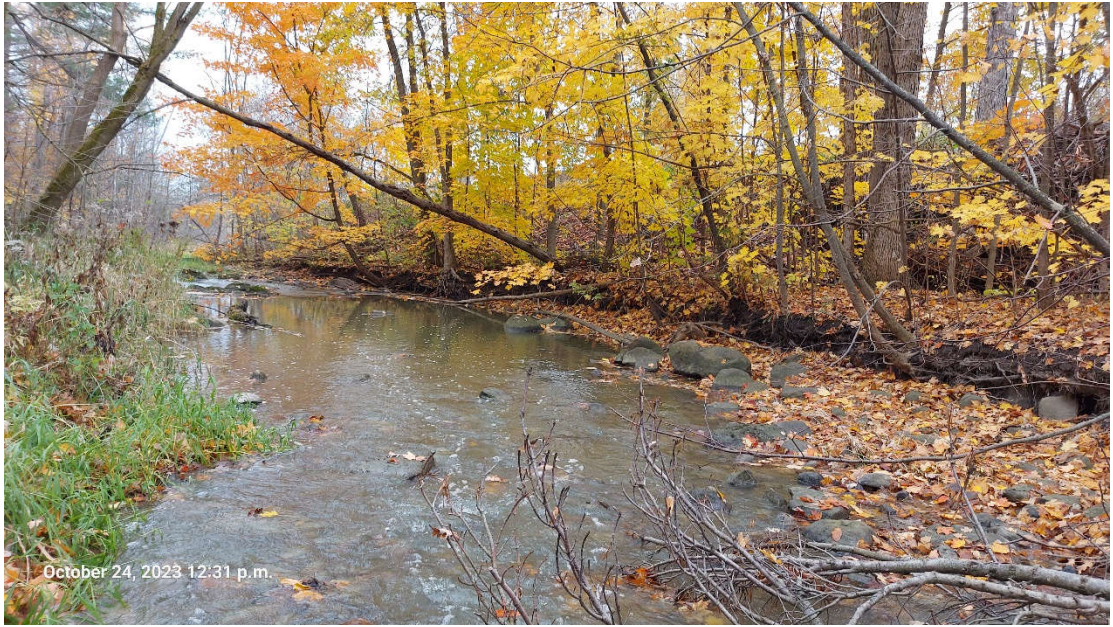
Photo 9
McKinnon's Creek
930 Smith Road, Navan

Photograph taken facing south at the most downstream extent of the reach. Basal scour was observed along the outside bend, and vegetated bars along the inside bend.

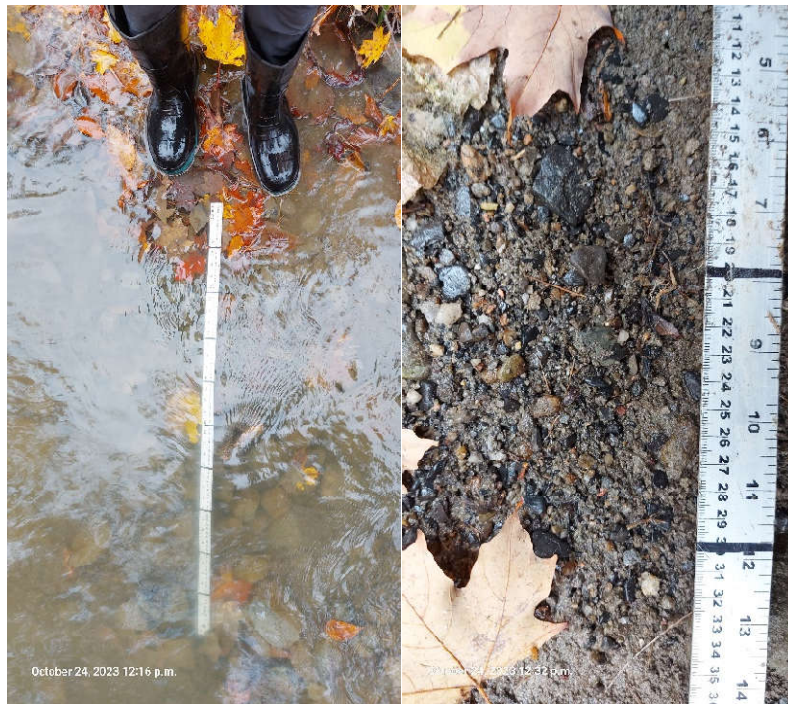
Photo 10
McKinnon's Creek
930 Smith Road, Navan

Photographs of the channel bed and banks. Instream substrate ranged from sand, gravel and cobbles in the pools and runs, and up to boulders in the riffles. Bank materials ranged from fine materials to gravel and cobbles.
