SUBSURFACE INVESTIGATION REPORT

73, 79 AND 83 STE CECILE ST., OTTAWA, ON, K4A 3N6

Report number: 59-HII-R1¹
January 30, 2025

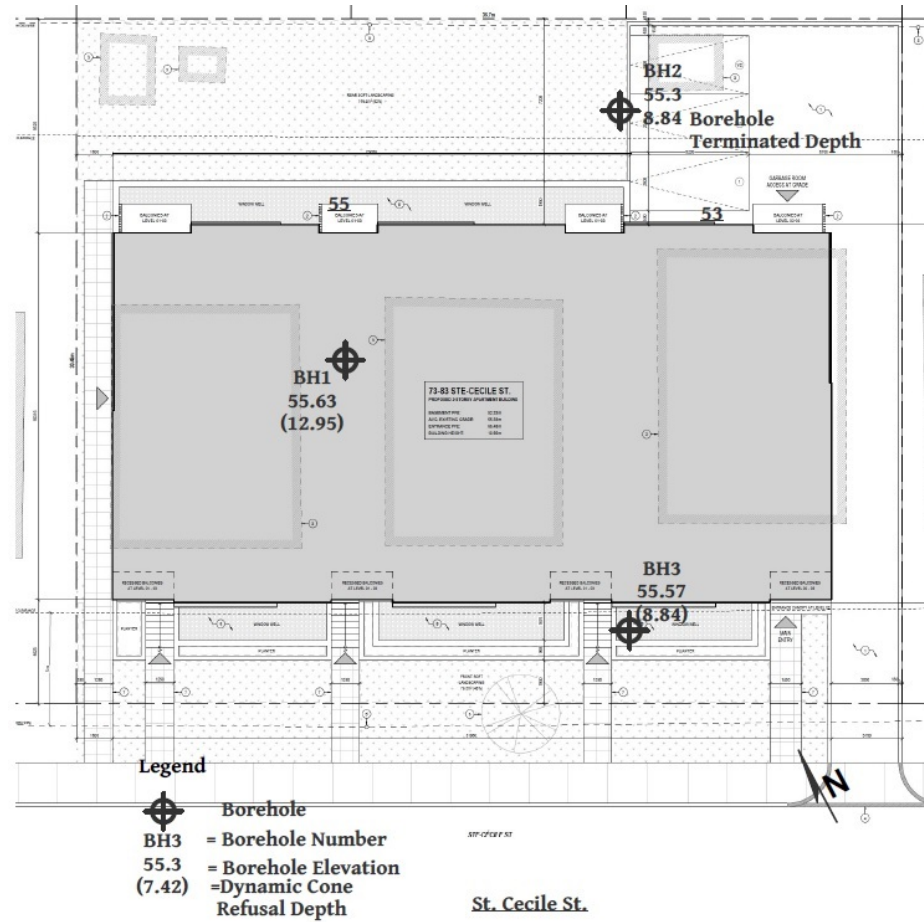
Figure 1: Test hole Locations Plan

The field program consisted in sampling the subsurface profile using boreholes located as shown in fig. 1 in page 7 along with field review, assessments and classification of samples.

The site consists on three residential lots within a city block. The general topography is flat. It consists on the 73, 79 and 83 Ste Cecile St. parcels in the City of Ottawa, ON. Figure 1 in page 7 shows a plan view of the site displaying the approximate test hole locations and depth.
