Report

Trail Road Battery Energy Storage System (BESS)  
Fluvial Geomorphology Assessment

H375035-0000-2B0-066-0001

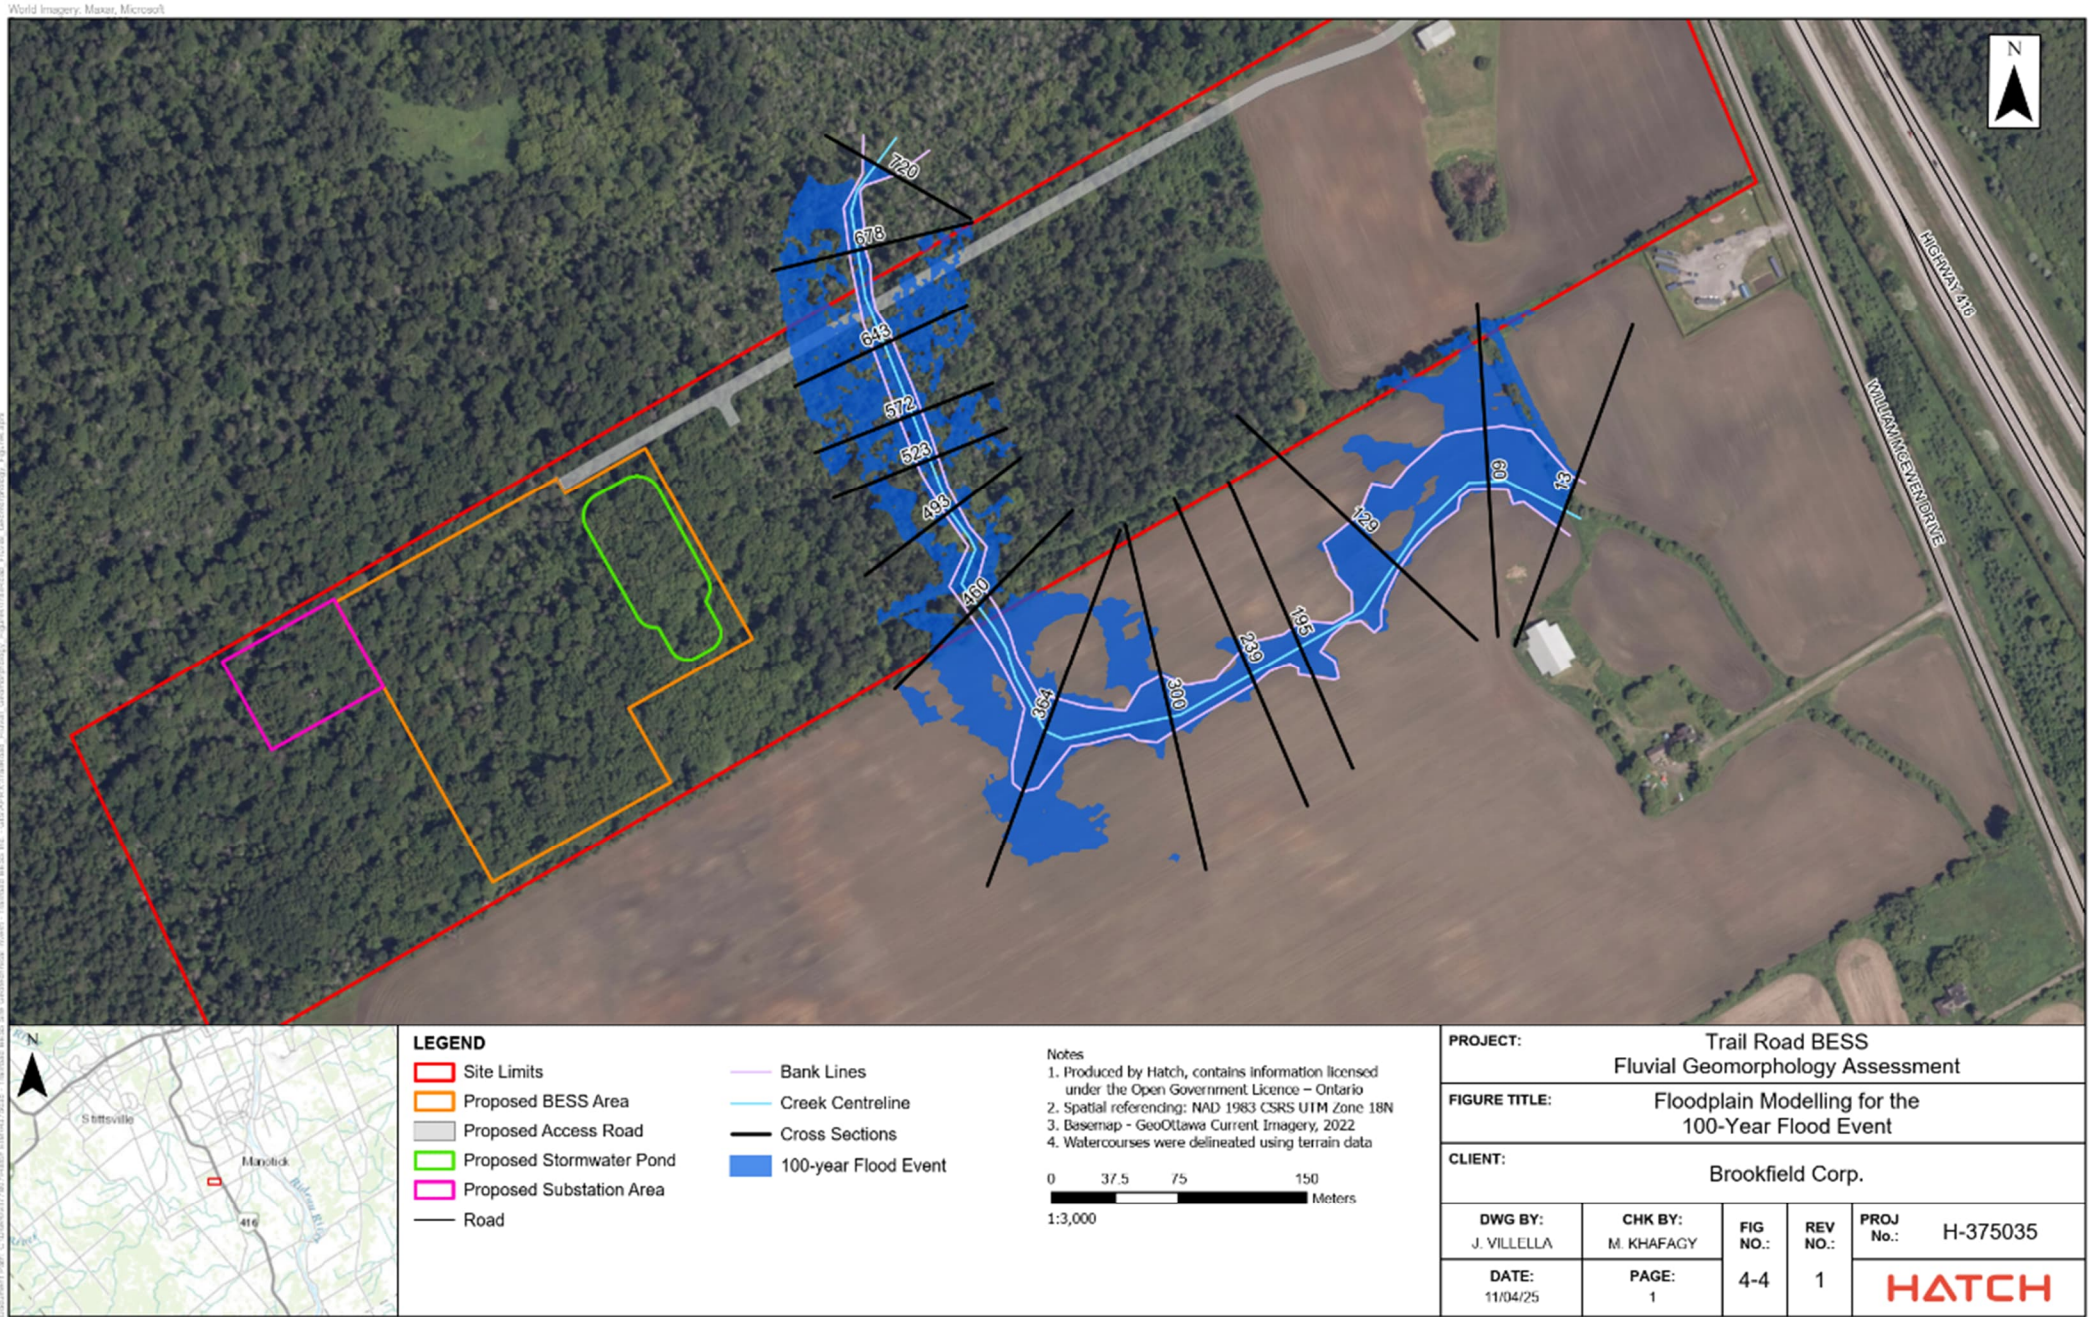
Figure 4-4: Results of Trail Road Creek Floodplain) Modelling for the 100-year Flood Event

The results of the 100-year flood events at the Creek are shown in Figure 4-4 below.

- HEC-RAS 1D hydraulic modelling was performed to estimate floodplain extents under various design flow scenarios. The 100-year floodplain delineation supported the erosion hazard assessment and confirmed no encroachment into the proposed development footprint.

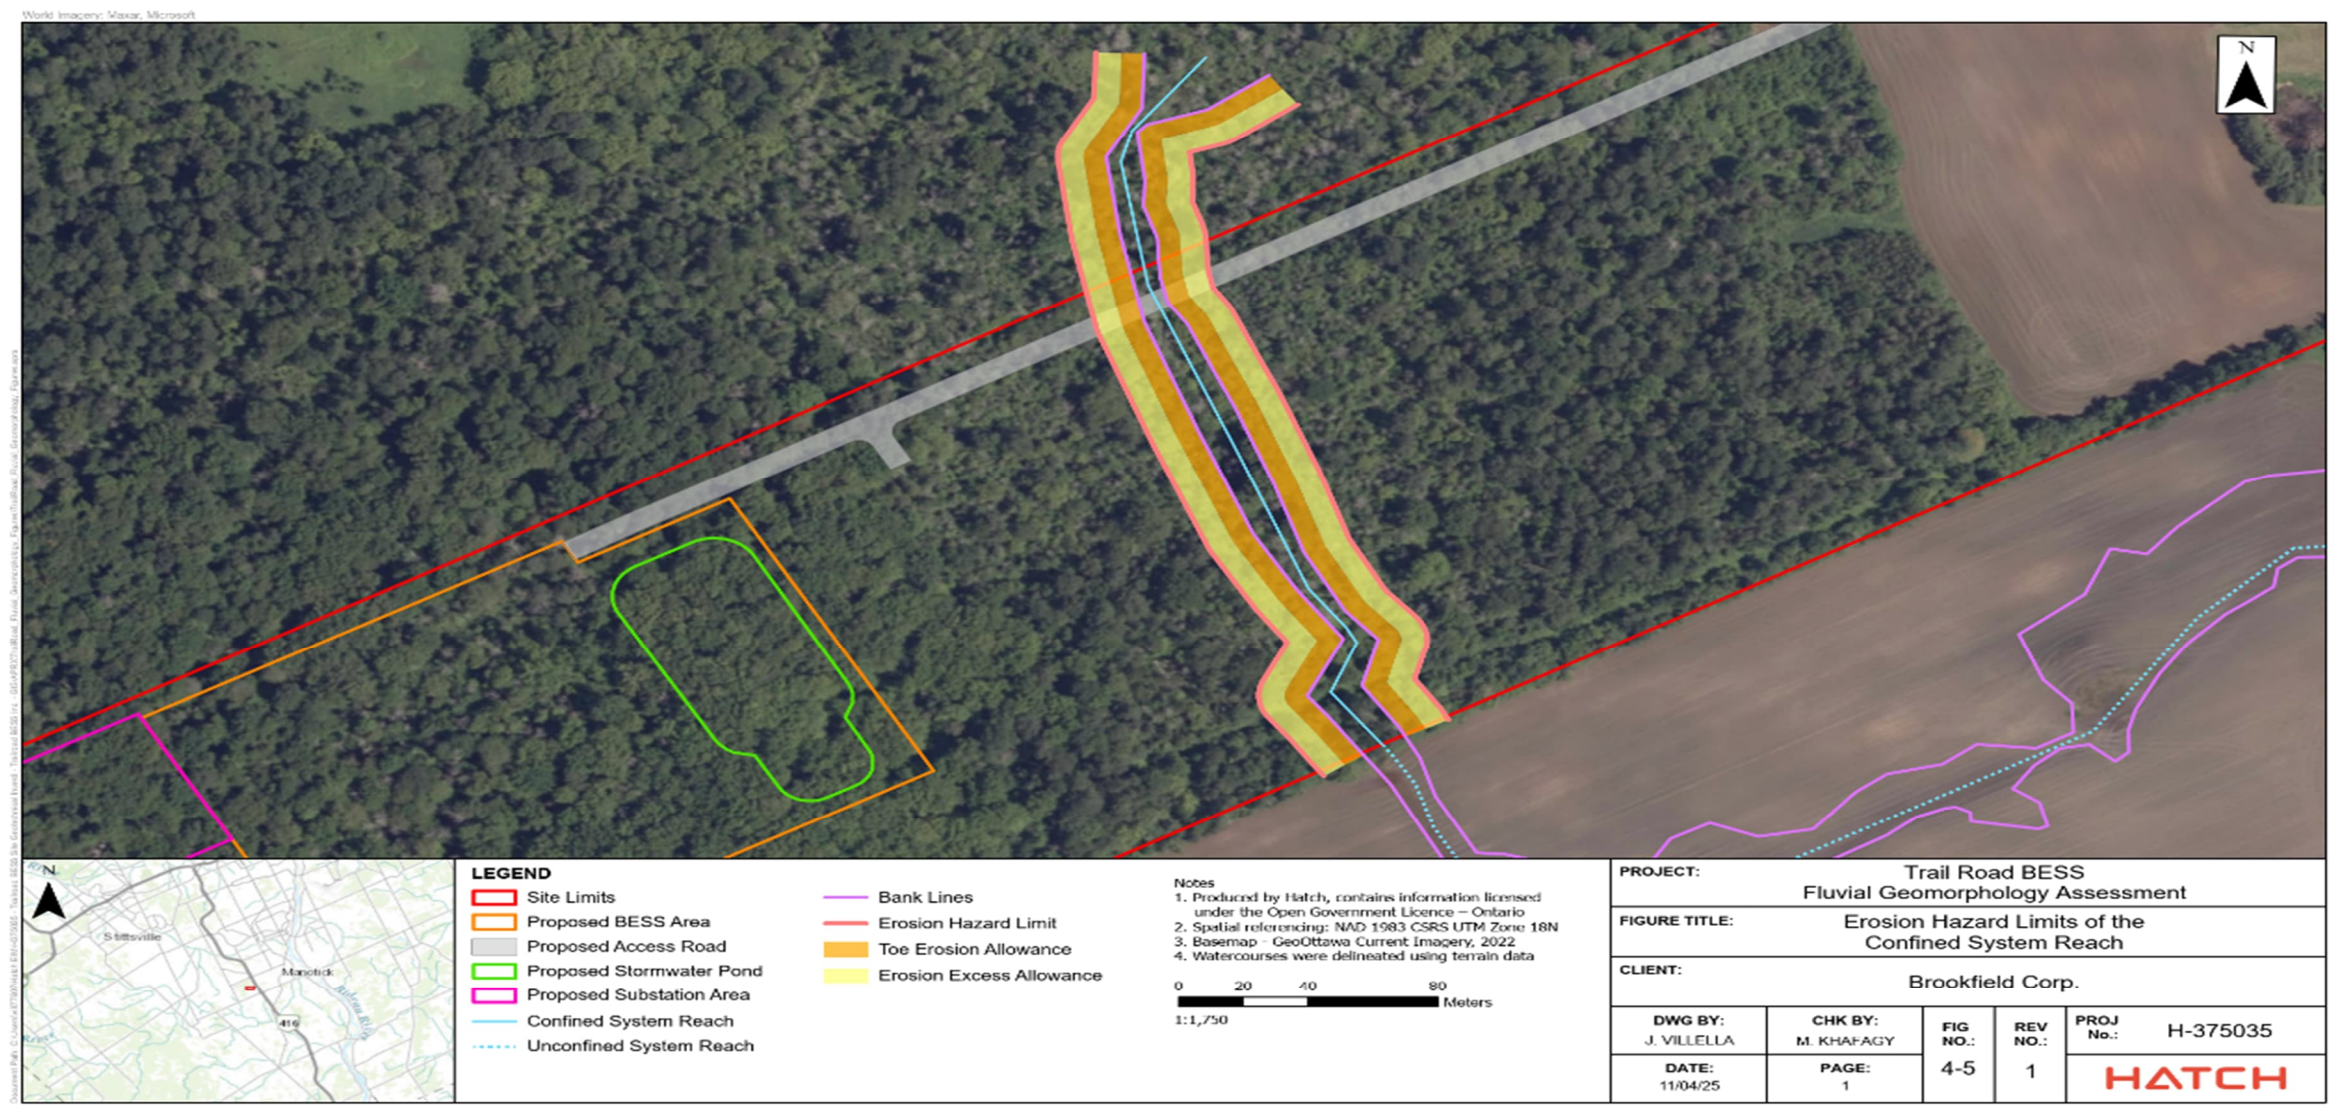
Figure 4-5: Erosion Hazard Limit of the Confined System Reach

An appropriate approach is to delineate the erosion hazard for the confined systems following MNR Erosion Hazard Limit Technical Guide (2002), where the erosion hazard is comprised of three main components: 1) the toe erosion allowance; 2) the stable slope allowance; and 3) the erosion access allowance. The toe Erosion Allowance represents the potential for channel migration at the base of the valley slope. A toe erosion allowance of 7 m was applied following the MNR Technical Guide (2001). Stable Slope Allowance is to address potential long-term slope instability, where the stable slope allowance is determined based on geotechnical criteria. Based on field observations and desktop review, the Creek within the study area exhibits a shallow bankfull depth of approximately 15 cm, and no defined valley slopes or steep embankments were identified adjacent to the channel. In accordance with the CVC Watershed Planning and Regulation Policies (2010), a stable slope allowance is required only where specific conditions apply, including: slope gradients steeper than 3:1, slope heights equal to or greater than 2 m, visible evidence of slope instability, proximity of bankfull flow to the valley toe of slope (within 15 m), or a known history of slope failure. Not all of these conditions were observed at the subject site.

Therefore, a stable slope allowance is not considered necessary for this reach of the watercourse. Erosion Access Allowance is a minimum access distance is typically applied at the top of the valley slope to allow space for maintenance or future stabilization works. Regarding the erosion access allowance, MNR Technical Guide (2002) guidelines note that for stiff/hard cohesive soil (clays, clay silt) and coarse granular (gravels) tills, a 5 to 8 m erosion access is to be applied. Given the evidence of erosion along the Creek, erosion access allowance of 8 m is recommended.

The proposed development area is located entirely outside the delineated erosion hazard limit associated with the confined system reach of the Creek. As shown in Figure 4-5, there is no overlap between the development footprint and the defined erosion hazard components, including the toe erosion allowance and erosion access allowance. Some considerations should be applied for the proposed service road crossing the Creek and discussed in Section 4.6. This confirms that the development, as currently planned, does not encroach upon areas identified as geomorphologically sensitive or at risk of fluvial erosion.

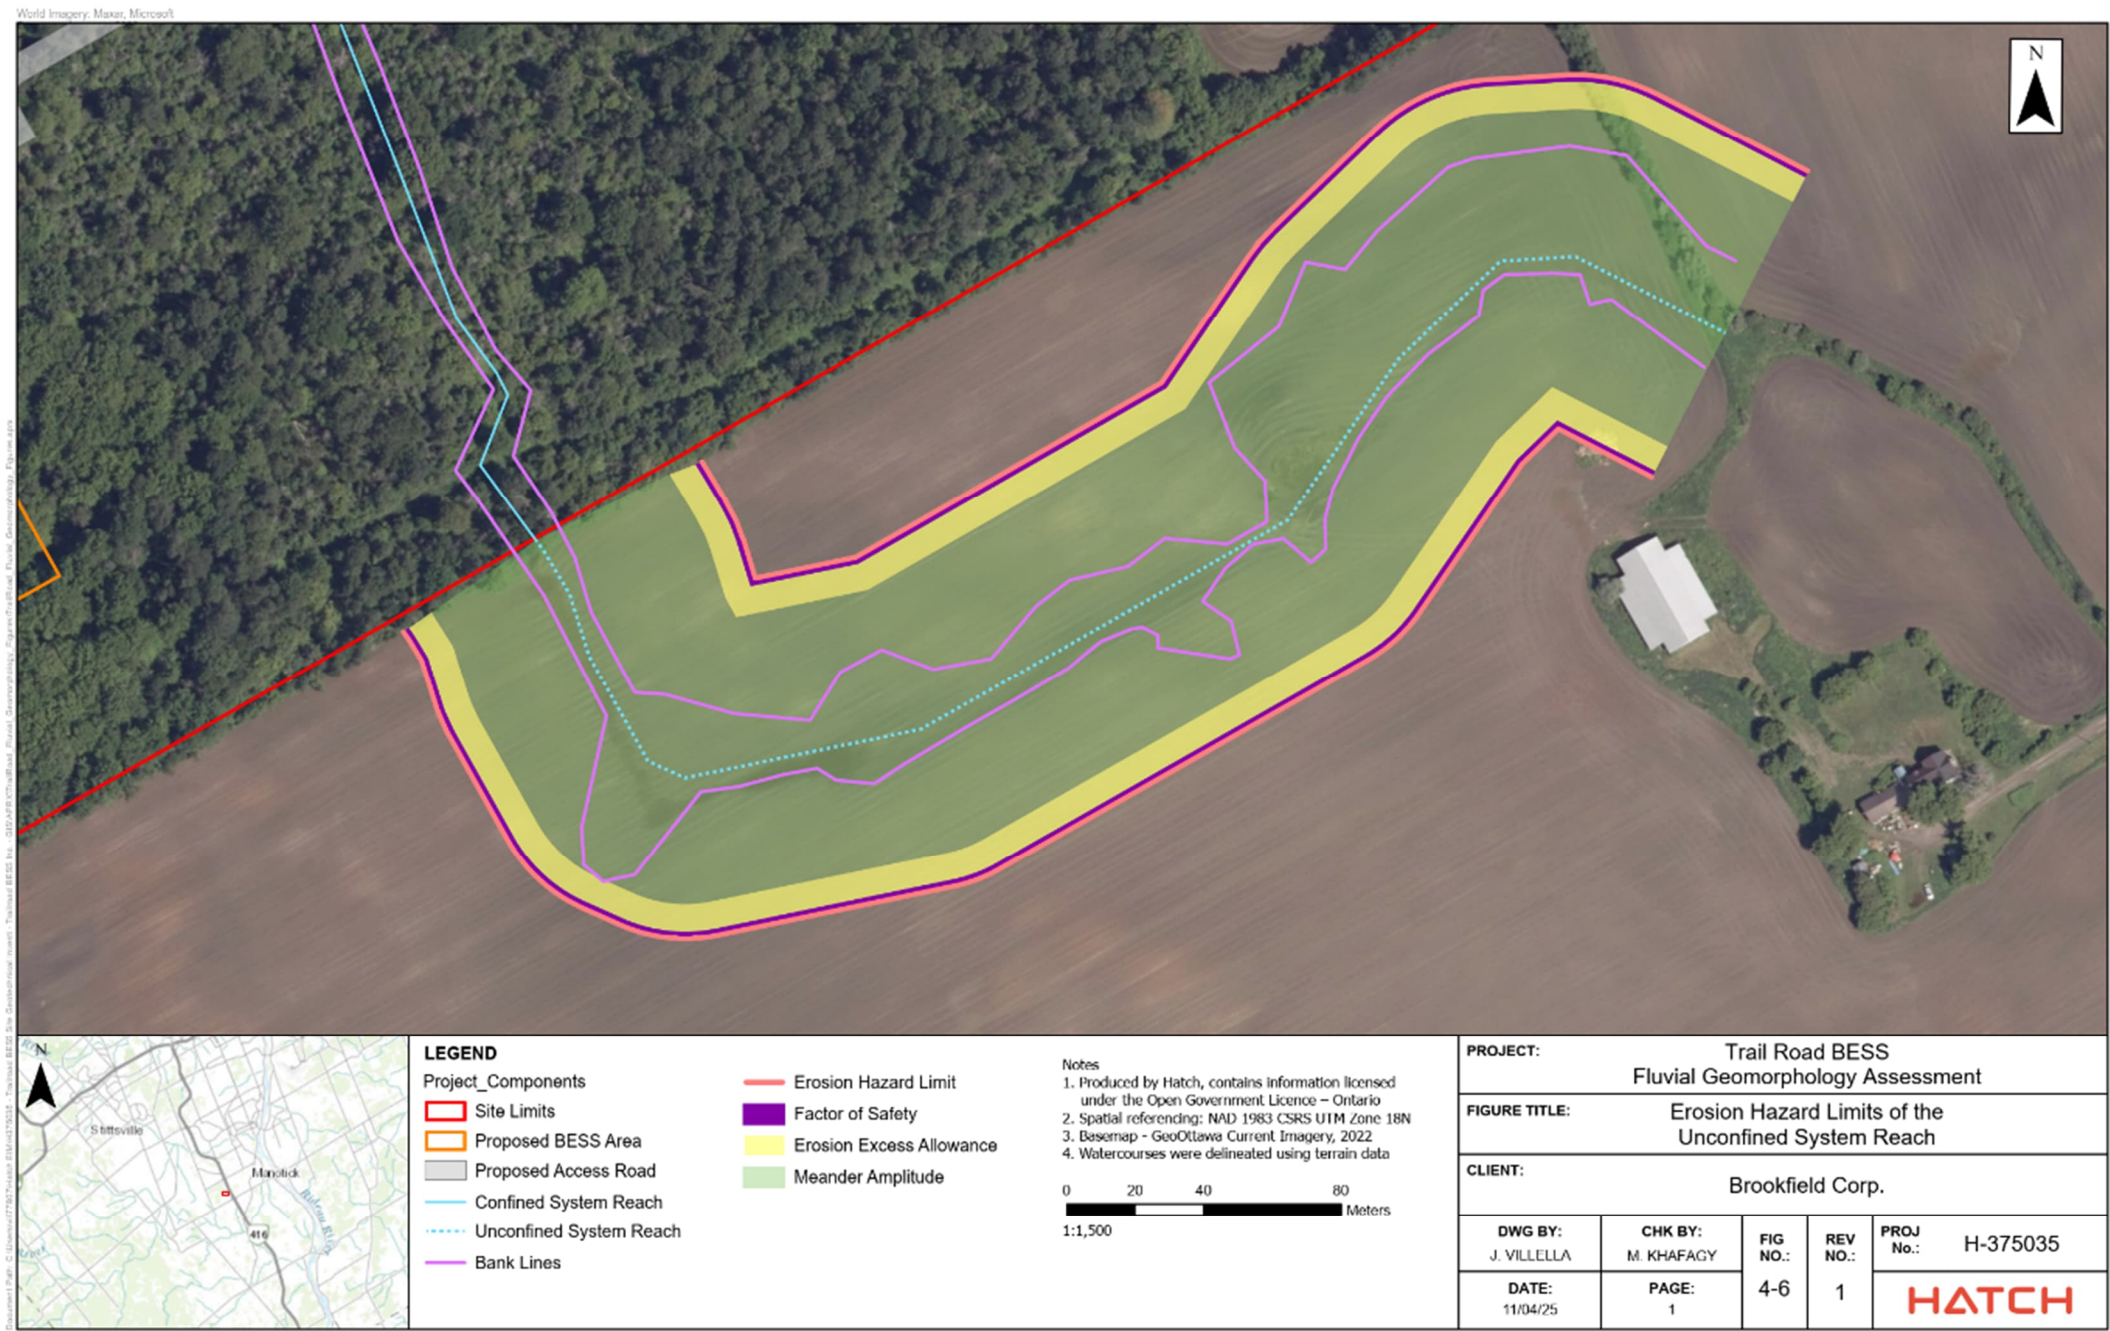
Figure 4-6: Erosion Hazard Limit of the Unconfined System Reach

The downstream reach of the Creek transitions into an unconfined system. In such systems, the erosion hazard is better assessed using a meander belt width approach, which reflects the maximum fixed lateral extent of historical and potential future channel migration. As per MNR Technical Guide (2002), the meander belt width is defined as the summation of meander amplitude and erosion access allowance. In this case, the historical aerial photograph analysis confirms lateral channel migration and expansion of the channel and adjacent wetland features over time. An erosion access allowance of 8 m is recommended for the unconfined system reach. Figure 4-6 shows the erosion hazard limit for both reaches of the Creek (Unconfined System) including the Meander belt Width and erosion access allowance.

An appropriate safety factor can be applied to the Erosion Hazard limit as per guideline recommendations. A 2 m safety factor has been applied to both reaches of the creek (the confined and unconfined systems).

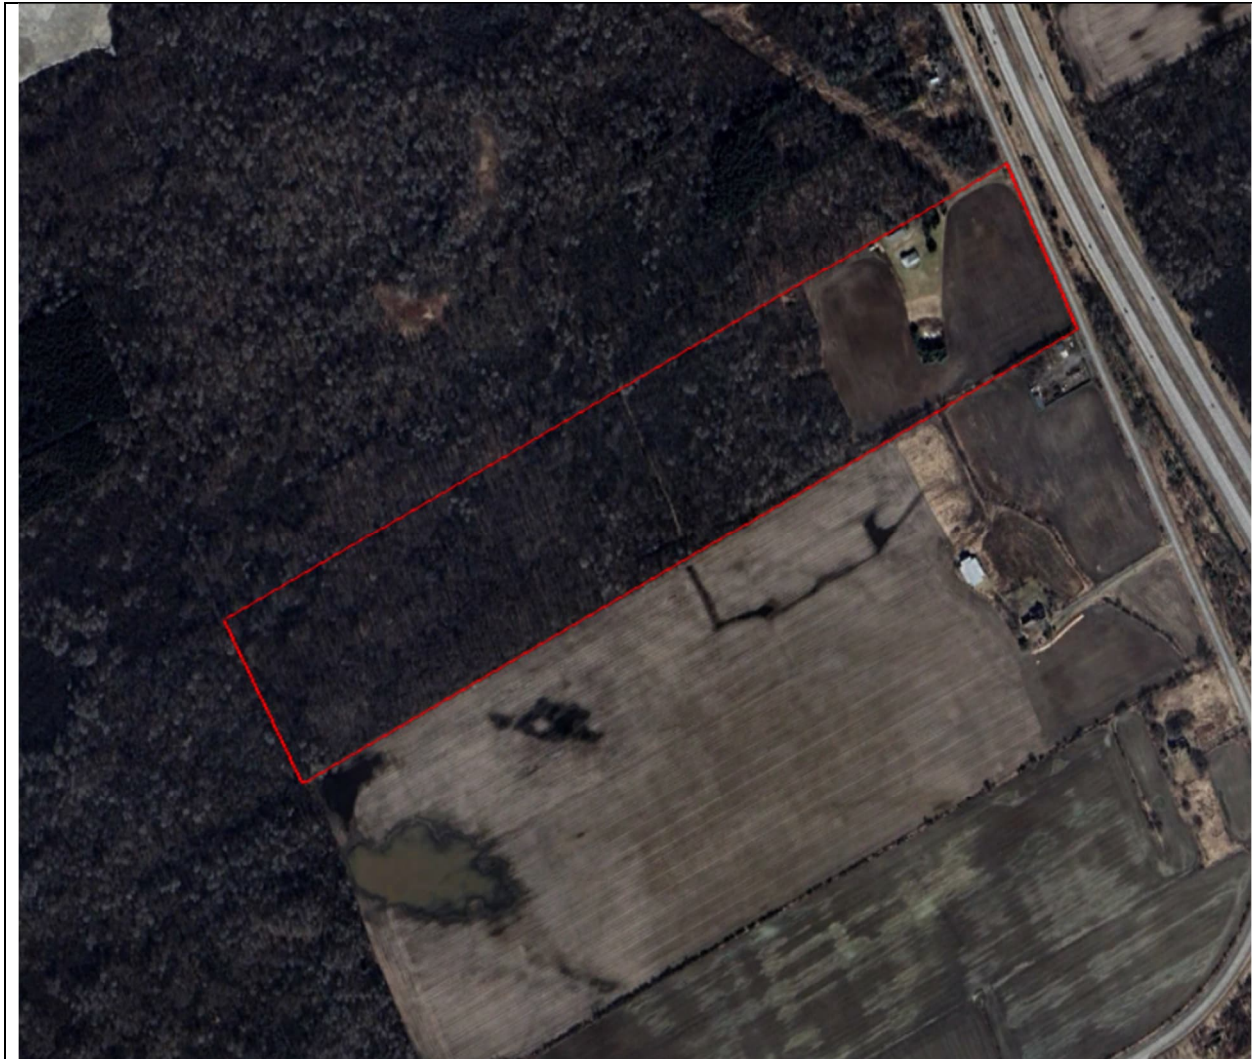
By 2020, the constructed banks are no longer visible, and the condition of the Creek continues to degrade through to 2024. In general, the Creek within the Project site follows a straight alignment; however, no visible changes to the planform of the tributary are observable in all aerial imagery due to tree cover.

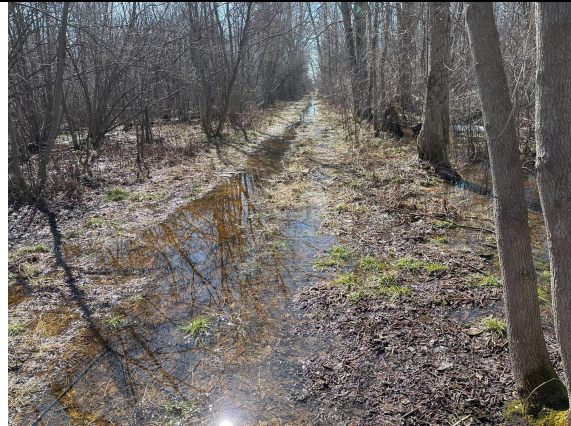
At the north boundary of the Project site, along the property line shared with the adjacent parcel, stagnant water was observed accumulating in a depressed corridor perpendicular to the main Creek alignment as shown in Photo 2 (Appendix B) from location S1. The presence of standing water outside the defined channel zone may also suggest the existence of secondary flow paths or backwater effects during wet periods, although no defined channel is visible in this area.

**Photo 2:** View looking northeast at the north site boundary (perpendicular to the creek), showing stagnant water on April 7, 2025.

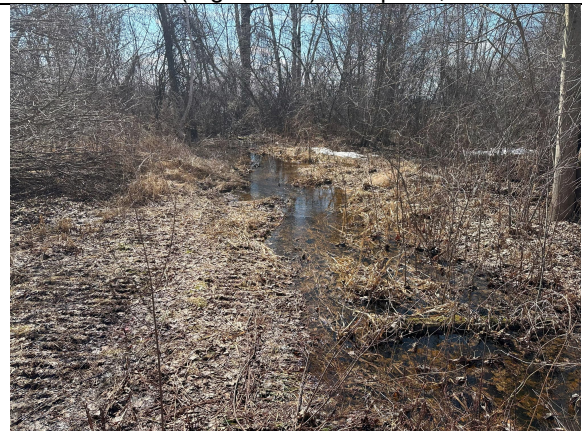
In several locations, including the area shown at location S8 (Photo 16 in Appendix B), evidence of localized channel adjustment and planform variability was observed. The Creek exhibits minor sinuosity, with lateral deflections of the low-flow channel that suggest active, albeit limited, fluvial processes. These deviations in flow alignment are likely the result of small-scale bank erosion and scour occurring along the outer margins of emerging meander features. While the degree of meandering is minimal due to the confined nature of the corridor and limited stream power, these features may represent the early development of a meander belt within the system.

**Photo 16:** View looking southeast (downstream) at location S8 (Figure 3-1) (minor sinuosity) on April 7, 2025.

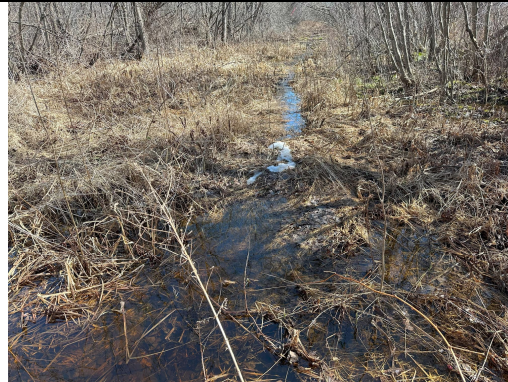
**Photo 20:** View looking east at the south site boundary from location S9, showing the head of a secondary reach of the creek that initiates on-site and flows eastward on April 7, 2025.
