## TREE CONSERVATION REPORT

5872-5884 Hazeldean Road & 7  
Savage Drive

Tree Conservation Report submitted as Partial  
Requirements for a Site Plan Control Application.

December 3, 2024

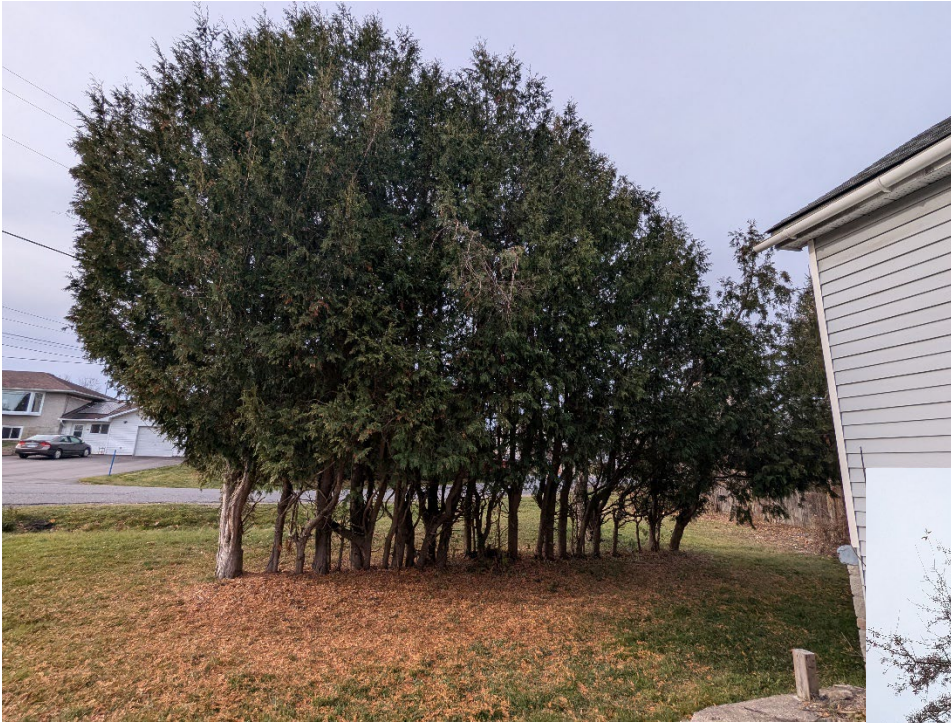
**Tree 1** will be severely impacted by the installation of the proposed walkway, driveway, and excavation.

Clockwise from top left: Tree 1 - cedar hedge to be removed.

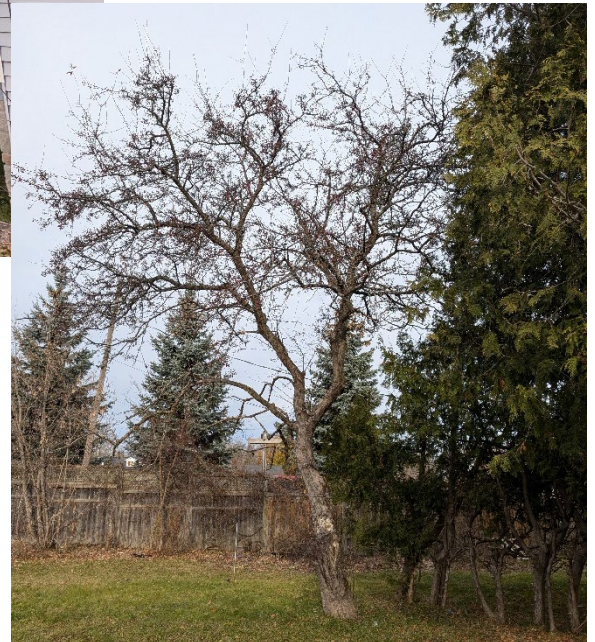
**Tree 2** is in direct conflict with the proposed driveway, and the tree is in poor condition.

Tree 2 - City crab apple to be removed.

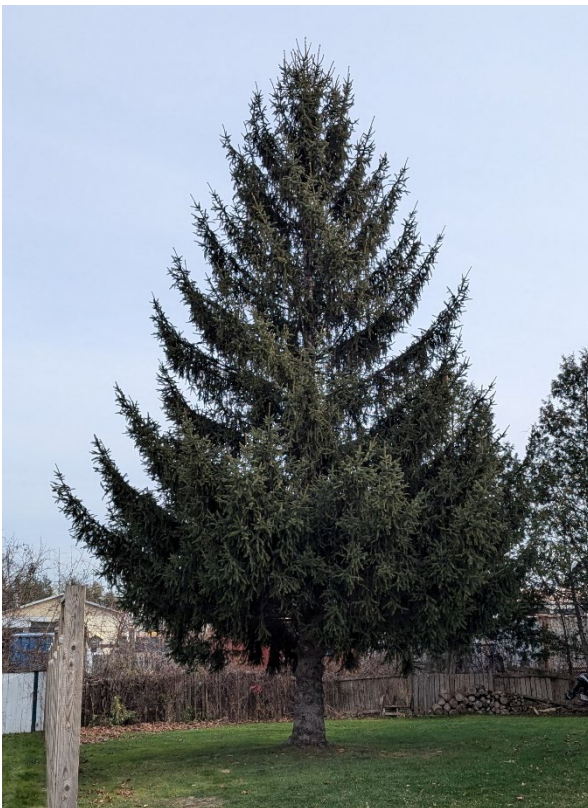
The amount of the defined Critical Root Zone of **Tree 3** that will be disturbed is minimal, and because the tree has good rooting space on the adjacent property, it is expected this tree will be able to endure construction.

Tree 3 - adjacent spruce to be retained.

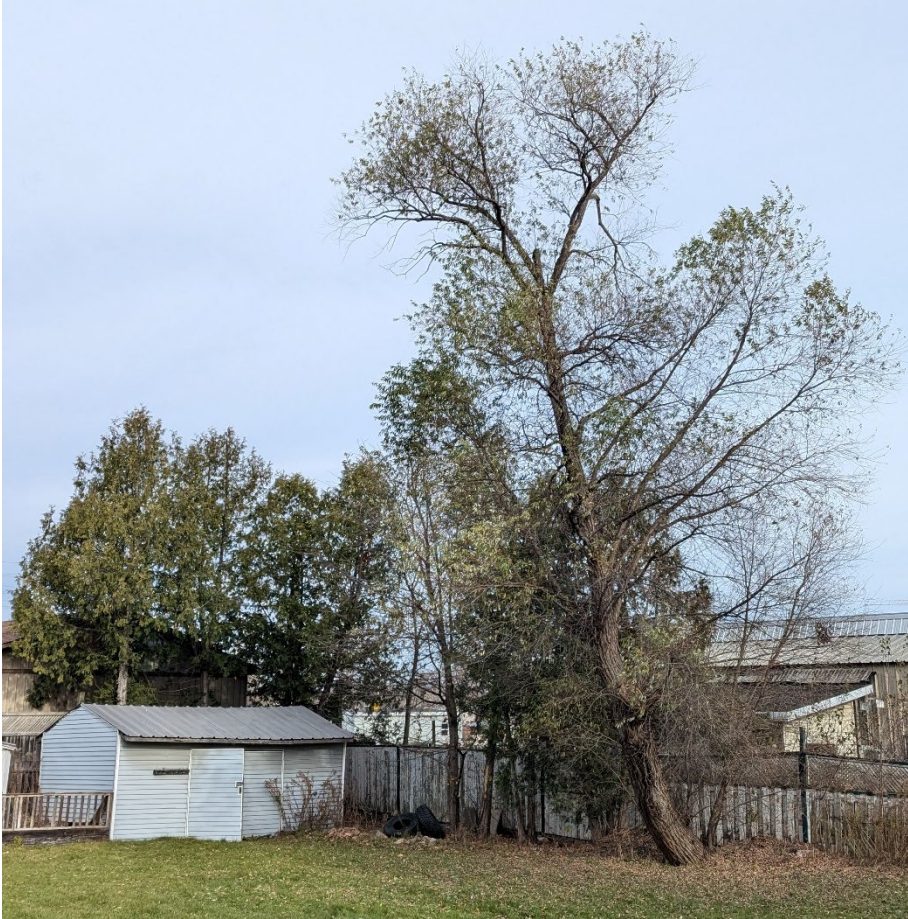
The proposed development includes 2 levels of underground parking covering a large majority of the lots. The required excavation will necessitate the removal of all private trees (specifically Trees **4-11** and **22-31**). Given these plans, it is unlikely engineering documents will change these recommendations.

**Above left: Trees 4-11 - private trees to be removed.**

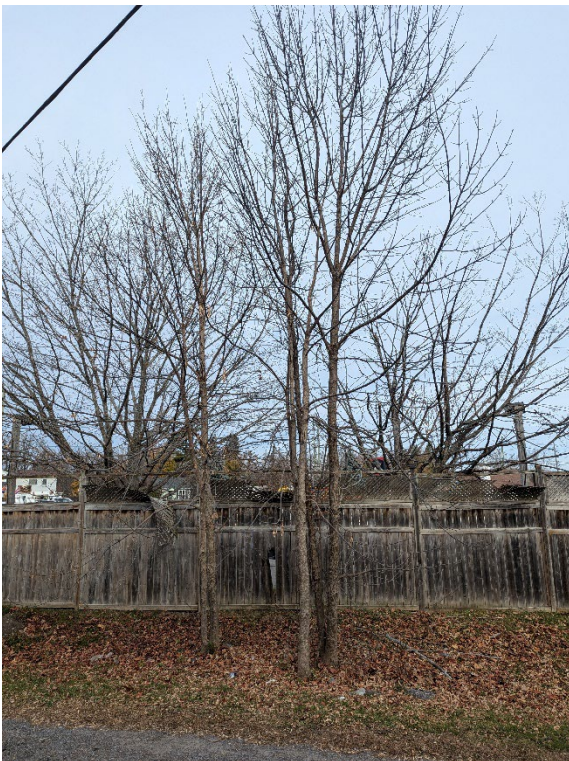
**Tree 12** is a likely self-seeded cluster of young ash stems. These are showing signs of insect damage, and it is possible they have already been infested with Emerald Ash Borer. It is unlikely these trees will survive long, despite construction, and the stress of construction will further hasten their decline.

**Below left: Tree 12 – cluster of ash stems to be removed.**

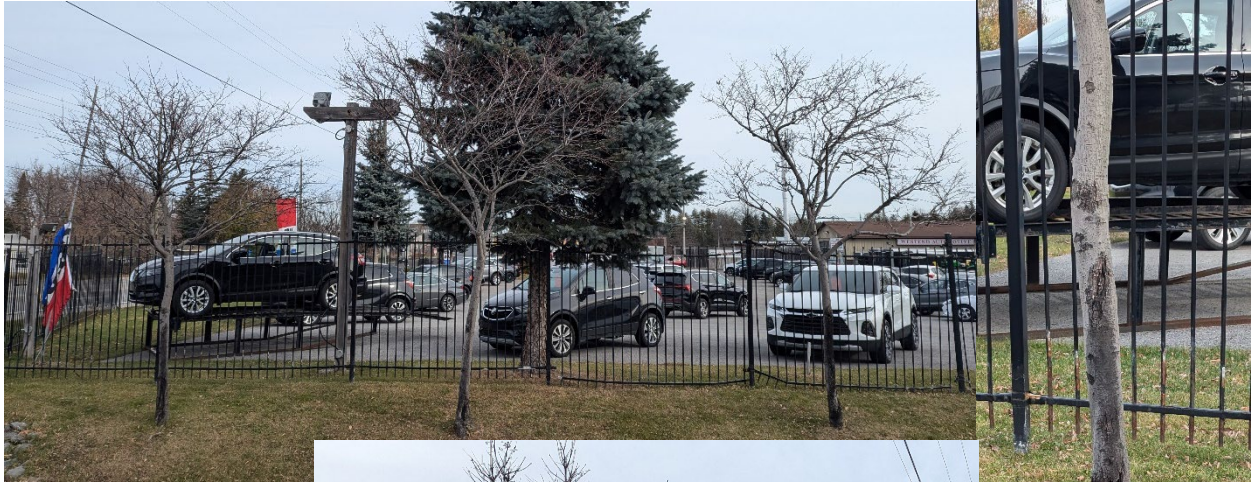
Above: City serviceberries and private spruce, all to be removed.

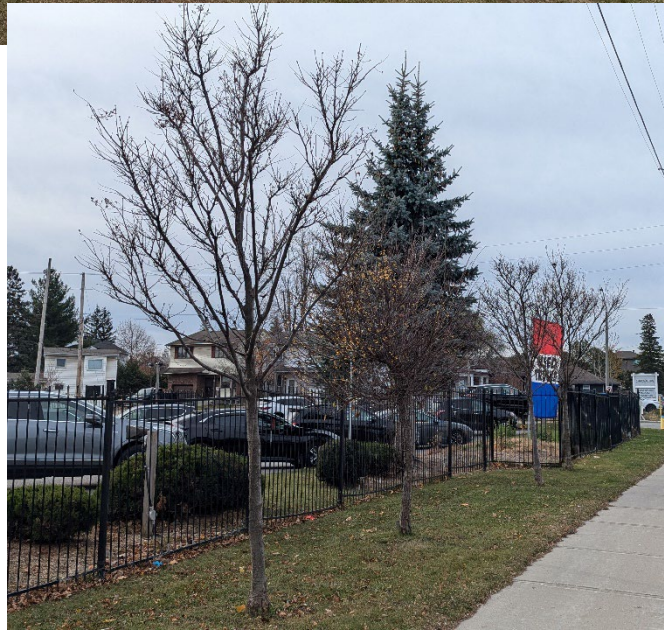
**Trees 13-21** are in poor condition – large wounds around the bases of the trees are pathways for infections, and with the added stress of construction, regardless of protections, these trees are likely to decline very quickly. It is recommended they be removed and replaced with healthier specimens.

Far right: trunk of Tree 13 - typical wound and coloring of Trees 13-15.

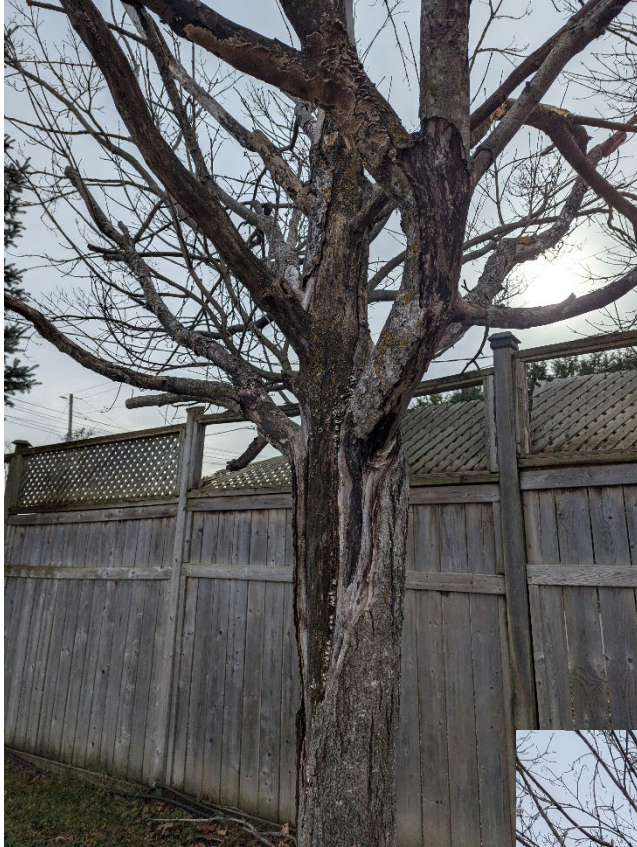
Above: Tree 32 - private sugar maple to be removed.

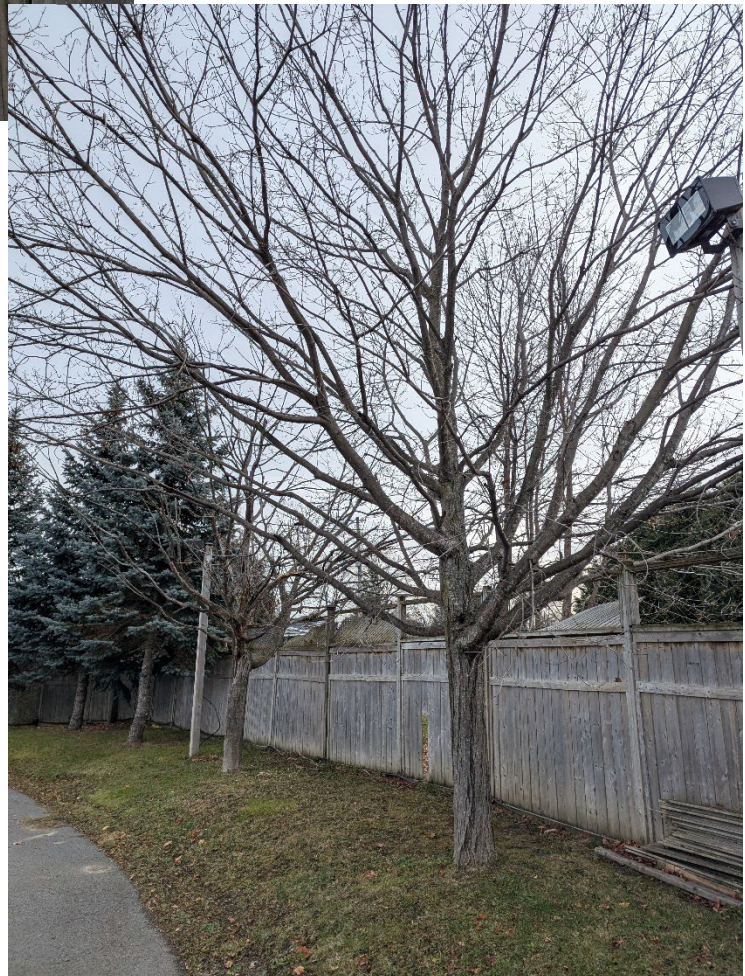
Right: Tree 33 - private sugar maple to be removed.
