TREE CONSERVATION REPORT

500 Edgeworth Ave

Tree Conservation Report submitted as Partial Requirements for a Site Plan Control and Zoning Bylaw Amendment Application, August 11, 2025

Date of Report: August 11, 2025

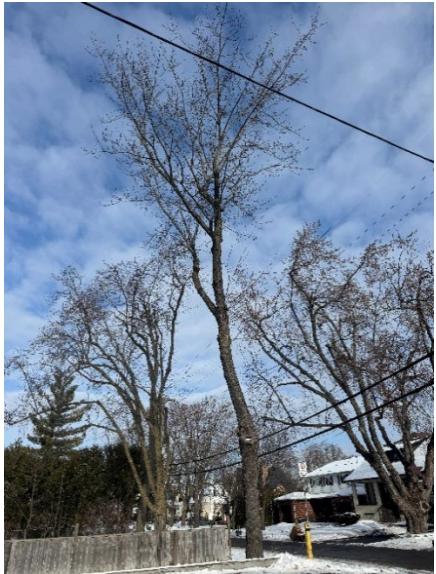
| Tree ¹ | Species | Diameter at breast height (cm) | Ownership ^{2,3} | Condition | Recommendations |
|---|---|---|---|---|--|
| 1 | Sugar maple (<i>Acer saccharum</i>) | 59 | Subject properties | Fair; pruned for hydro clearance, epicormic shoots, old branch attachment wound with decay at 4 m grade | Remove due to excavation for parking lot |

Picture 1: Tree 1, privately owned silver maple

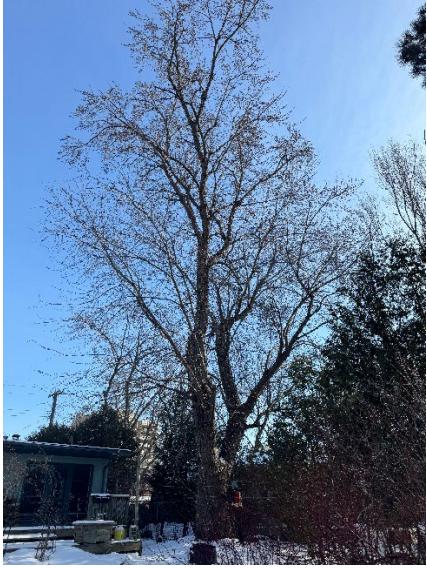
| 16 | Sugar maple (<i>Acer saccharum</i>) | 120 | Subject properties | Poor/fair; old branch attachment wound, multi-stemmed | Remove due to excavation for parking lot |

Picture 5: tree 16, large silver maple at 508 Edgeworth

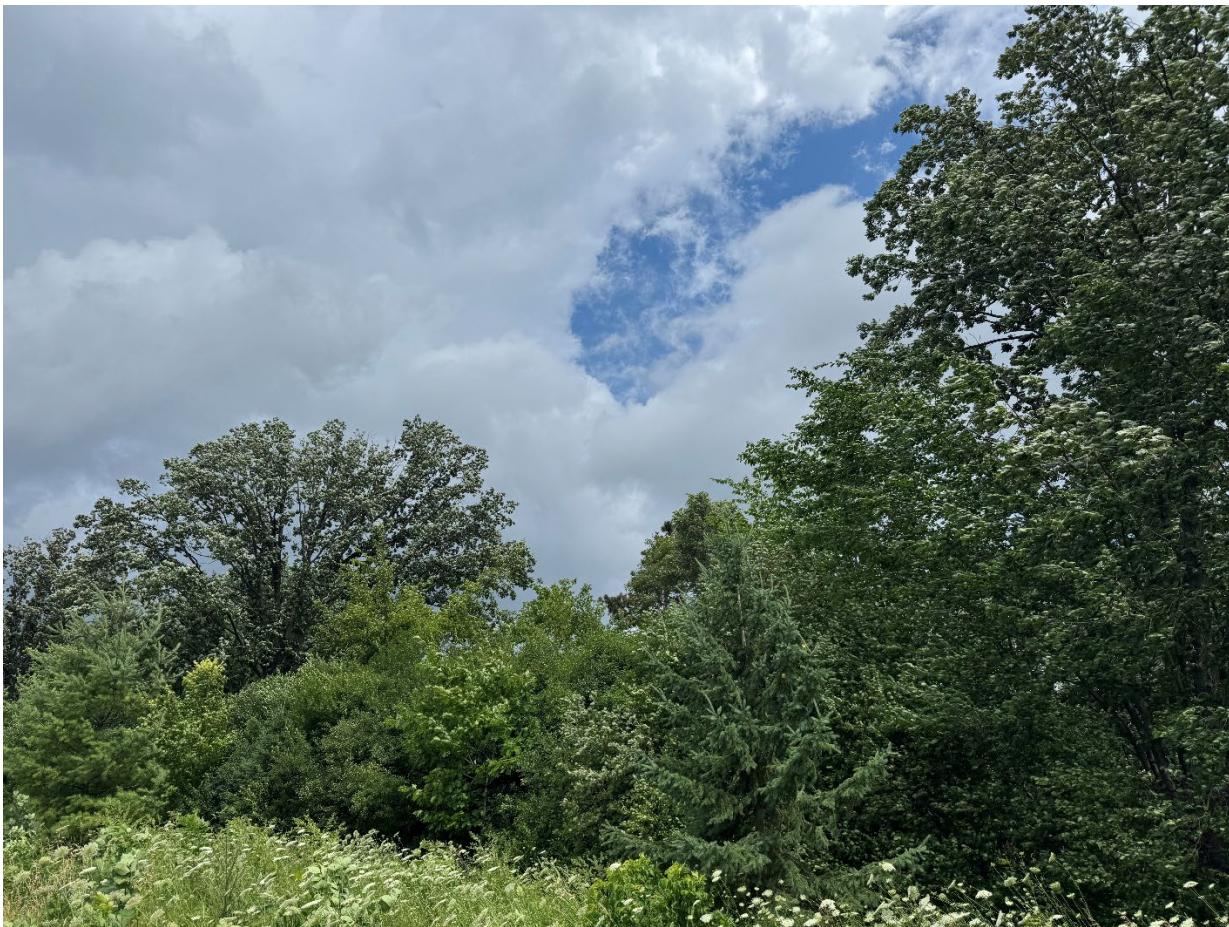
In addition to those trees identified on TCR maps, there is also a line of thick buckthorn shrubs along the edge of the NCC property. Due to their invasive nature, these should all be removed along with the trees that need to be removed to accommodate the excavation and make the area free of any risks of tree failures. During deep excavations such as this, the falling distance increases for those trees along the edge, resulting in higher consequences of failure for the construction crews working below.

Picture 8: Taken from the NCC property, row of buckthorn along the property line interspersed with recently planted trees along the west side
