# Claridge Homes Wurtemburg Street Condominium Development Ottawa, Ontario

April 19, 2010

Project Number: GP 10106

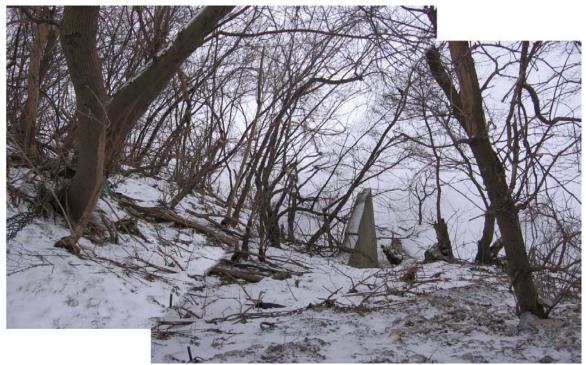
Photos 1, 2 and 3 in Appendix 1 depict the slope of the property and foreshore along the Rideau River on February 21, 2010. On the side adjacent to the Rideau River, the property slopes steeply toward the river as indicated in Photos 1 and 2. The slope is vegetated with trees and shrubs. Although it did not appear as though there was extensive ground cover, the ground was covered with snow on February 21, 2010 and this was difficult to confirm.

Photo 1. View down slope to the Rideau River on February 21, 2010. The concrete abutment is the upstream extent of the development property.

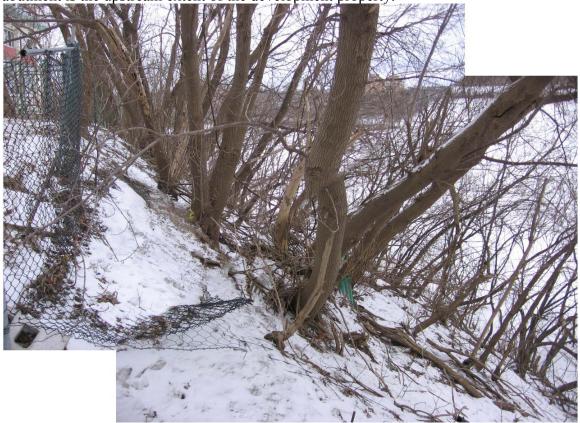
Photo 2. View across the slope on February 21, 2010. The fence represents the top of the slope on the development property.

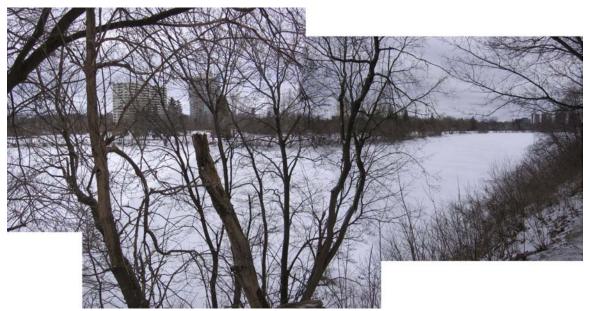
Photo 3. View along the Rideau River looking upstream from the upstream side of the development property, on February 21, 2010.

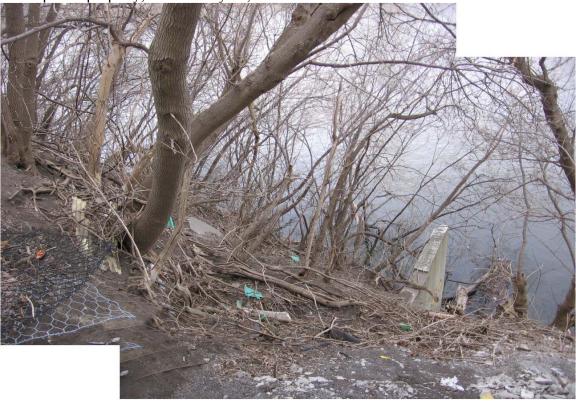
Photo 4. View down slope to the Rideau River on March 25, 2010. The concrete abutment is the upstream extent of the development property.

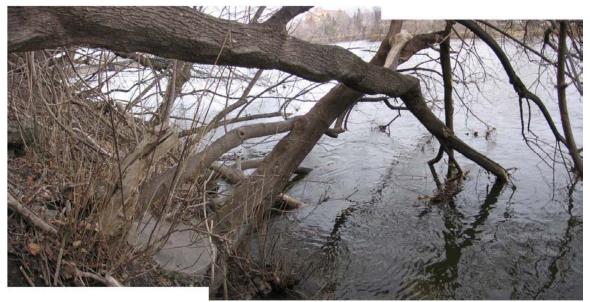
Photo 5. View along the foreshore of the Rideau River, looking downstream from the upstream side, on March 25, 2010.

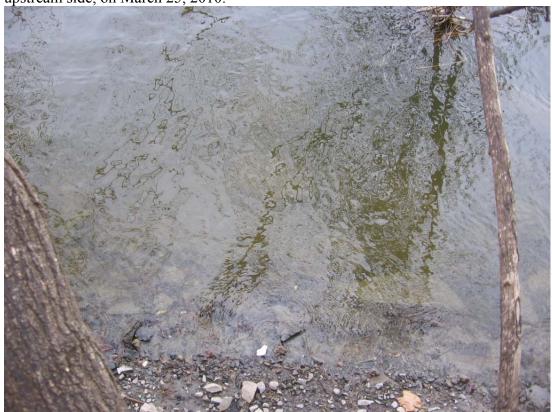
Habitat Resiliency	<ul> <li>the food chain.</li> <li>The shoreline habitat currently present at the site is a mix of broken concrete and related granular material, along with a mix of fine particle substrate and gravel, as indicated in Photos 6, 7 8, 12, 13 and 16 in Appendix 1. It can be seen from the photos that the gravel is fairly embedded.</li> <li>The shallow littoral habitat is comprised of a sloping silty substrate (Photos 14 and 15), with some large woody debris present.</li> <li>The Manitoba maples overhang the shoreline providing shade. There is virtually no understory.</li> <li>Generally, along this section of river, the littoral habitat</li> </ul>
	<ul> <li>Generally, along this section of fiver, the intoral habitat (Photos 10 and 11) is similar to that depicted in Photos 6, 7 and 8 in Appendix 1. The property immediately downstream has a concrete retaining wall however (Photo 10).</li> <li>Golder Associates (2010) indicates that the existing bank is erosional and the slope is unstable. This was also noted in the site visits reported upon in this report. Placement of rip-rap is intended to correct this ongoing source of habitat alteration.</li> <li>Structure provided by large woody debris can be replaced by rip-rap. If necessary, large woody debris could be placed with the rip-rap.</li> <li>Overhanging vegetation can be replaced with appropriate species of shrubs.</li> </ul>

Photo 6. Close-up of the littoral zone along the front of the property showing substrate and degree of embeddedness - March 25, 2010

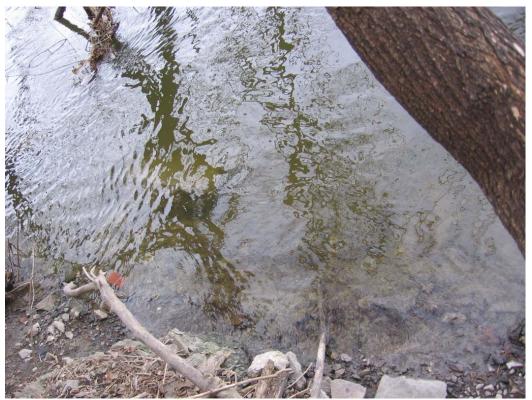
Photo 7. Close-up of the littoral zone along the front of the property showing substrate, habitat structure and degree of embeddedness - March 25, 2010.

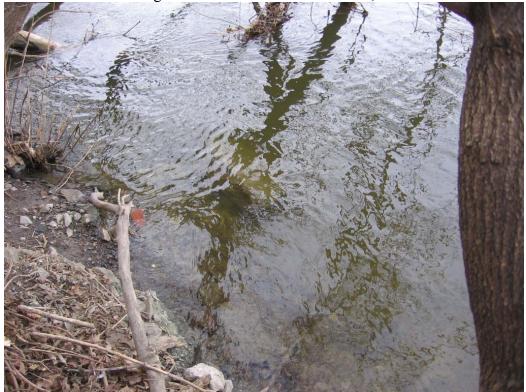
Photo 8. Close-up of the littoral zone along the front of the property showing substrate, habitat structure and degree of embeddedness - March 25, 2010.

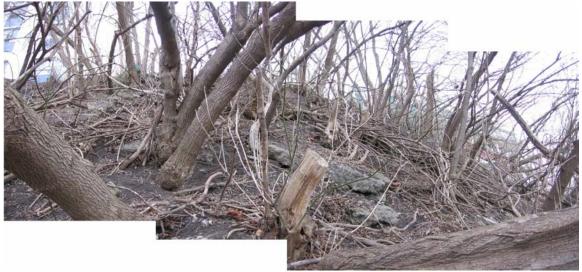
Photo 9. View from the water looking upslope - March 25, 2010.

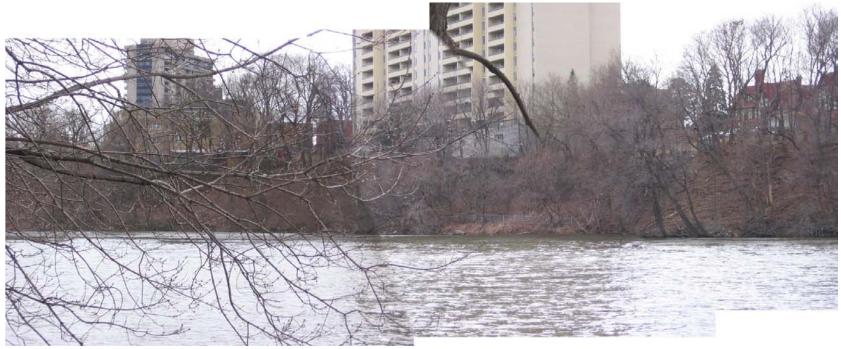
Photo 11. View of the upstream shoreline from across the Rideau River - March 25, 2010.

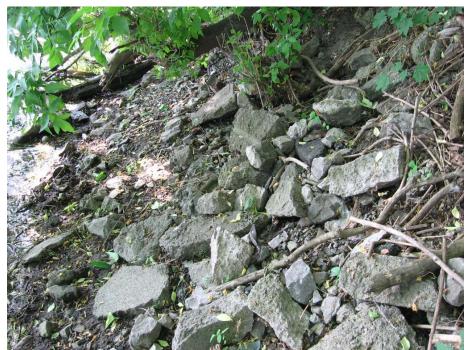
Photos 12 through 16 in Appendix 1 depict the Rideau River shoreline and shallow littoral zone along the property on May 25, 2010. From Photos 12, 13 and 16 it is apparent that the shoreline has a substantial component that is comprised of broken concrete and granular material. Photos 14 and 15 show the shallow littoral zone where the substrate is comprised of silty material. Some submergent aquatic vegetation and a minor amount of large woody debris were present.

Photo 12. Shoreline showing broken concrete that has been moving downslope toward the river – May 25, 2010.

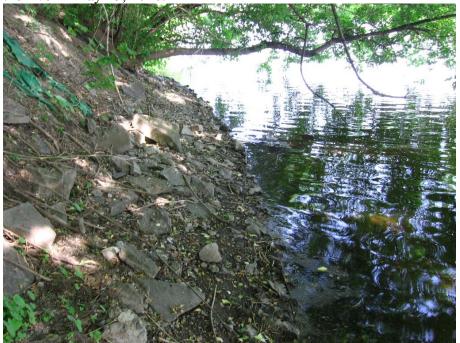
Photo 13. Shoreline showing broken concrete and unconsolidated material that has been moving downslope toward the river. While the Manitoba maples provide overhead shade, the shoreline itself lacked riparian vegetation – May 25, 2010.

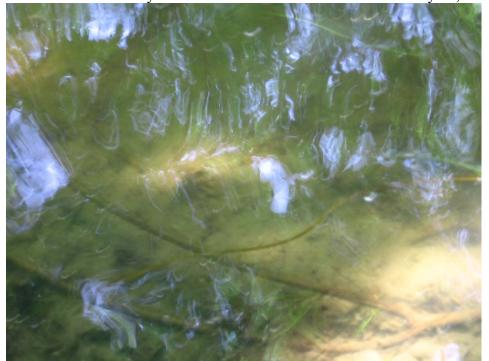
Photo 15. View of silty substrate in the shallow littoral zone – May 25, 2010.

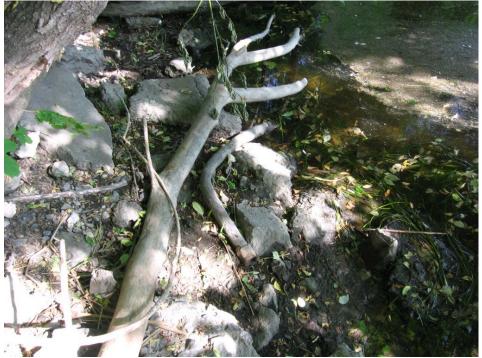
Photo 16. Riparian zone – May 25, 2010.

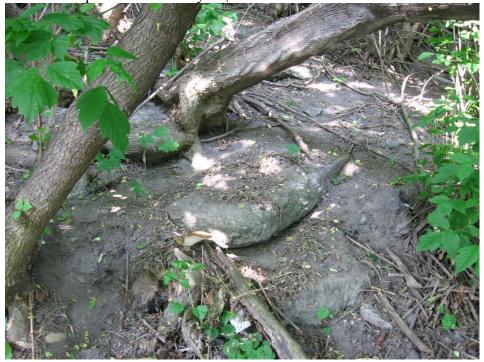
The habitat currently present at the site is a granular mix of fine particle substrate and gravel, and the gravel is fairly embedded. The existing bank is considered erosional and the slope is unstable. Placement of rip-rap is intended to correct this ongoing source of habitat alteration. The habitat change resulting from the project represents a very small proportion of habitat along this section of the Rideau River. It is not apparent that the relevant habitat contributes in any unique or critical manner to the productive capacity of species found in this section of the Rideau River. The habitat changed by the project represents a very small proportion of similar habitat along this section of the Rideau River. The relevant habitat is not considered rare. Species at risk were not identified in this section of the Rideau River

Photo 17. Eroding slope above the shoreline – May 25, 2010.

- Grading the slope to the angle required to ensure stability;
- Stabilizing the slope with rip-rap; and
- Stabilizing the toe of the slope at the Rideau River with rip-rap.

Rip-rap at the toe of the slope would extend approximately 2 meters into the littoral areas of the adjacent Rideau River for a distance of 17.3 meters. Approximately 35 square meters of fish habitat would be altered by the placement of rip-rap at the toe of the slope. Rip-rap would also be placed on the slope itself, meaning that existing vegetation would be removed. Trees would be planted along the toe of the slope, through spaces between the rip-rap.
