485 RICHMOND ROAD
OTTAWA, ONTARIO

MINTO COMMUNITIES INC.

ARBORIST REPORT

ARB-1

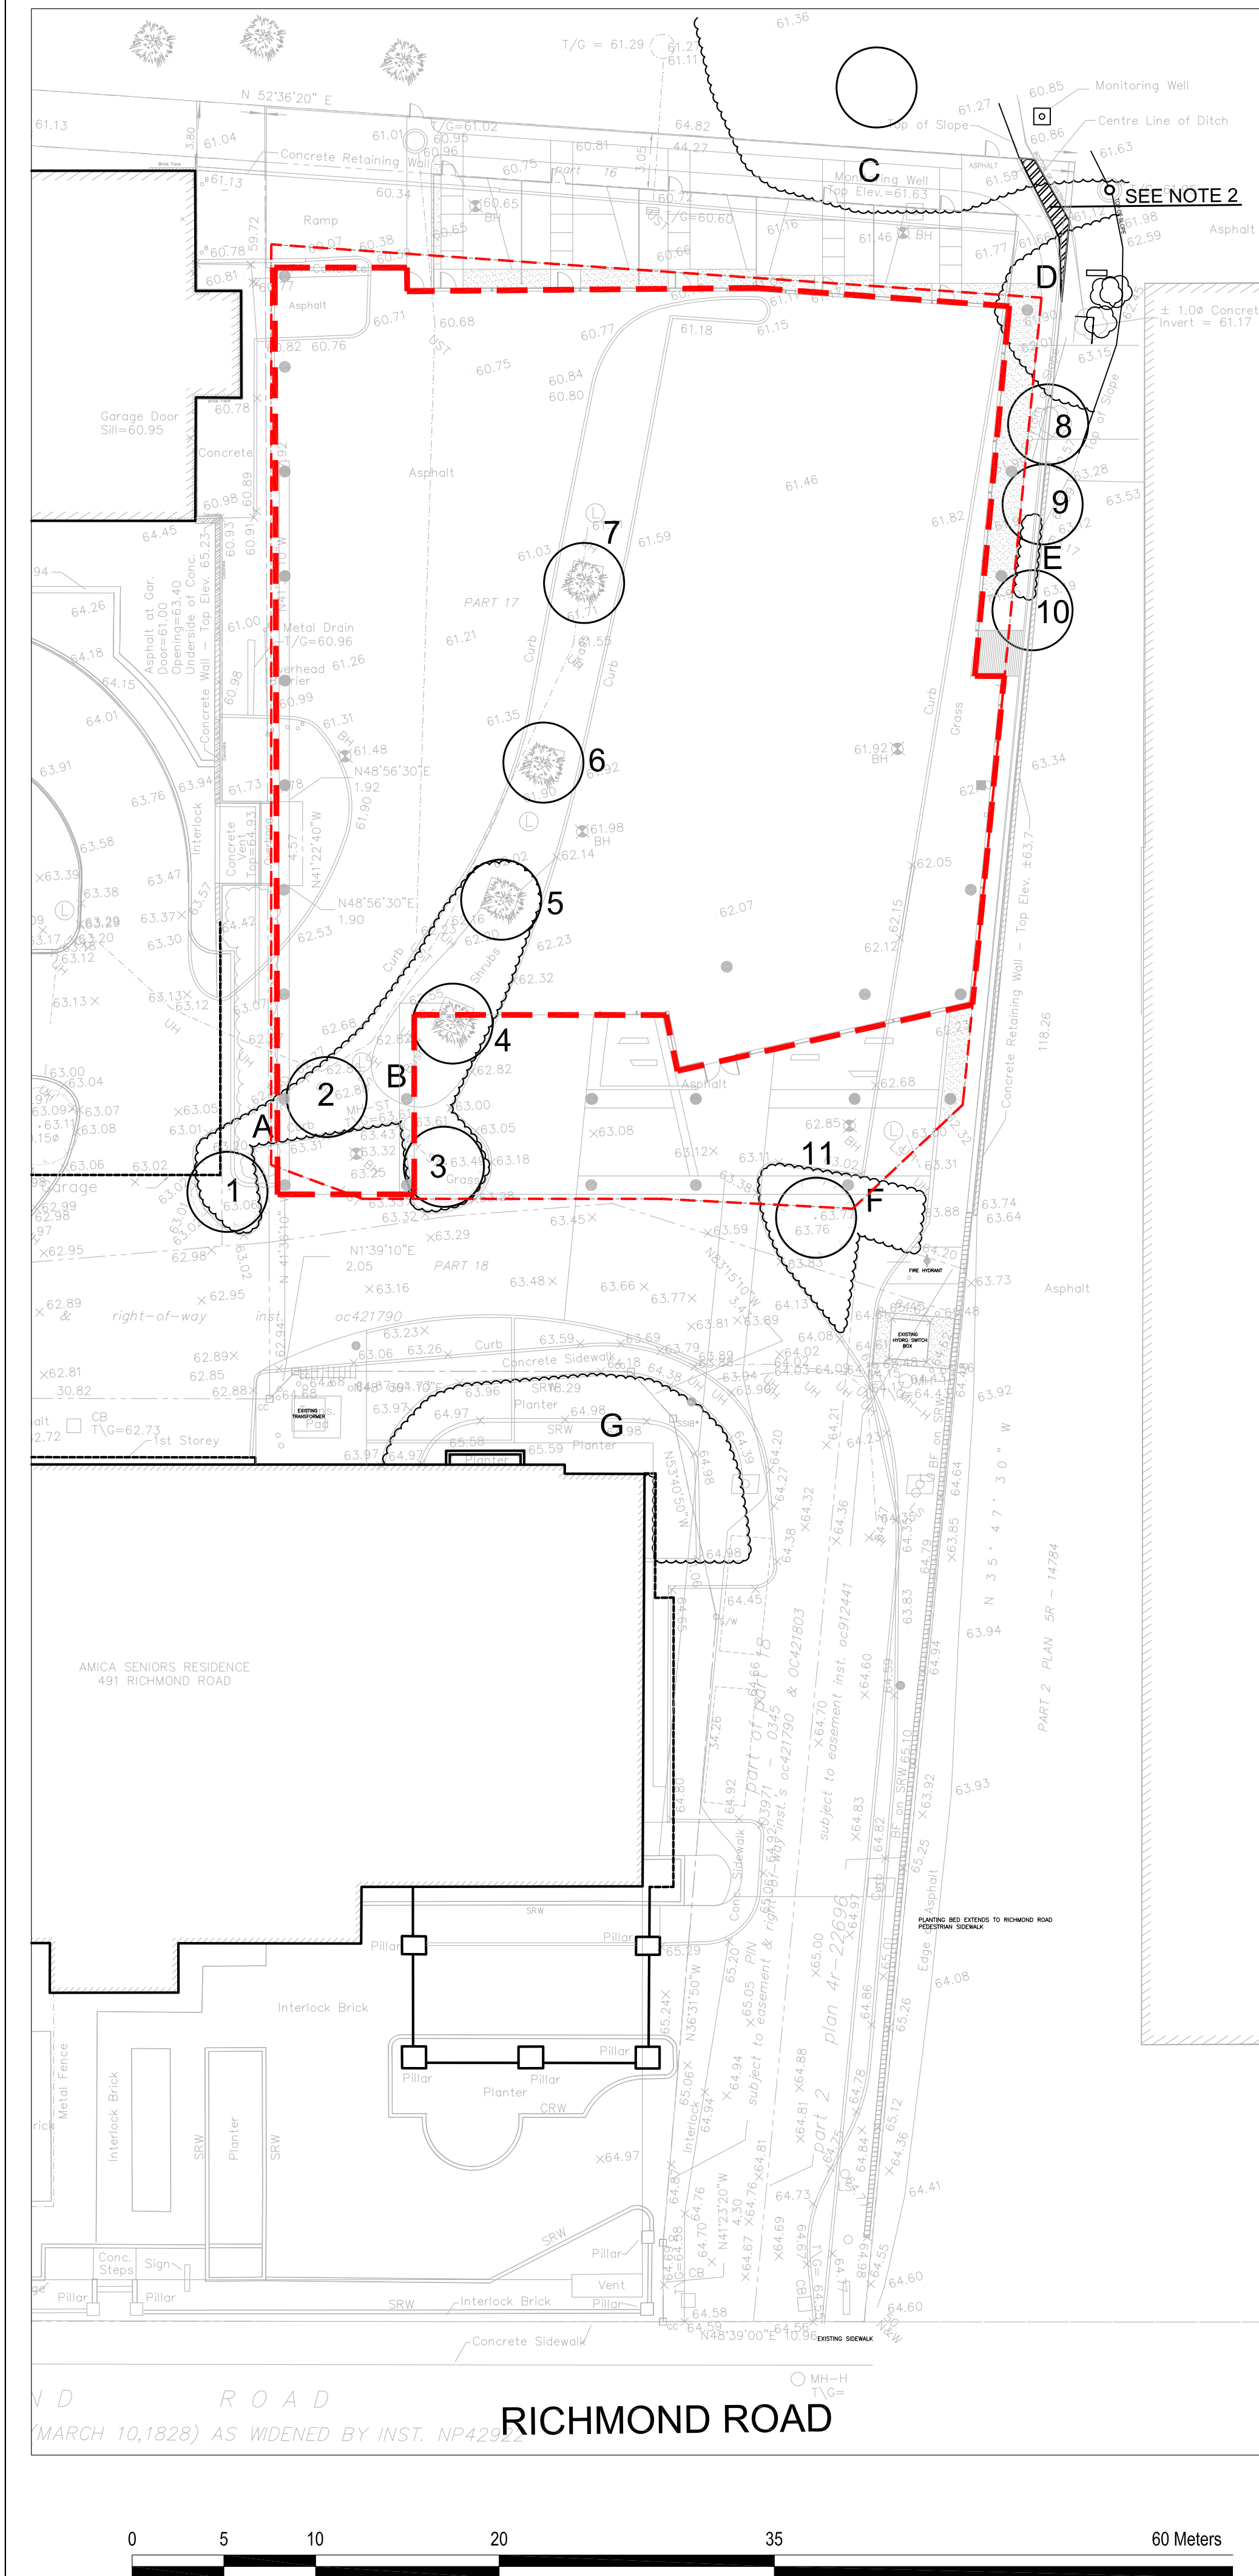
| Tree# | BOTANICAL NAME | COMMON NAME | CALIPER (cm) | CONDITION | APPROXIMATE AGE | HIGH QUALITY TREE | RARE TREE | COMMENTS | TO BE PRESERVED |
|---|---|---|---|---|---|---|---|---|---|
| 1 | Quercus rubra | Red Oak | approx 10 | Poor | 15 | NO | NO | Tree completely surrounded by landscape shrubs. Canopy is damaged and half dead. Tree is off property. | NO |
| 2 | Gleditsia tricanthos | Honeylocust | 11.5 | Good | 15-20 | NO | NO | Tree is well-maintained and in good condition | NO |
| 3 | Gleditsia tricanthos | Honeylocust | 14.0 | Good | 15-20 | NO | NO | Tree is well-maintained and in good condition | NO |
| 4 | Pinus mugo | Mugo Pine | M5 | Moderate | 30 | NO | NO | Tree is surrounded by Manitoba Maple suckers and honeysuckle shrubs. Tree seems to be in good condition, though is very mature. | NO |
| 5 | Pinus mugo | Mugo Pine | MS(5) range from 8-15 | Moderate | 30 | NO | NO | Tree is very mature, though in relatively good condition. | NO |
| 6 | Pinus mugo | Mugo Pine | MS(3) range from 8-15 | Moderate | 30 | NO | NO | Tree is very mature, though in relatively good condition. | NO |
| 7 | Pinus mugo | Mugo Pine | MS(5) range from 10-15 | Moderate | 30 | NO | NO | Tree is very mature, though in relatively good condition. | NO |
| 8 | Acer negundo | Manitoba Maple | MS(4) range from 29-37 | moderate-good | 30 | NO | NO | Tree is very mature and very large for this species. One of the stems is injured, but overall the tree is healthy. | NO |
| 9 | Acer negundo | Manitoba Maple | 25.0 | moderate-poor | 20 | NO | NO | The tree is leaning slightly, one stem having been removed already. The remaining base from the removed stem is decaying with some cavities. There are injuries on the remaining trunk. | NO |
| 10 | Acer negundo | Manitoba Maple | MS(2) 33 and 29 | moderate-poor | 99 | NO | NO | Co-dominant stems are weakly joined, with the smaller of the two stems showing signs of injury. | NO |
| 11 | Acer x freemanii | Freeman Maple | 13.0 | Good | 15 | NO | NO | Tree is well-maintained and in good condition | NO |

- A) LANDSCAPE SHRUBS ON ADJACENT PROPERTY. WELL-MAINTAINED.
- B) OVERGROWN HONEYSUCKLE BUSHES AND MANITOBA MAPLE VOLUNTEERS. OBSCURES TREE '4'.
- C) WEEDY PERENNIAL/ ANNUALS, MANITOBA MAPLE VOLUNTEERS. THE CANOPY OF A LARGE ELM ON THE ADJACENT PROPERTY OVERHANGS THE SITE.
- D) THE CANOPY OF A LARGE MANITOBA MAPLE ON THE ADJACENT PROPERTY OVERHANGS THE SITE.
- E) 5 SMALL *THUJA OCCIDENTALIS* (ALL WITH DBH <10cm DBH), IN POOR CONDITION.
- F) LANDSCAPE SHRUBS IN MODERATE CONDITION, INCLUDING LILAC, RUGOSA ROSE.
- G) LANDSCAPE SHRUBS, IN GOOD CONDITION, INCLUDING PRIVET HEDGE, AND RUGOSA ROSE.
