PROJECT:
 GREELY COMMERCIAL CENTRE
 7107 MARCO ST, 5640 BANK ST, 7041 MITCH OWENS RD, OTTAWA, ON

DRAWING:
 TREE CONSERVATION REPORT

SCALE:	1:1000	DRAWING NO.	ARB-1
DRAWN:	LM/JG	CHECKED:	ML
DATE:	2013-10-27	REVISION NO.	2.

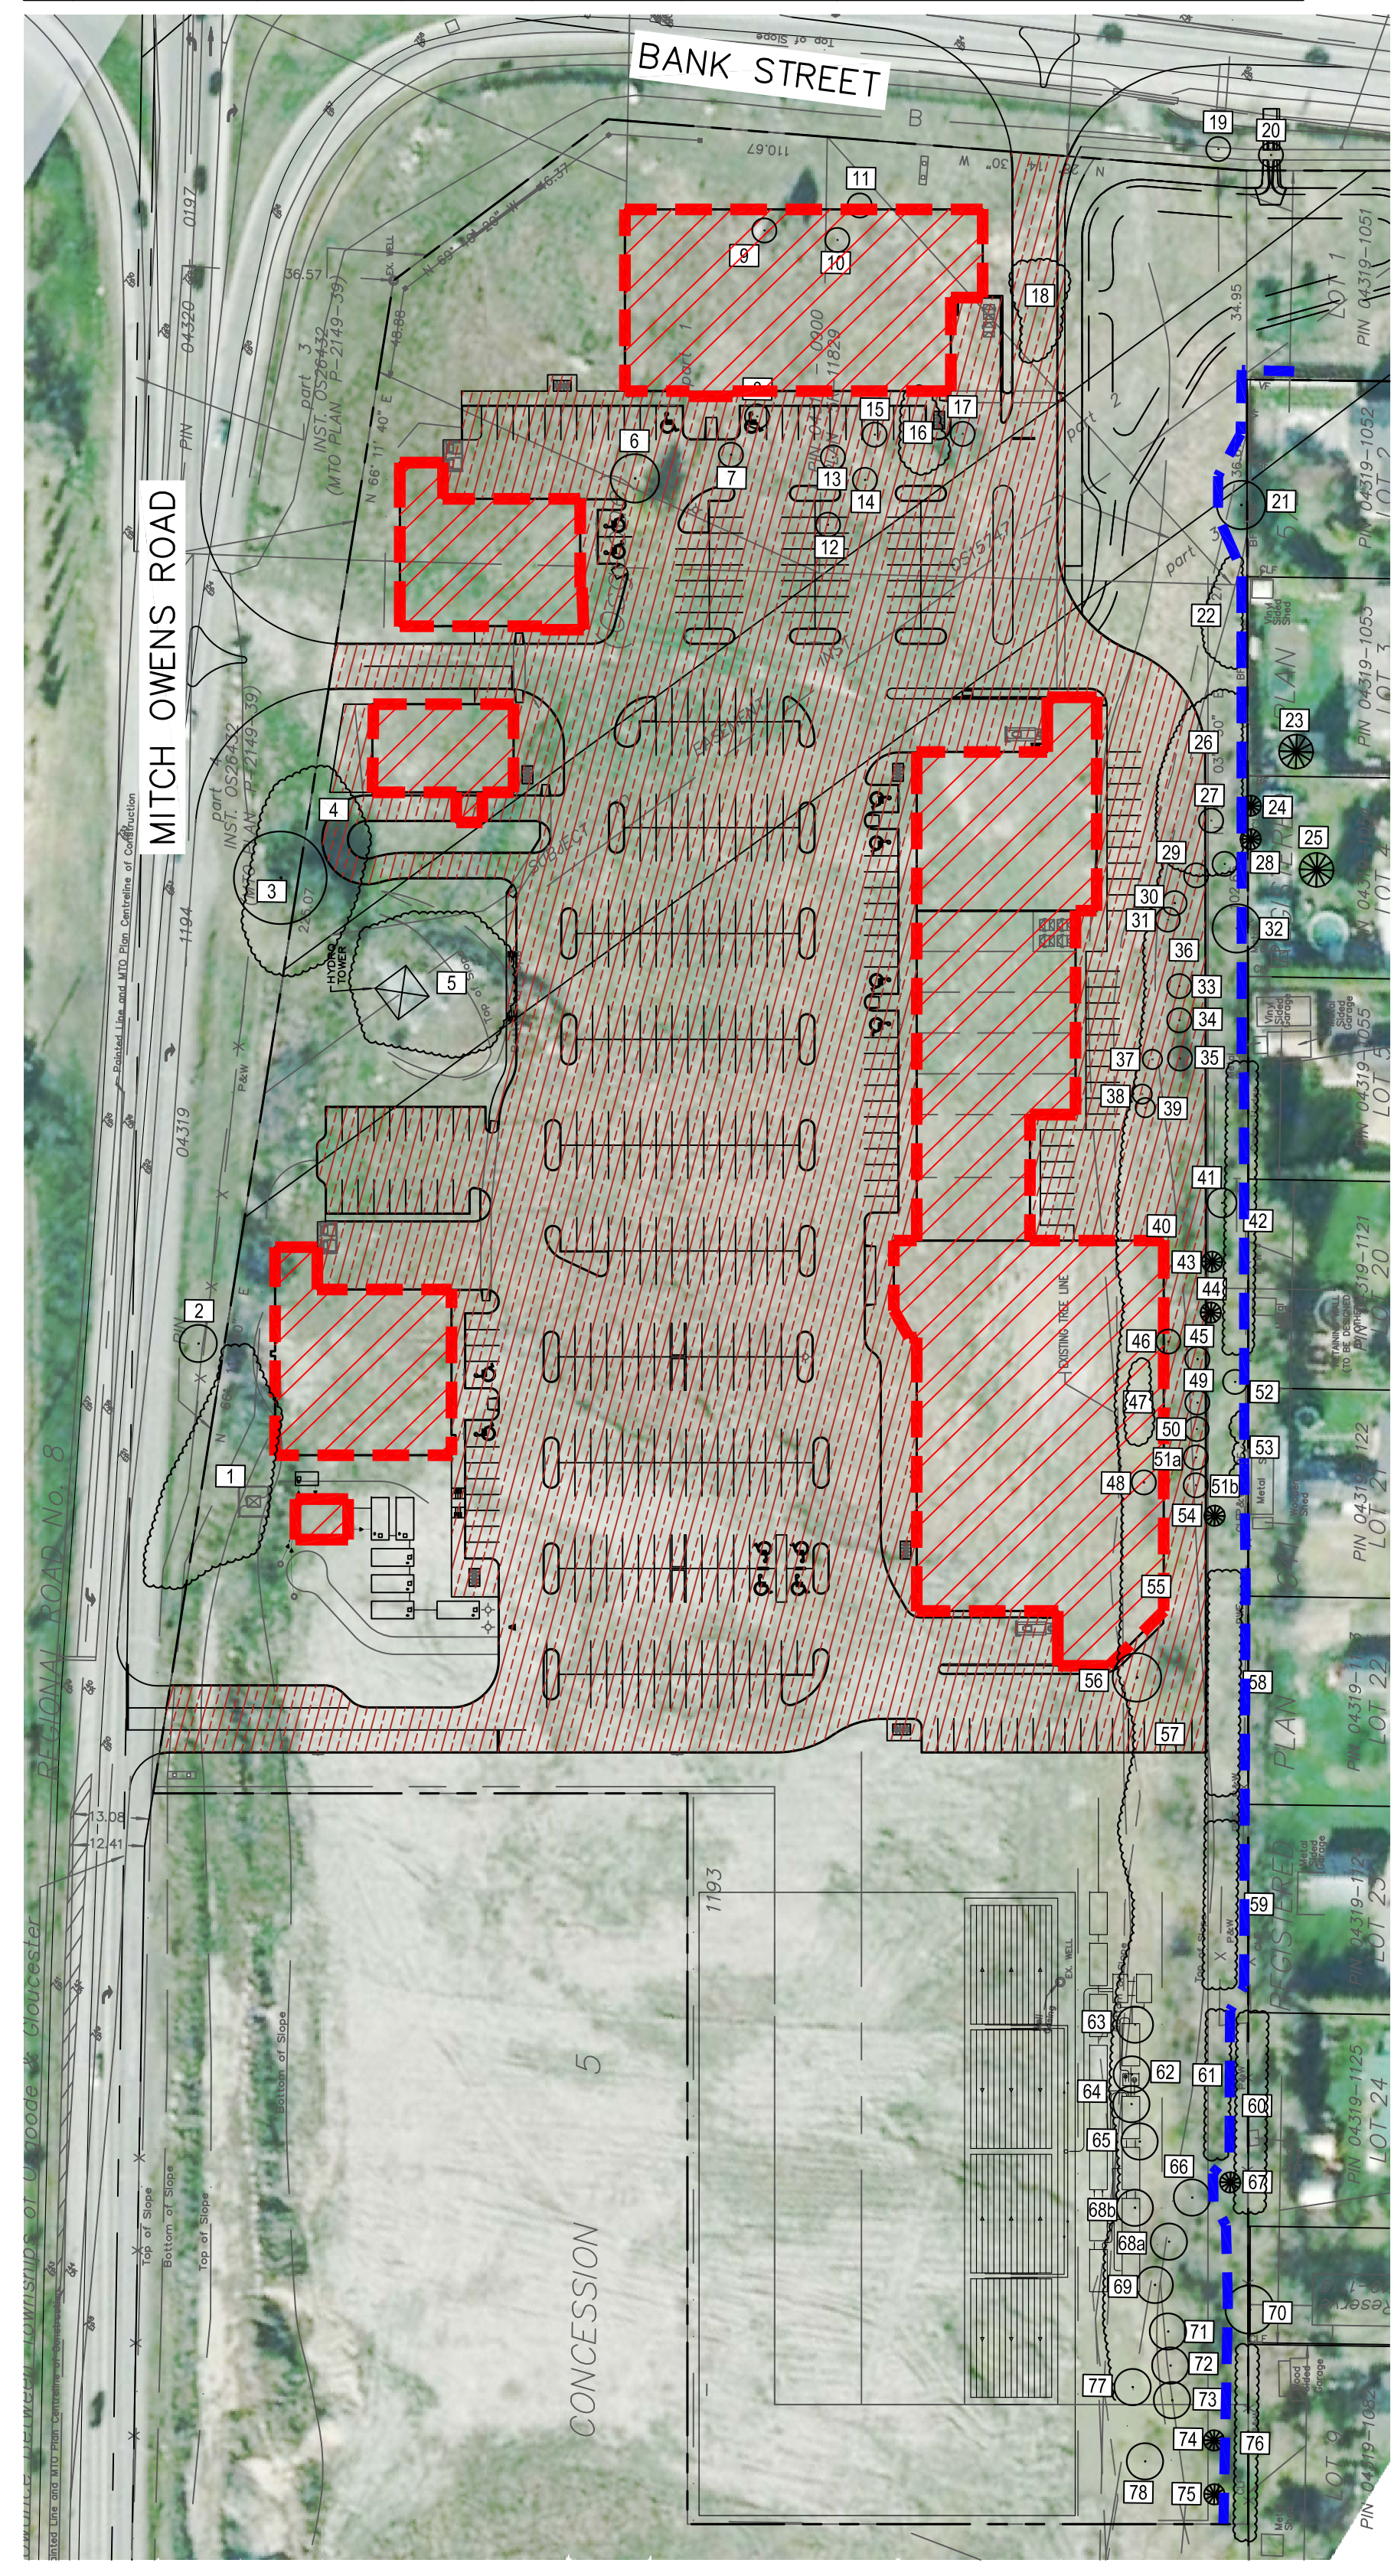
THE SITE IS OF MODERATE-TO-LOW VALUE ENVIRONMENTALLY. THE MAJORITY OF THE SITE HAS BEEN CLEARED OF VEGETATION FOR ITS FORMER USE AS A GRAVEL QUARRY. THE MAJORITY OF THE VEGETATION ON THE SITE IS ALONG THE SOUTH BORDER OF THE PROPERTY, ADJACENT TO A RESIDENTIAL AREA. THIS VEGETATED AREA IS GROWING ALONG A VERY STEEP SLOPE, AND IS LIKELY A FACTOR IN STABILIZING THE SURFACE SOILS OF THE SLOPE.

THE MAJORITY OF THE TREES ON THE SITE ARE ROBINIA PSEUDOACACIA, BLACK LOCUST, IDENTIFIED AS AN INVASIVE SPECIES BY THE CITY OF OTTAWA.

THE PROPOSED LOSS OF VEGETATION FOR THIS PHASE OF DEVELOPMENT WILL BE AS FOLLOWS:
 - APPROXIMATELY 92 TREES OVER 10CM DBH WITH APPROXIMATELY 3000 SQ M. OF SHRUBBY VEGETATED AREAS AND IMMATURE TREES. THE MAJORITY OF THESE WILL BE REMOVED FOR THE INSTALLATION OF A RETAINING WALL TO STABILIZE THE SLOPES TO THE SOUTH OF THE SITE - SEE ENGINEERING DRAWINGS AND REPORTS.

THE MAJORITY OF THE TREES TO BE REMOVED ARE OF LIMITED VALUE DUE TO SPECIES AND CONDITION. THE GREATEST CHANGE TO THE SITE WILL BE WITH REGARD TO THE CHANGE IN PERMEABLE SURFACES, WHICH WILL BE FAIRLY SIGNIFICANTLY DECREASED.
