DRAWING NO. **ARB-1**

PROJECT: CAPITAL VIEW DEVELOPMENTS
67 & 71 MARQUETTE AVE.
OTTAWA, ON

DRAWING: TREE CONSERVATION REPORT

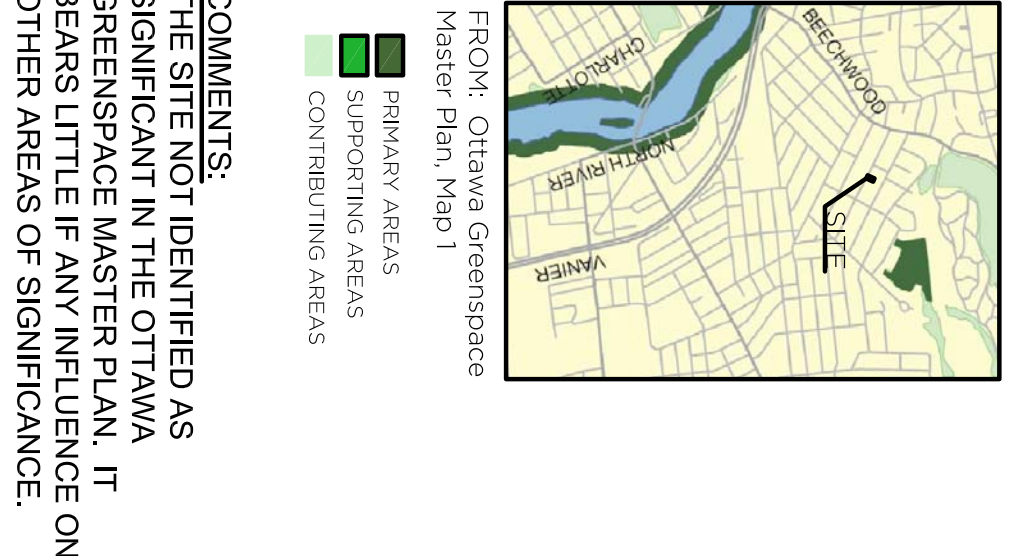
GREENSPACE LINKAGES

COMMENTS:
 THE SITE NOT IDENTIFIED AS SIGNIFICANT IN THE OTTAWA GREENSPACE MASTER PLAN. IT BEARS LITTLE IF ANY INFLUENCE ON OTHER AREAS OF SIGNIFICANCE.

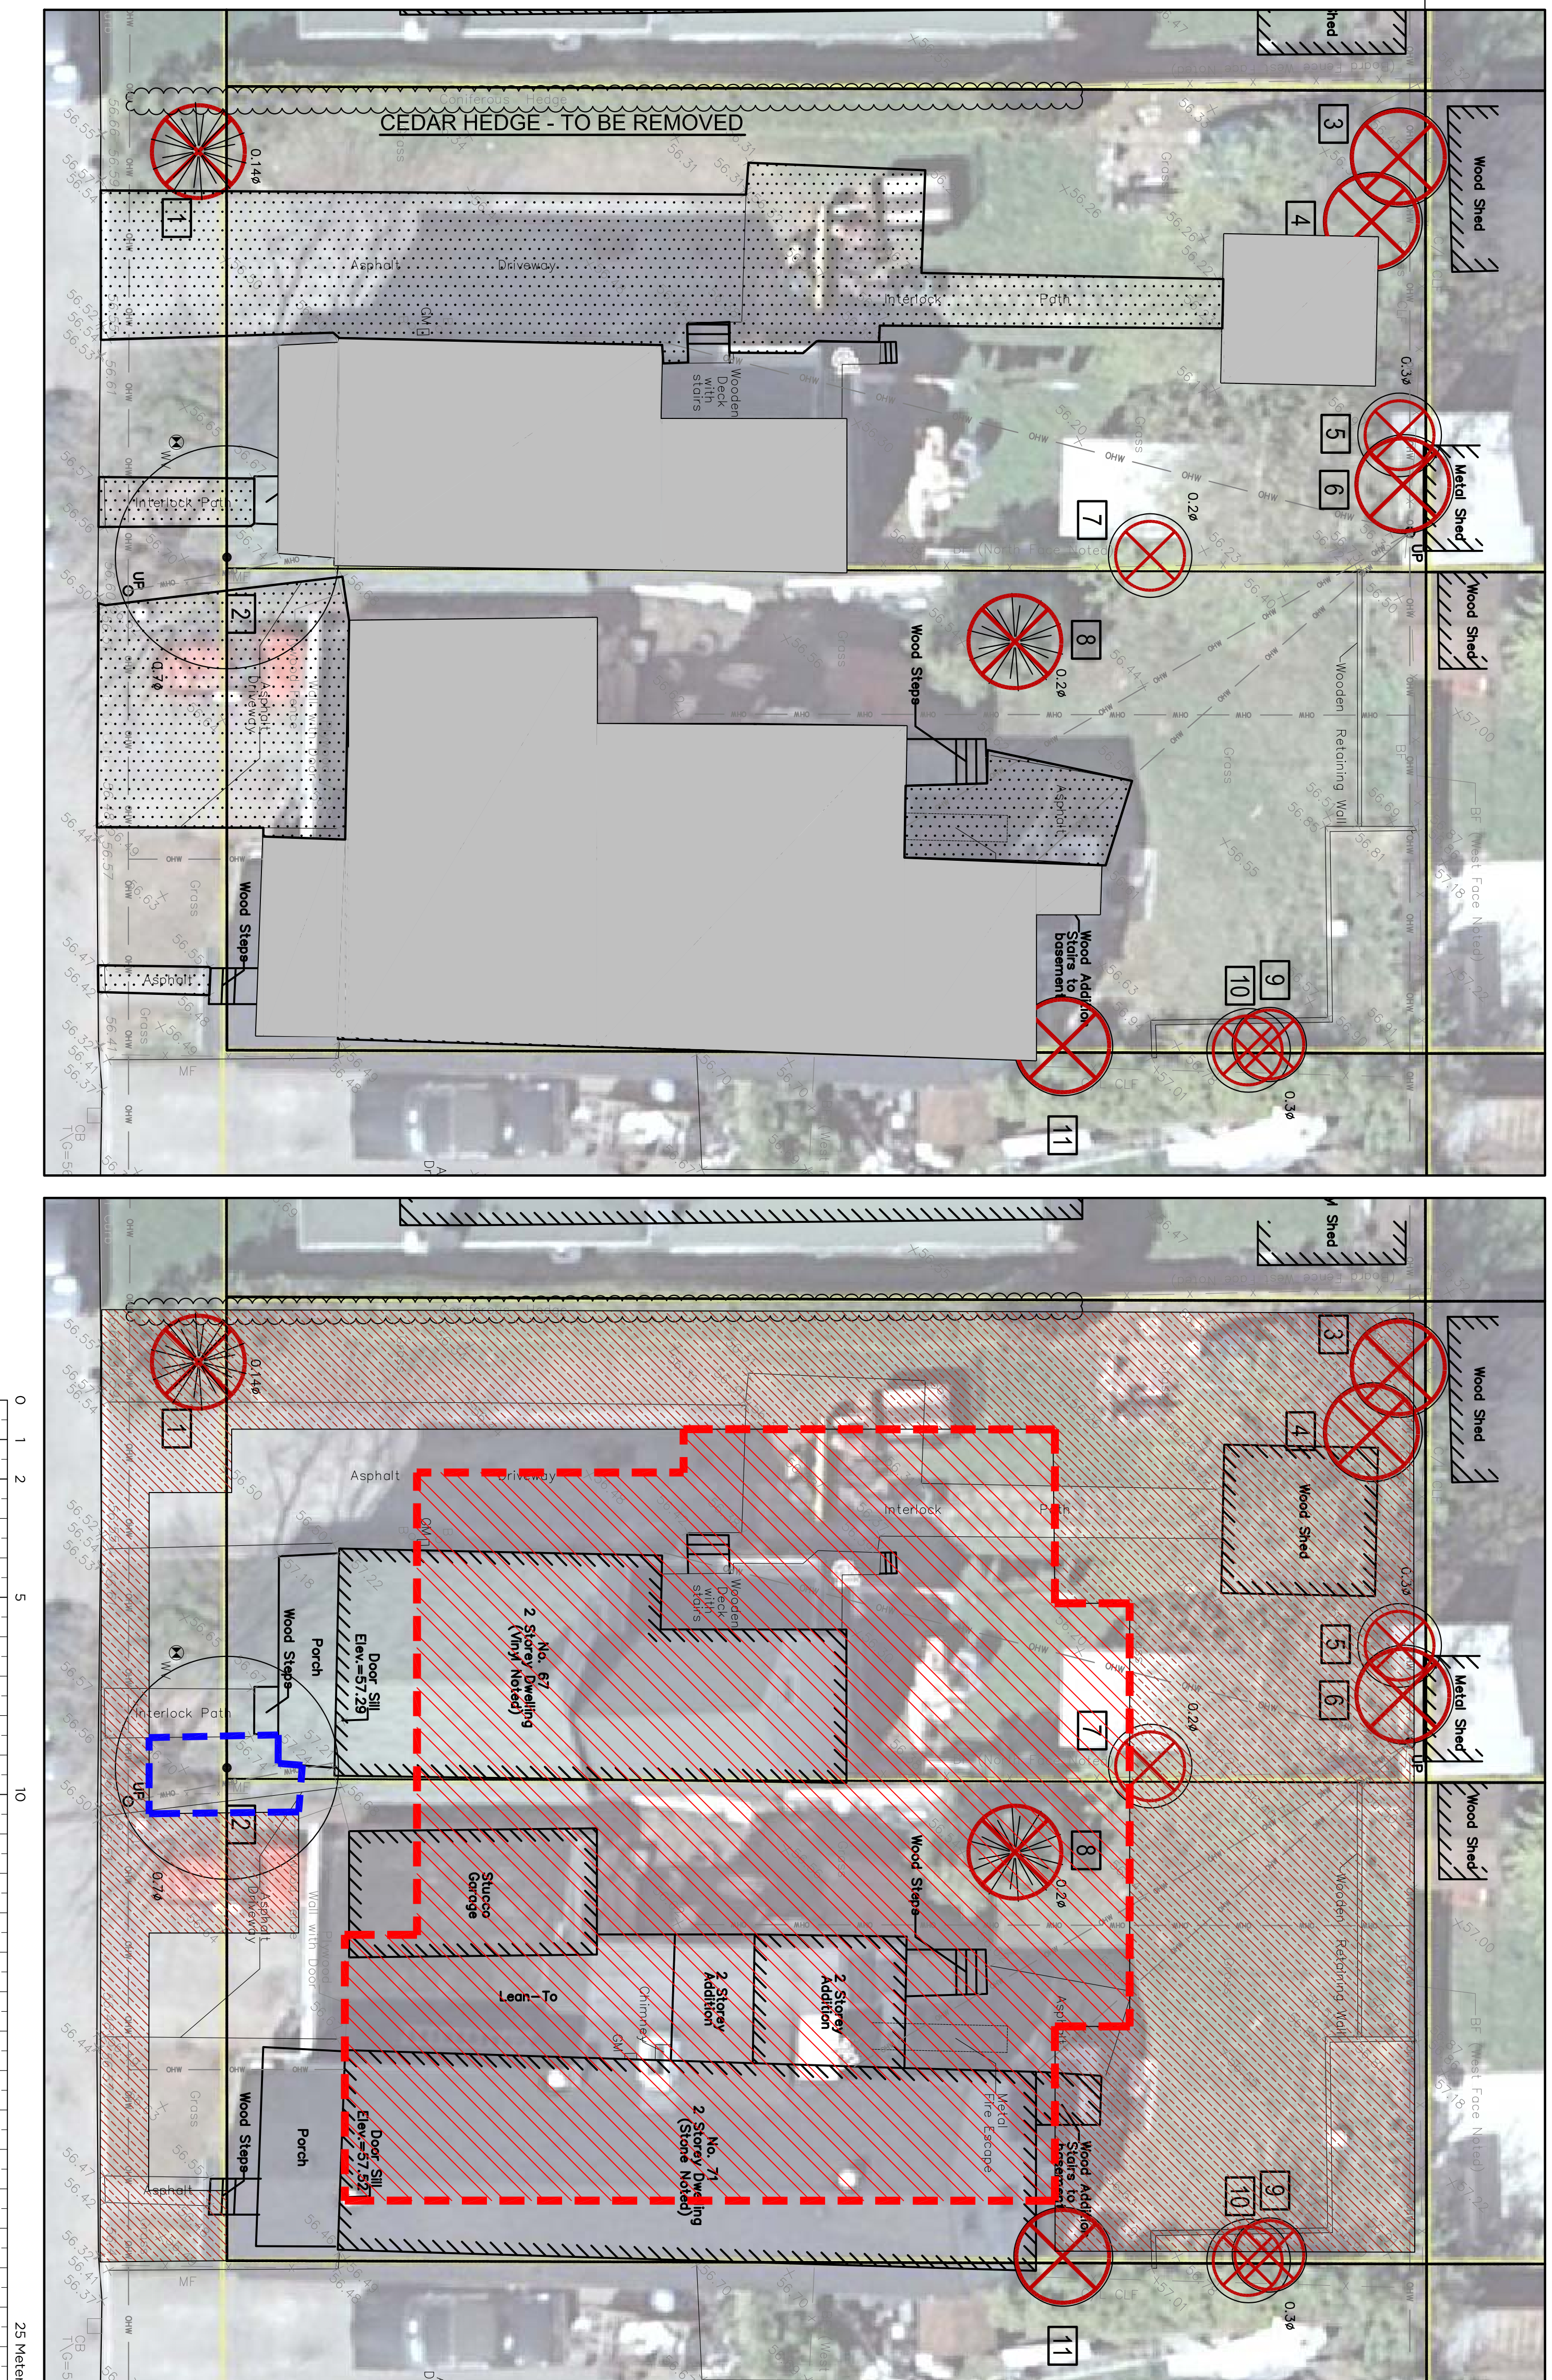
NOTES:
 THE PROPOSED LOSS OF VEGETATION FOR THIS PHASE OF DEVELOPMENT WILL BE AS FOLLOWS:
 - 10 TREES, 1 CEDAR HEDGE

THE MAJORITY OF THE TREES TO BE REMOVED ARE OF LIMITED VALUE DUE TO SPECIES AND CONDITION (THE LARGEST ONES ARE LEANING SEVERELY). THE GREATEST CHANGE TO THE SITE WILL BE WITH REGARD TO THE CHANGE IN PERMEABLE SURFACES, WHICH WILL BE FAIRLY SIGNIFICANTLY DECREASED.

THERE WILL BE LIMITED OPPORTUNITIES TO PLANT NEW TREES ON THE SITE. THE AREAS OF THE SITE THAT WILL NOT BE OCCUPIED BY BUILDING OR HARD SURFACE ARE LIMITED AND ALREADY OCCUPIED BY EXISTING TREES TO BE PRESERVED.
