November 21, 2022

#### **<u>Re: Tree Conservation Report for Silver Maple #38 at 114 Richmond Road,</u>** <u>Ashcroft Homes' Q West Development</u>

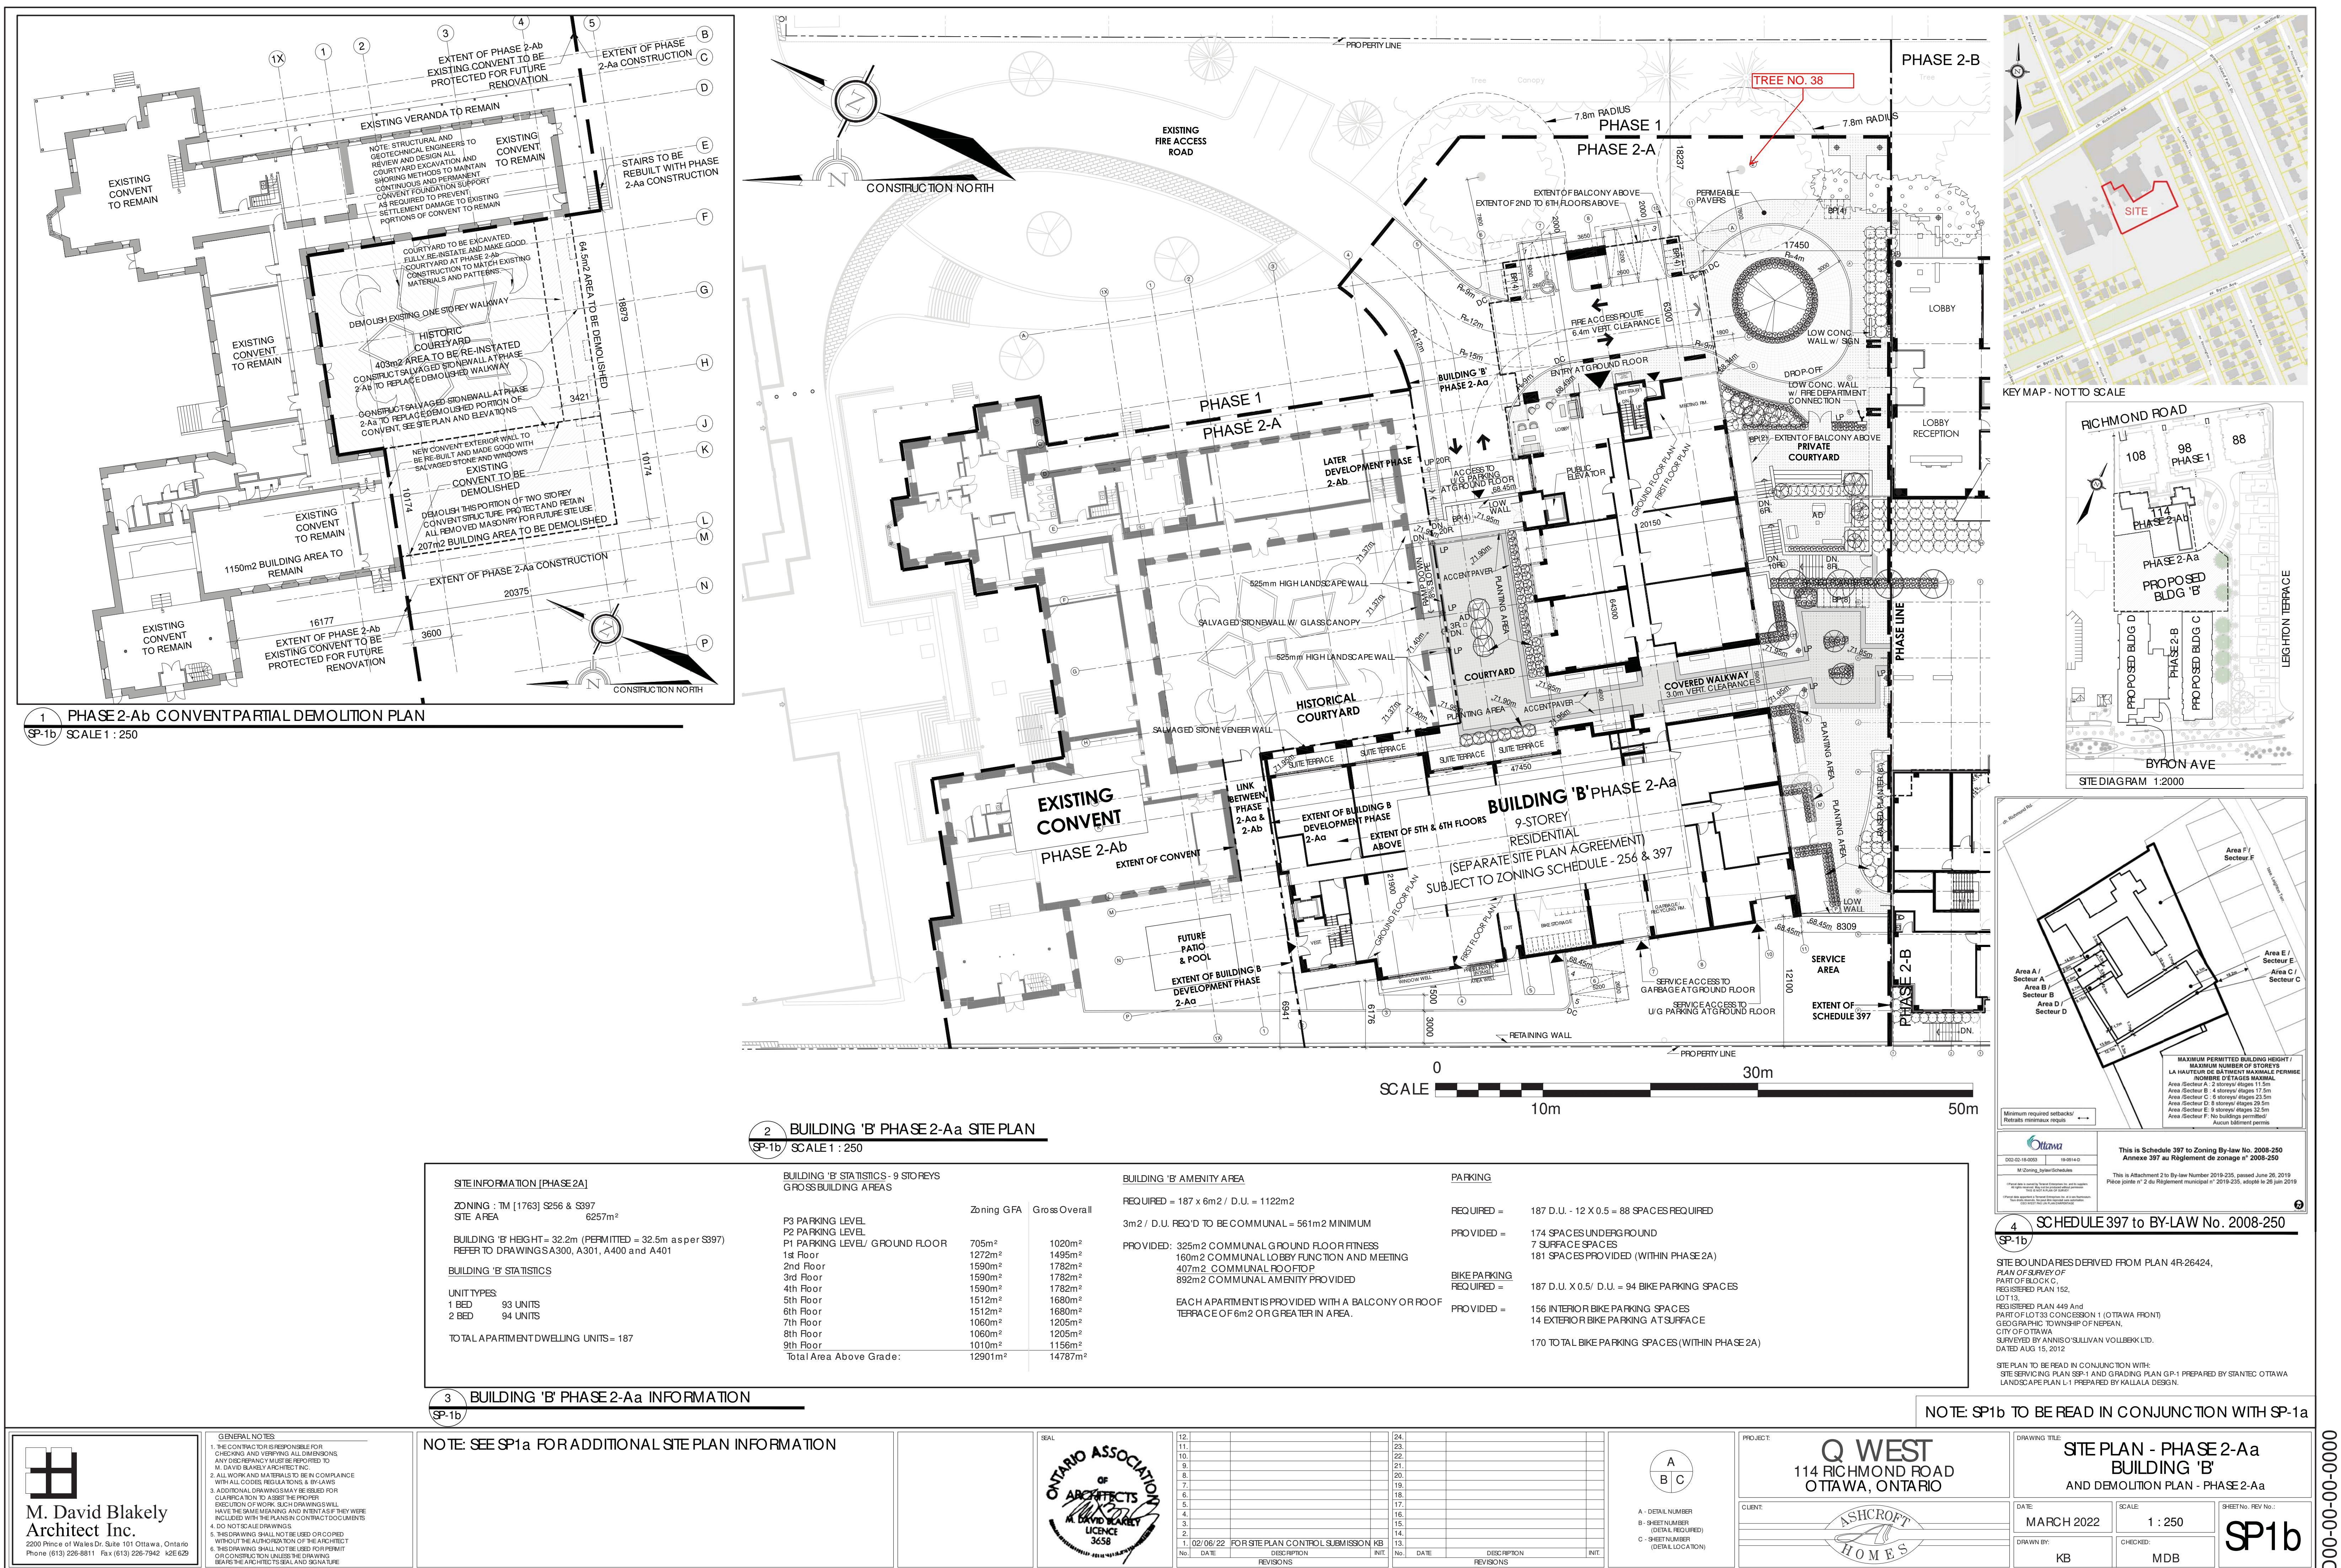
This letter report adds to several earlier reports related to trees on this development site. In particular, the preservation of a single, 78cm diameter silver maple (*Acer saccharinum*) impacted by excavation necessary for a fire route and turning circle within its critical rooting zone (see site plan prepared by M. David Blakely Architect on page 2 of this report). This tree is identified as number 38 in all reports.

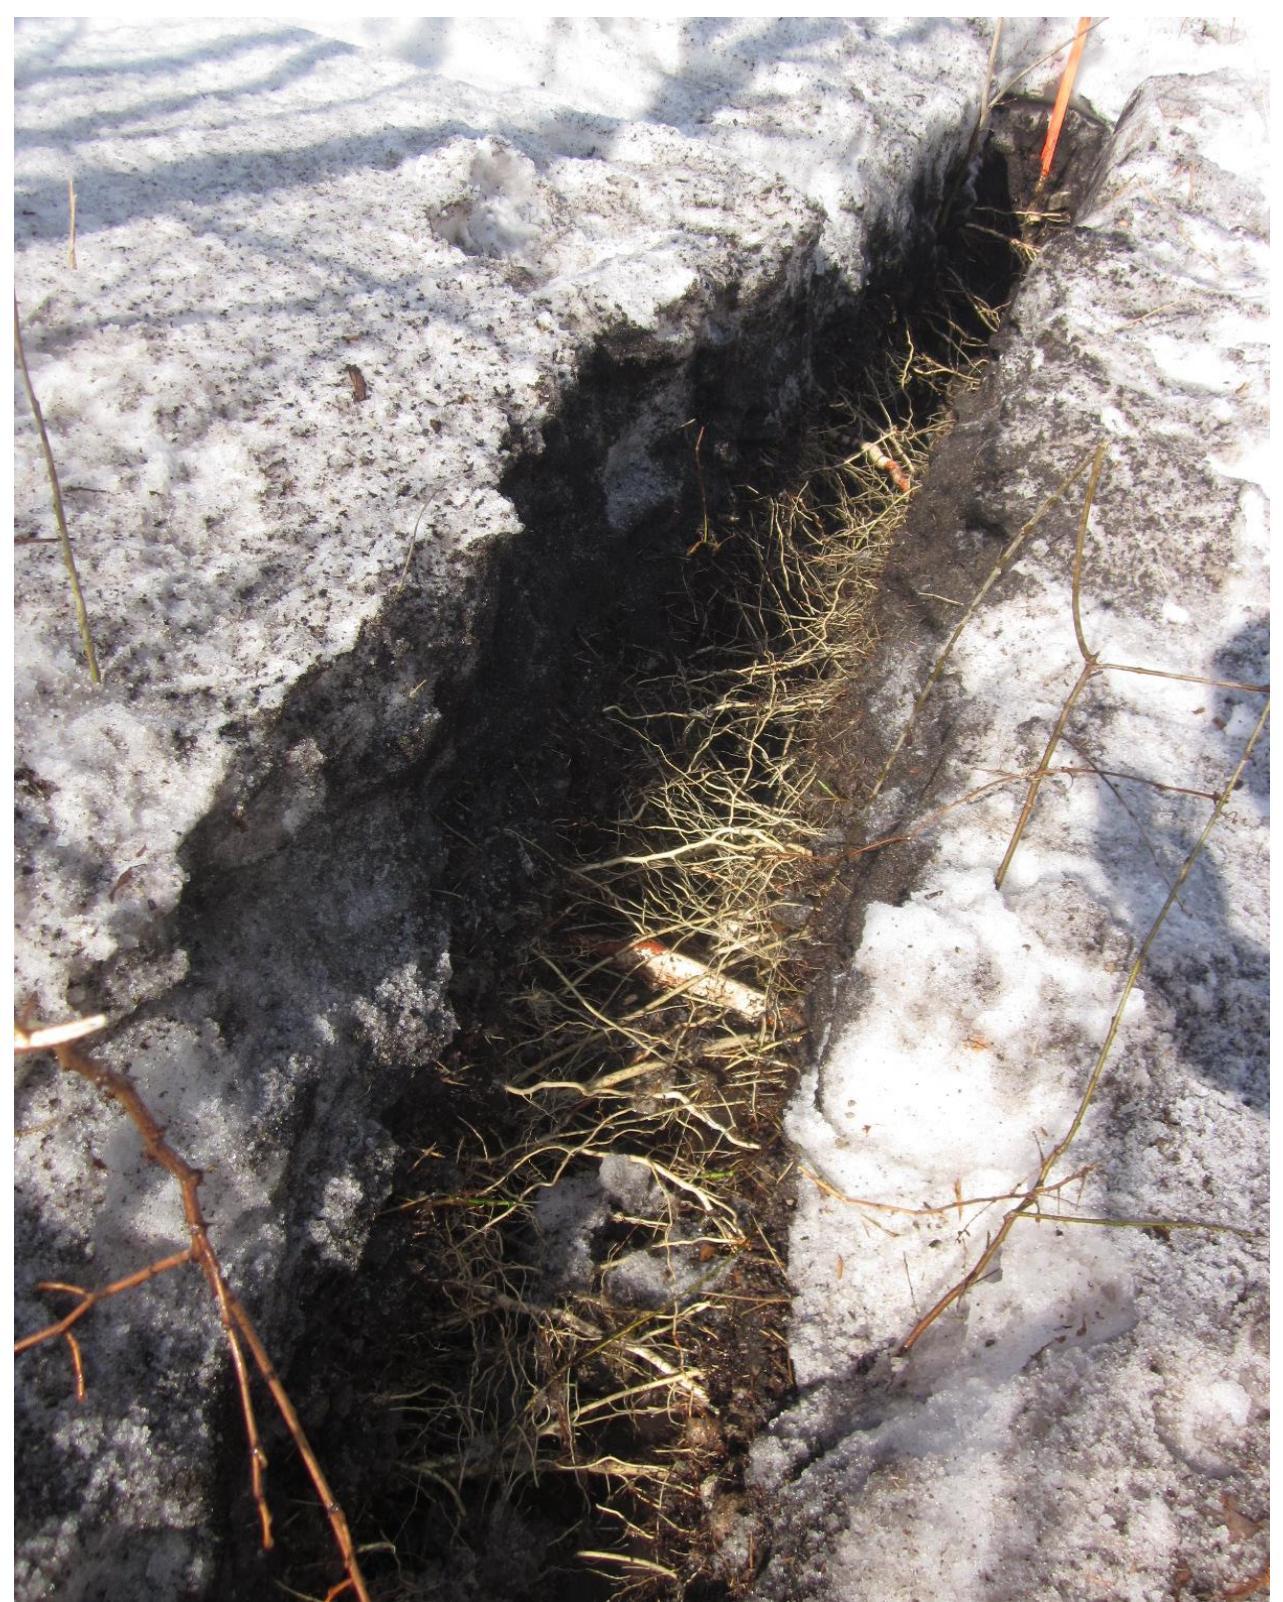
In March 2020, an exploratory hydro excavation was undertaken to determine the number of roots present at a distance of 7.8m from the tree – a distance equal to its critical rooting zone (CRZ). Many fine feeding roots and several larger roots were encountered (see Picture 1 on page 3). Under the present development proposal, the curb of the fire lane is 5.4m away. The inside edge of the turning circle will be roughly half that distance from the tree. In order to lessen the amount of root loss associated with the proposed excavation, the following general construction methods and materials are recommended. An engineer should be consulted for exact design details:

Picture 1. Results of hydro excavation 7.8m from tree #38 (photo taken March 2020).

1. Hydro excavation along the edge of excavation in closest proximity to the tree to carefully expose roots. Exposed roots will then be cleanly cut and sealed with an organic beeswax-based product. Excavation can then resume using traditional mechanical means. Sealing the cleanly cut root ends will help prevent the loss of moisture and facilitate healing. If the excavation is to be left open for any amount of time a covering of at least three layers of moistened burlap is to be draped over the exposed face of excavation. This will help reduce the loss of soil moisture.

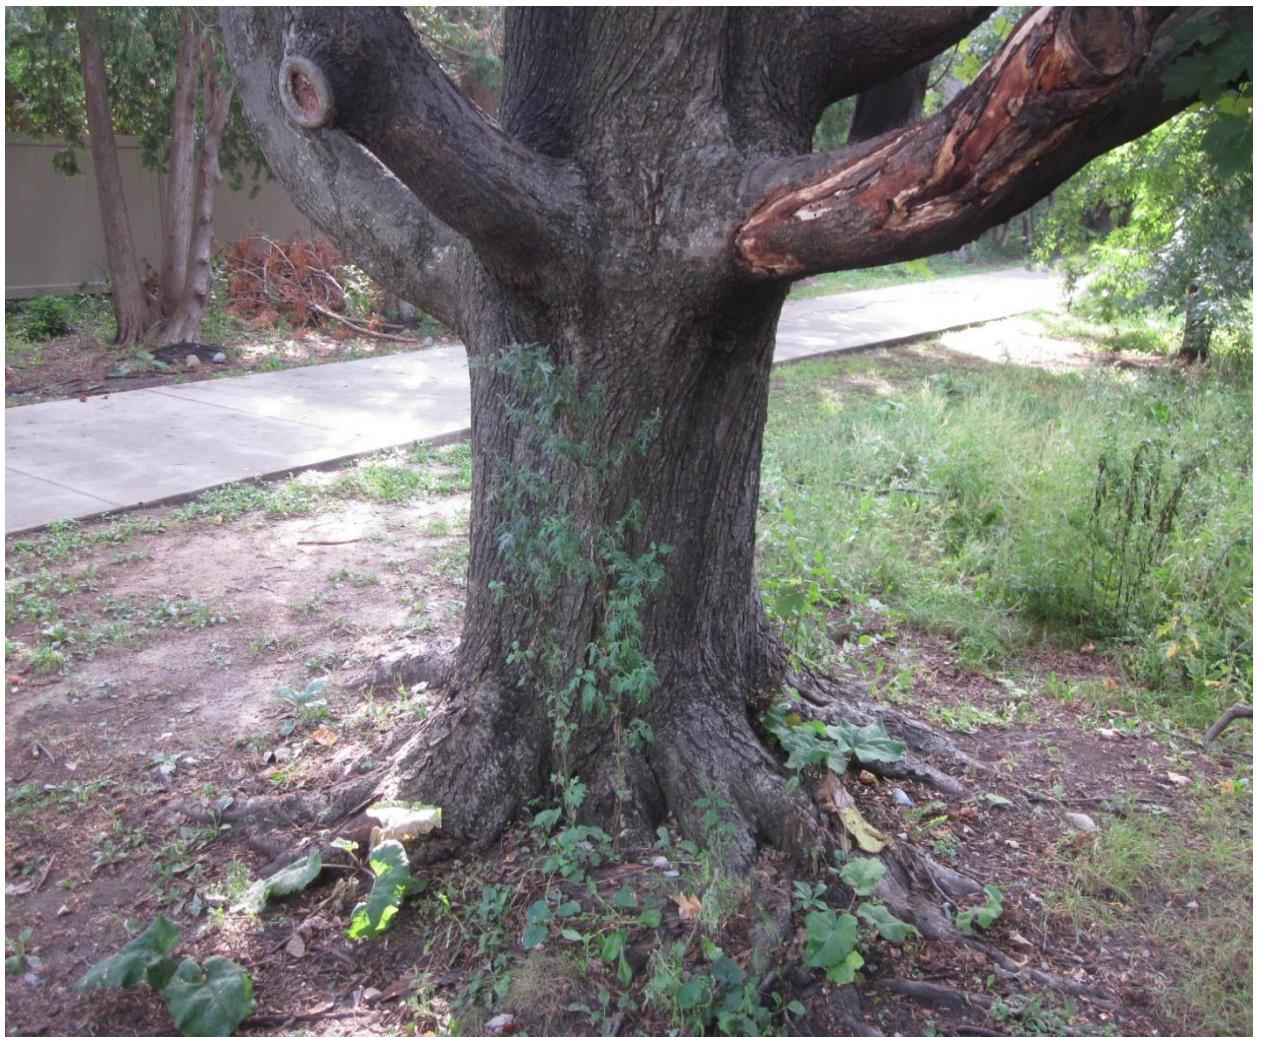
Picture 2. Typical surface conditions beneath silver maple tree line at 114 Richmond Road (photo taken September 2022).
