TREE CONSERVATION REPORT – 6688 FRANKTOWN ROAD, OTTAWA

April 31, 2018

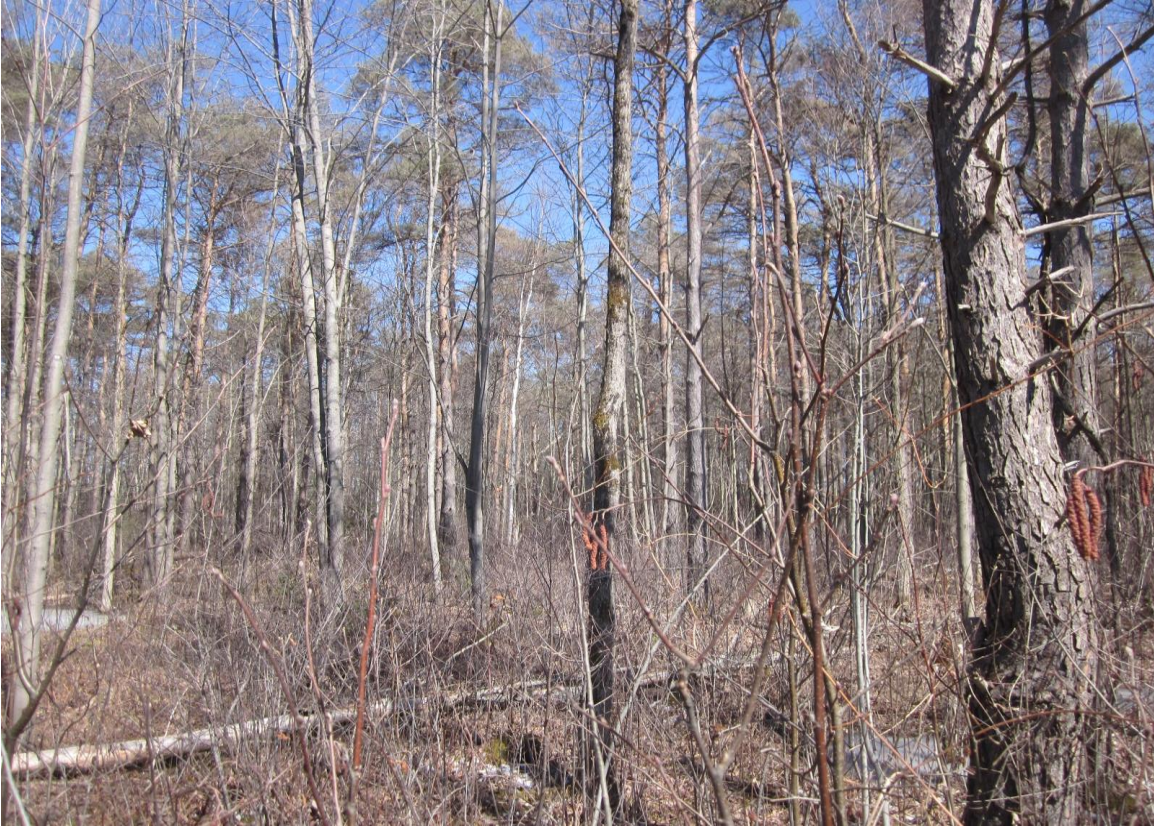
the property, buckthorn is most dense in the northern half due to the available sunlight within and adjacent to the failing plantation.

Picture 1. Typical understory conditions below the pine plantation on the subject property – dense buckthorn.

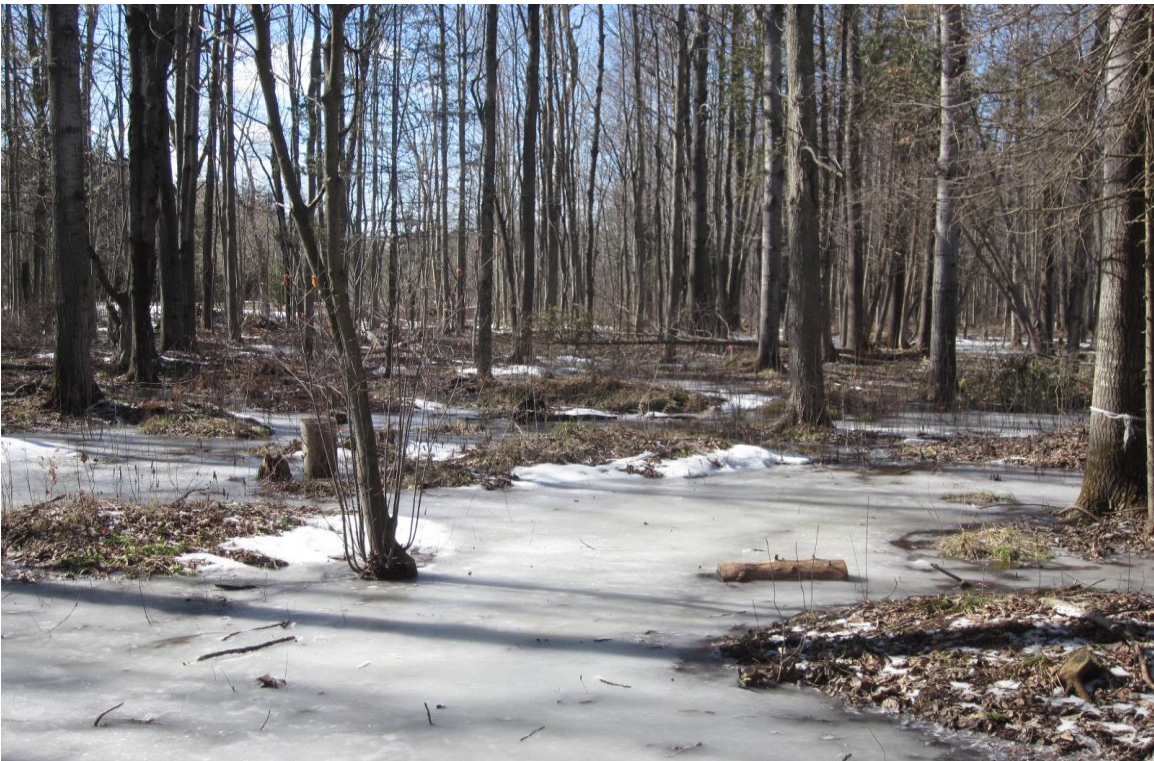
The lowland hardwood stand consists of the same species as elsewhere on site, though with markedly less conifers. In particular, there are many older, senescent poplars in this stand. The ash which are present have suffered the same fate as elsewhere – dead due to emerald ash borer. White elm (*Ulmus americana*) were also present in significant numbers in the past but the spread of Dutch elm disease (*Ophiostoma ulmi*) has greatly reduced their frequency. A number of these trees have been removed more recently as storage and gathering areas have been cleared.

Picture 2. Typical conditions within the lowland hardwood stand on the subject property.

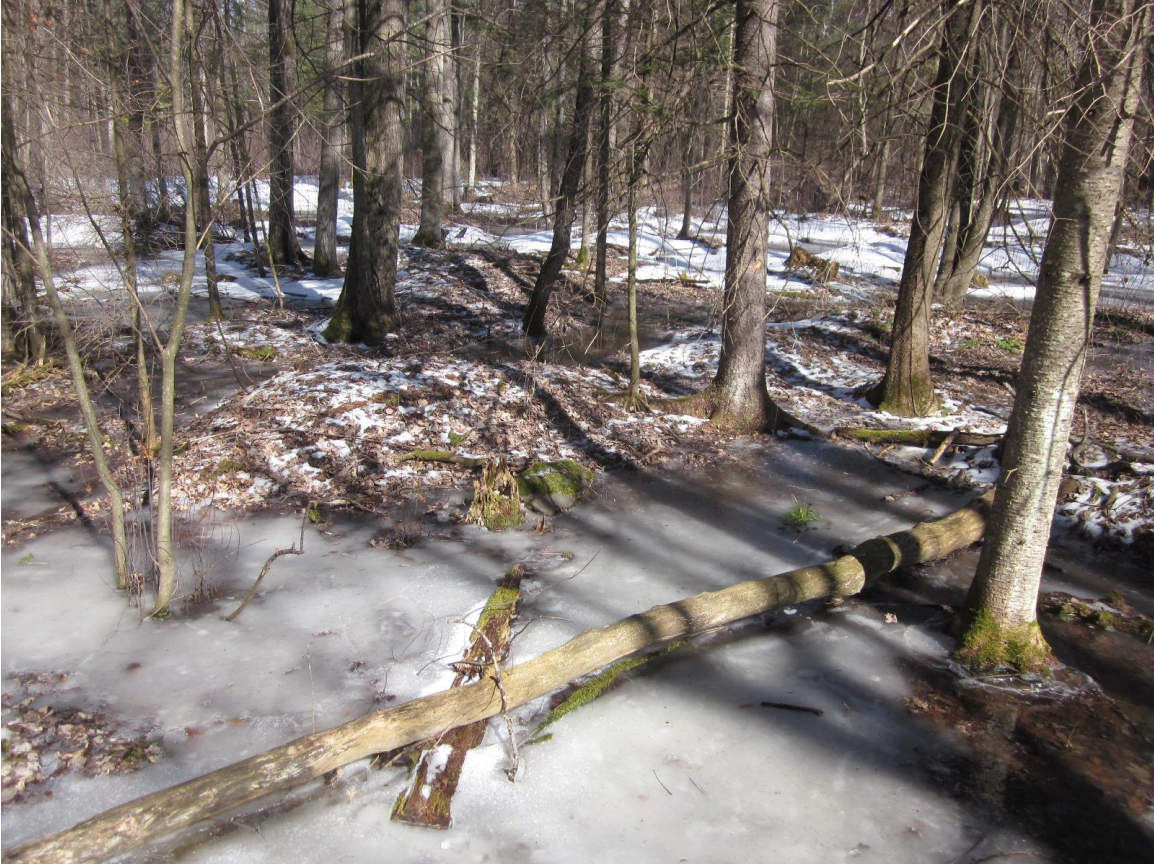
The two other dominant stand types on the property are a lowland mixedwood stand in the eastern-most corner and a lowland hardwood stand in the southern. The mixed wood stand consists of dense groupings of a diversity of tree species: white spruce (*Picea glauca*), trembling aspen (*Populus tremuloides*), balsam fir and red maple. Other native tree species present, though less frequently than four mentioned above, are bur oak (*Quercus macrocarpa*), black cherry (*Prunus serotina*), and eastern white cedar (*Thuja occidentalis*).

Picture 3. Typical conditions within the lowland mixedwood stand on the subject property
