October 23, 2019

RE: TREE CONSERVATION REPORT FOR 24-30 PRETORIA AVENUE, OTTAWA

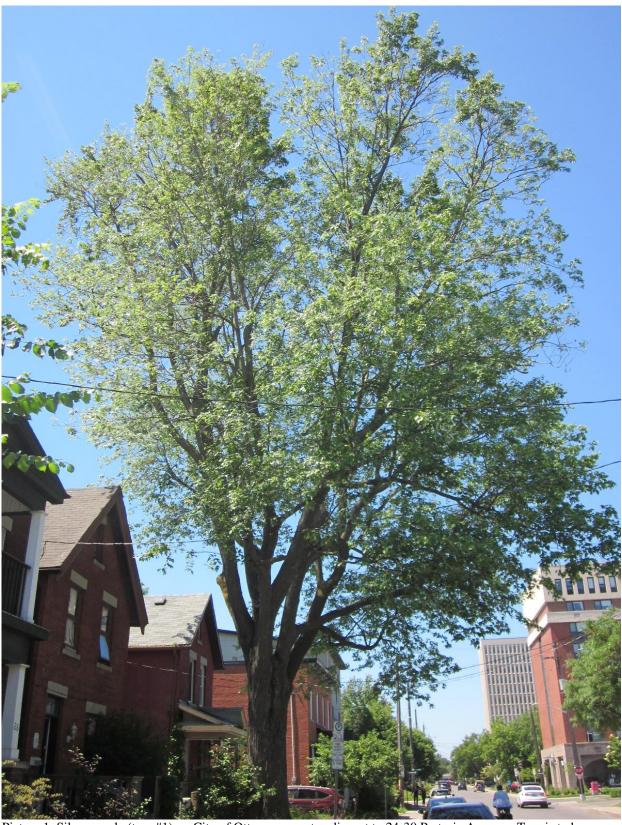
Table 1	Table 1. Species, condition, diameter, ownership and status of trees at 24-30 Pretoria Avenue.								
Tree	Tree Species	Condition	DBH ¹	Owner	Tree Condition Notes &				
No.		$(VP \rightarrow E)$	(cm)	-ship	Preservation Status (to be removed				
					or preserved and protected)				
1	Silver maple	Fair	110	City	Very mature; five co-dominant				
	(Acer				stems at 4m from grade; broad				
	saccharinum)				crown – slightly asymmetrical due				
					to clearance pruning from house;				
					good flower bud set for 2019; within				
					very restricted rooting area; native				
					species; to be removed due to				
					conflicts with excavation – in				
					particular the underground				
					parking garage which will be				
					within 0.5 metres of its trunk				
2	White spruce	Fair	16	Private	Maturing; vine growth into lower				
	(Picea glauca)				and mid-crown; heavy cone crop in				
					2019; to be removed

Picture 1. Silver maple (tree #1) on City of Ottawa property adjacent to 24-30 Pretoria Avenue. Tree is to be removed.

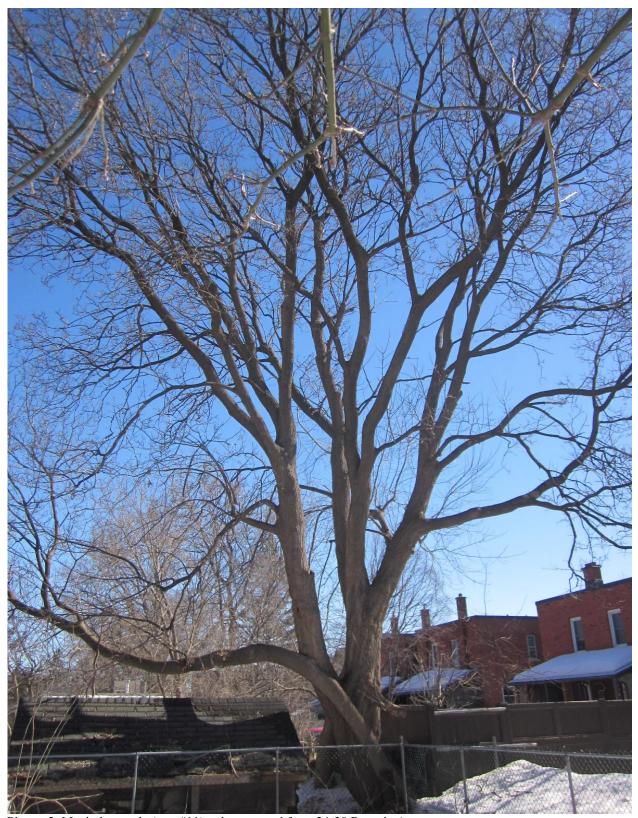
1.1	Manitalaamanla	Fair	00	Duizzata	Vary material and dominant stomes of
11	Manitoba maple	Fair	98	Private	Very mature; co-dominant stems at
					2.5m; very broad crown; secondary
					lateral stem very divergent towards
					northwest; to be removed
12	Manitoba maple	Good	32	Private	Mature; upright growth form; to be
					removed
13	White cedar	Poor	5 avg.	Private	Immature; likely planted as a hedge;
	(Thuja				native species; to be removed
	occidentalis)				•
14	Manitoba maple	Fair	64	Private	Very mature; tri-stemmed at 1m
					from grade – broad crown; to be
					removed
15	Manitoba maple	Fair	12	Neigh-	Maturing; likely originated from
			avg.	bour	seed; some stems overhanging
					property line – will have to be cut
					back; to be preserved and
					protected

Picture 2. Manitoba maple (tree #11) to be removed from 24-30 Pretoria Avenue.

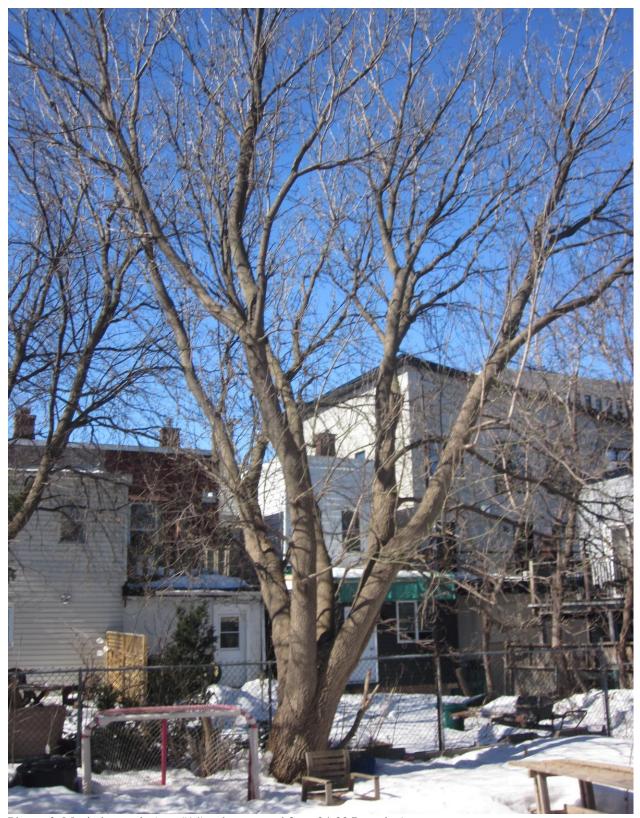
Picture 3. Manitoba maple (tree #14) to be removed from 24-30 Pretoria Avenue.
