**Canada Bank Note Limited**

**FINAL TREE INVENTORY AND  
PROTECTION PLAN**

Ottawa, Ontario

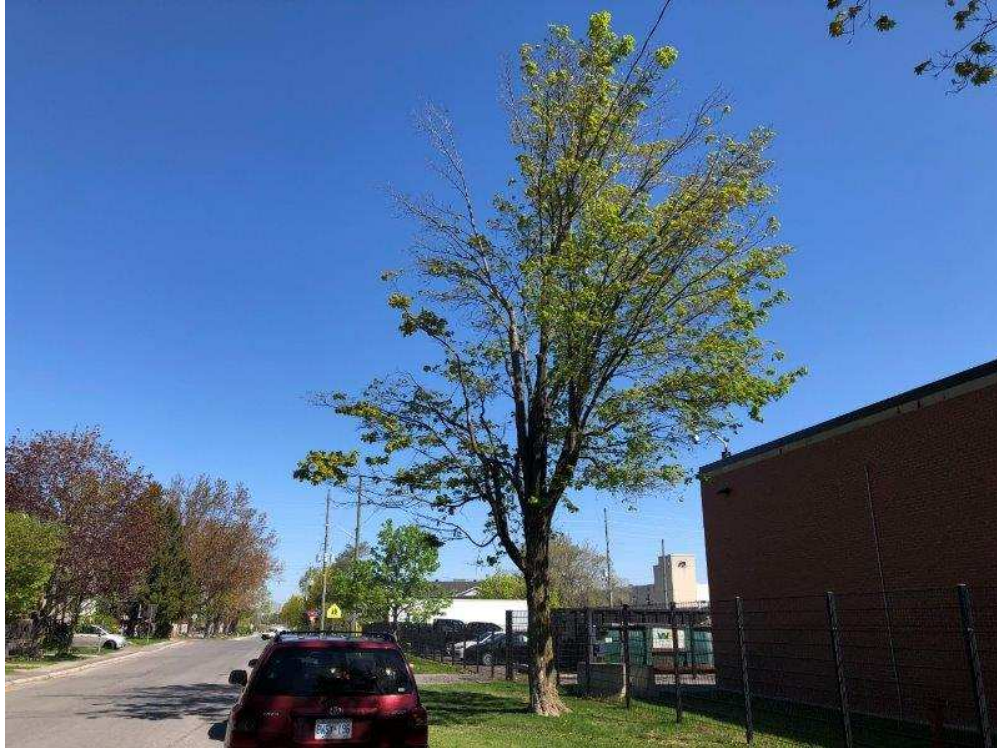
The site contained one (1) tree with a dbh of greater than 50 cm. This was a Sugar Maple with a dbh of 51 cm in Fair condition with dieback in the crown. This tree does not require removal as it is outside the limits of construction and therefore, is not anticipated to require compensation. If this tree is damaged during construction, the contractor will be required to obtain a Distinctive Tree Permit from the City of Ottawa.

**Photo 1.** Tree #1 – Sugar Maple in Fair condition along west side of Canadian Bank  
Note Limited building, facing north. May 20, 2020

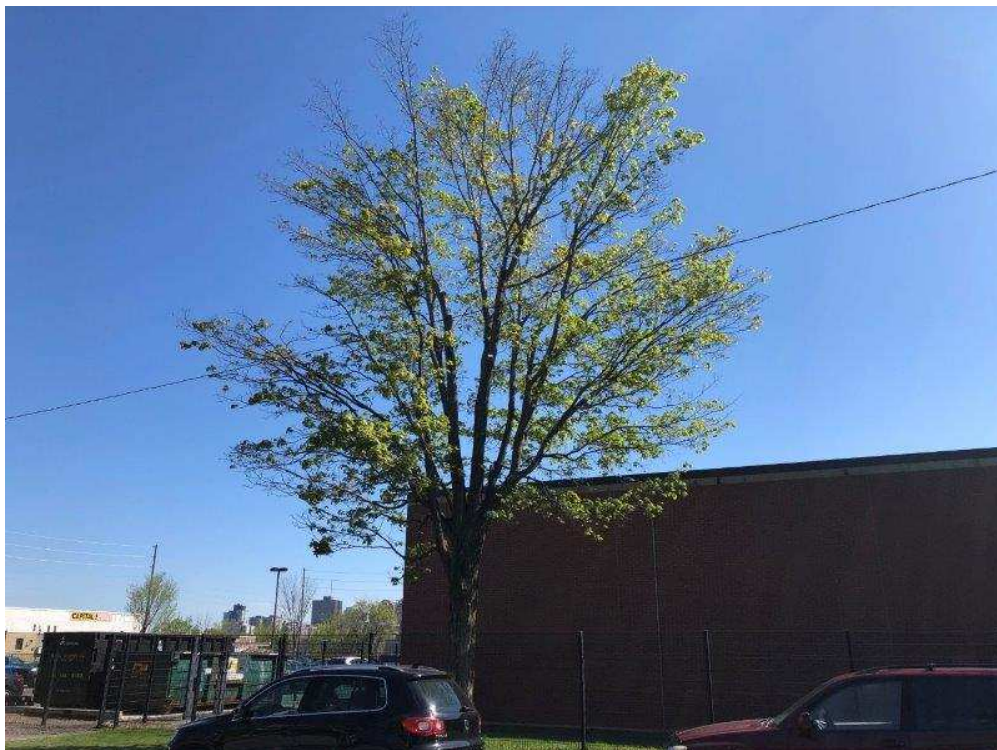
**Photo 2.** Tree #1 – Sugar Maple in Fair condition along west side of Canadian Bank  
Note Limited building, facing east. May 20, 2020

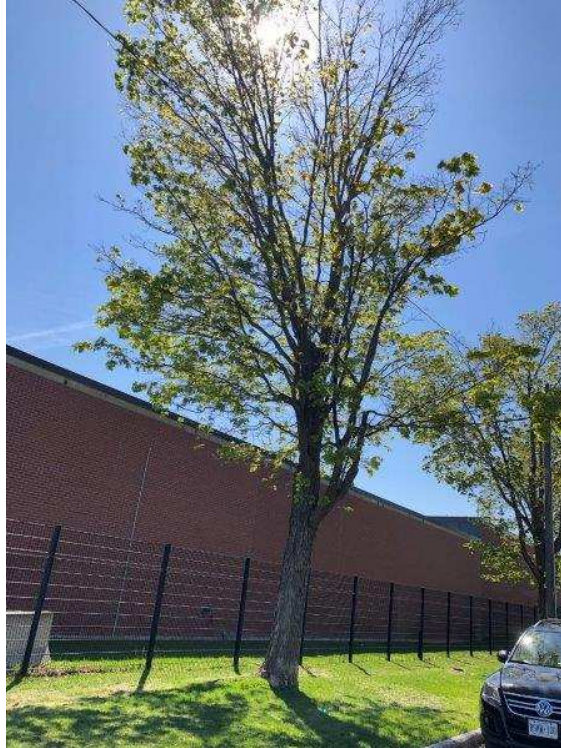
**Photo 3.** Tree #1 – Sugar Maple in Fair condition along west side of Canadian Bank Note Limited building, facing south. May 20, 2020

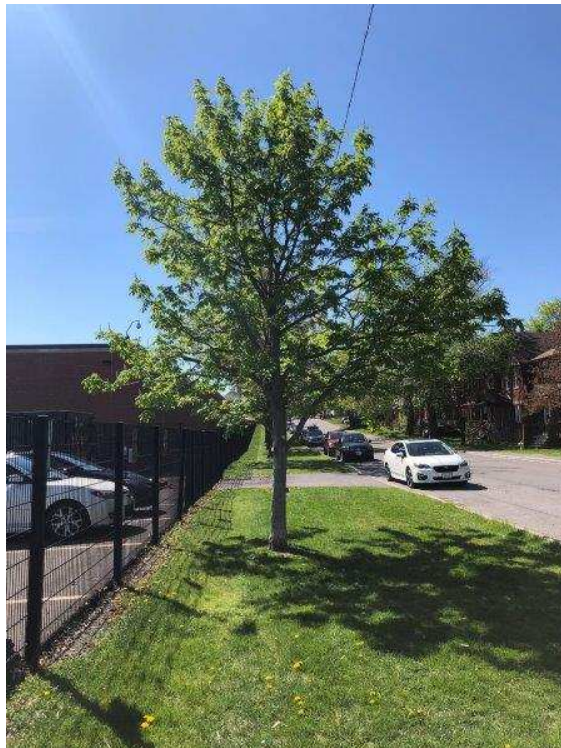
**Photo 4.** Tree #2 – Horsechestnut in Excellent condition along west side of Canadian Bank Note Limited building, facing south. May 20, 2020

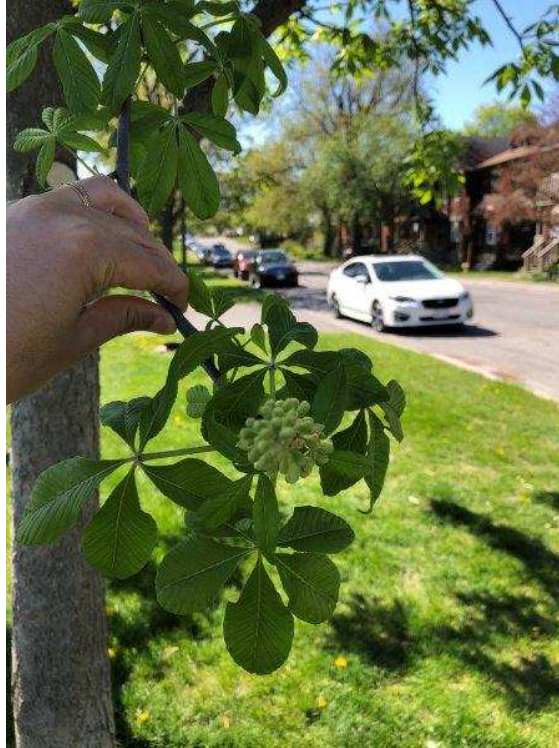
**Photo 5.** Tree #2 – Horsechestnut leaves and flowers along west side of Canadian Bank Note Limited building, facing south. May 20, 2020

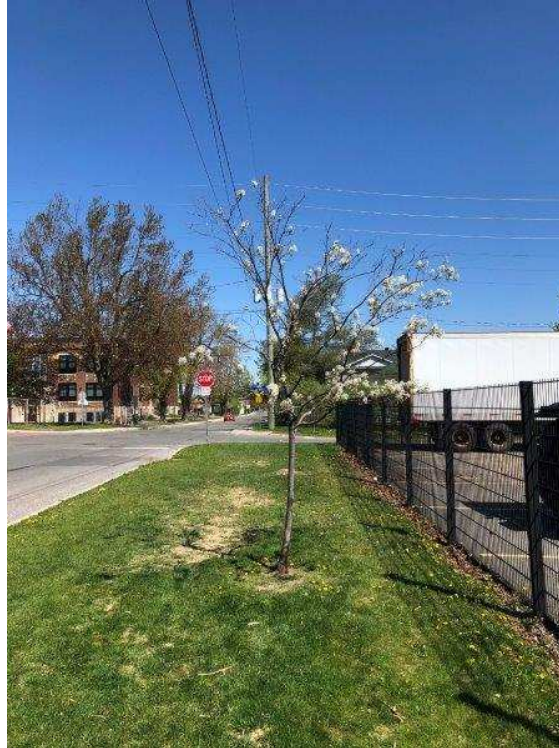
**Photo 6.** Tree #3 – Serviceberry in Excellent condition along west side of Canadian Bank Note Limited building, facing north. May 20, 2020

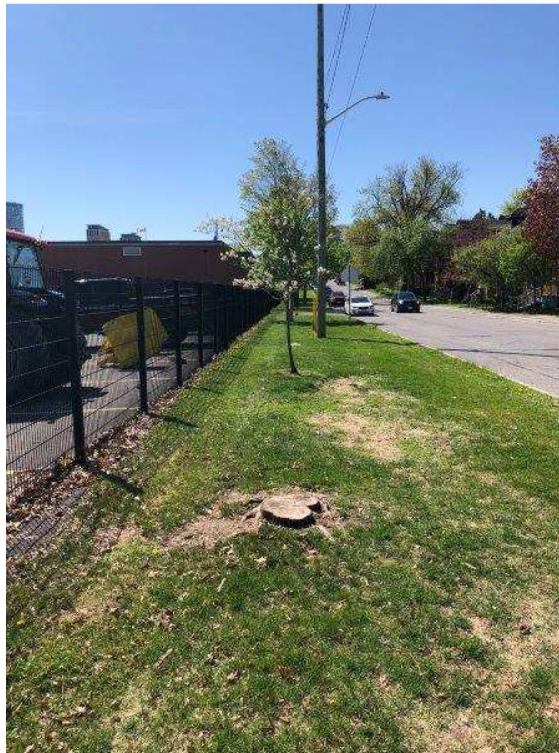
**Photo 7.** Tree #3 – Serviceberry behind cut tree stump along west side of Canadian Bank Note Limited building, facing south. May 20, 2020

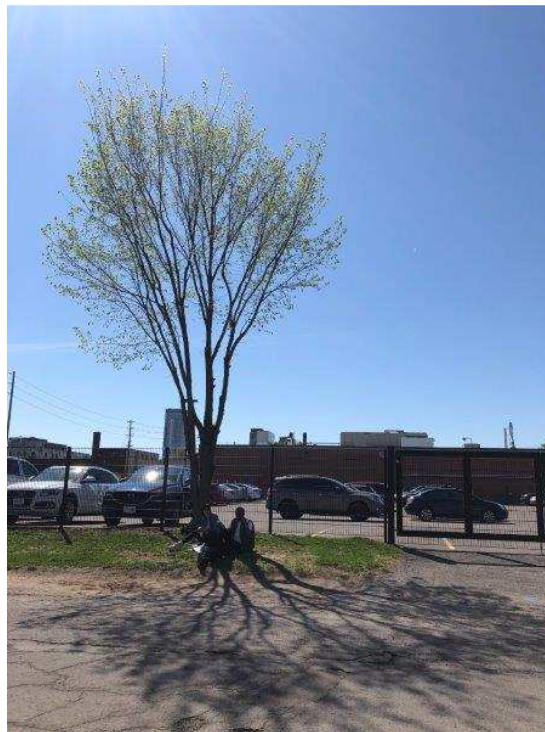
**Photo 8.** Tree #4 – Siberian Elm in Good condition located along northern limits of Canadian Bank Note Limited building, facing south. May 20, 2020

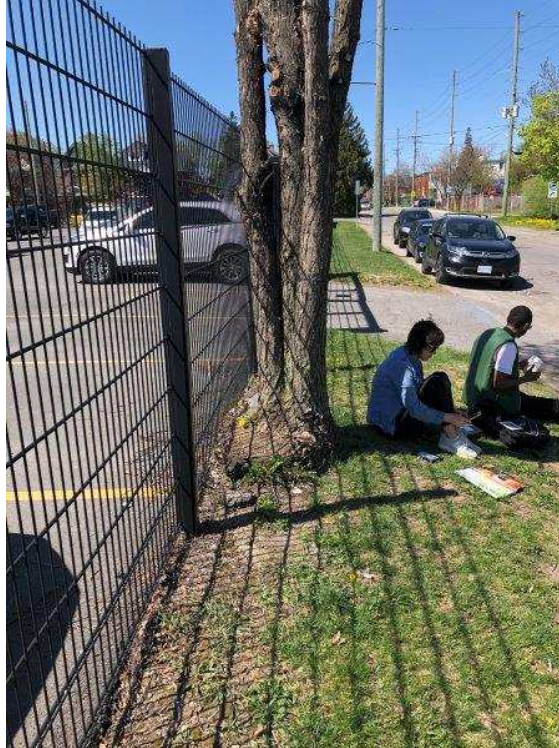
**Photo 9.** Tree #4 – Siberian Elm in Good condition showing tree roots being girdled by fence, facing west. May 20, 2020

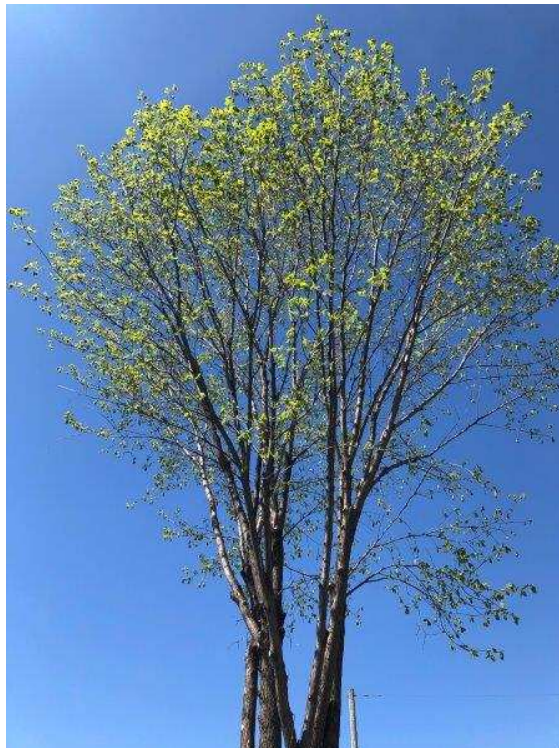
**Photo 10.** Tree #4 – Siberian Elm in Good condition showing healthy crown. May 20, 2020

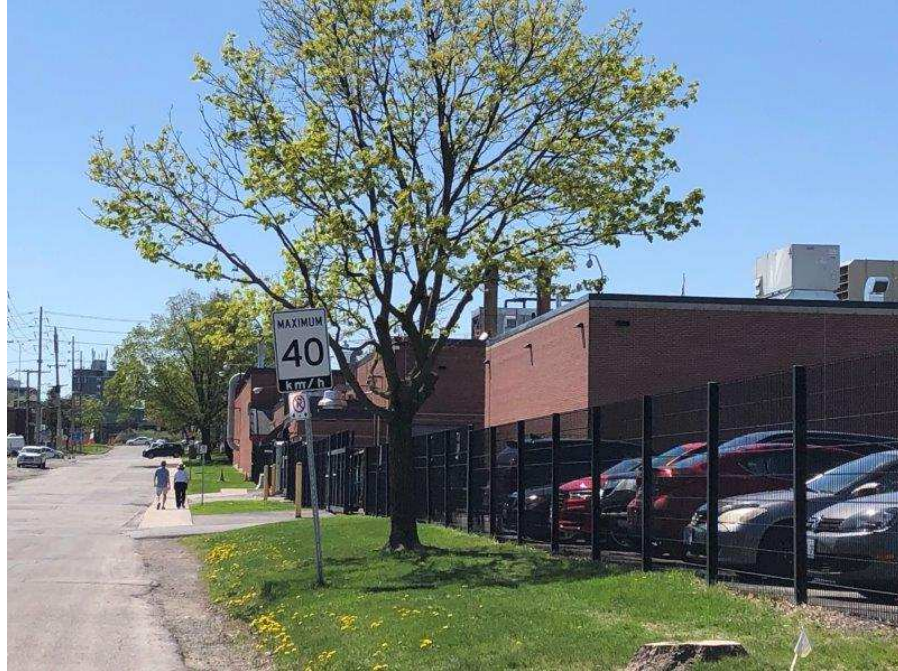
**Photo 11.** Tree #5 – Maple species in Fair condition located along eastern limits of Canadian Bank Note Limited building, facing south. May 20, 2020
