Mr. Phil Thibert Brigil 98 rue Lois Gatineau, QC J8Y 3R7

January 10, 2020

# Re.: UPDATED - Tree Conservation Report for Petrie Block 8 – 8466 Jeanne D', Ottawa, Ontario

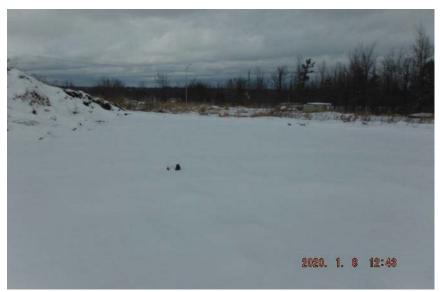
Photo 1: Looking north from the center of the Site (January 8, 2020)

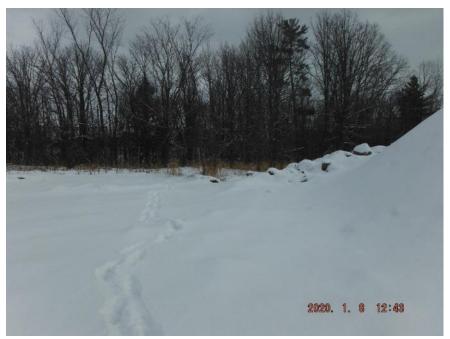
Photo 2: Looking east from the center of the Site (January 8, 2020)

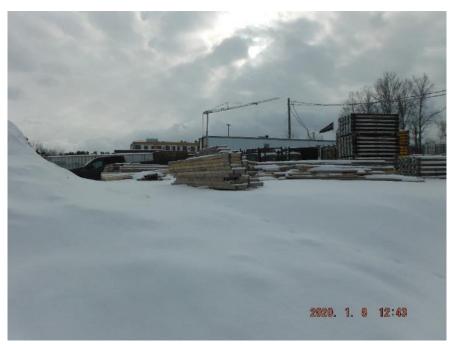
Photo 3: Looking south from the center of the Site (January 8, 2020)

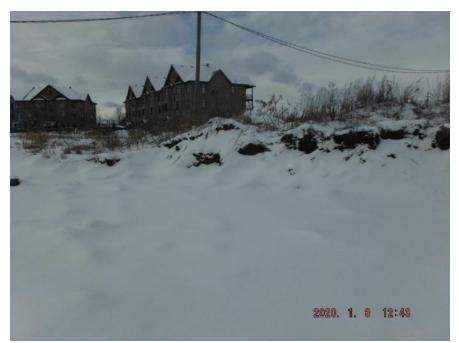
Photo 4: Looking west from the center of the Site (January 8, 2020)

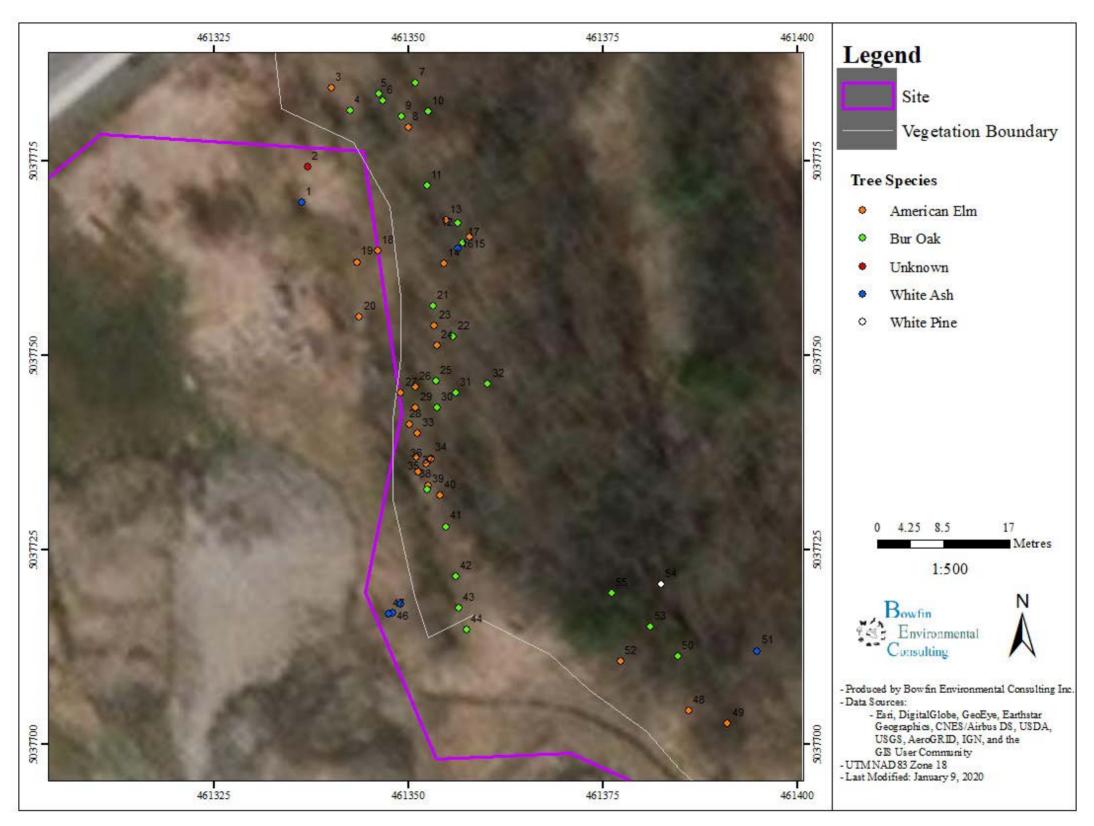
Figure 2: Location of Trees (≥10 cm)

There was a total of 55 trees with a DBH greater than 10 onsite or near. The majority of the trees had a dbh <30 cm. Three larger trees were noted: Tree 43 (white oak, 64 cm), Tree 50 (bur oak, 95 cm) and Tree 54 (white pine, 83 cm). The most common species were: American elm, bur oak and white ash. A summary of these is provided in Table 1. Details are appended to this

letter (Table 2). Most of the trees were healthy however there were a few trees that have fallen over or have some twig dieback.

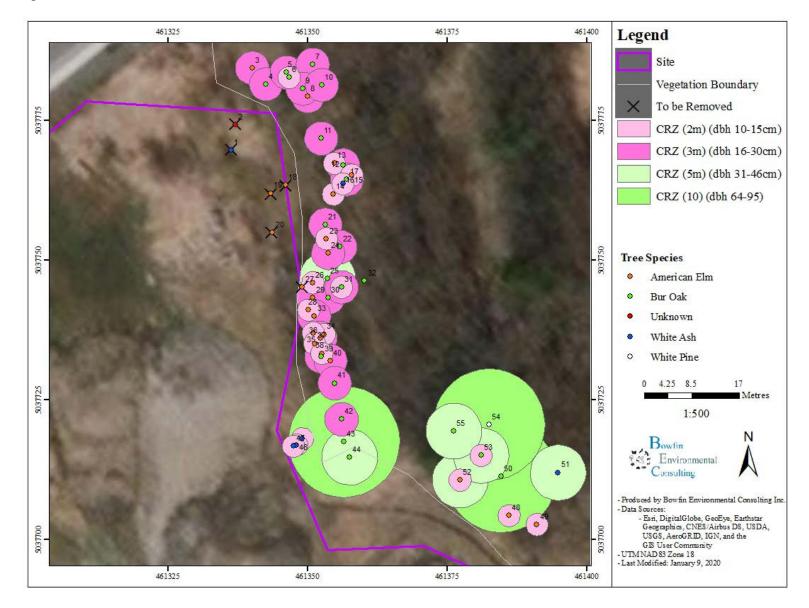
Figure 3: Identification of Trees to be Removed/Retained

All six trees within the site will be removed (Figure 3). These were individuals were: Tree 1 (white ash, dbh 15 cm), Tree 2 (unknown, dbh 20 cm), Tree 18 (American elm, dbh 12 cm), Tree 19 (American elm, 18 cm), Tree 20 (American elm, dbh 23 cm) and Tree 27 (American elm, dbh 20 cm). Of these, the unknown and three elms were dead (individuals 2, 18, 19 and 27).

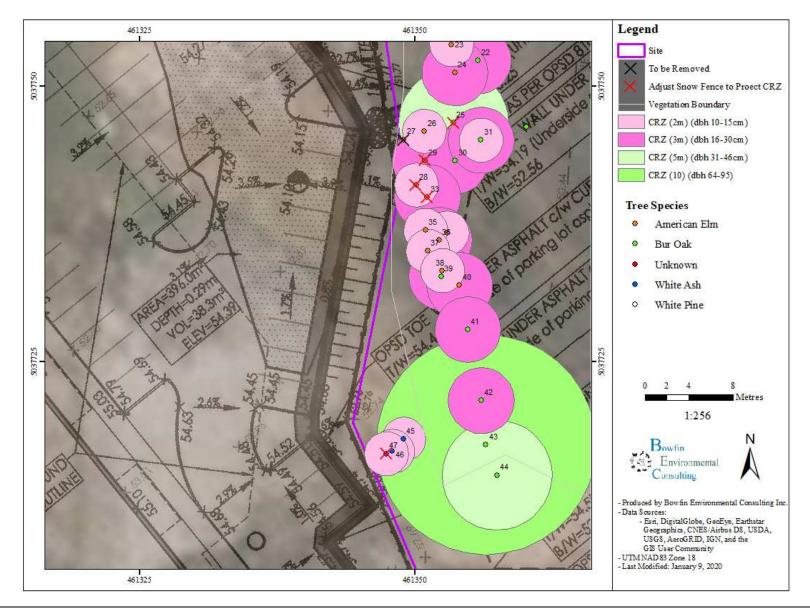
Figure 4: Trees whose CRZ are in or on Edge of the Site

There are also five trees whose critical root zone (crz) (defined by the City of Ottawa as 10x the dbh) was in or immediately next to the edge of the development [individuals 25 (bur oak, dbh 36 cm), 28 (American elm, dbh 15 cm), 29 (American elm, dbh 16 cm – dead), 33 (American elm, dbh 19 cm) and 47 (white ash, dbh 11 cm)]. To prevent harming of these additional trees it is recommended that the snow fencing (see mitigation measures) be brought in, away from the crz in the two locations. The locations in question are seen on Figure 4. It is recommended that the clearing of trees, grading and infilling be limited to the area fenced (see below) to prevent root damage to trees meant to be left in place. Table 2 and Figure 3 show which trees will be removed and which will be retained.

- A tree permit is needed before trees can be removed from site.
- Sturdy fencing will be installed on the edge of the Site, which is outside of the Critical Root Zone (crz) (defined by the City as 10 x the DBH) of the adjacent trees, for almost all of the trees to be retained. There are two locations where the crz of trees to be retained infringes into the Site. In these locations, the fence will be brought in slightly (1-2 m) to ensure that the crz of all trees ≥10 cm offsite is protected. To ensure that this measure is followed, the surveying of this portion of the snow fence will be verified by a biologist or arborist prior to the installation of the fence.

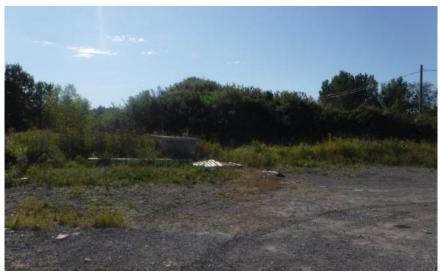
This community was present throughout the Site and continued south until Highway 174. The community was highly disturbed with storage containers, discarded garbage, gravel pads and spoil piles. The dominant layer was the ground cover (100% cover) which was characterized by reed canary grass, Canada goldenrod, late goldenrod, and rough goldenrod. The canopy (5-6 m tall; provided 2% cover) consisted of: white ash (average dbh 10 cm) which was more common than American elm (average dbh 12 cm). The sub-canopy (2-3 m tall; 5% cover) was dominated by Manitoba maple which was more common than staghorn sumac, common buckthorn or white ash. The understory (1 m tall; 10% cover) consisted of: wild red raspberry followed by purple flowering raspberry and black raspberry.

Photo 5: Cultural Meadow (September 22, 2015)

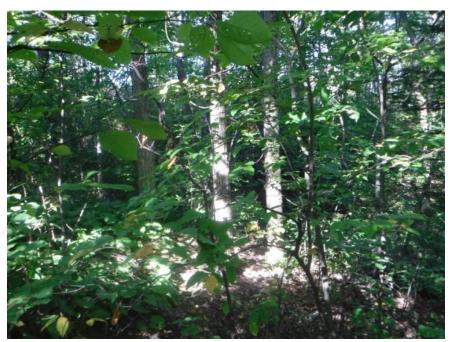
This deciduous community was found within the eastern side of the adjacent lands. It was composed of 95% tree cover which included 5% coniferous trees. This forested community was present on a steep ravine. The canopy was 13-15 m tall and provided 40% canopy cover. The dominant species was bur oak (95%, average dbh 15 cm) which was much more abundant than white pine (5%, average, dbh 45 cm). The sub-canopy (8-10 m tall; 60% cover) was still strongly vegetated with bur oak followed by white ash, white birch, American basswood and trembling aspen. The understory (1-3 m tall; 30% cover) was composed of: white ash, Tartarian honeysuckle, and common buckthorn. The ground layer (40% cover) included: large-leaved aster, common strawberry, and northern lady fern. The bottom of the ravine was vegetated with reed canary grass.

Photo 6: Fresh- Moist Bur Oak Deciduous Forest (FODM9-4) (September 22, 2015)

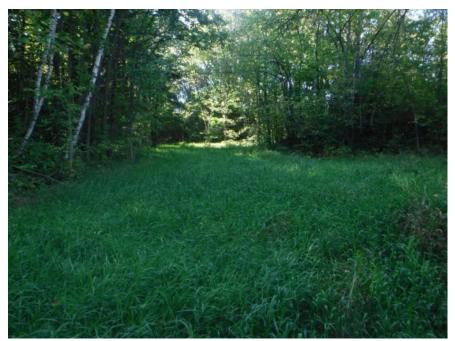
Photo 7: Reed Canary Grass in the bottom of Ravine (September 22, 2015)
