**Re.: Tree Conservation Report for 180 Prestige Circle - Petrie II - Block 8**

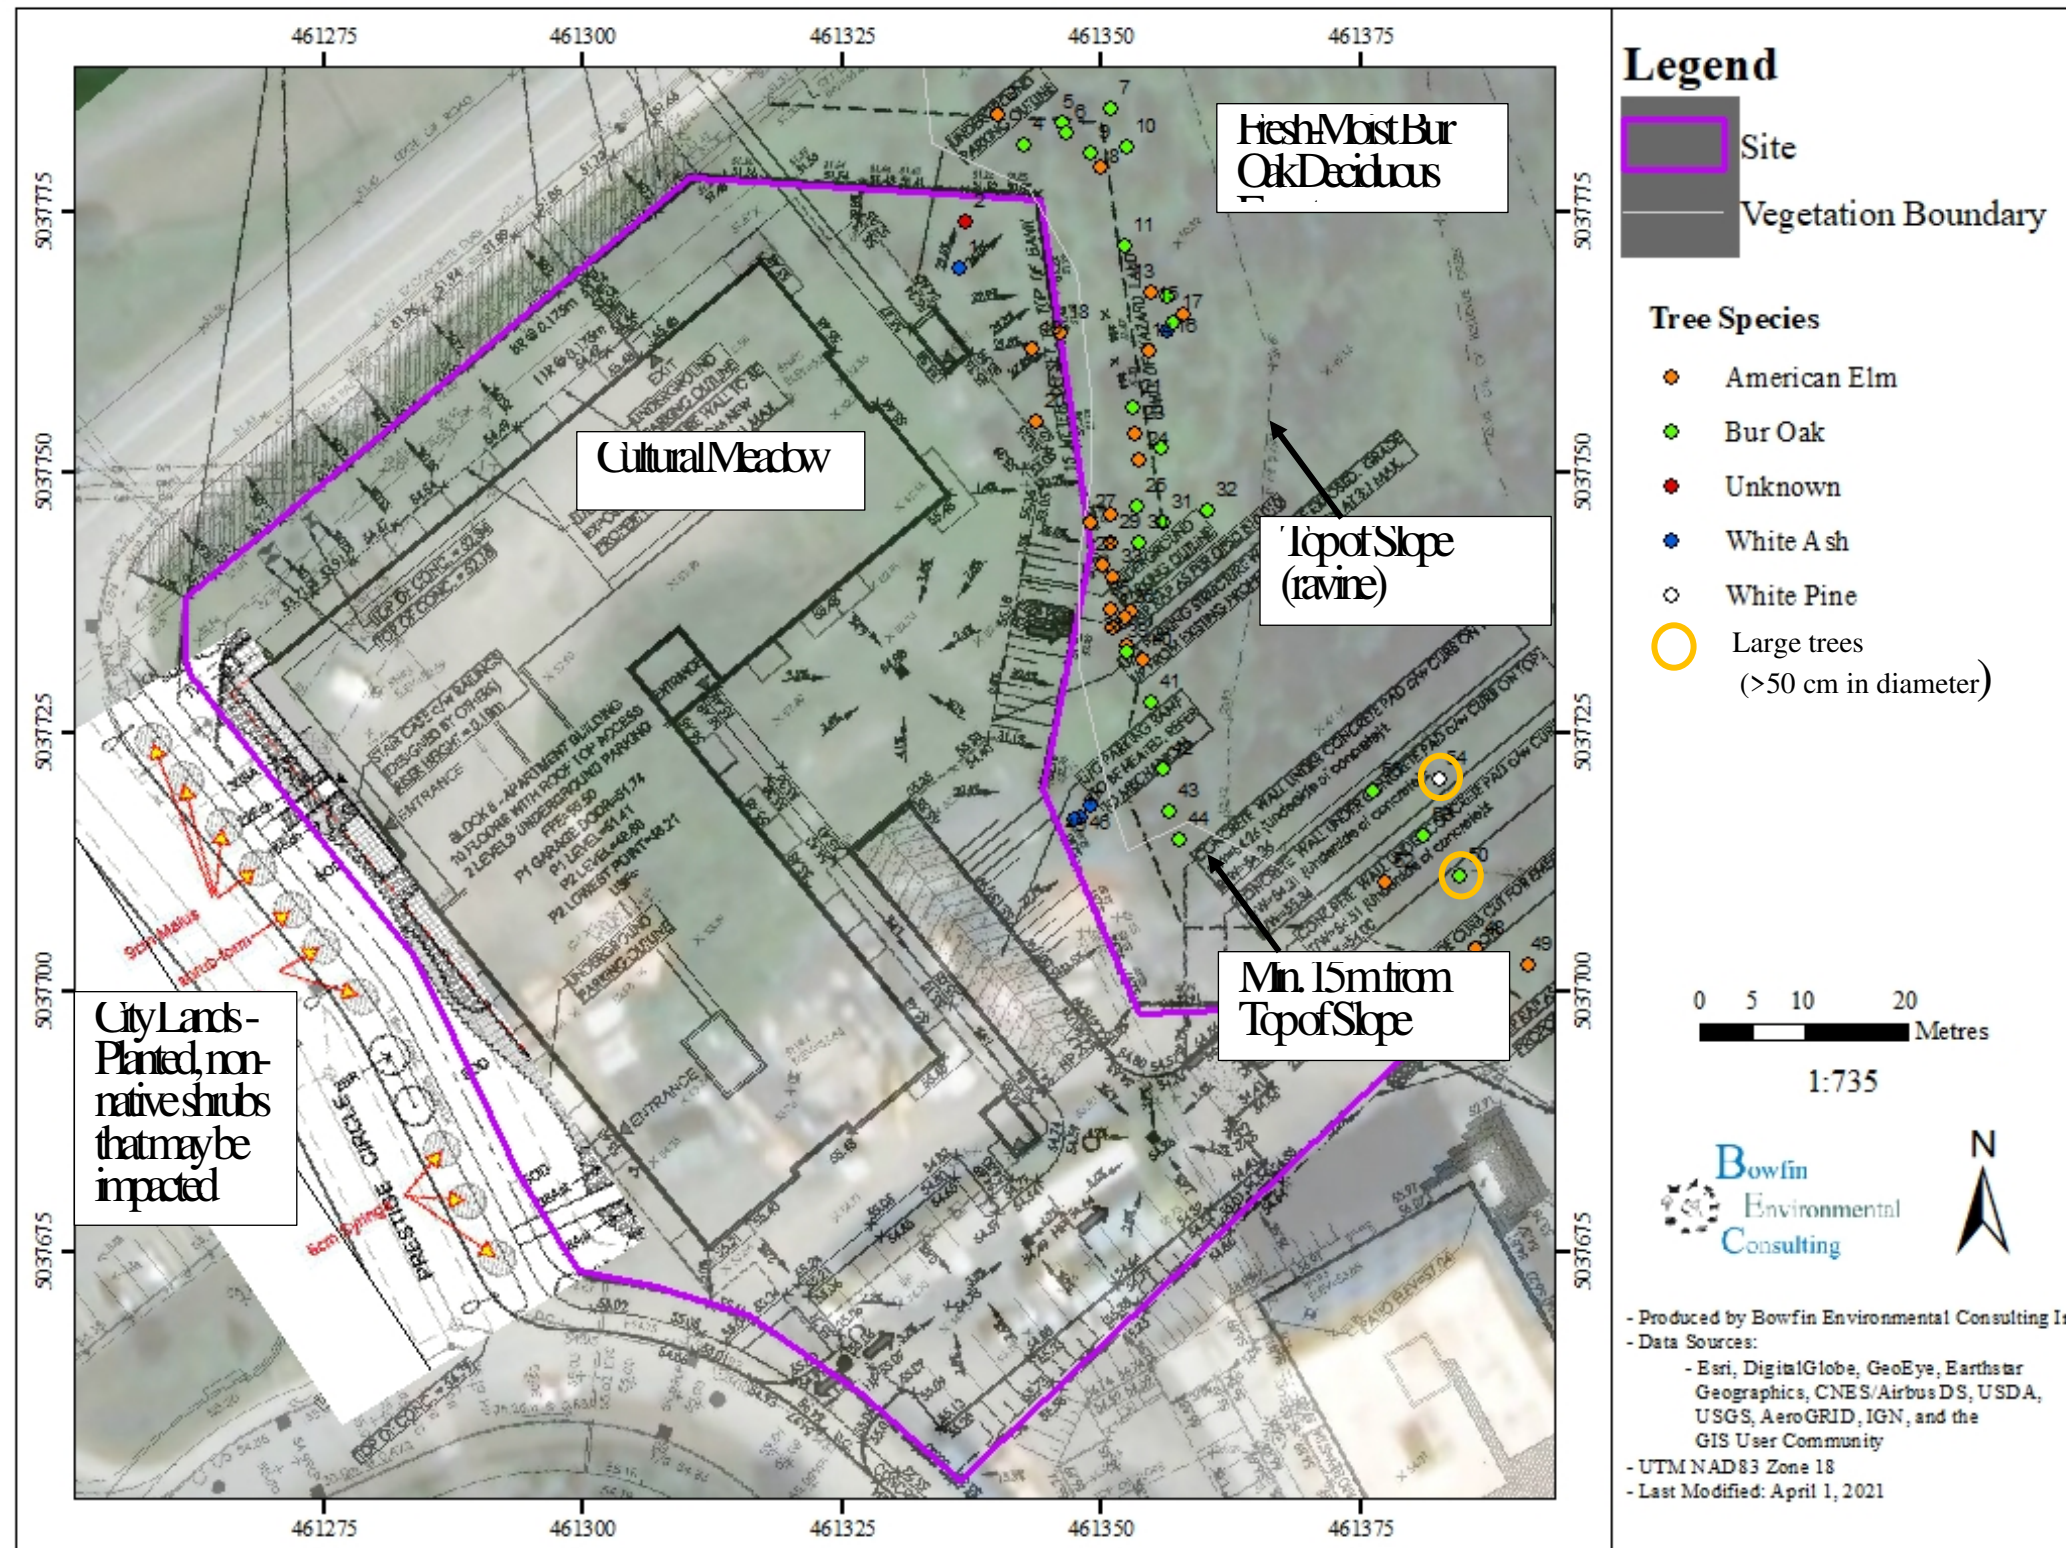
Figure 2: Location of Trees  $\geq 10$  cm and Natural Features

There were 55 trees with a diameter greater than 10 cm on or within 10 m of the Site. The majority of the trees had a diameter of <30 cm. Two larger trees were noted: No. 50 (Bur Oak, 95 cm) and No. Tree 54 (White Pine, 83 cm). These larger individuals were all more than 10 m from the area to be cleared and will not be impacted (Figure 2). The most common species were: American Elm, Bur Oak and White Ash. A summary of these is provided in Table 1. Details are

appended to this letter (Table 3). Most of the trees were healthy however there were a few trees that have fallen over or have some twig dieback. It is noted that the 2015 site investigations noted that many of the White Ash were dead or dying, these had either fallen over or could not be differentiated from the live trees under the winter conditions.

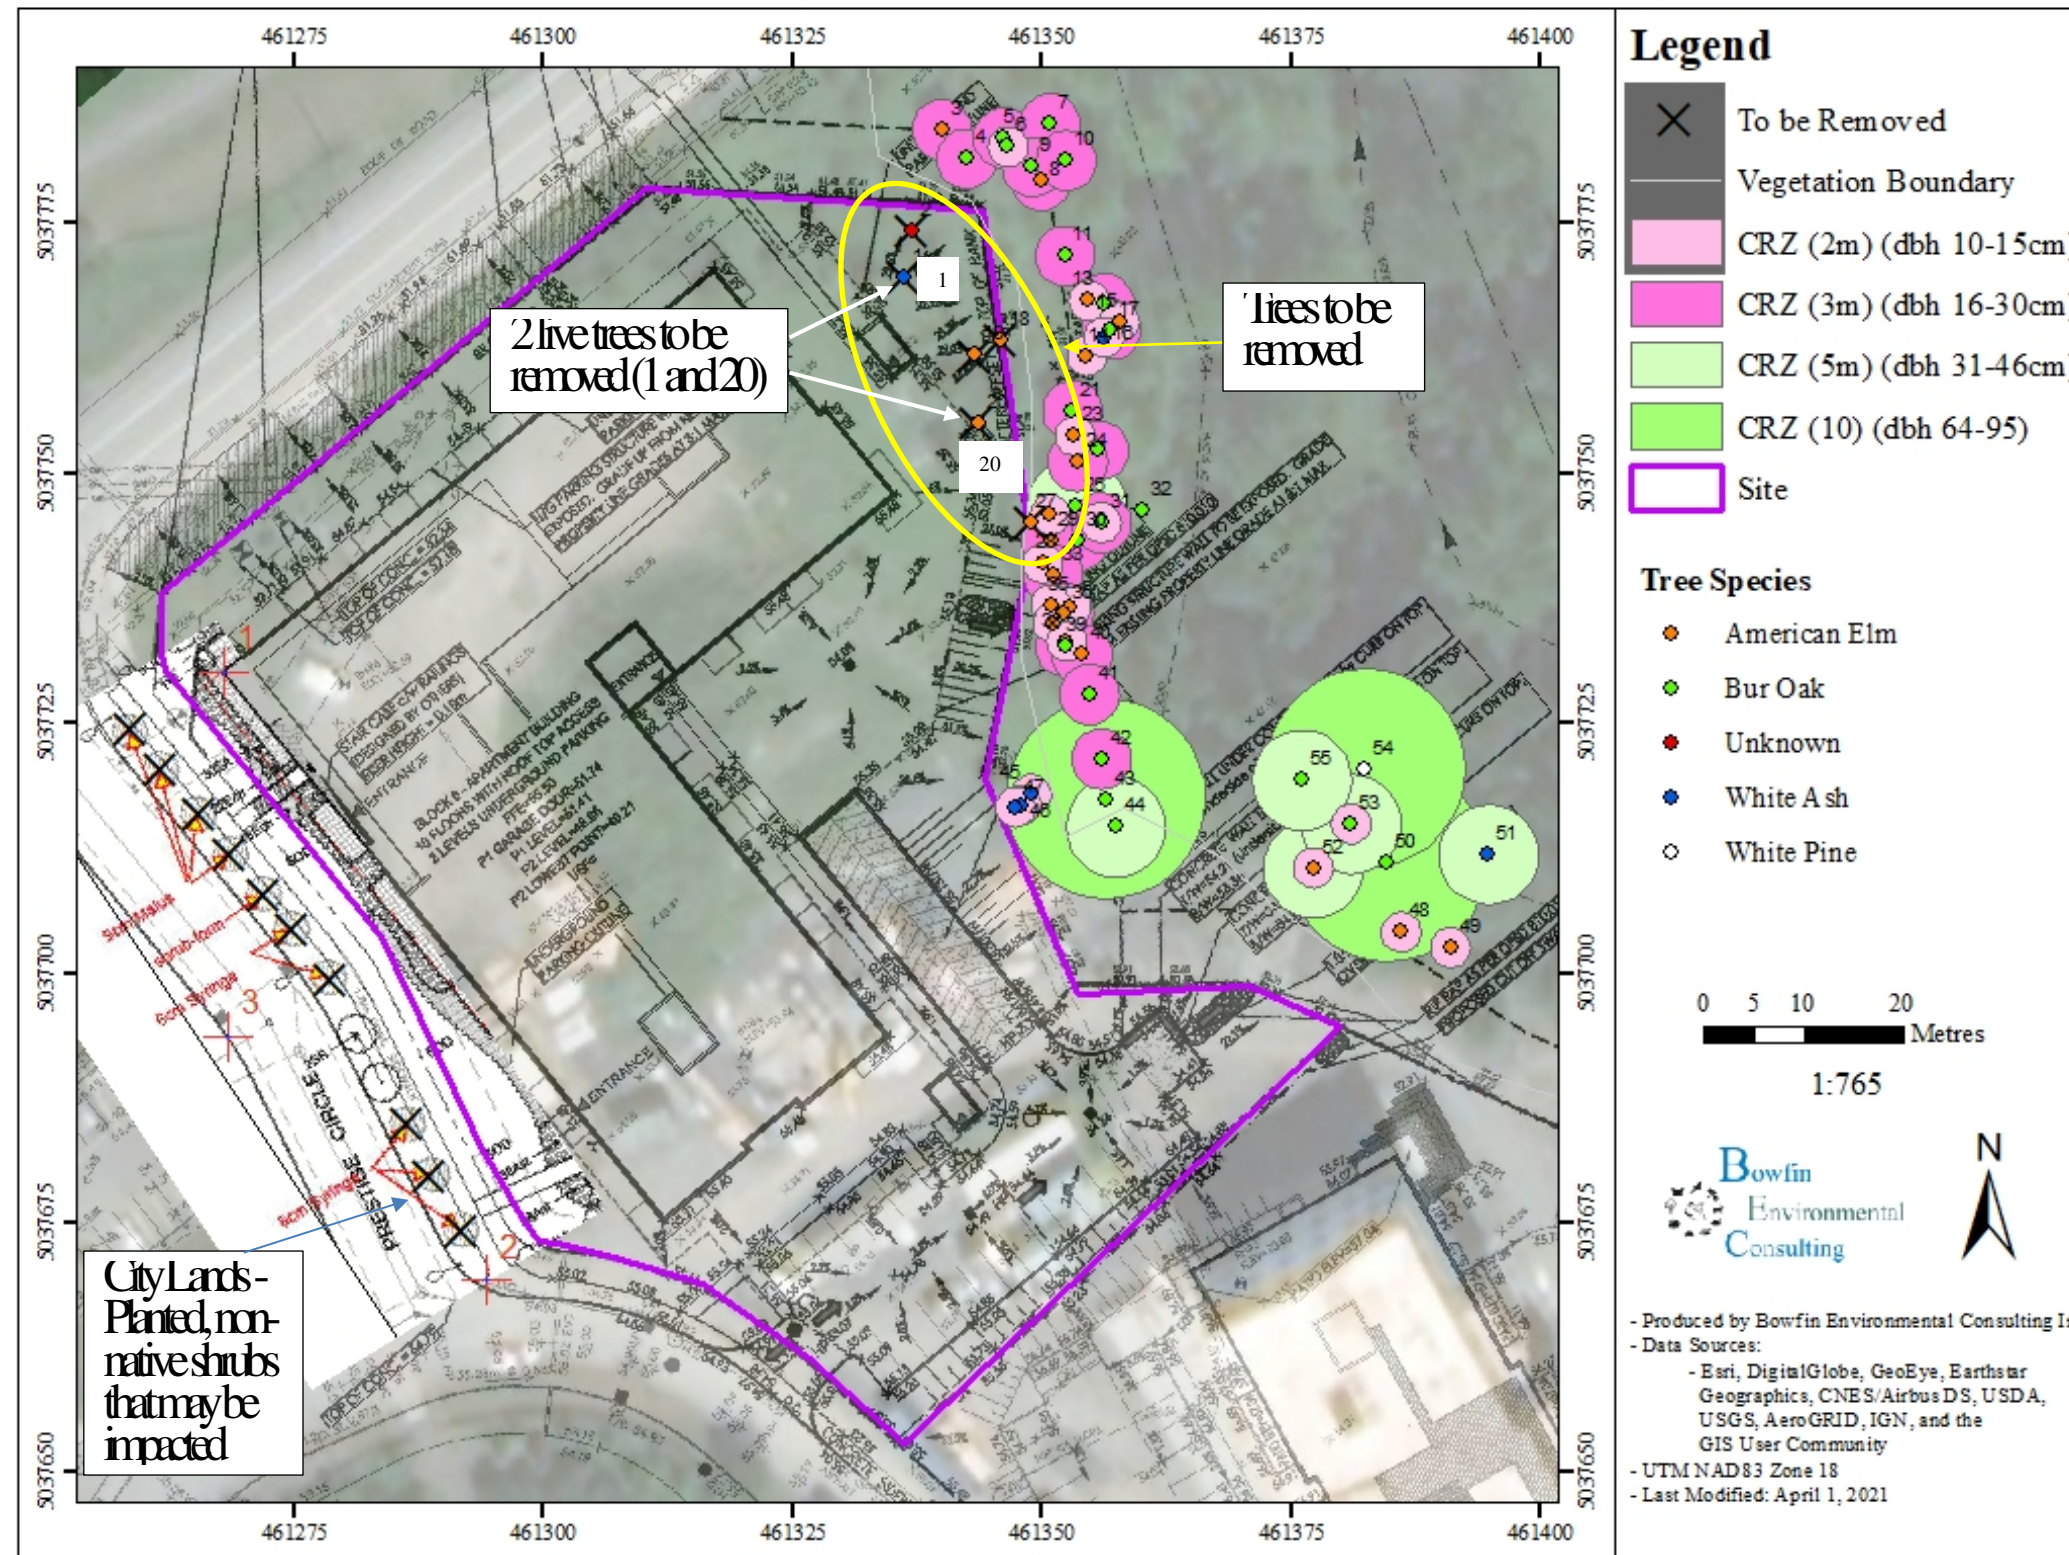
Figure 3: Identification of Trees to be Removed/Retained

Six trees within the site will be removed but of these only two were alive (individuals 1 and 20 (Figure 3). Because of the small size of the site, it is not possible to save these two individuals. The trees to be removed are:

- White Ash
  - No. 1, dbh 15 cm – Live (highlighted on Figure 3)
- American Elm
  - No. 18, dbh 12 cm – Dead
  - No. 19, dbh 18 cm – Dead
  - No. 20, dbh 20 cm – Live (highlighted on Figure 3)
  - No. 27, dbh 20 cm - Dead
- Unknown
  - No. 2, dbh 20 cm - Dead

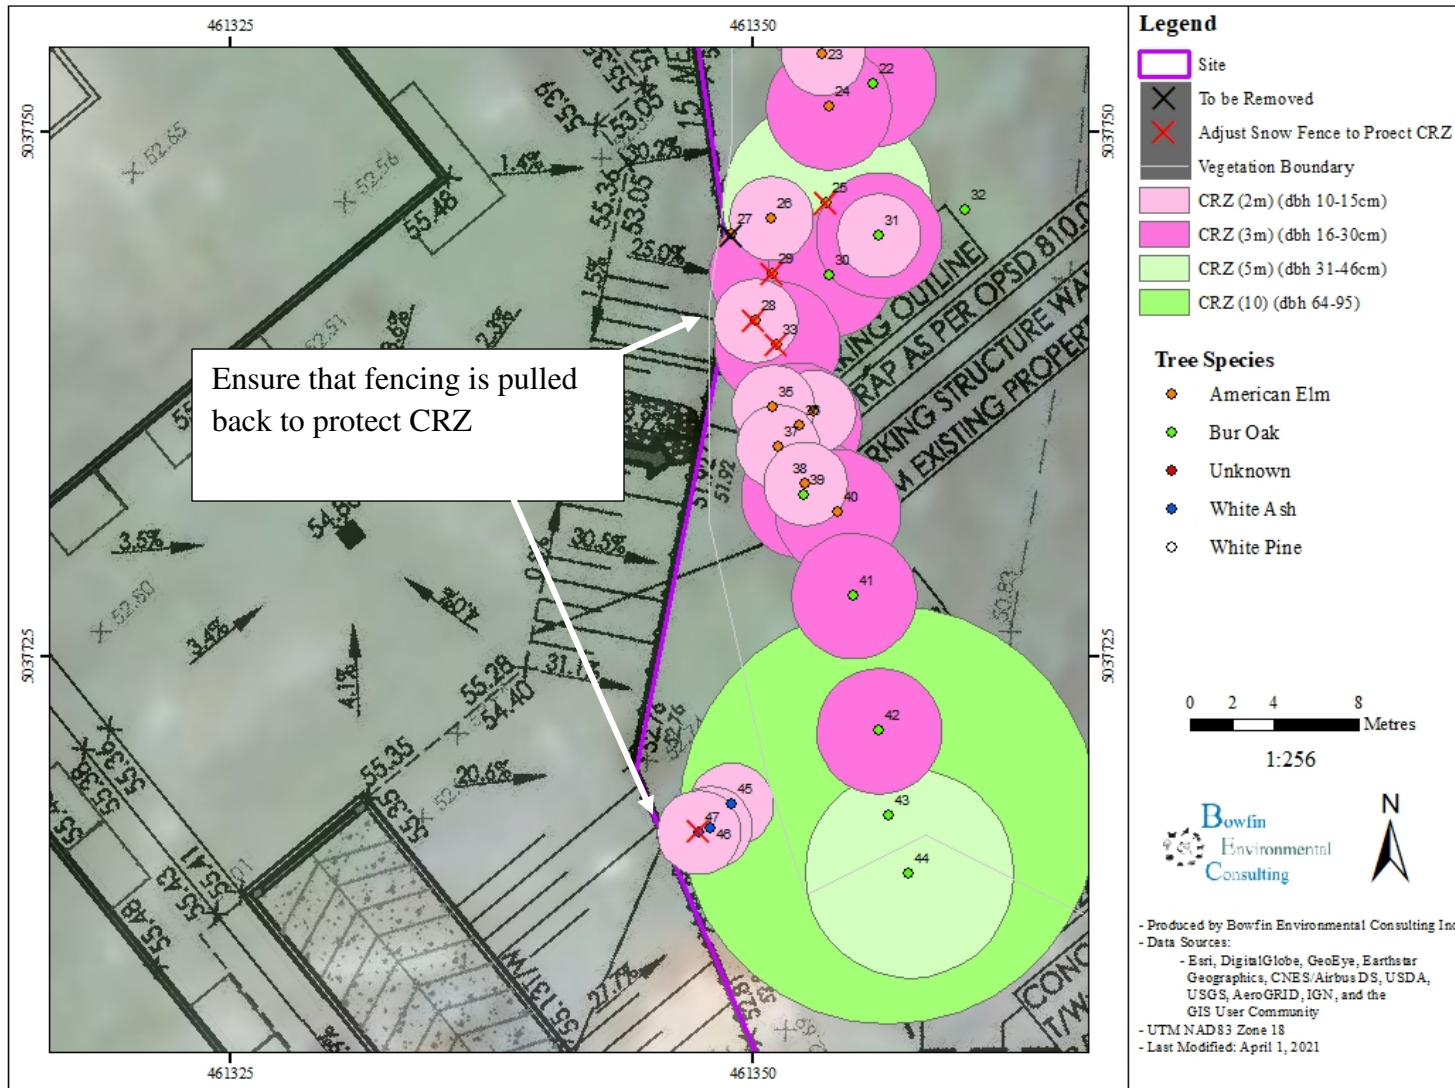
Figure 4: Trees whose CRZ are in or on Edge of the Site

There are also four live trees whose critical root zone (crz) (defined by the City of Ottawa as 10x the dbh) were in or immediately next to the edge of the development [individuals 25 (bur oak, dbh 36 cm), 28 (American elm, dbh 15 cm), 33 (American elm, dbh 19 cm) and 47 (white ash, dbh 11 cm)]. To prevent harming of these additional trees it is recommended that the snow fencing (see mitigation measures) be brought in, away from the crz in the two locations. The locations in question are seen on Figure 4.

all of the trees to be retained. There are two locations where the crz of trees to be retained infringes into the Site. In these locations, the fence will be brought in slightly (1-2 m) to ensure that the crz of all trees  $\geq 10$  cm offsite is protected. To ensure that this measure is followed, the surveying of this portion of the snow fence will be verified by a biologist or arborist prior to the installation of the fence.

- The need of a sturdy snow fence around the Site, with special notes highlighting the two locations where the fence must be adjusted to protect the crz, will be clearly noted on the site plans.
