REVISED
**Hazardous Building
Materials Assessment**

320 McRae Avenue and 311 &
315 Tweedsmuir Avenue,
Ottawa, Ontario

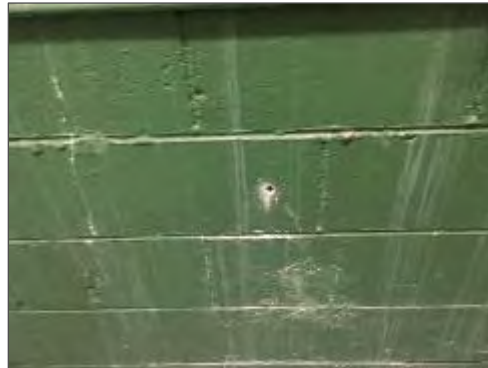
No vermiculite was present in the block walls at 320 McRae Avenue.

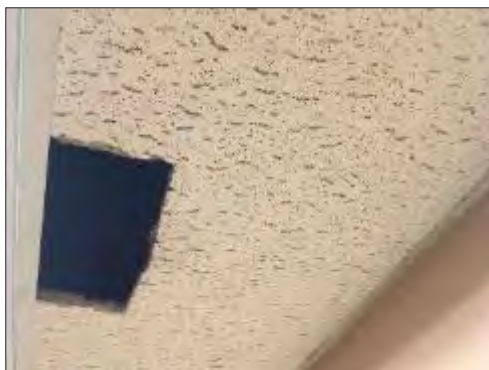
Non-asbestos acoustic ceiling tiles, 24"x48" with width-wise fissures and pinholes, present in Office 1 at 320 McRae Avenue.

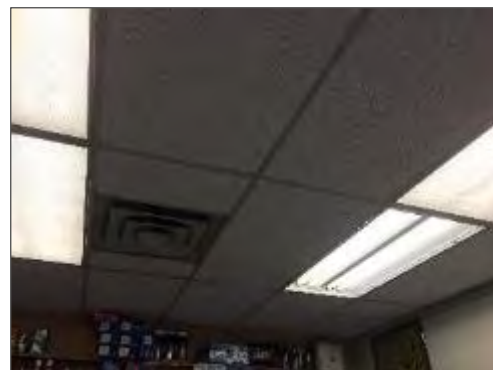
Non-asbestos acoustic ceiling tiles, 24"x48" with non-directional fissures and pinholes, present in Garage 1 at 320 McRae Avenue.

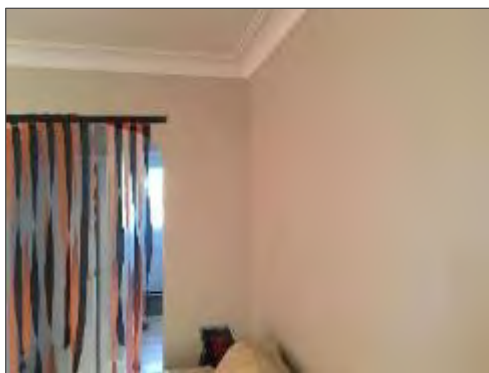
Asbestos-containing smooth plaster on the walls at 311 Tweedsmuir Avenue.

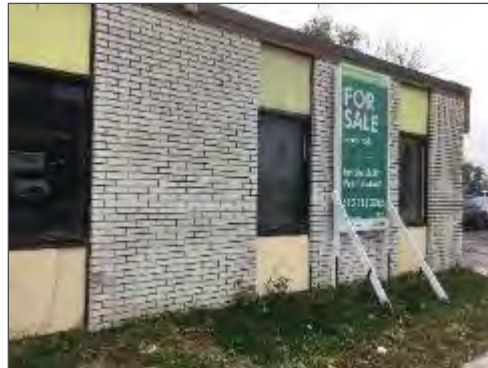
Asbestos-containing cement board present above and below the windows along Office 1 & 2 at 320 McRae Avenue.

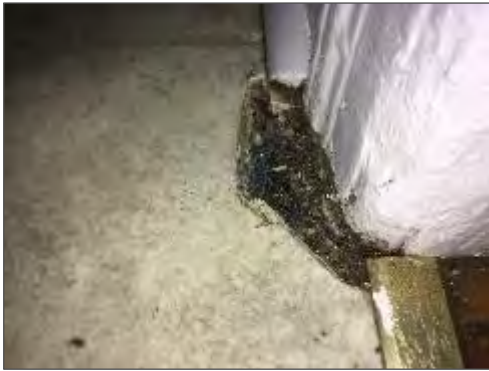
Asbestos-containing vinyl sheet flooring present in the multi-layered flooring at 311 Tweedsmuir Avenue.

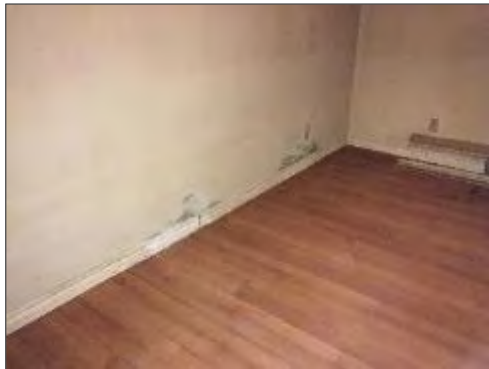
Mould present on the drywall walls in the Basement at 315 Tweedsmuir Avenue.

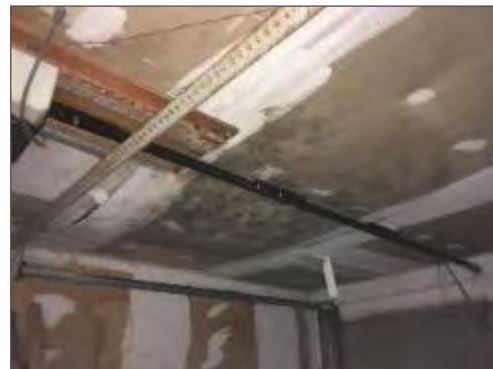
Mould present on the drywall ceiling in the separate Garage at 315 Tweedsmuir Avenue.

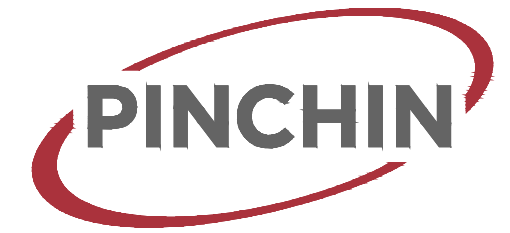
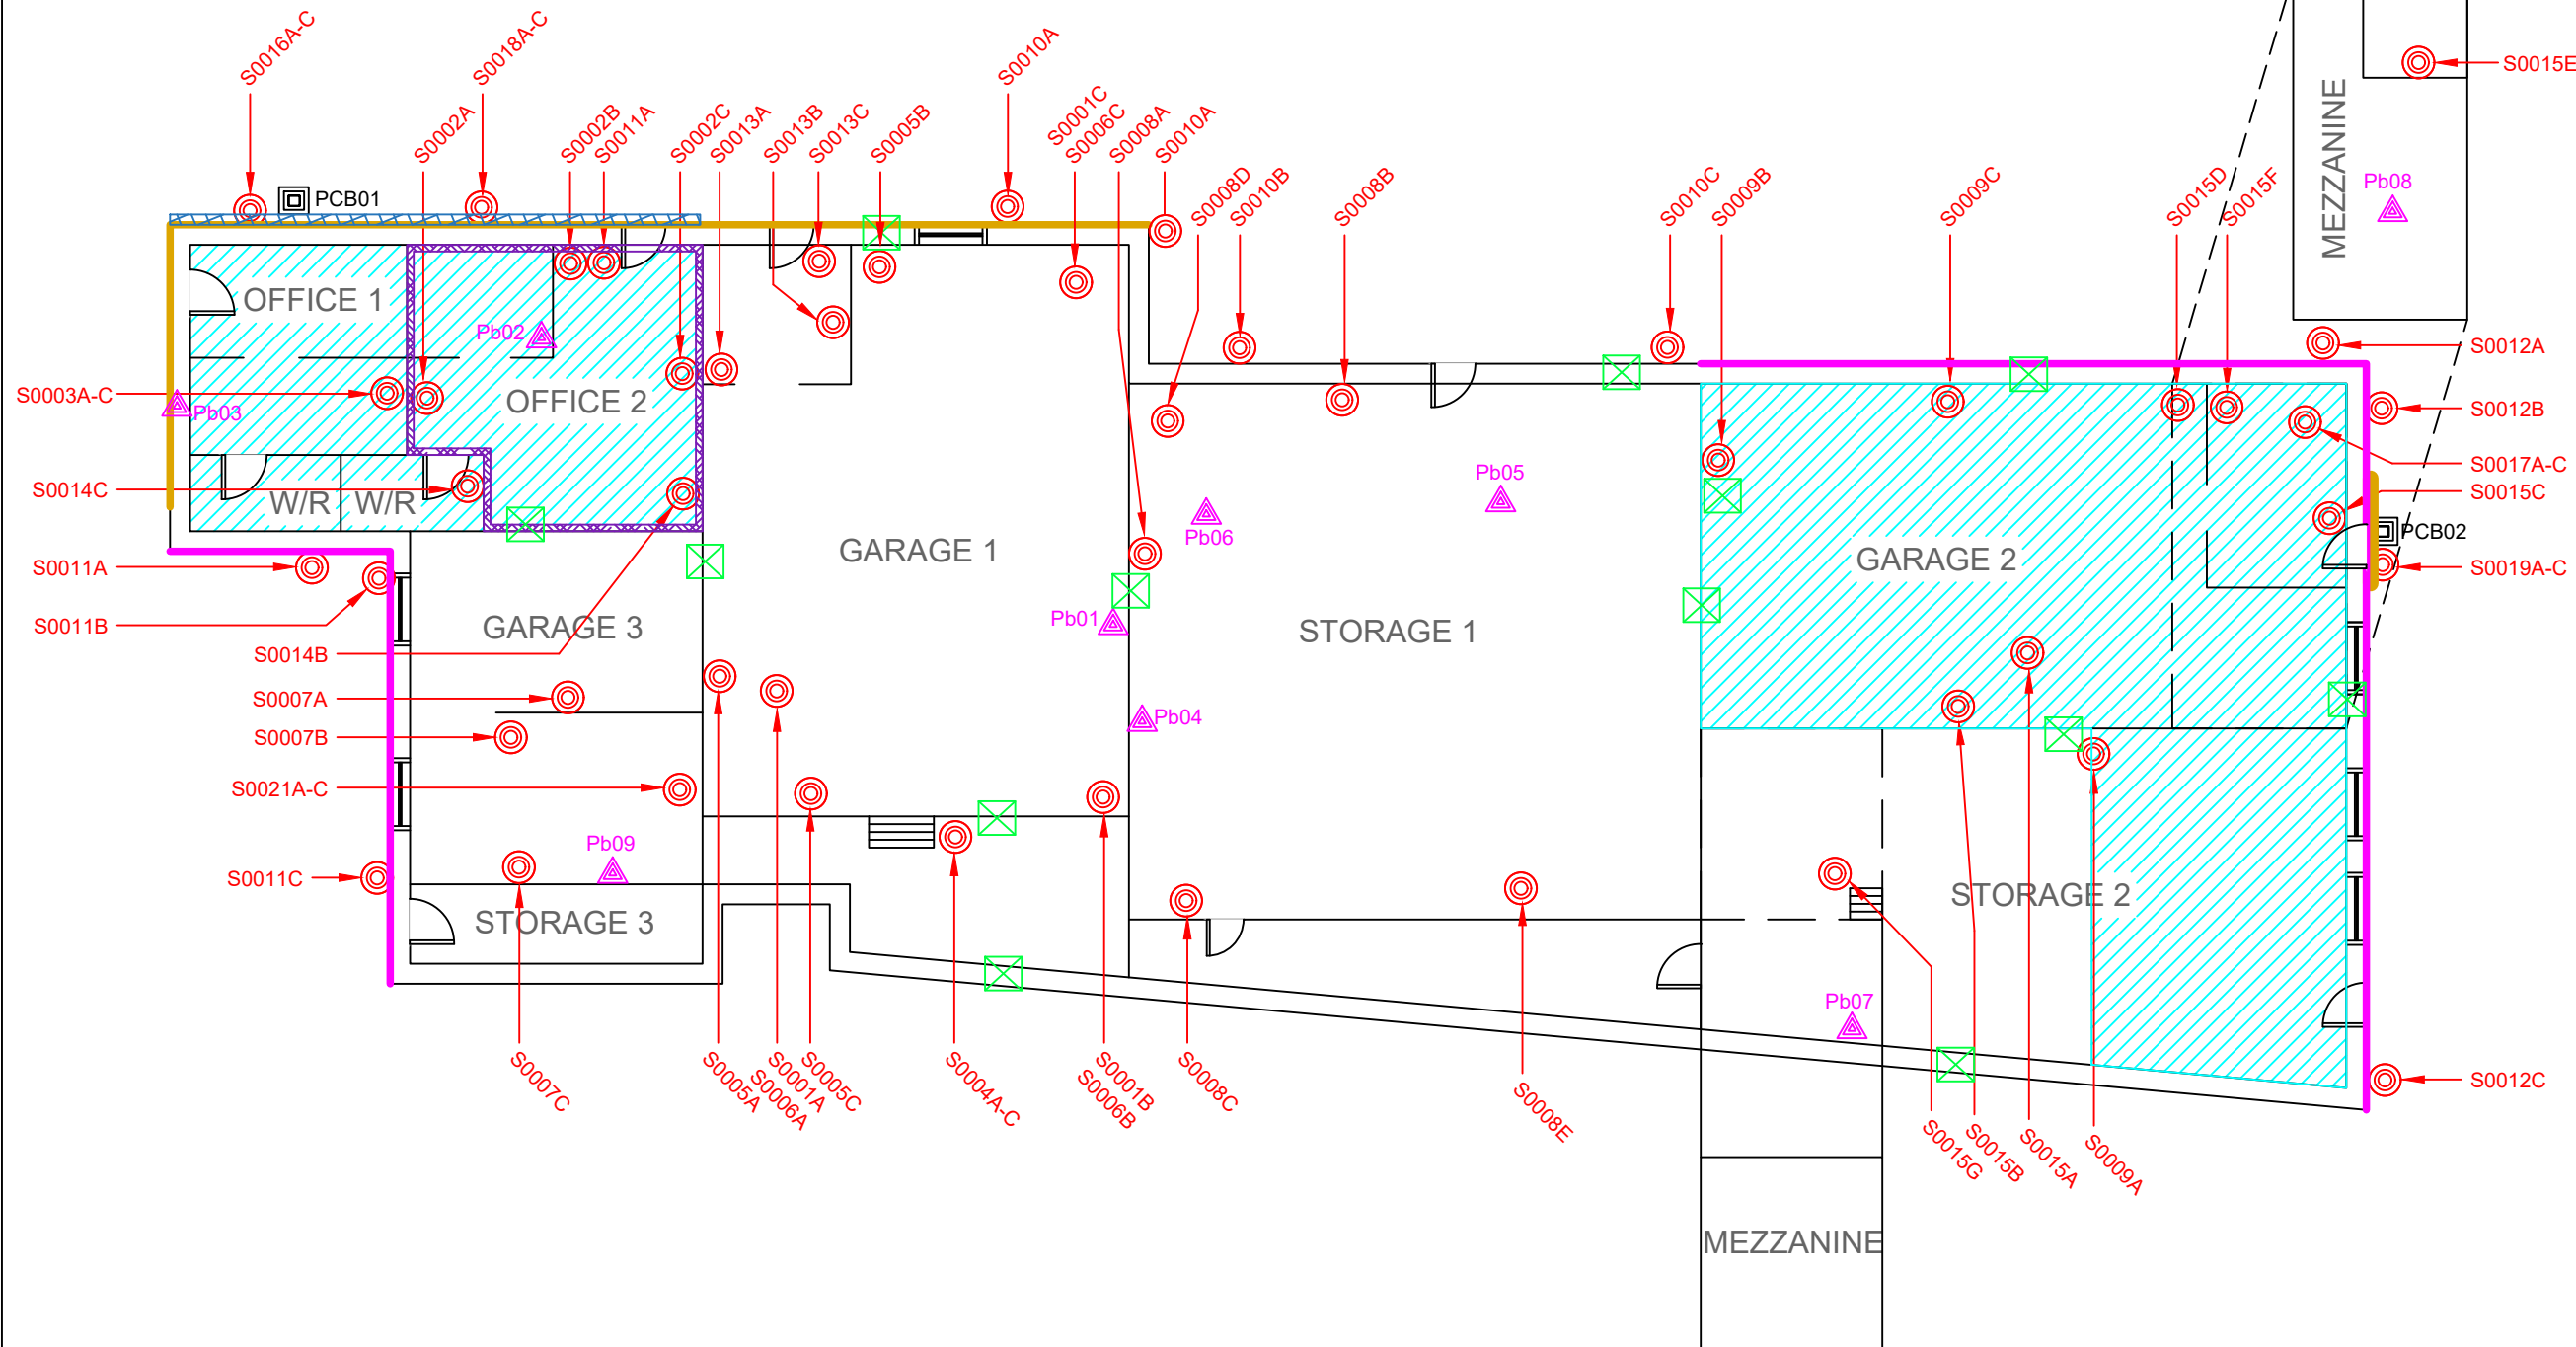
- LEGEND:**
- ASBESTOS BULK SAMPLE
 - LEAD BULK SAMPLE
 - PCB BULK SAMPLE
 - NAR NO ACCESS TO ROOM/AREA
 - INTRUSIVE INSPECTION LOCATION
- ASBESTOS-CONTAINING MATERIALS:**
- DRYWALL JOINT COMPOUND
 - SWIRL TEXTURE FINISH
 - CEMENT BOARD
 - AGGREGATE EMBEDDED STUCCO
 - CAULKING/PUTTY

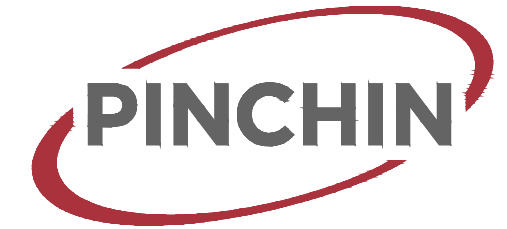
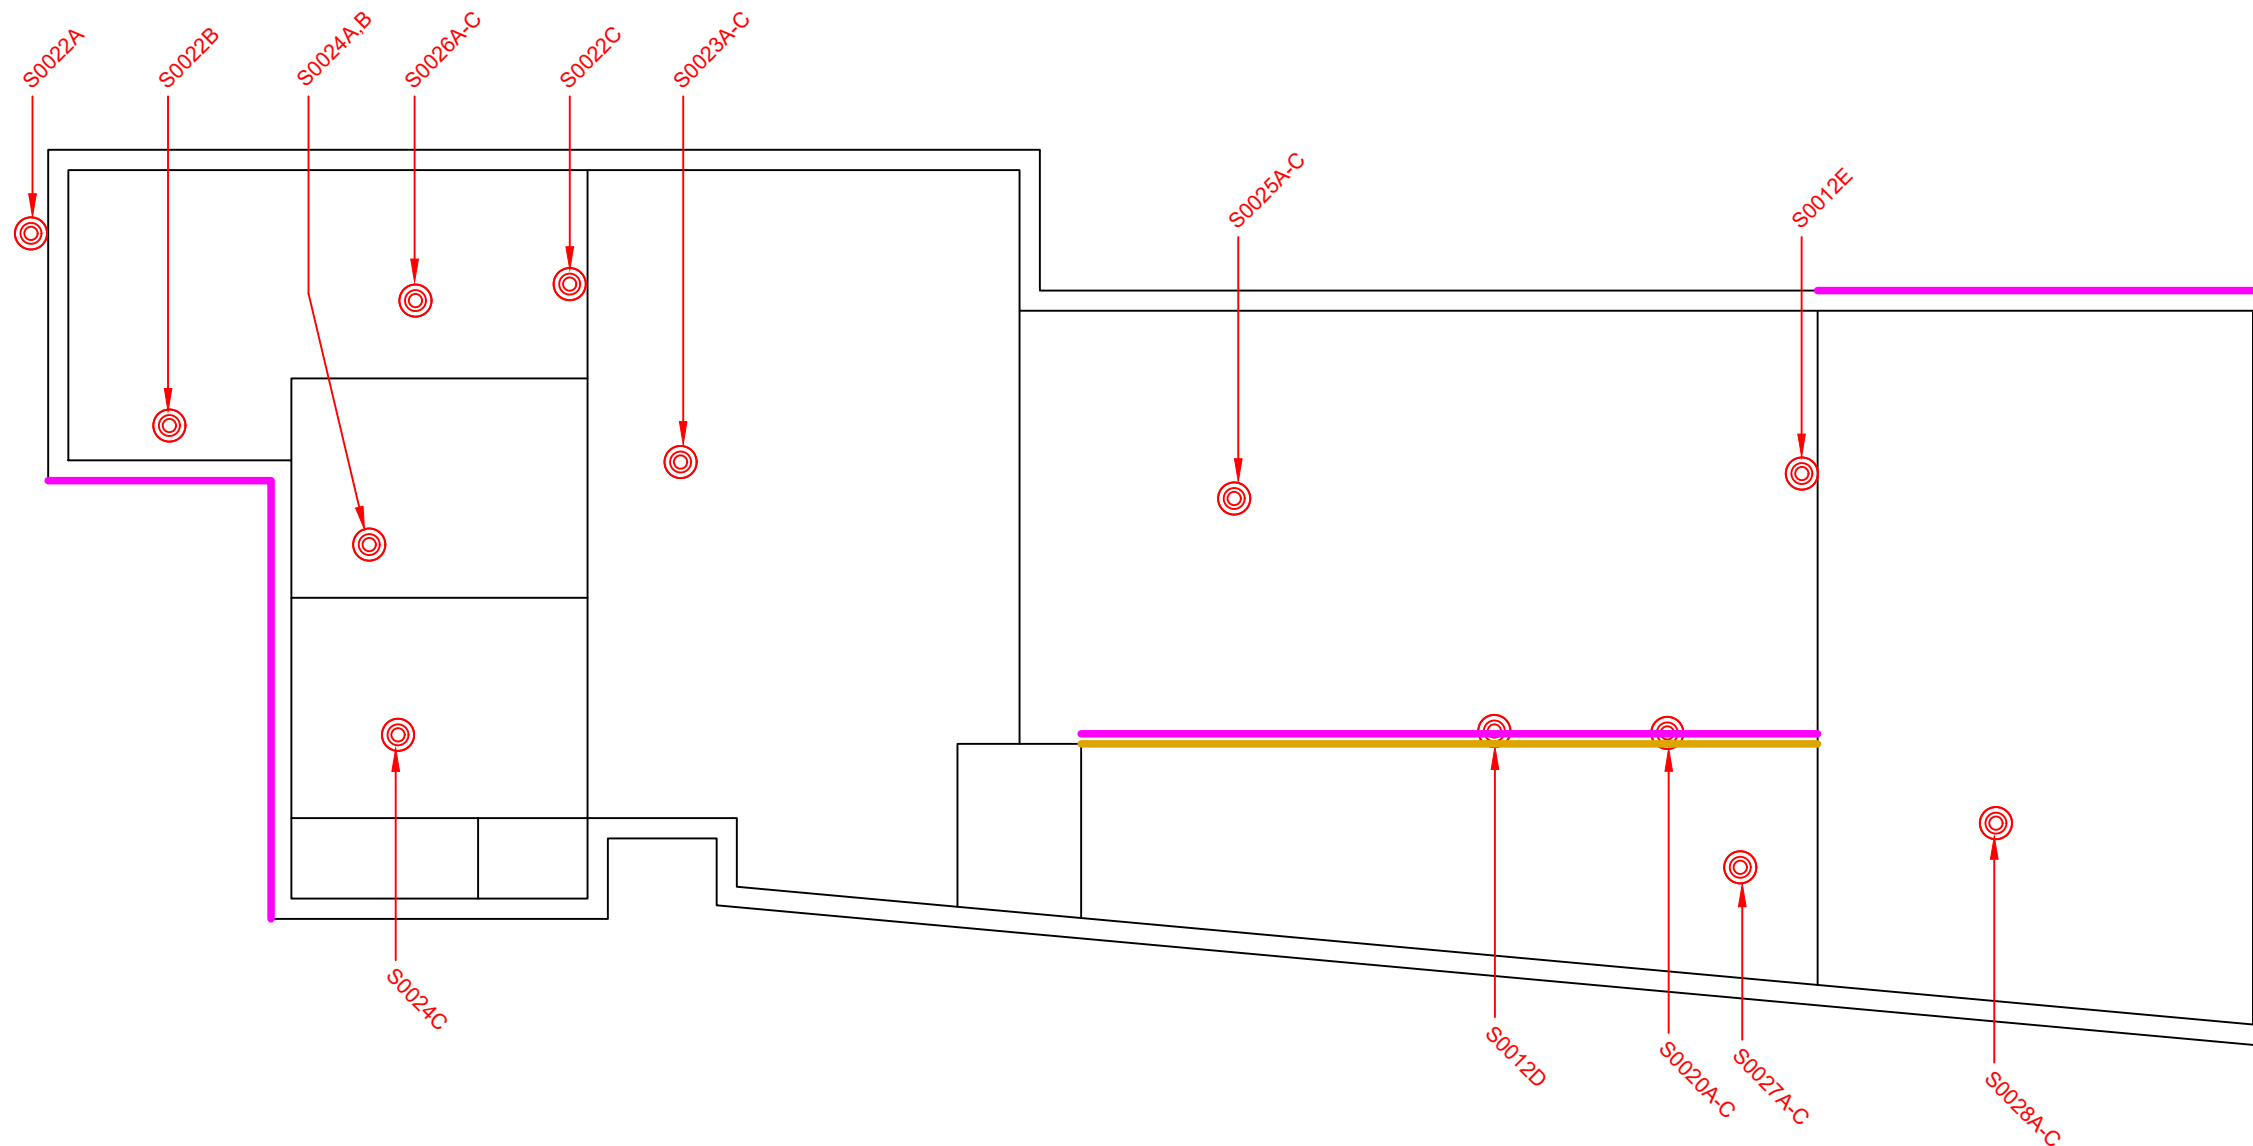
LEGEND IS COLOUR DEPENDENT. NON-COLOUR COPIES MAY ALTER INTERPRETATION.

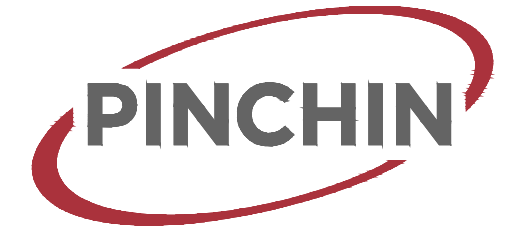
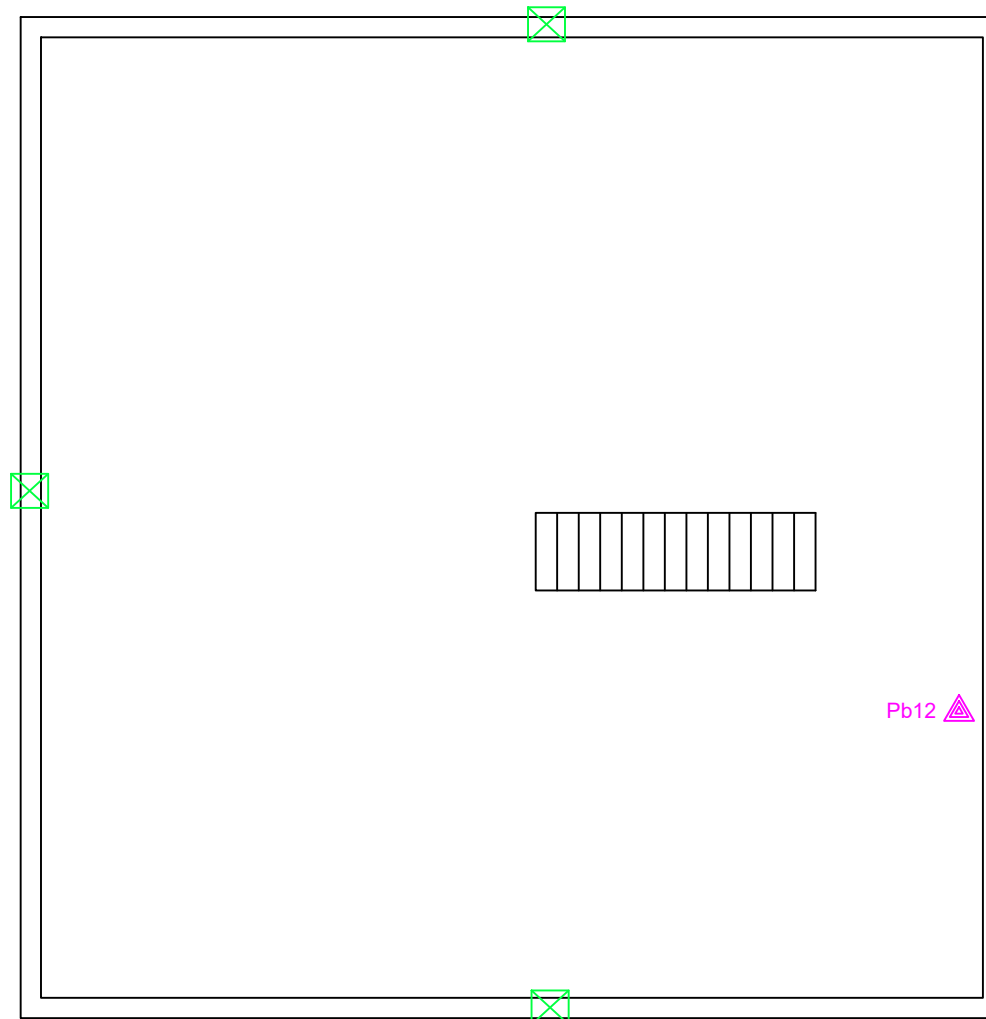
LEGEND IS COLOUR DEPENDENT. NON-COLOUR COPIES MAY ALTER INTERPRETATION.

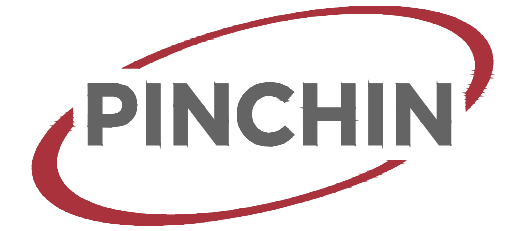
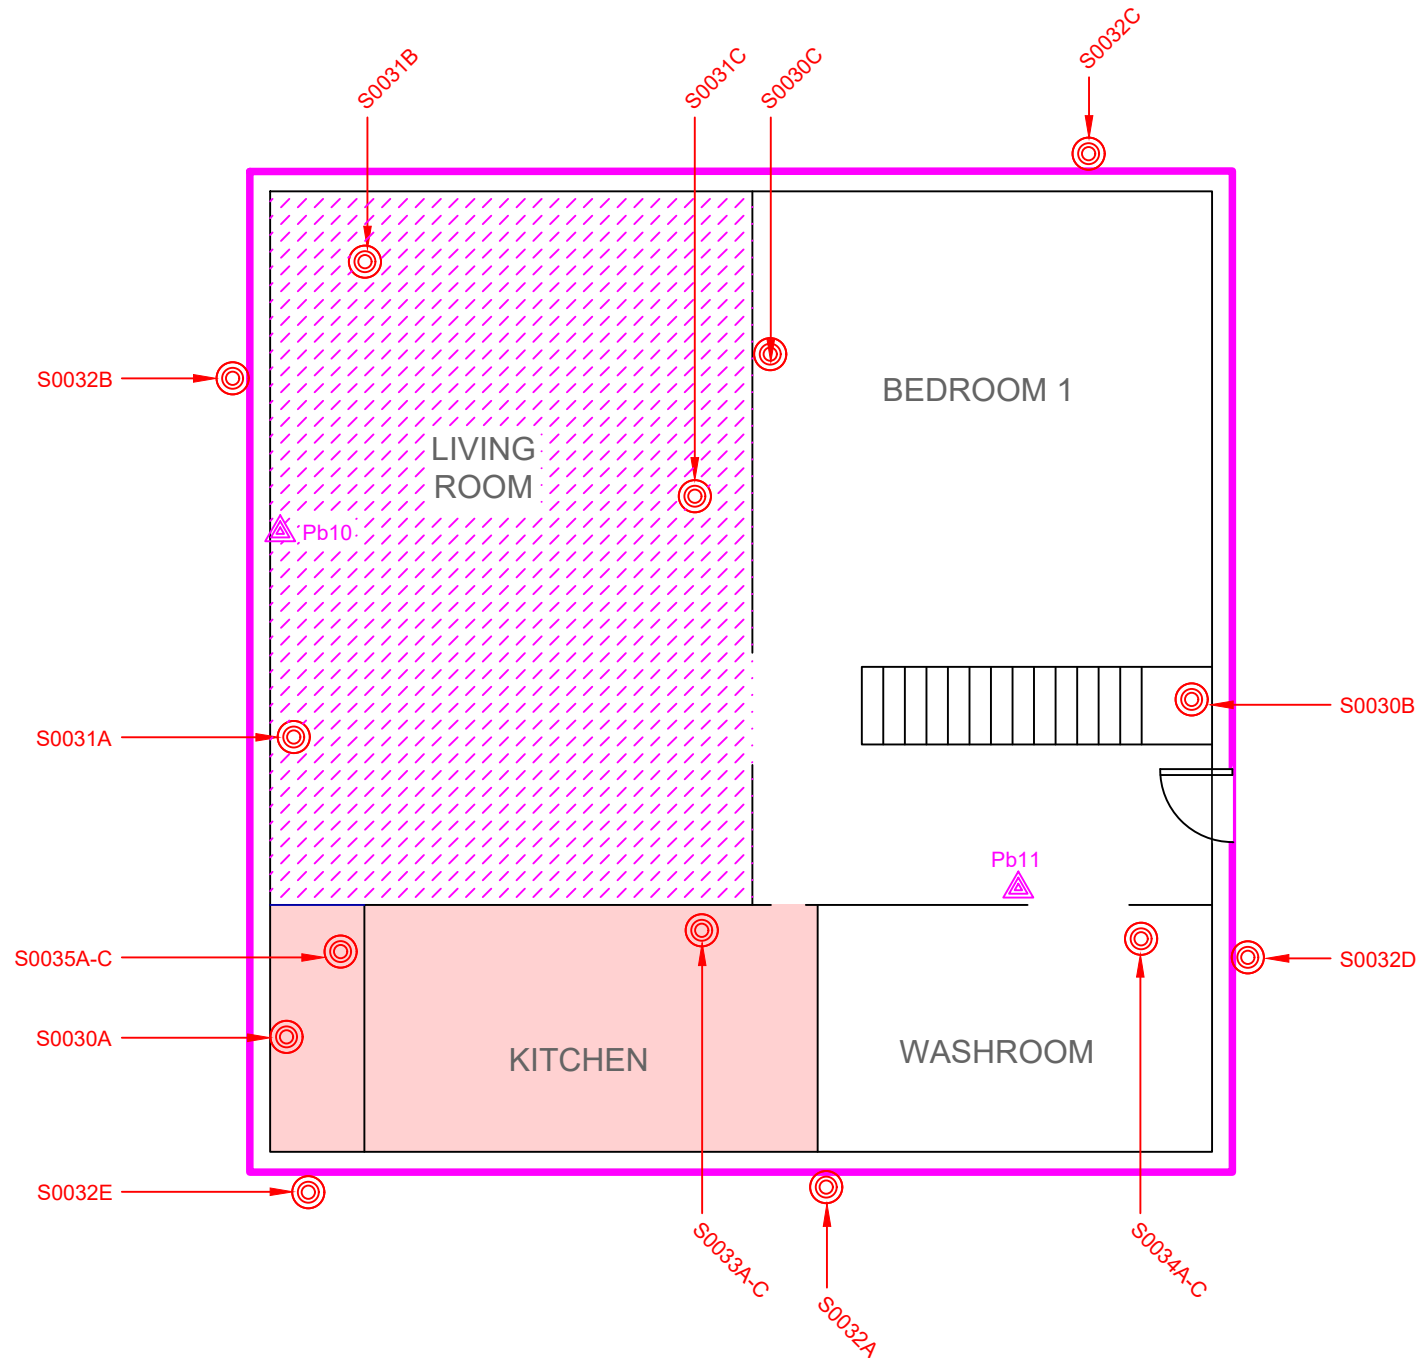
LEGEND IS COLOUR DEPENDENT. NON-COLOUR COPIES MAY ALTER INTERPRETATION.

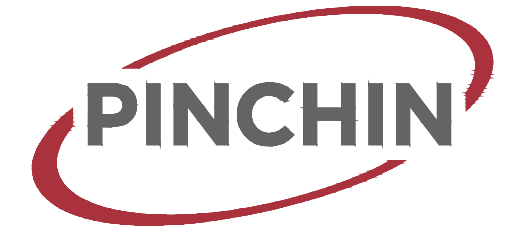
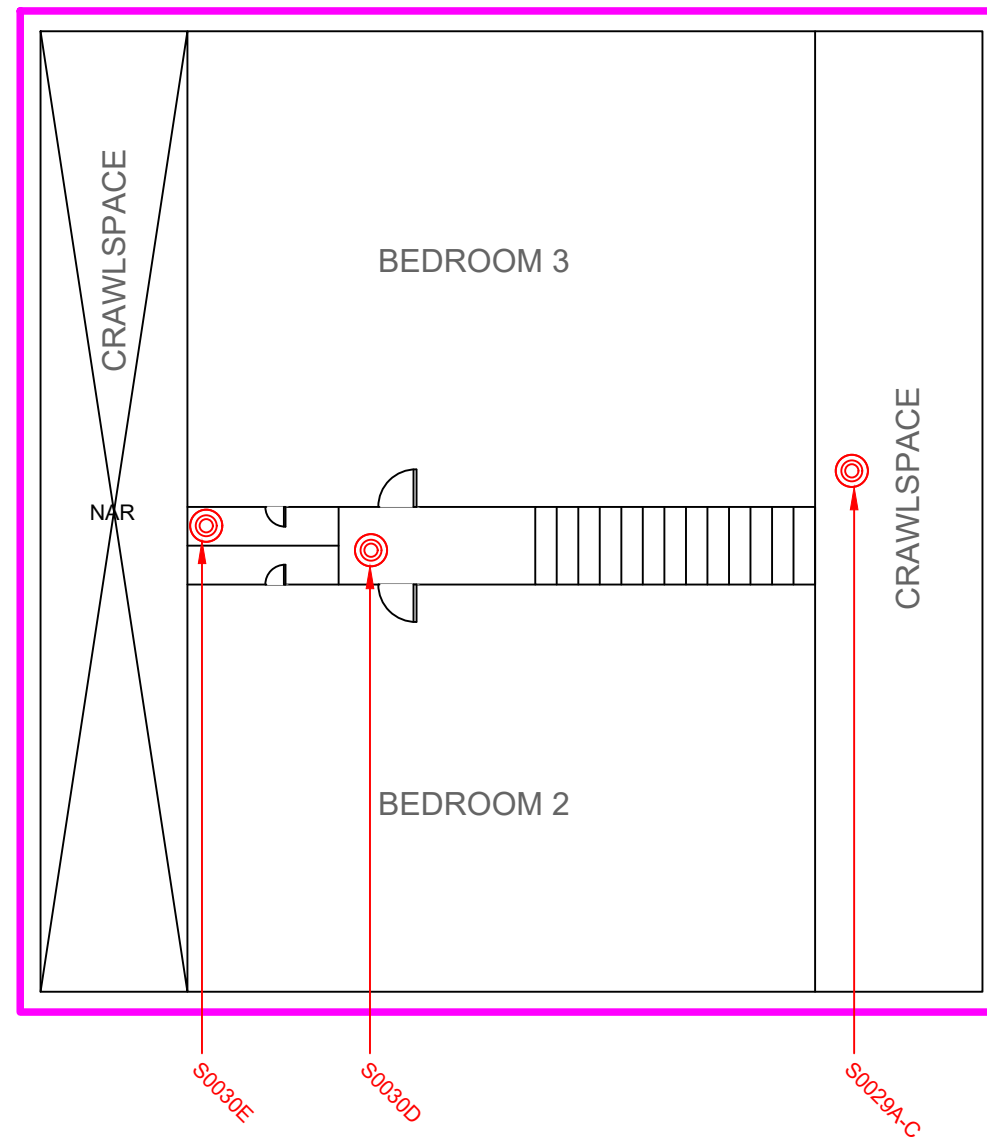
LEGEND IS COLOUR DEPENDENT. NON-COLOUR COPIES MAY ALTER INTERPRETATION.

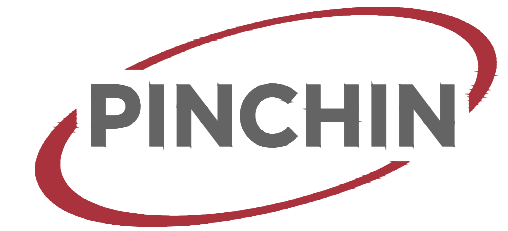
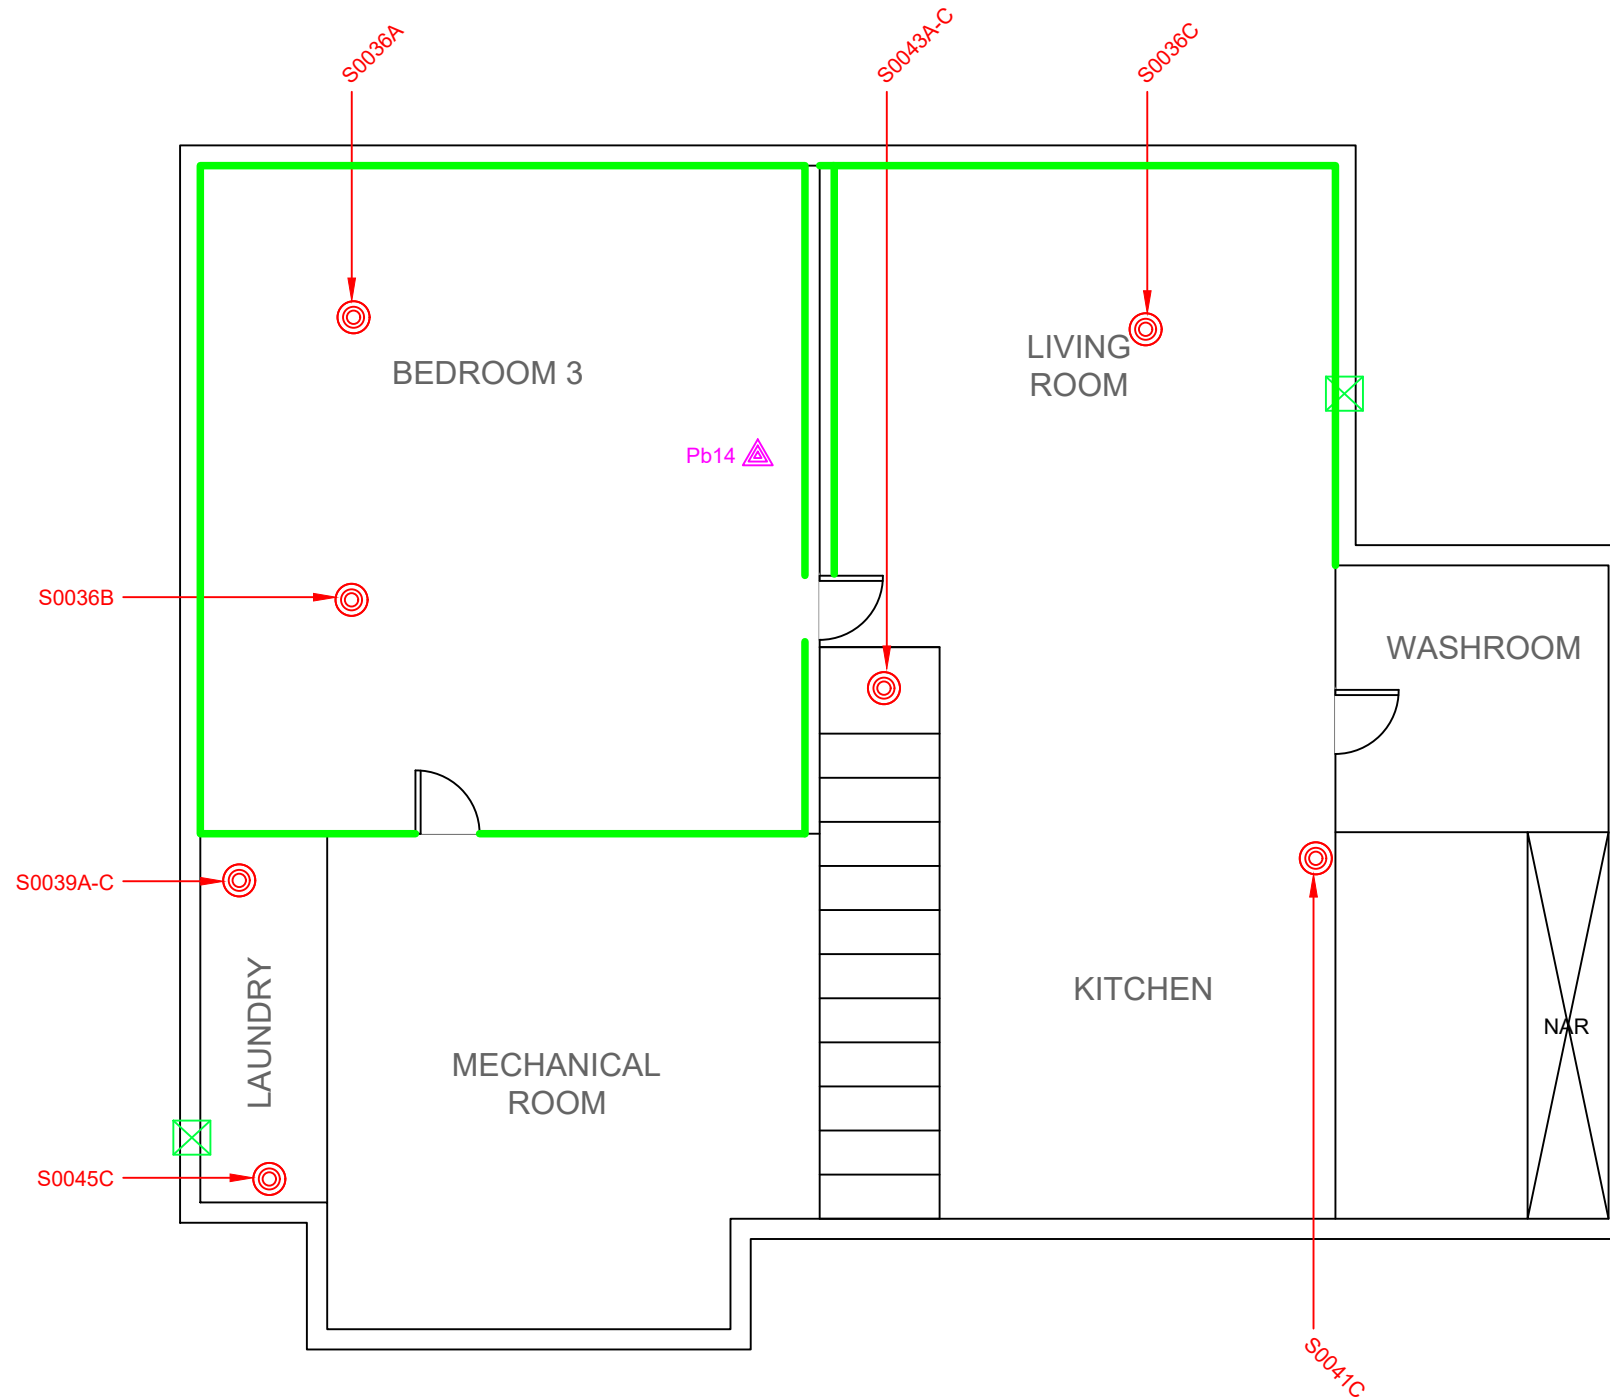
LEGEND IS COLOUR DEPENDENT. NON-COLOUR COPIES MAY ALTER INTERPRETATION.

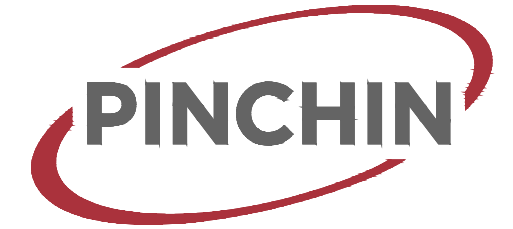
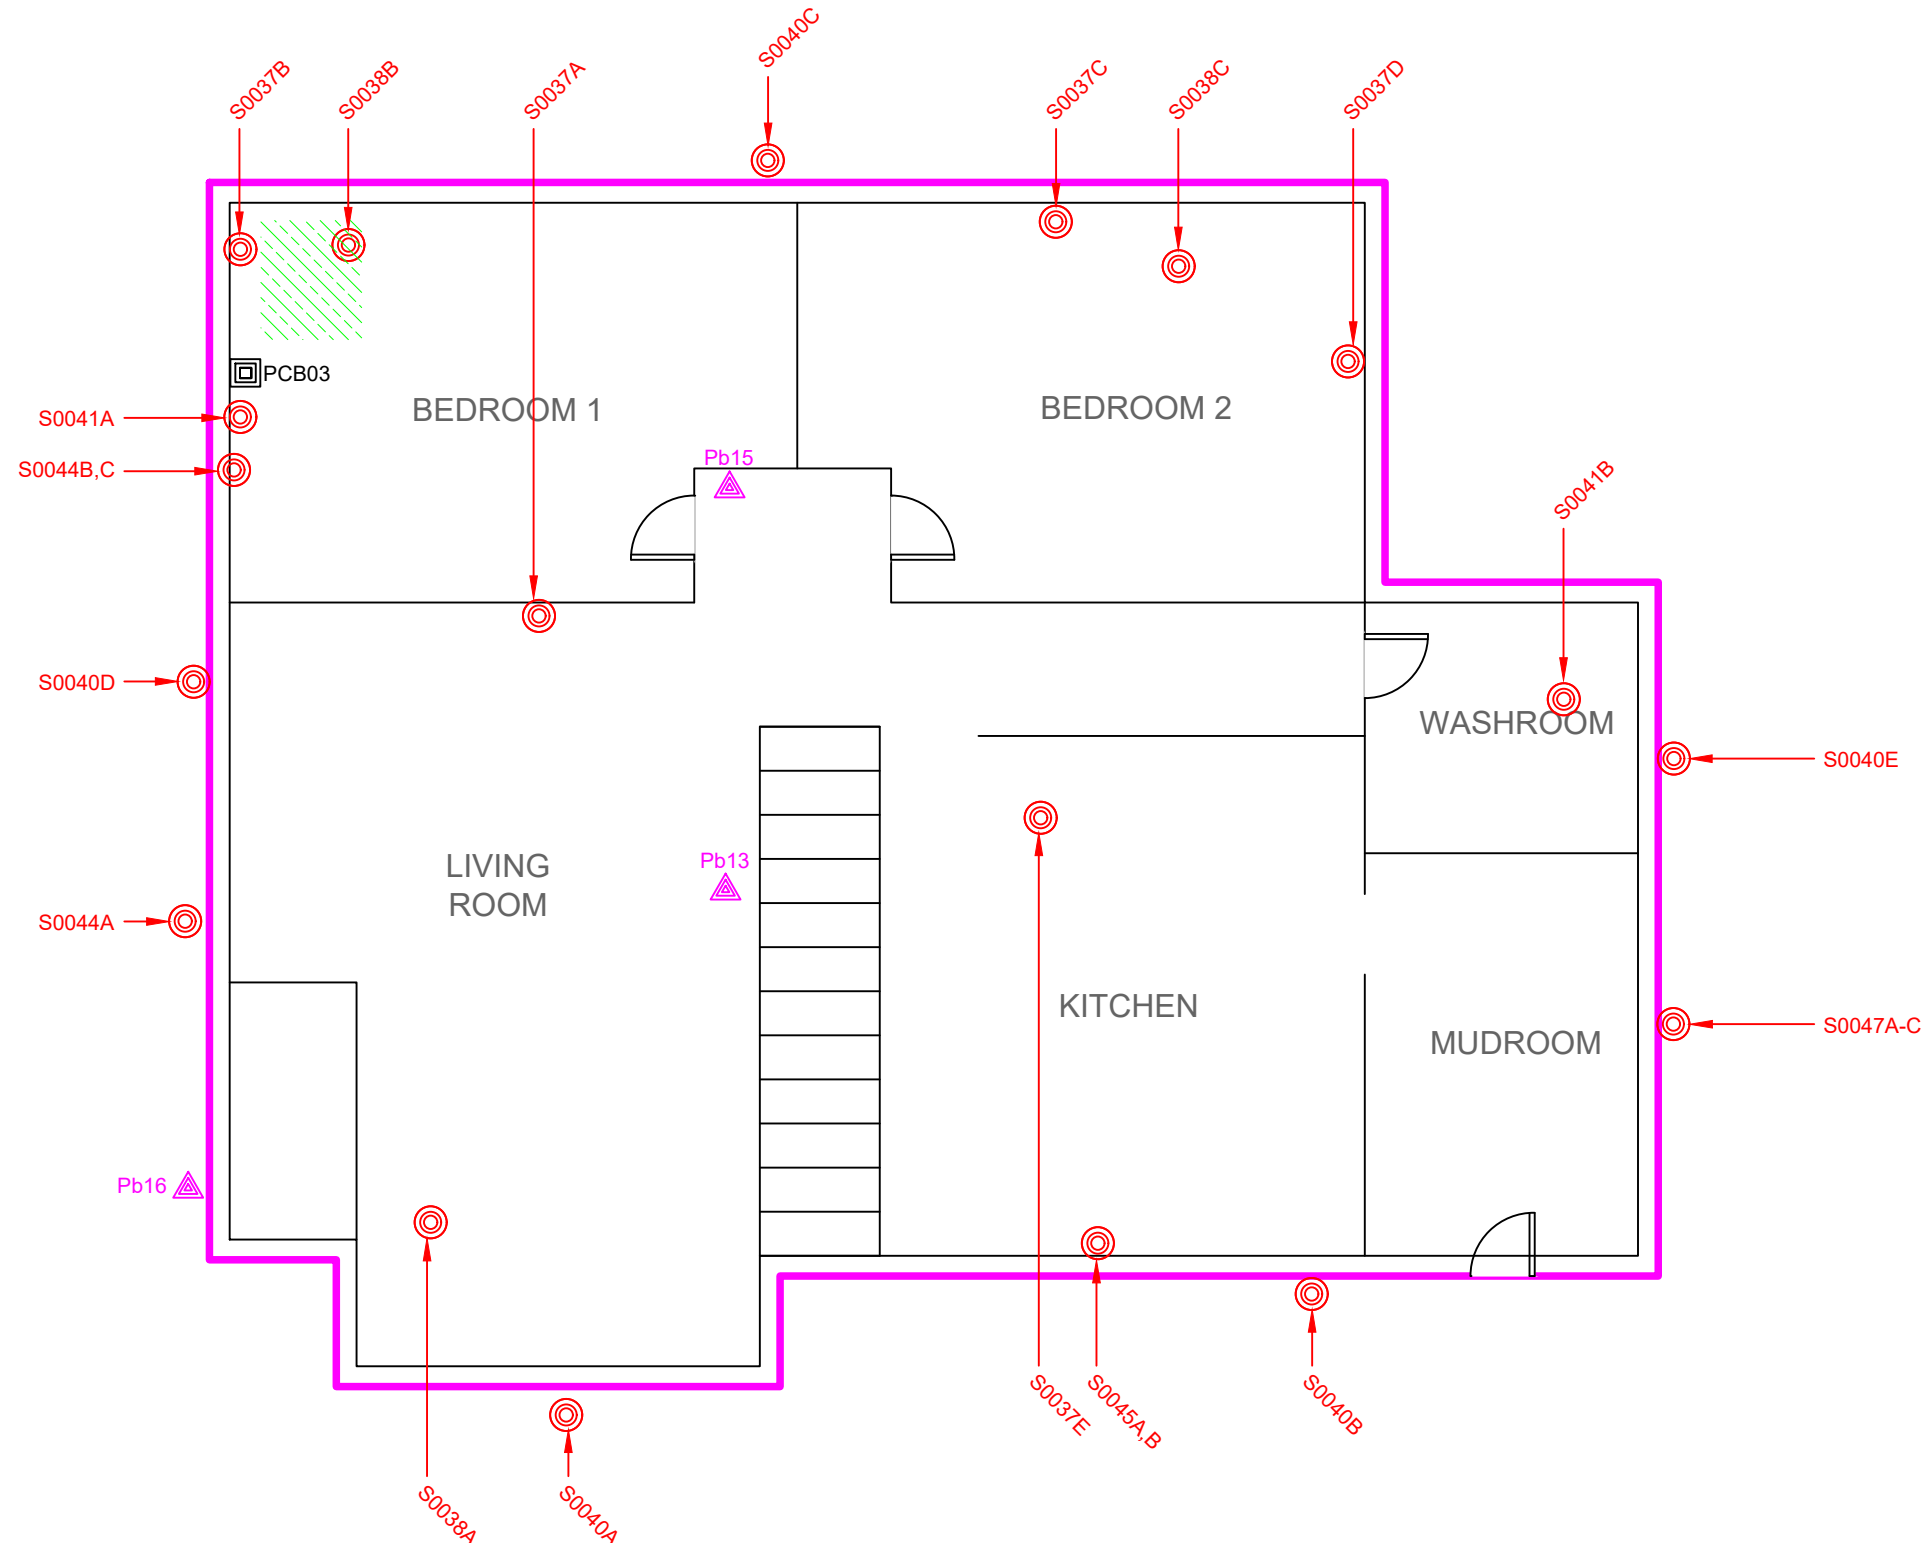
LEGEND IS COLOUR DEPENDENT. NON-COLOUR COPIES MAY ALTER INTERPRETATION.

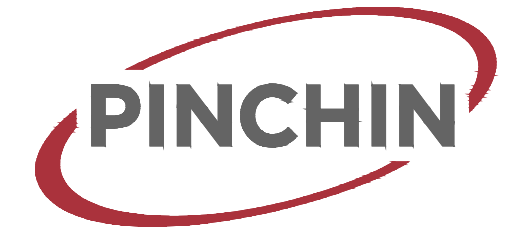
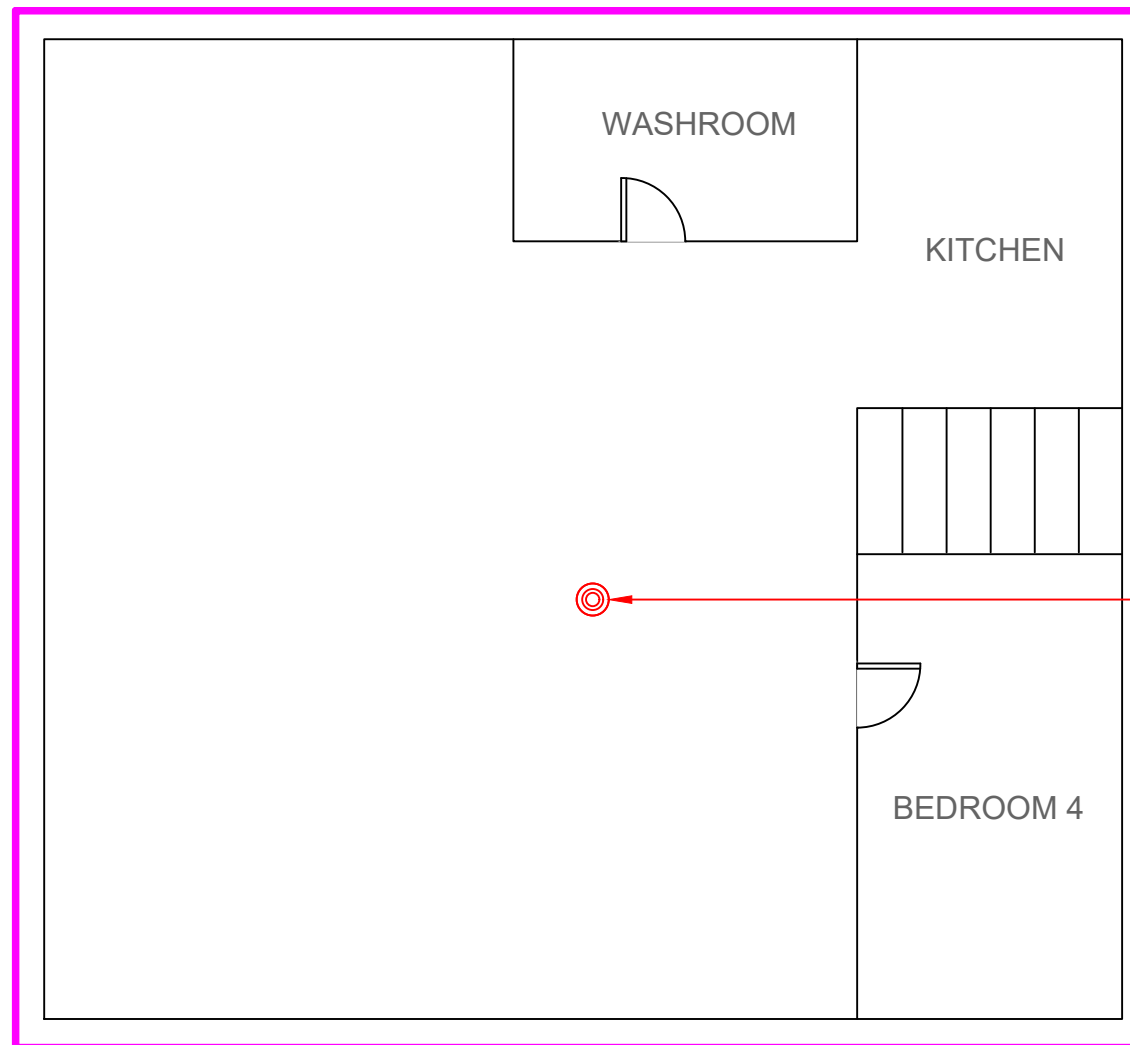
LEGEND IS COLOUR DEPENDENT. NON-COLOUR COPIES MAY ALTER INTERPRETATION.

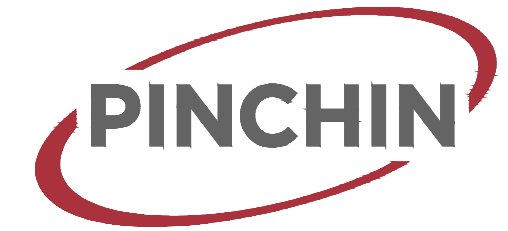
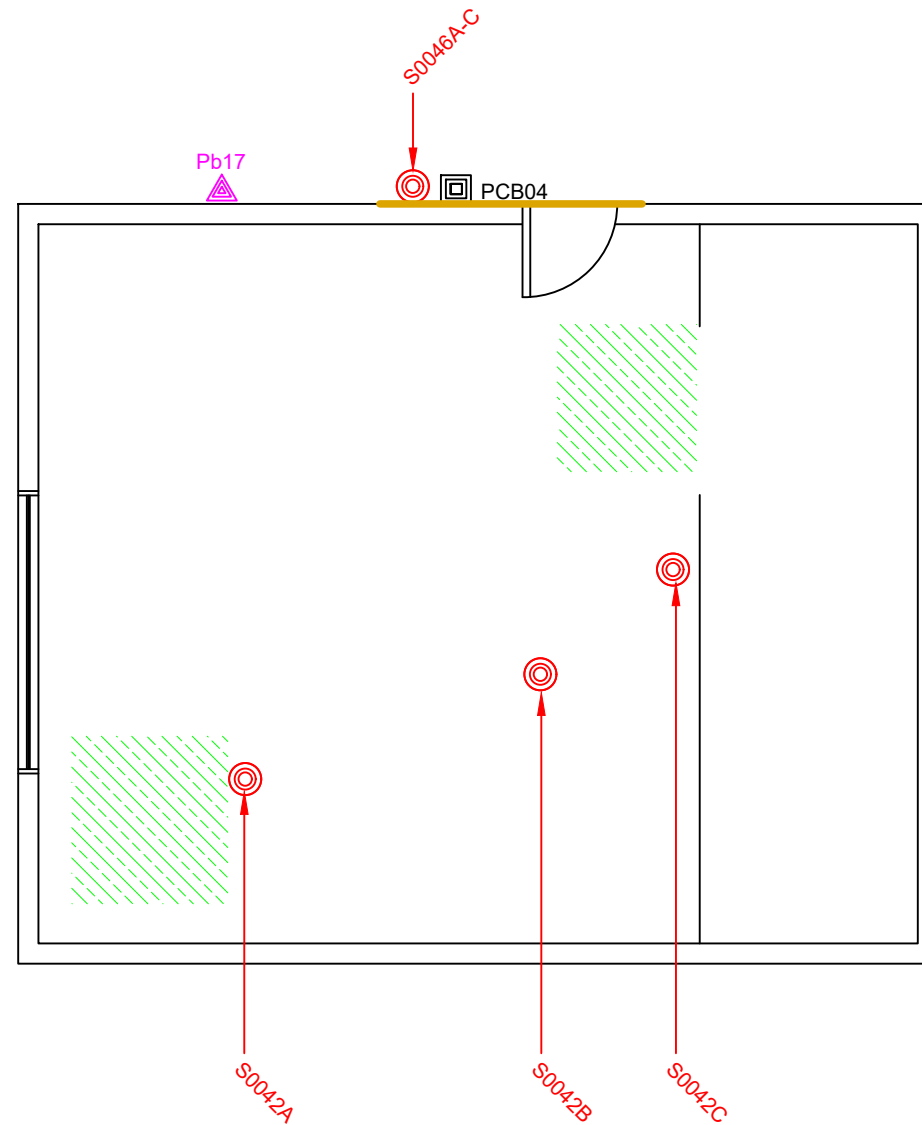
LEGEND IS COLOUR DEPENDENT. NON-COLOUR COPIES MAY ALTER INTERPRETATION.
