URBAN FORESTRY & FOREST MANAGEMENT CONSULTING

September 22, 2020

RE: TREE CONSERVATION REPORT FOR 320 MCRAE AVENUE, OTTAWA

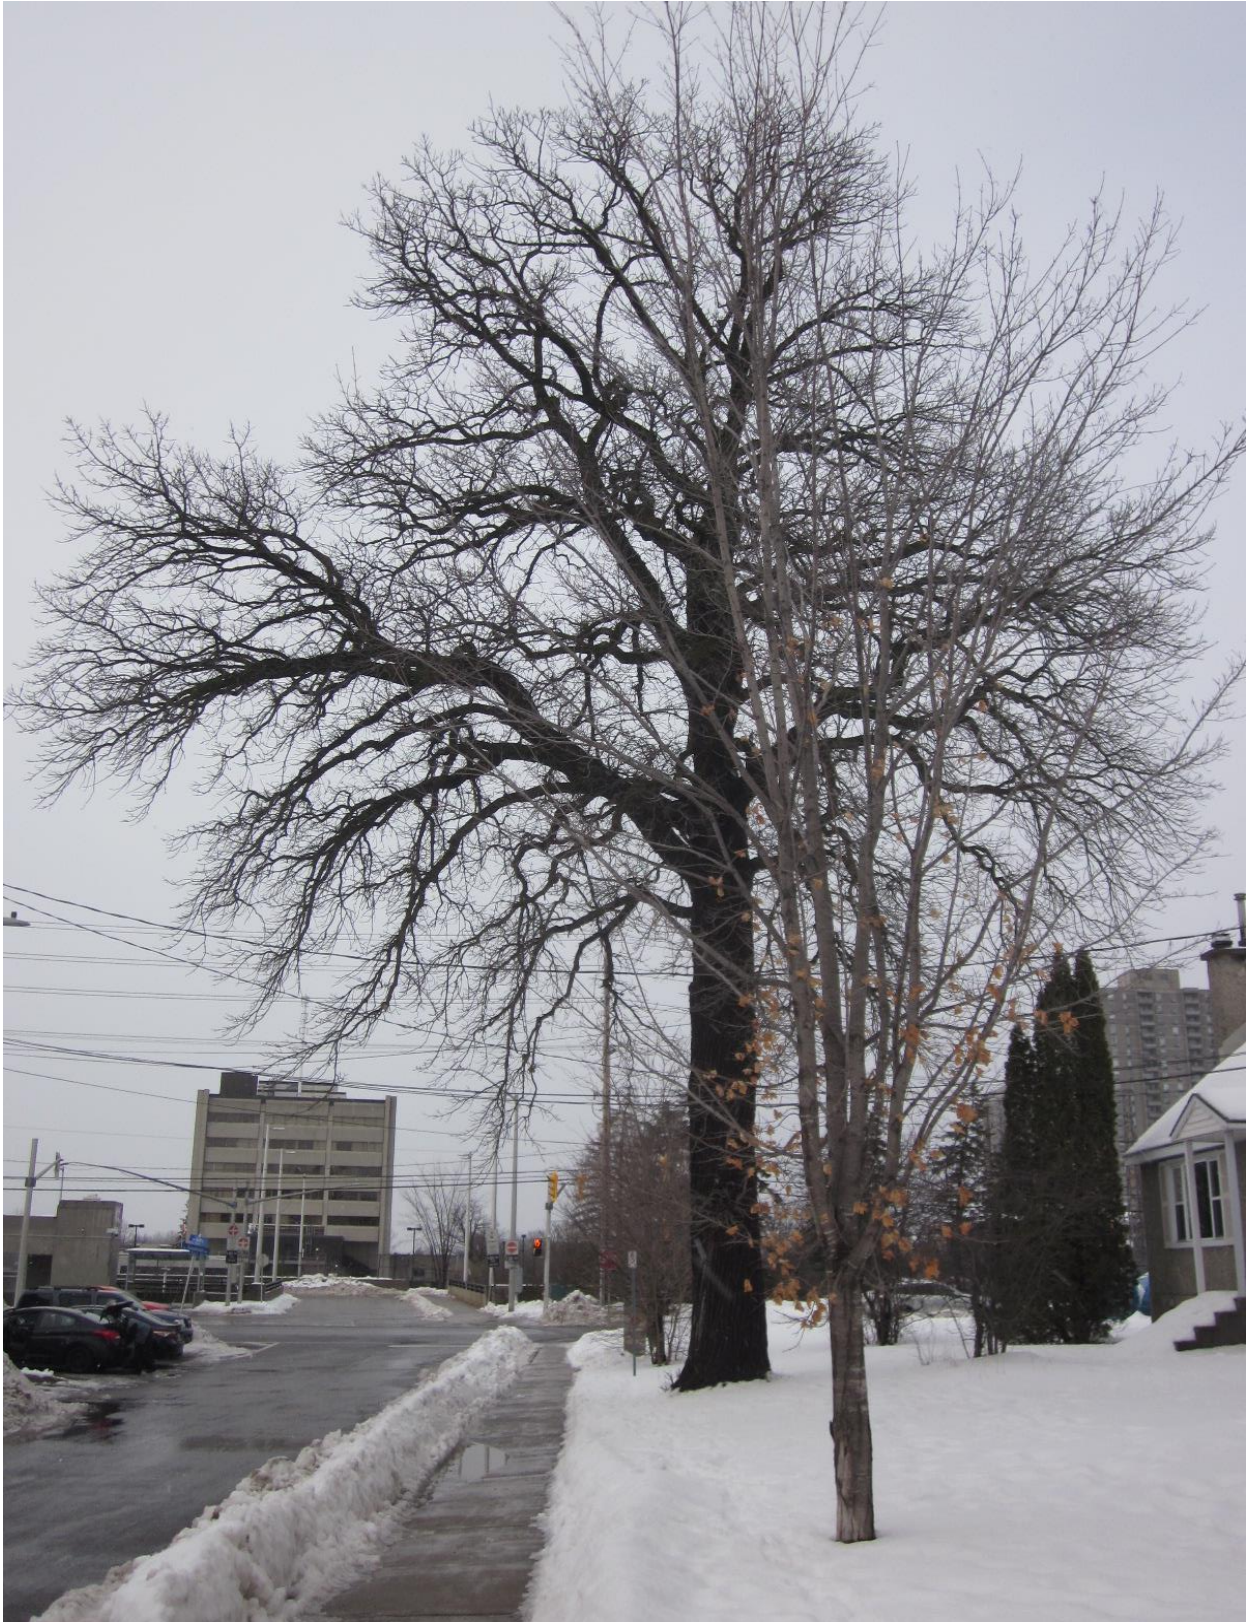
Picture 1. Sugar maple (tree #1 – in foreground) and bur oak (#2) adjacent to the development site.

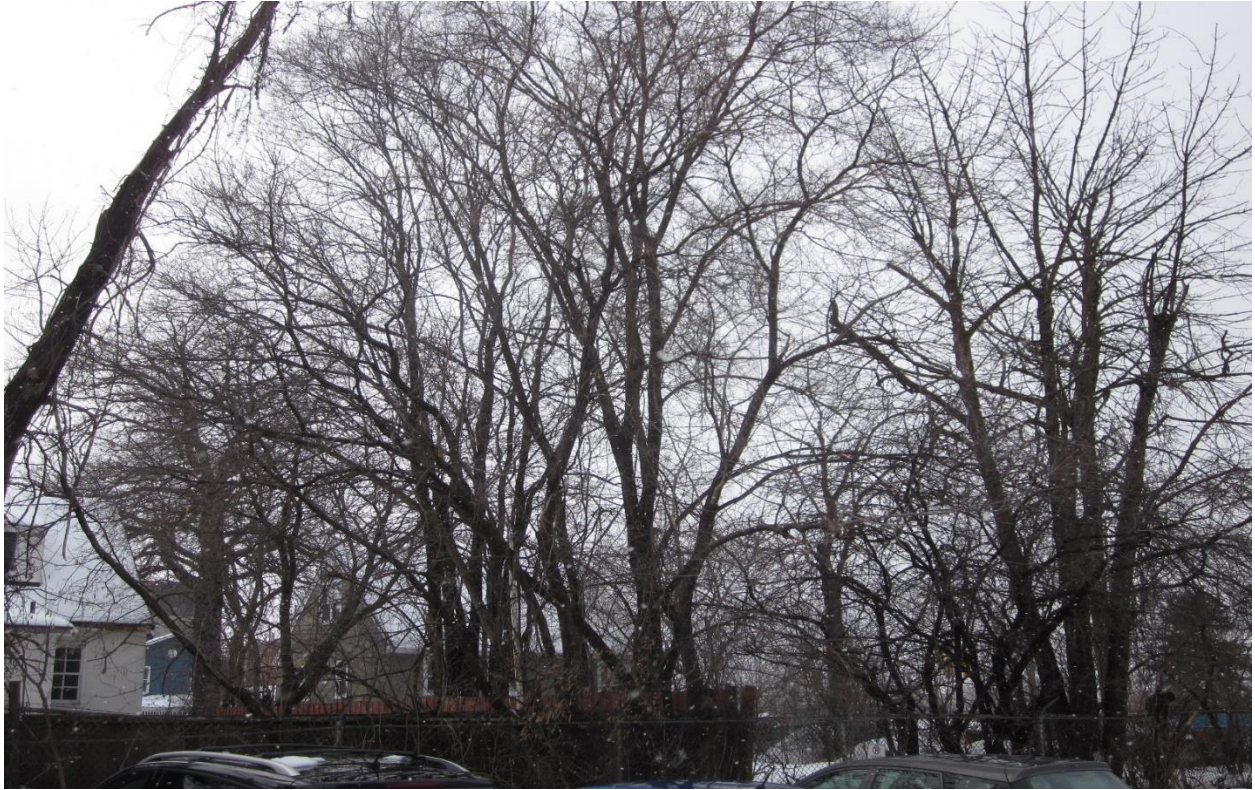
Picture 2. Trees #6 through 12 on the development site.

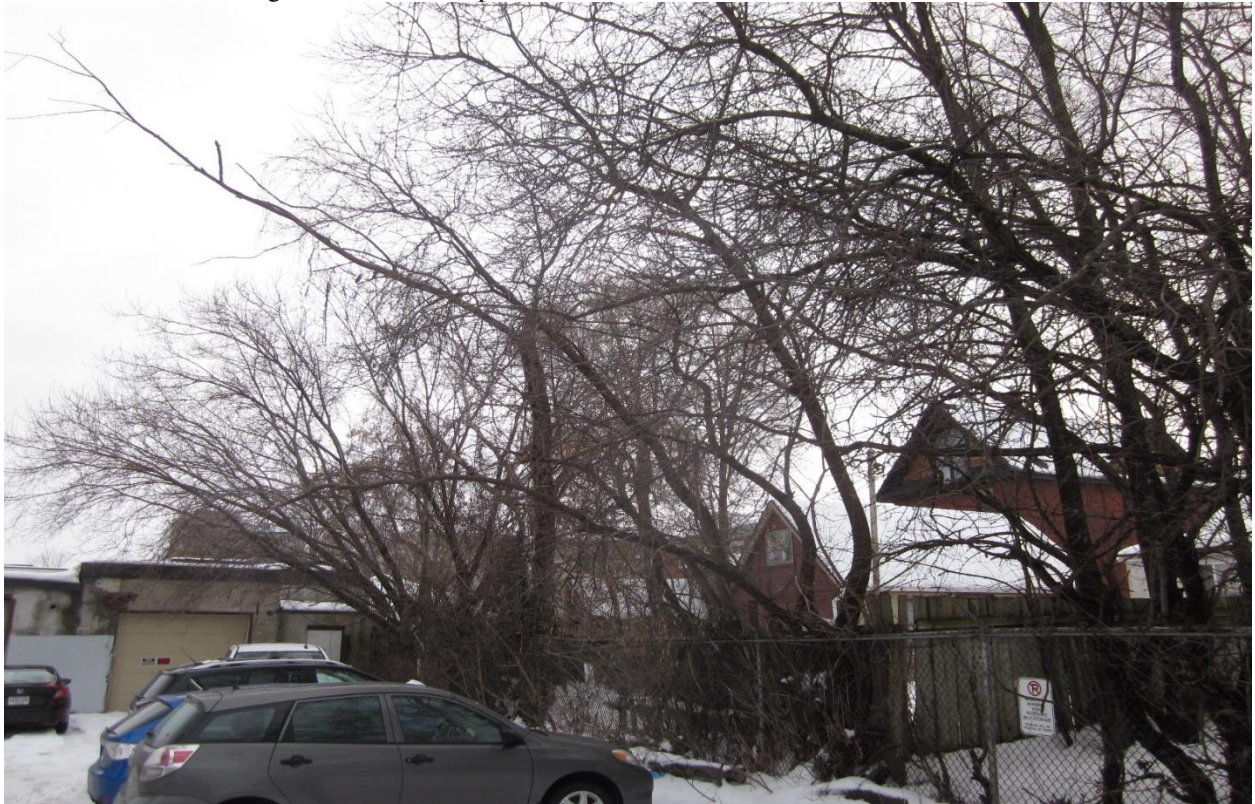
Picture 3. Trees #8 through 14 along property line of the development site (in distance stems of tree #14 far overhang property line).

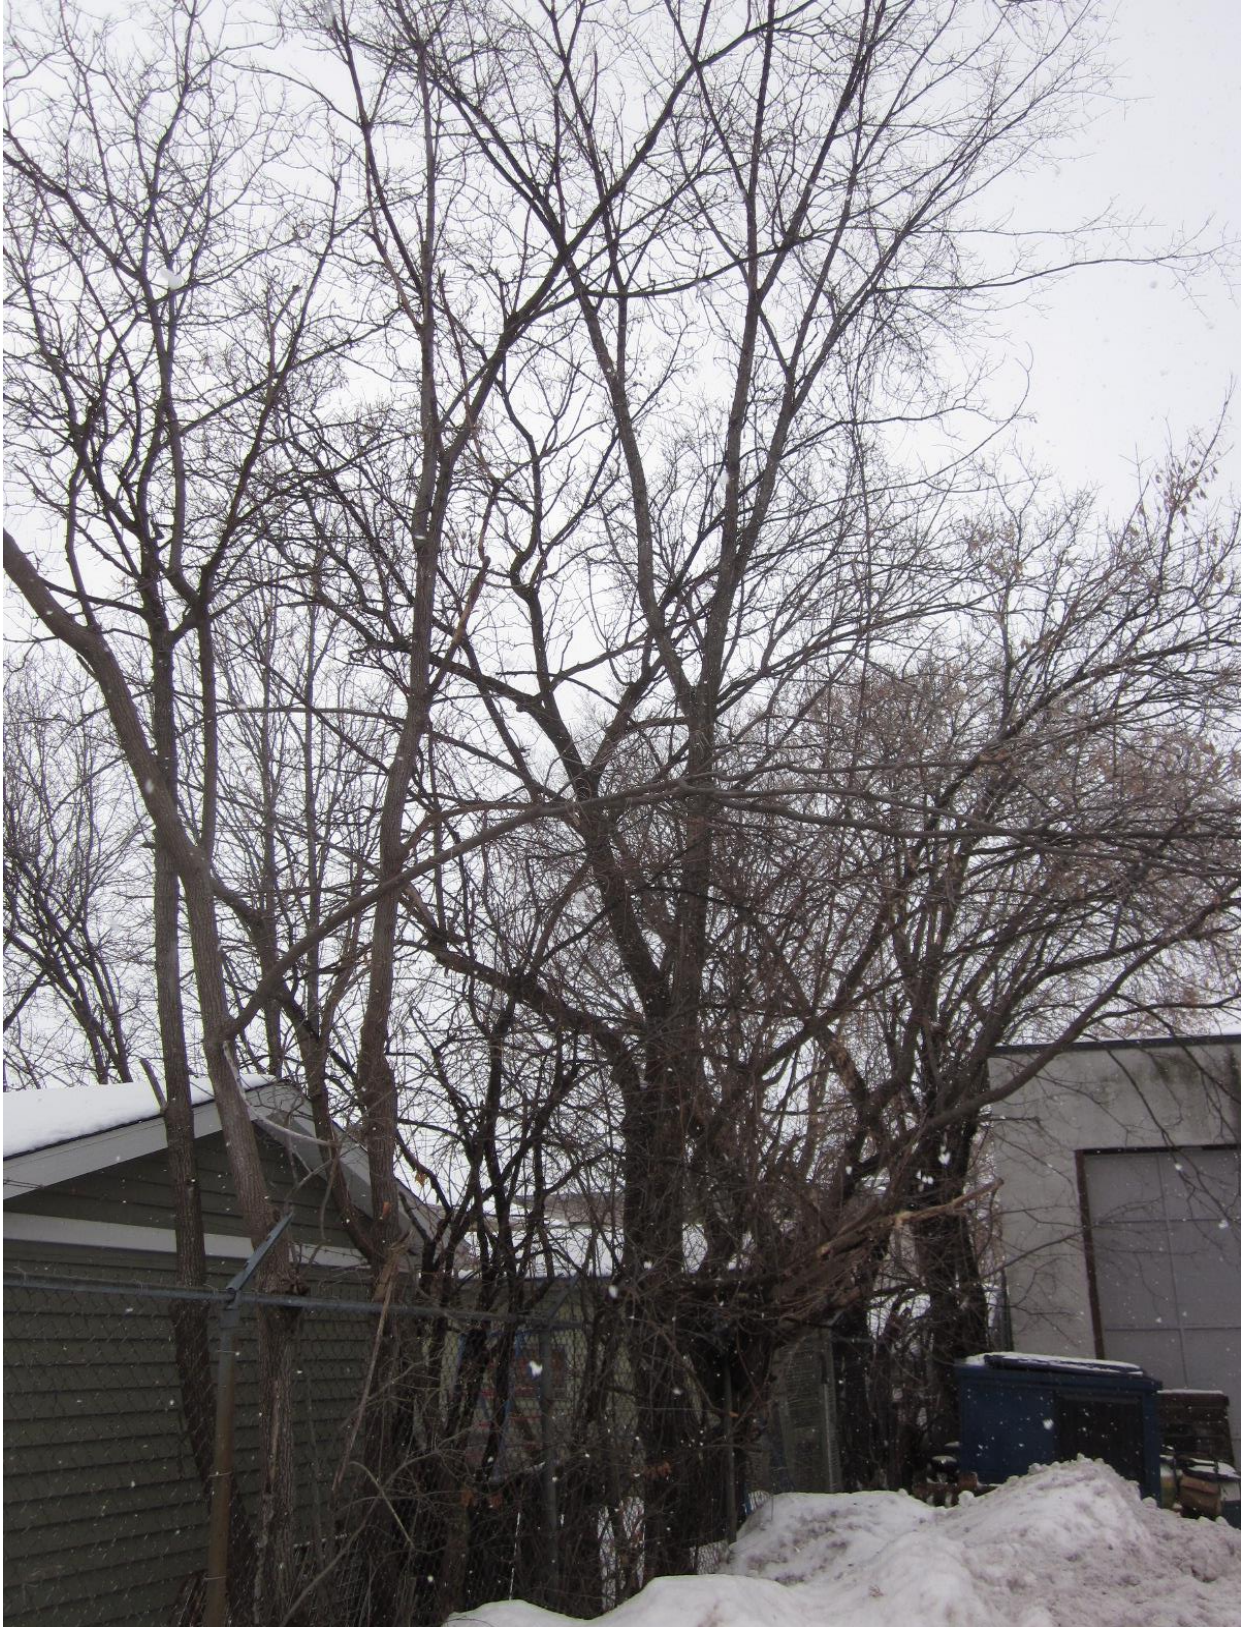
Picture 4. Tree grouping #16 on far side of property line of the development site (most trees overhang property line).

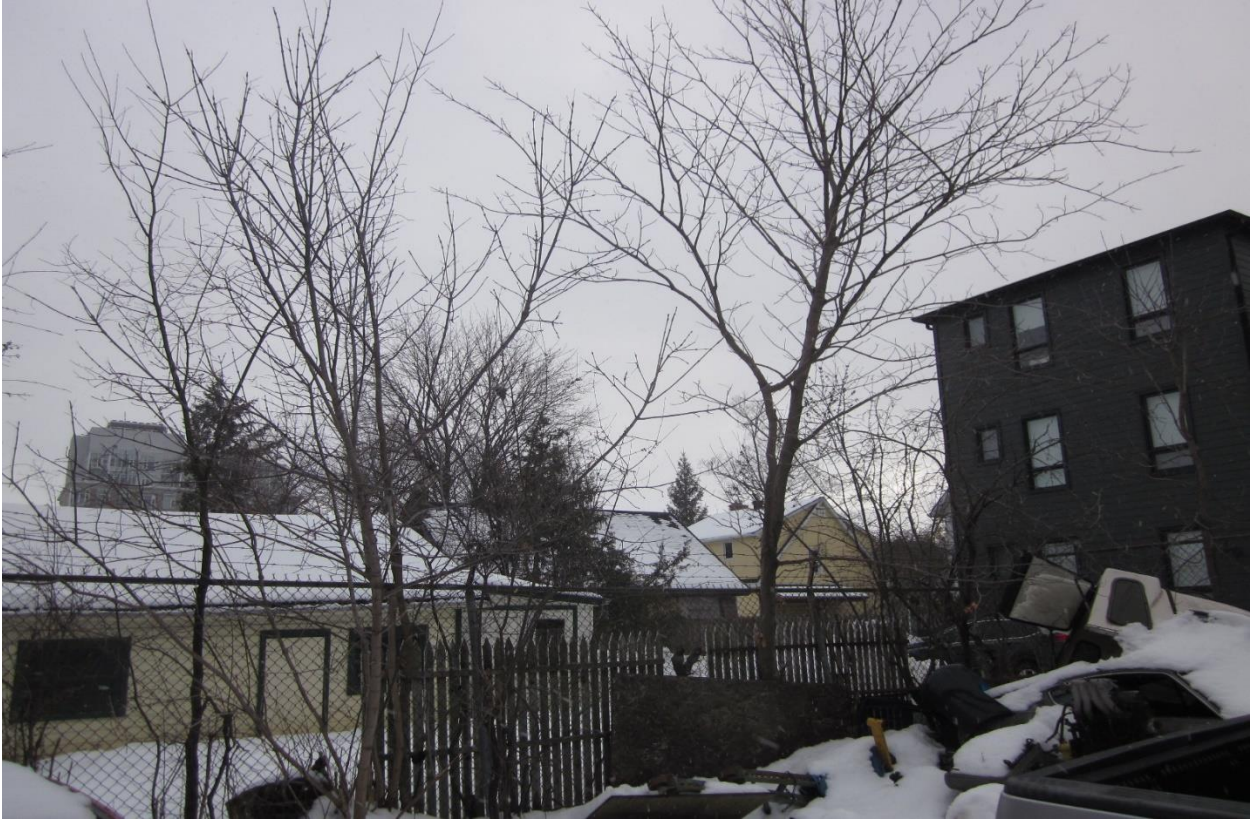
Picture 5. Trees #15, 16 and 17 on the development site.

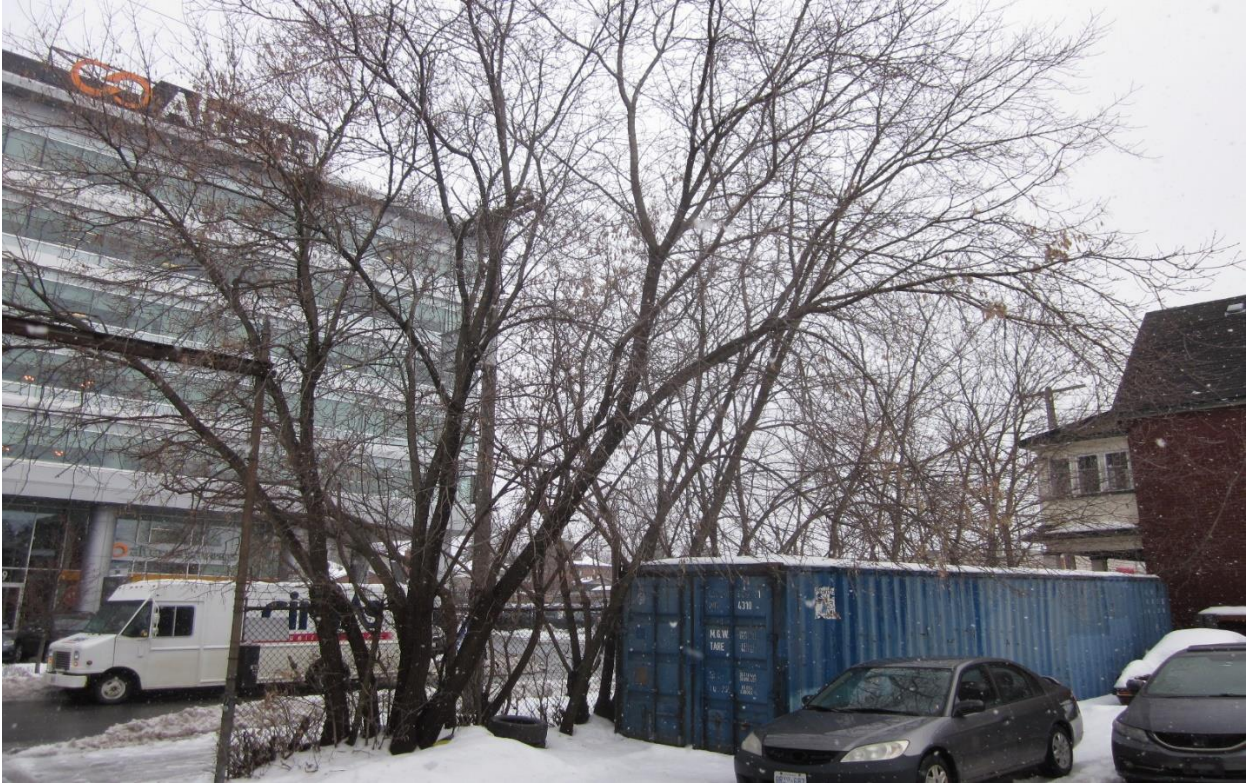
Picture 6. Tree grouping #19 on the development site
