Project:
CLV GROUP
327 RICHMOND ROAD

Drawing:
TREE CONSERVATION REPORT

Project Number: 1942-12 Sheet Number: TCR 01

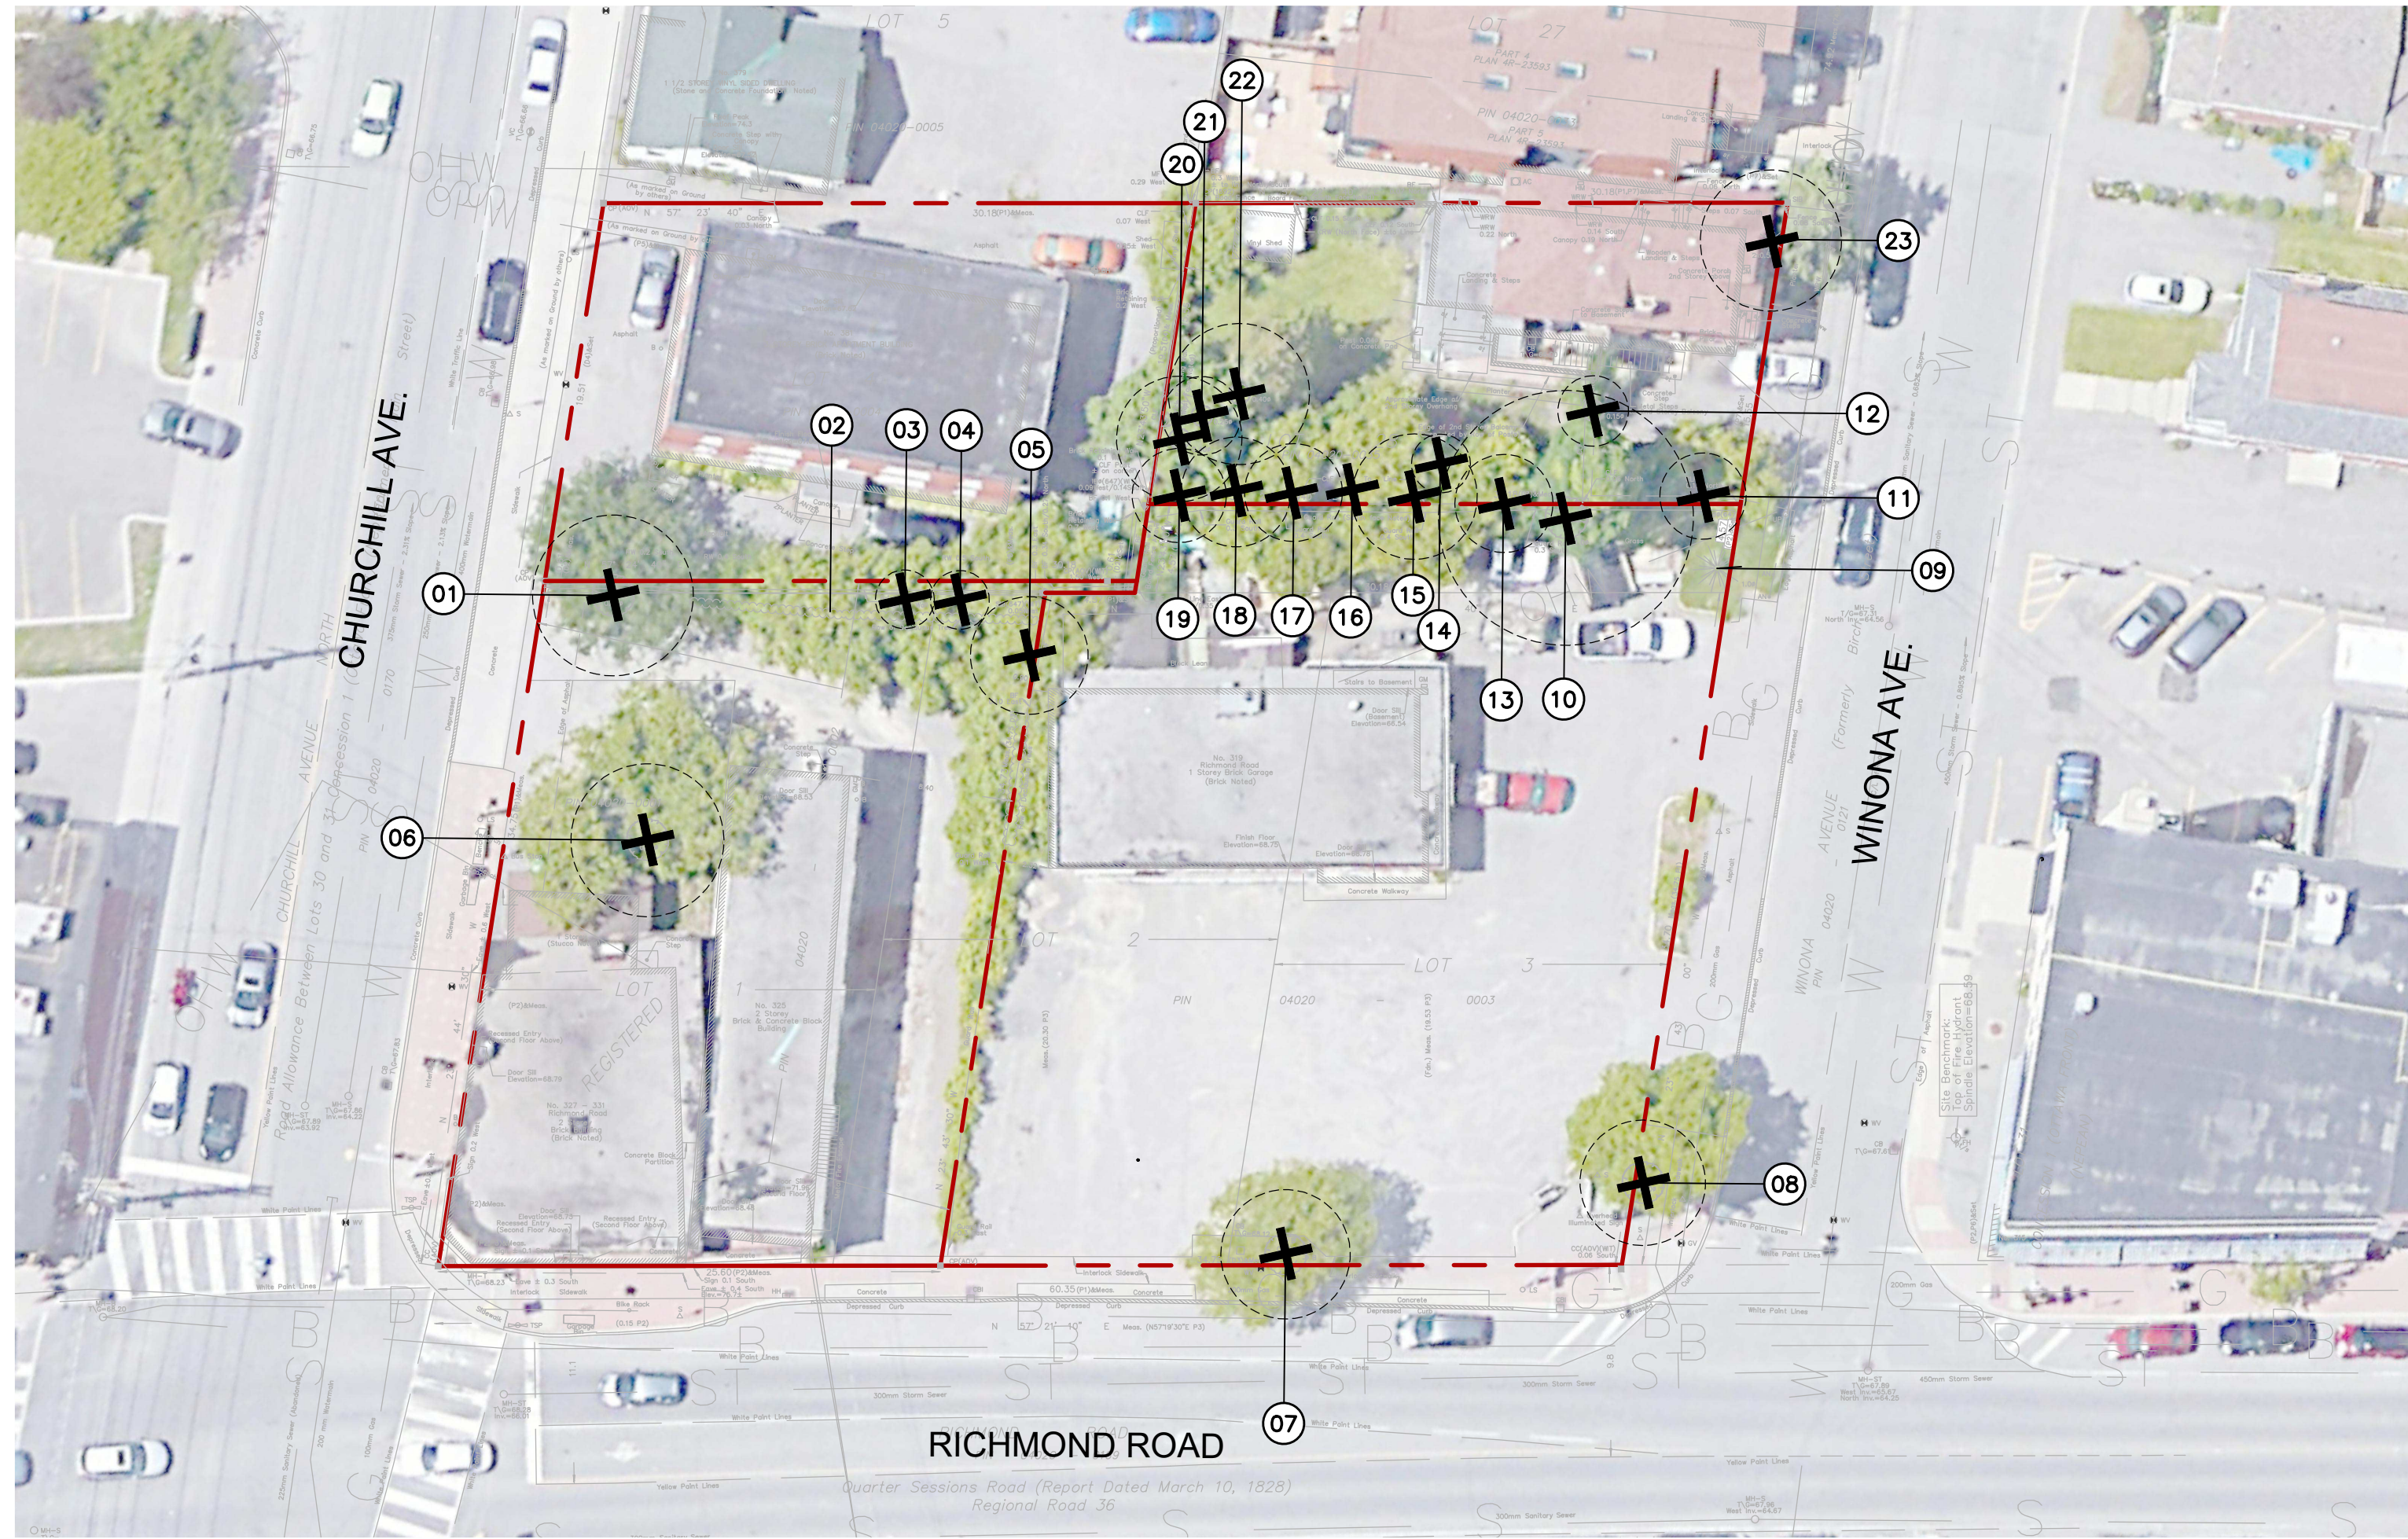
1 EXISTING SITE

Tree #	Botanical Name	Common Name	Caliper (cm)	Condition	High Quality Tree	Rare Tree	Comments	Disposition
1	Ulmus pumila	Siberian Elm	41	Good	No	No	Privately owned, Symmetrical canopy, Single stem, Co-dominant leaders: 2 @ ~3m above grade, Die back ~5% @ branches	Remove
2	Group: Acer negundo / Rhamnus carthartica	Group: Manitoba Maple / Common Buckthorn	<10	Moderate	No	No	Privately owned, Row of volunteer Manitoba Maple & Common Buckthorn along property line.	Remove
3	Acer negundo	Manitoba Maple	12 to 15	Poor	No	No	Privately owned, Asymmetrical canopy, Multi-stem, Pruned, Broken limbs, included bark, Asphalt paving over CRZ.	Remove
4	Acer negundo	Manitoba Maple	10 to 15	Moderate	No	No	Privately owned, Asymmetrical canopy, Multi-stem, Broken limbs.	Remove
5	Acer negundo	Manitoba Maple	30	Poor	No	No	Privately owned, Asymmetrical canopy, Single stem, Pruned leader, Broken limbs, Heart rot & Bark rot @ trunk.	Remove

6	Acer negundo	Manitoba Maple	25, 31, 39	Moderate	No	No	Privately owned, Asymmetrical canopy, Single stem, Co-dominant leaders: 3 @ ~1m above grade, leaning, bark damage @ leader.	Remove
7	Gleditsia triacanthos	Honey Locust	33	Good	No	No	Privately owned, Symmetrical canopy, Single stem, Bark rot @ trunk.	Remove
8	Gleditsia triacanthos	Honey Locust	32	Moderate	No	No	City owned, Symmetrical canopy, Single stem, Co-dominant leaders: 3 @ ~2.5m above grade, Tree guard grown into trunk.	Remove
9				Missing				
10	Quercus robur 'Fastigiata'	Pyramidal English Oak	65	Good	Yes	No	Privately owned, Symmetrical canopy, Single stem, Bark rot @ trunk.	Remove
11	Acer negundo	Manitoba Maple	22	Poor	No	No	Privately owned, Asymmetrical canopy, Single stem, Leaning, Broken limbs, Bark damage.	Remove
12	Ulmus pumila	Siberian Elm	18	Moderate	No	No	Privately owned, Symmetrical canopy, Single stem.	Remove
13	Acer negundo	Manitoba Maple	24	Moderate	No	No	Privately owned, Asymmetrical canopy, Single stem, Poor branch angle.	Remove

14	Picea glauca	White Spruce	15	Poor	No	No	Private property, Asymmetrical canopy, Single stem, 70% die-back @ canopy.	Remove
15	Acer negundo	Manitoba Maple	32	Moderate	No	No	Private property, Asymmetrical canopy, Single stem, Leaning	Remove
16				Dead				
17	Acer negundo	Manitoba Maple	25	Moderate	No	No	Privately owned, Asymmetrical canopy, Single stem, Grown into chain link fence	Remove
18	Acer negundo	Manitoba Maple	28	Moderate	No	No	Privately owned, Asymmetrical canopy, Single stem, Leaning, Grown into chain link fence.	Remove
19	Acer negundo	Manitoba Maple	24	Moderate	No	No	Privately owned, Asymmetrical canopy, Single stem.	Remove
20	Acer saccharum	Sugar Maple	36	Good	No	No	Private property, Asymmetrical canopy, Single stem, Co-dominant leaders: 2 @ 1.5m above grade, Broken limbs,	Remove
21	Picea glauca	White Spruce	20	Good	No	No	Privately owned, Symmetrical canopy, Single stem, Existing feature: lumber fastened to trunk.	Remove

22	Thuja occidentalis	Eastern White Cedar	36	Good	No	No	Privately owned, Symmetrical canopy, Single stem, Existing feature: lumber fastened to trunk.	Remove
23	Picea pungens	Colorado Spruce	32, 28	Moderate	No	No	Privately owned, Asymmetrical canopy, Single stem, Co-dominant leader: 2 @ 0.1m above grade, Pruned @ hydro.	Remove
