TCR
TREE
CONSERVATION
REPORT

2487 INNES
ROAD OTTAWA

MAY 4 2020
FOR SPC 1

RE: TREE CONSERVATION REPORT FOR 2487 INNES ROAD, OTTAWA

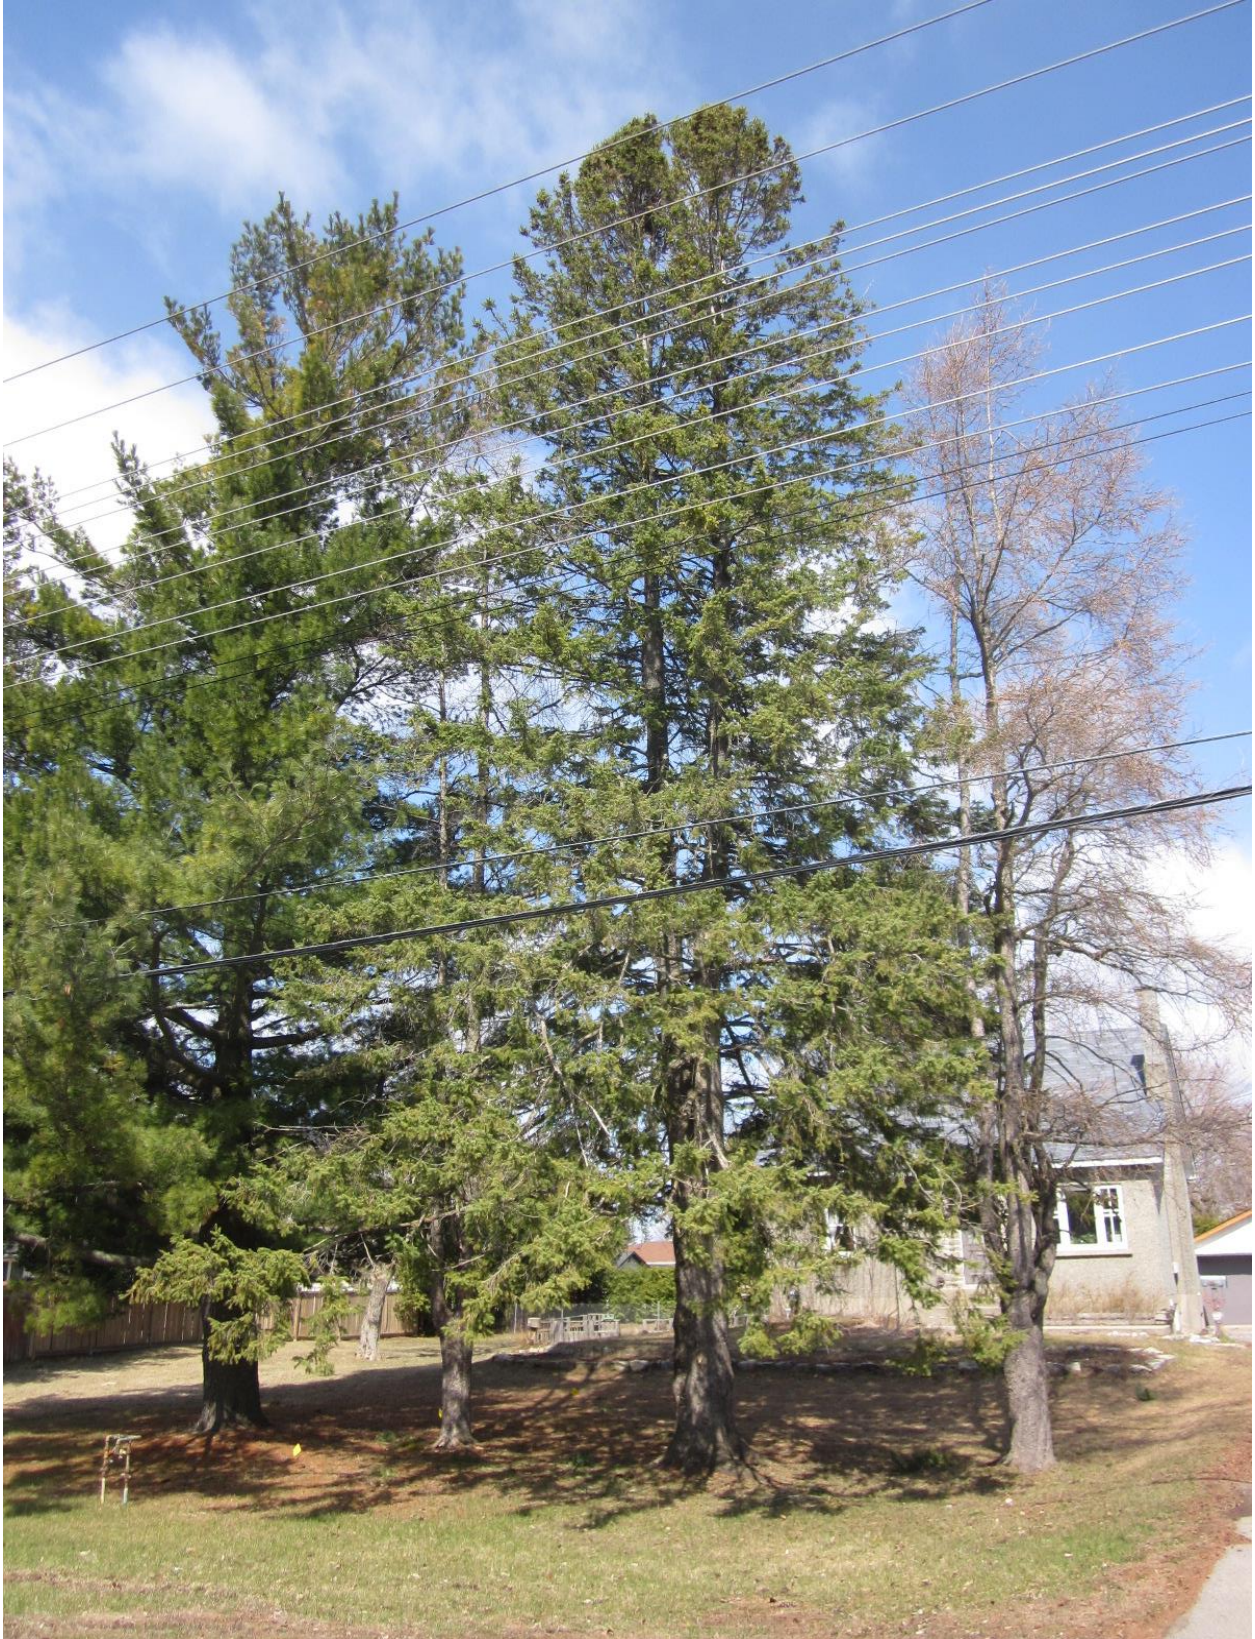
Tree No.	Tree species	Condition (VP→E)	DBH ¹ (cm)	Age class, tree condition notes & preservation status (to be removed or preserved and protected)
1	Eastern larch (<i>Larix laricina</i>)	Poor	44	Mature; tri-stemmed at 2.5m from grade; all three upright, southernmost stem dominant; open seam with exposed xylem in lower bole; native species; to be removed

2	White spruce (<i>Picea glauca</i>)	Fair	67	Mature; co-dominant stems at 3.-3.5m from grade; included bark within primary union; good crown density, annual increment and needle colour; native species; to be removed
3	Eastern larch	Very poor	37	Mature; double stemmed at 2m – northernmost stem dominant; very narrow crown, only apex alive; heavy woodpecker activity; tree is in advanced decline; native species; to be removed
4	White pine (<i>Pinus strobus</i>)	Good	95	Mature; single dominant stem for most of height; crown very asymmetric due to unequal competition for sunlight; native species; to be removed
5	White spruce	Fair	67	Mature; tri-dominant stems at 3-3.5m from grade; good crown density, annual increment and needle colour; native species; to be removed
6	Balsam fir (<i>Abies balsamea</i>)	Fair	+/-30	Mature; co-dominant leader lost in recent past – major stem wound; good crown density, annual increment and needle colour; located on adjacent private property; native species; to be preserved and protected

Picture 1. Trees #1-4 (right to left) located at 2487 Innes Road, Ottawa

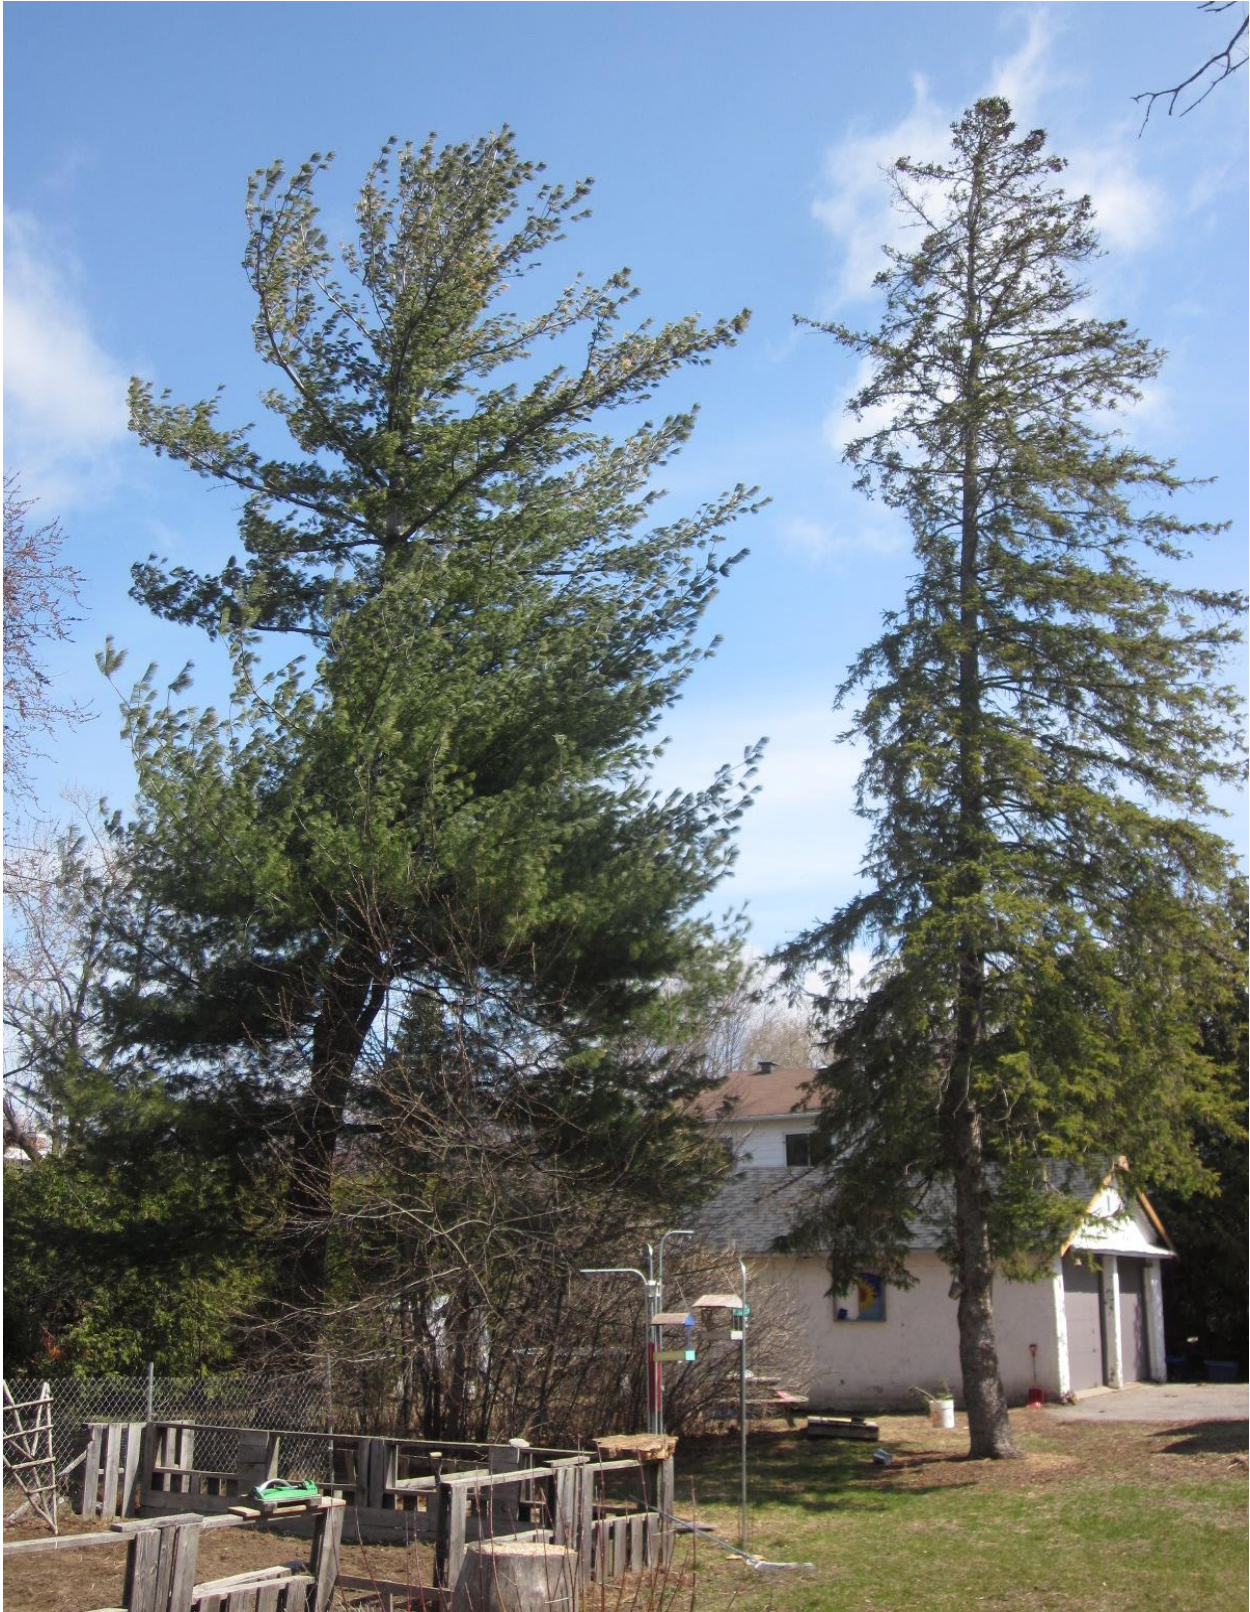
7	Manitoba maple (<i>Acer negundo</i>)	Very poor	52	Mature; extensive basal wounding and decay; majority of crown is dead; tree is in advanced decline and hazardous; naturalized species; to be removed
8	White spruce	Fair	36	Mature; upright, narrow crown form; poor crown density, fair annual increment and needle colour; tree is in early decline; native species; to be removed
9	White pine	Good	60	Mature; single dominant stem for most of height; lower laterals removed leaving major wounds; crook in main stem at 6m; fair crown density, annual increment and needle colour native species; to be removed
10	White cedar (<i>Thuja occidentalis</i>)	Good	+/-10	Mature; majority of length maintained in hedge form, certain portions allowed to grow into full-sized trees; straddles property lines – some stems likely fully on adjacent private property; native species; to be preserved and protected

Picture 2. Trees #8 (right) and 9 located at 2487 Innes Road, Ottawa

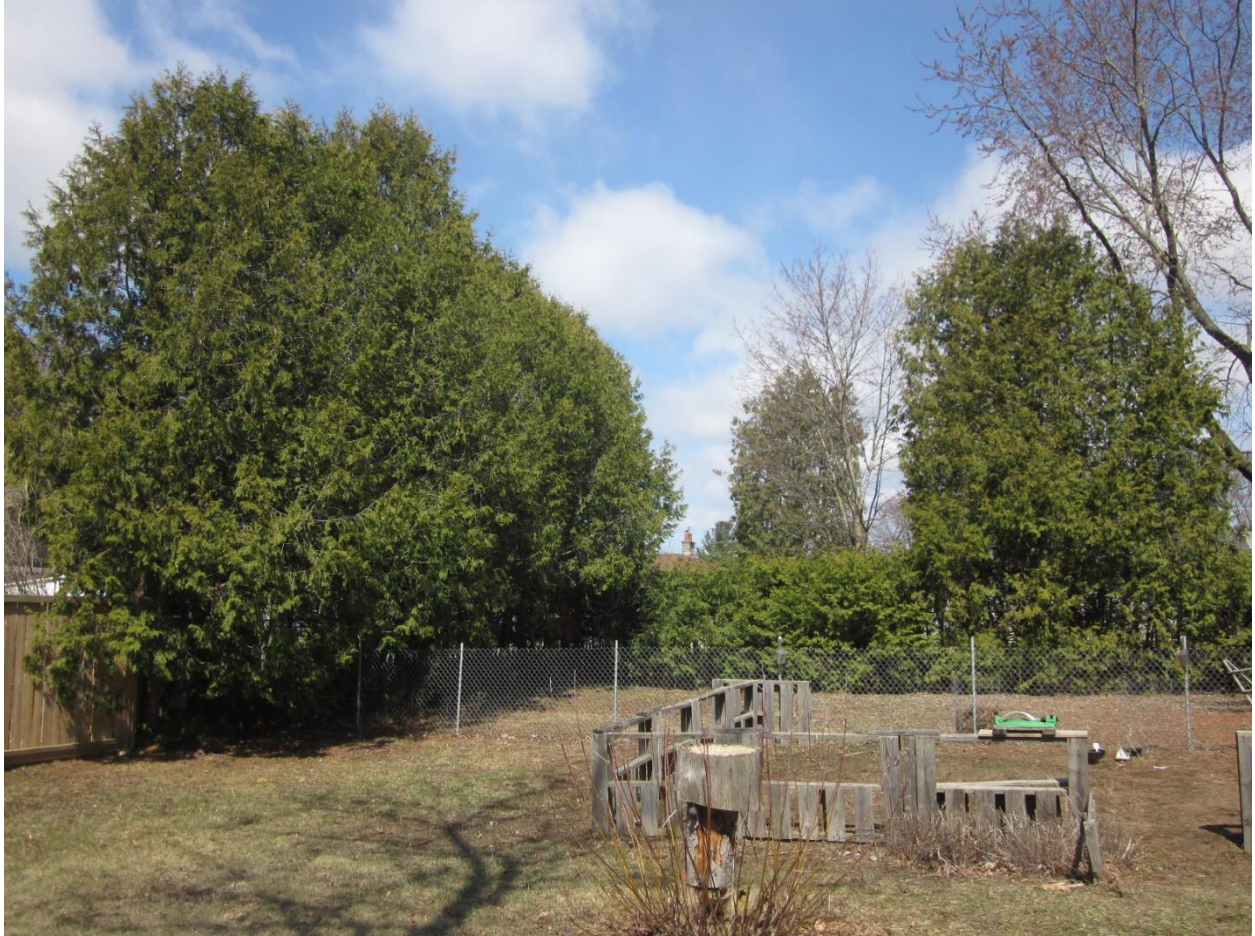
Picture 3. Portion of cedar hedge surrounding 2487 Innes Road, Ottawa (note maintained hedge and fully grown trees)

Preservation and protection measures intended to mitigate damage during construction will be applied for the hedge surrounding the subject property. The following measures are the minimum required by the City of Ottawa to ensure tree survival during and following construction:

1. Erect a fence at the critical root zone (CRZ¹) of trees;
2. Do not place any material or equipment within the CRZ of the tree;
3. Do not attach any signs, notices or posters to any tree;
4. Do not raise or lower the existing grade within the CRZ without approval;
5. Tunnel or bore when digging within the CRZ of a tree;
6. Do not damage the root system, trunk or branches of any tree;
7. Ensure that exhaust fumes from all equipment are NOT directed towards any tree's crown.
