TREE CONSERVATION REPORT

APARTMENT BUILDING DEVELOPMENT

DUNBAR COURT

October 21, 2020

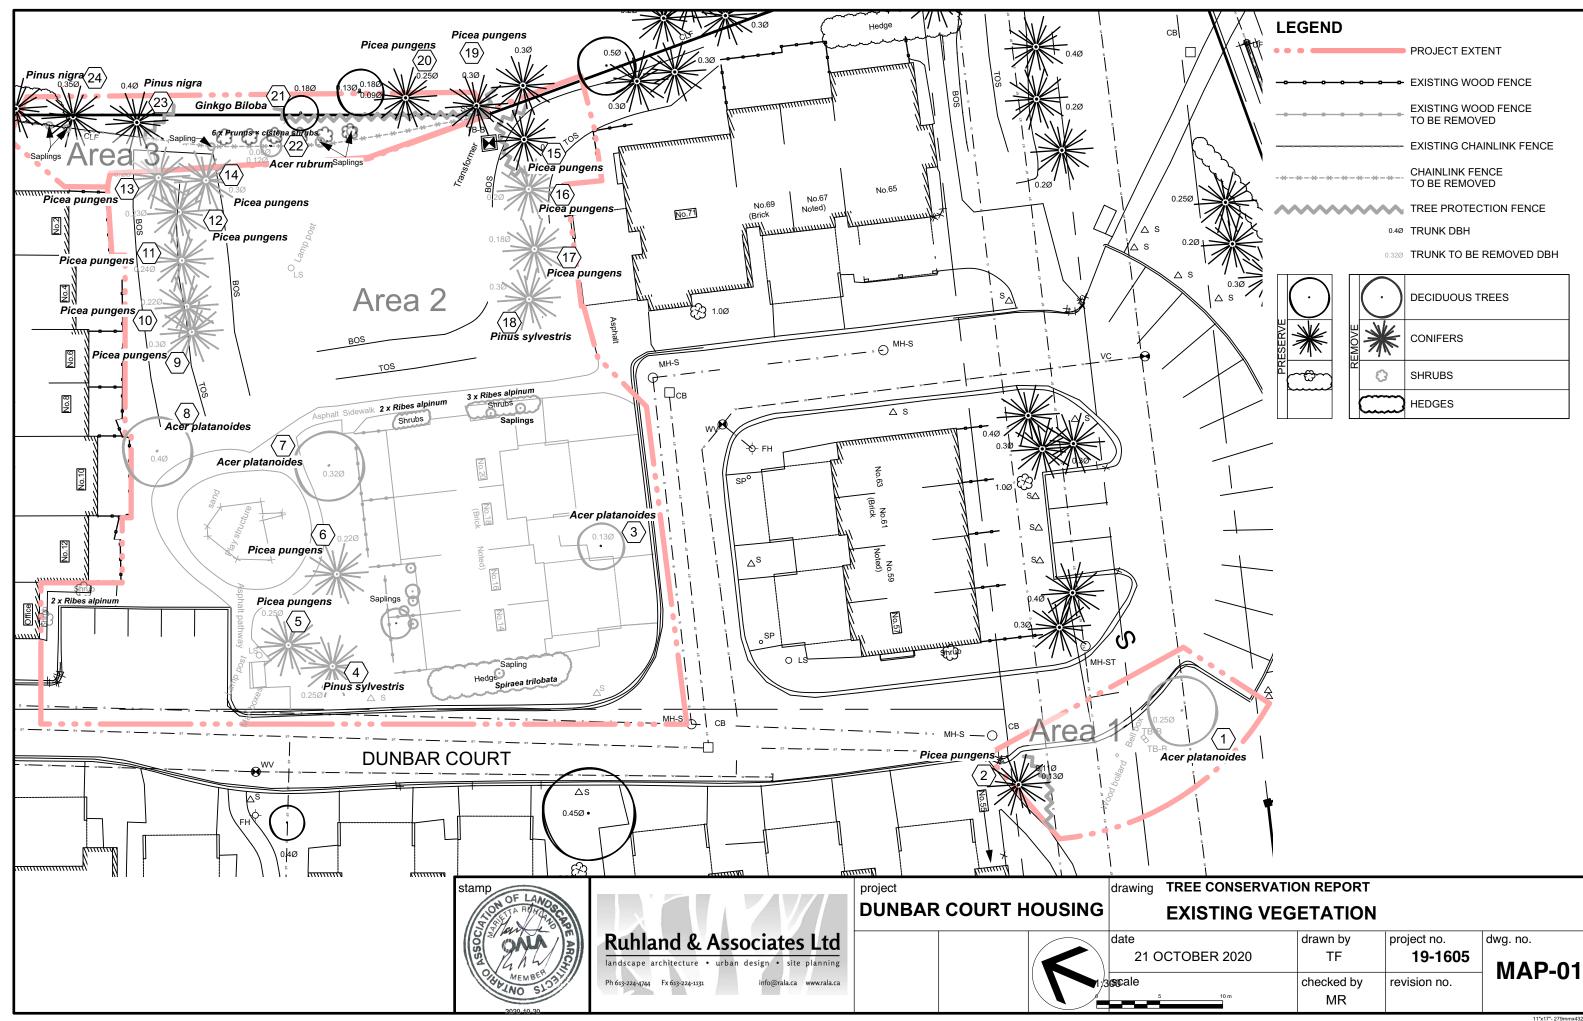
PLANT ID #	SIZE DBH* / ht. (cm)	COMMON NAME			COMMENTS	ACTION	RATIONALE
AREA 1							
1	25	Norway Maple	Acer plantanoides	Р	Poor, thinning, large scar @±2m - diseased?	Remove	In middle of new parking
2	13,11	Blue/Colorado Spruce	Picea pungens	G	Unpruned, split @±0.5m, leader cut?	Preserve if feasible	Review excavation limits / grade changes at time of construction
AREA 2							
3	13	Norway Maple	Acer plantanoides	F	Unpruned volunteer	Remove	In hardscape footprint
4	25	Scots Pine	Pinus sylvestris	Р	Split @±2m, very sparse	Remove	In hardscape footprint, poor condition
5	25	Blue/Colorado Spruce	Picea pungens	G		Remove	In hardscape footprint
6	22	Blue/Colorado Spruce	Picea pungens	G		Remove	In building footprint
7	32	Norway Maple	Acer plantanoides	F	Thinning centre of crown, tourniquet on major branch	Remove	In building footprint
8	40	Norway Maple	Acer plantanoides	E		Remove	In hardscape footprint
9	30	Blue/Colorado Spruce	Picea pungens	G		Remove	In building footprint

10	22	Blue/Colorado Spruce	Picea pungens	G		Remove	In building footprint
11	24	Blue/Colorado Spruce	Picea pungens	Р	Very sparse pale needles	Remove	In building footprint
12	23	Blue/Colorado Spruce	Picea pungens	G		Remove	In building footprint
13	20	Blue/Colorado Spruce	Picea pungens	Р	Stunted, sparse branches	Remove	In building footprint, poor condition,
14	30	Blue/Colorado Spruce	Picea pungens	G	15º slant at base	Remove	In building footprint
15	30	Blue/Colorado Spruce	Picea pungens	F	On slope	Preserve if feasible	Review excavation limits / grade changes at time of construction
16	20	Blue/Colorado Spruce	Picea pungens	F	On slope	Remove	In building footprint
17	18	Blue/Colorado Spruce	Picea pungens	F	On slope	Remove	In building footprint
18	30	Scots Pine	Pinus sylvestris	F	Sparse, browning needles, 10° slant at base	Remove	In building footprint
AREA 3							
19	30	Blue/Colorado Spruce	Picea pungens	P	Some needle browning	Preserve	Next property, good size

20	25	Blue/Colorado Spruce	Picea pungens	G	Heavy pruning north side, some browning	Preserve	Next property, good tree
21	18,13,9	Maidenhair tree	Ginkgo biloba	G	Spindly leader, just other side of property line	Preserve	Next property, good tree
22	12,6	Red Maple	Acer rubrum	F	Volunteer, unpruned, multistem	Remove	Volunteer, poor habit, on old fence to be removed.
23	40	Austrian Pine	Pinus nigra	F	Split trunk about 2/3 up. Slight needle browning	Preserve	Fair condition, good size
24	35	Austrian Pine	Pinus nigra	F	Slight needle browning	Preserve	Fair condition, good size
				CONDITION

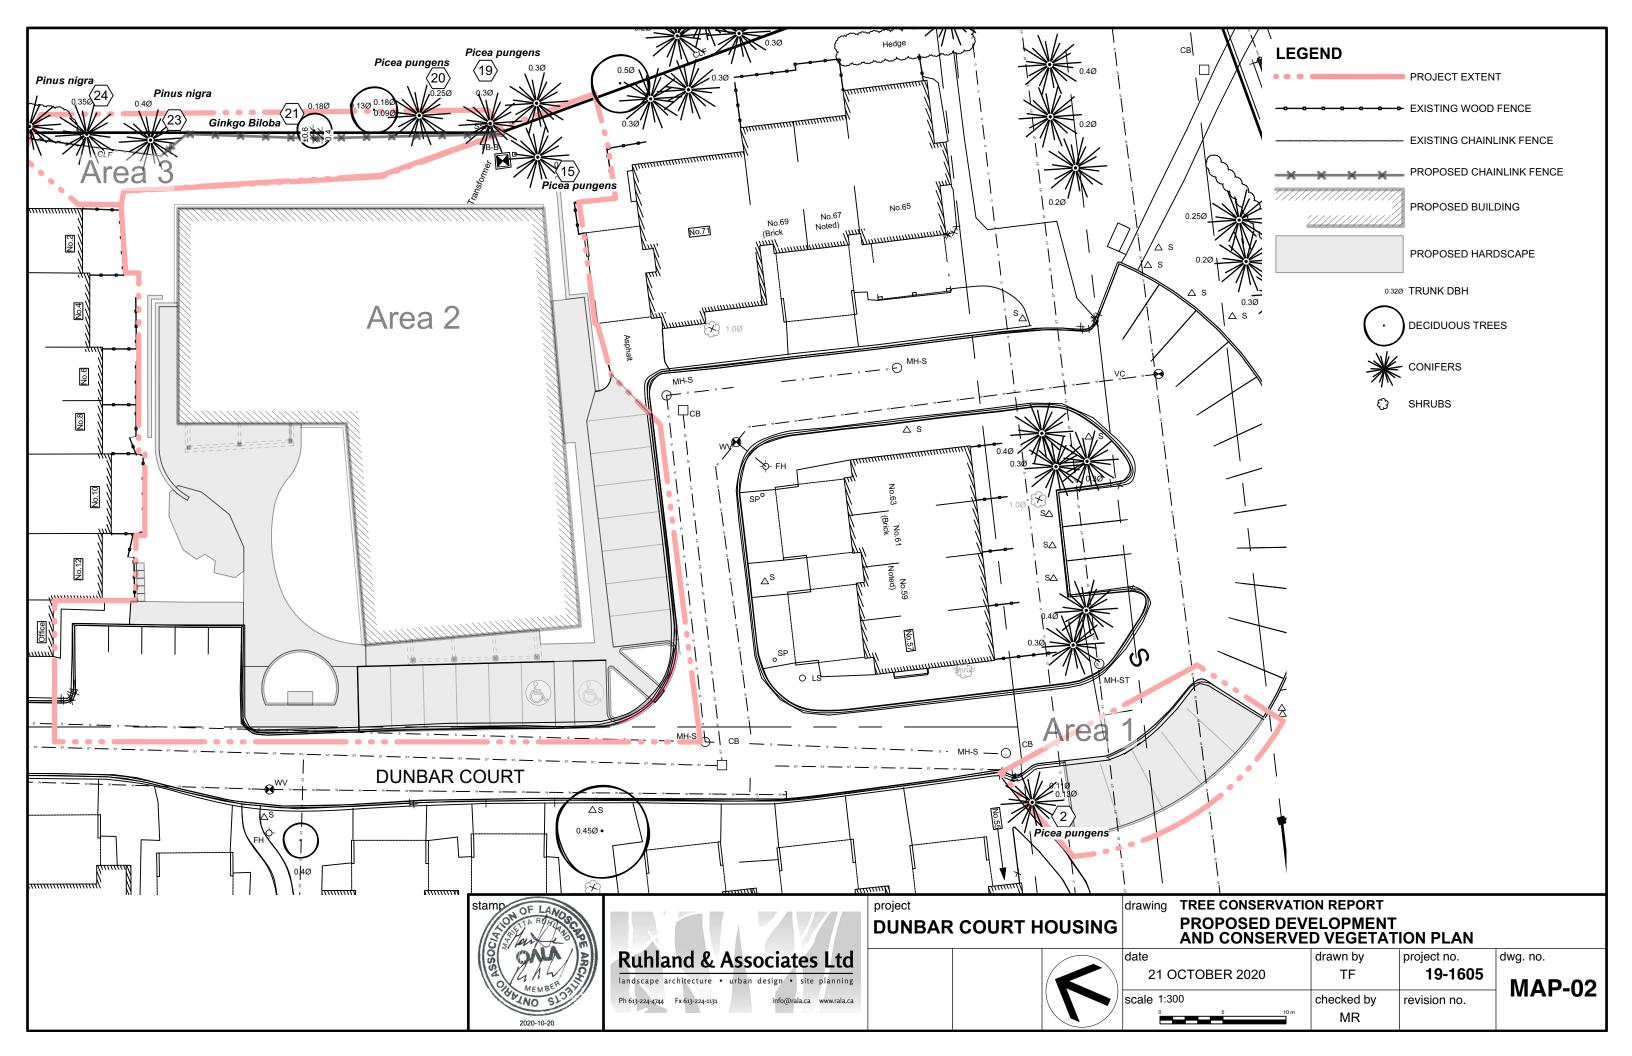
Trees 19, 20, and 21 are on the neighbouring property near the property line where the fence will be being relocated. It is considered worth aligning the new fence away from the property line in order to preserve these trees.

Trees 23 and 24 are on the site property. It is considered worth leaving the fence intact next to these trees in order not to disturb them.
