Muncaster Environmental Planning Inc.

September 10, 2020

RE: 176 Nepean Street and 293 & 307 Lisgar Street <u>Tree Conservation Report and Environmental Impact Statement</u>

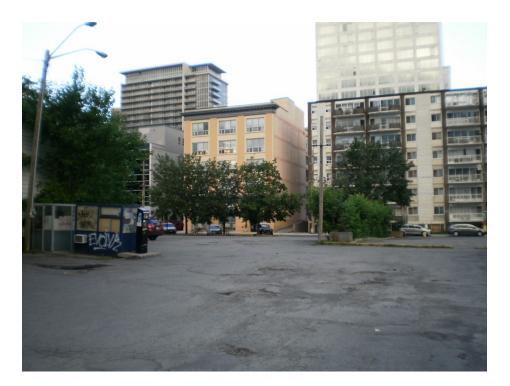
The land use on and adjacent to the site is highly urbanized, with most of the site used for surface parking (Map 1, Photo 1). No aquatic habitat potential is on or adjacent to the site. Garden plots (the 'Off-Bank Community Garden') are in the location of a former residence in the northwest corner of the site, south of Nepean Street. Planted trees are along the Nepean and Lisgar Street boulevards with deciduous trees and shrubs along other portions of the site peripheries (Map 1). A row of Norway maple between 25 and 30cm diameter at breast height (dbh) is along the south side of Nepean Street. Leaf-out was poor on the larger Norway maple, with better leaf-out on the smaller examples but trunk damage was present. Planted Japanese lilac up to 18cm dbh are along the north side of Lisgar Street. These trees appeared to be in good condition.

Photo 1 – Central and west portions of the site, with planted Norway maples in the rear on the south side of Nepean Street. View looking north from north of Lisgar Street

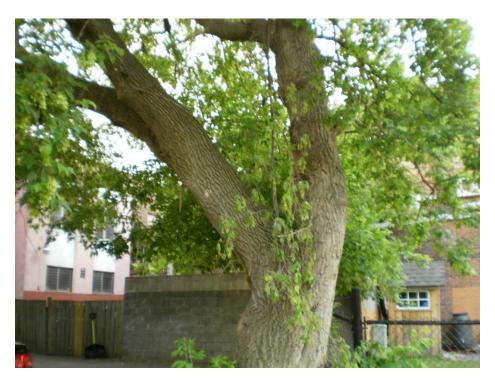
Manitoba maple was along the north portion of the east site boundary (Photo 2), as well as adjacent to the remaining residence in the southwest portion. The largest Manitoba maple was a mature (75cm dbh) example to the northwest of the residence (Photo 3). This tree has some trunk damage and reduced leaf-out in areas, but had good leaf-out on most branches. The other Manitoba maple were much smaller, up to 20cm dbh, and appeared to be in generally good condition.

Photo 2 – Mature Manitoba maple in the west portion of the site

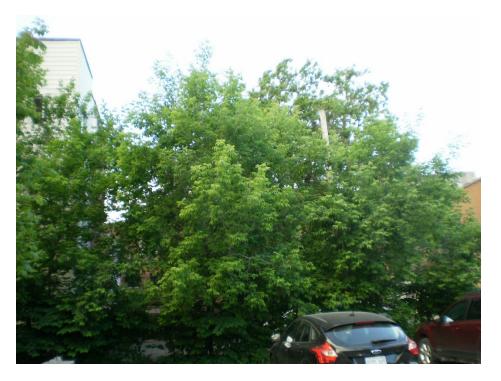
Photo 3 – Manitoba maple along the north portion of the east edge of the side, south of Nepean Street

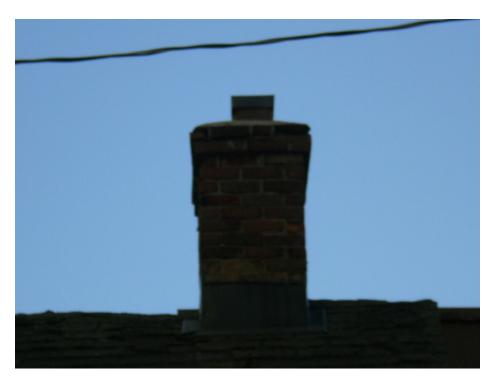
Species at Risk reported in the Ontario Breeding Bird Atlas for the 10 km square 18VR42 that includes the site and general area are least bittern, eastern whip-poor-will, chimney swift, bobolink, eastern meadowlark, bank swallow, and barn swallow. Except for chimney swift, no suitable habitat is present on or adjacent to the site for these species. No large grassland areas are available for bobolink or eastern meadowlark. Barn swallow nests on structures with open rafters such as barns, larger agricultural sheds and bridges. Bank swallow is a colonial nester; burrowing in eroding silt or sand banks and sand pit walls. Eastern whip-poor-will utilize rock or sand barrens with scattered trees, savannahs, old burns or other disturbed sites in a state of early to mid-forest succession, or open conifer plantations. Least bittern is found in larger marshes and is known from the Ottawa River corridor, approximately 800 metres to the north of the site. No suitable nesting habitat or structures for these birds was observed on or adjacent to the site. Chimney swift nest in accessible brick chimneys without metal linings and historically in the cavities of large trees in deciduous forests. As access and internal opening size for the chimney on the remaining residence was not confirmed (Photo 4), field surveys were completed to identify any chimney swift utilization.

Photo 4 – Chimney on the remaining residence in the southwest portion of the site.

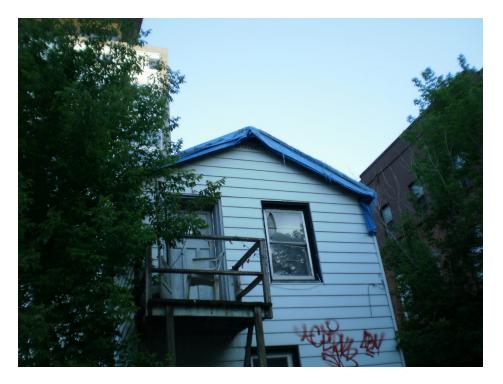
The inside of the residence in the southwest portion of the site was surveyed for evidence of bat activity on the evening of June 28th. The roof lattice and other open spaces were well exposed due to the deteriorated condition of the ceilings. No bats were observed and there was no evidence of bat usage in the residence. Tarps were in place to prevent wildlife access into the building where the side of the roof had decayed (Photo 5).

Photo 5 – Tarps to prevent wildlife access to the remaining residence in the southwest portion of the site. View looking south to the north portion of the residence
