TREE
CONSERVATION
REPORT V2.0

1655 and **1619** Carling Ave

Tree Conservation Report submitted as Partial Requirements for a Site Plan Control Application

Date: February 23, 2021

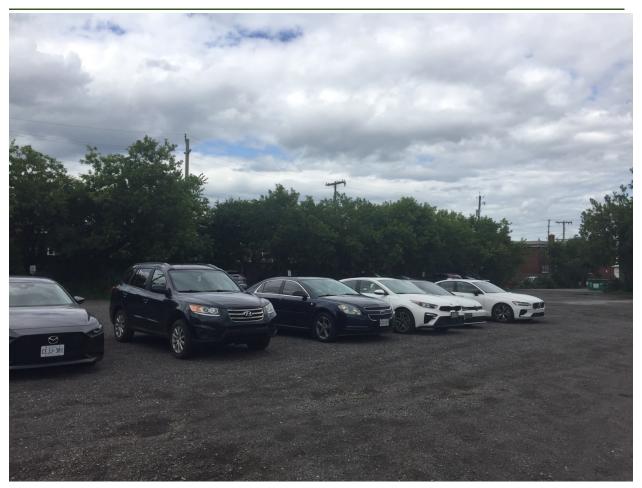
Figure 1: Trees along the northeast side of the property

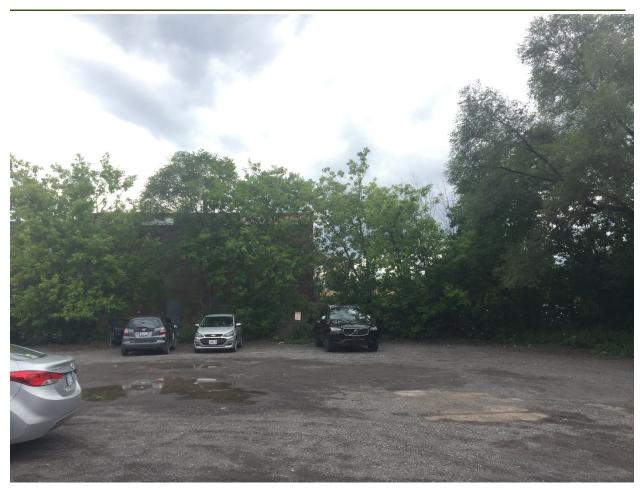
Figure 2: Trees along the west side of the property

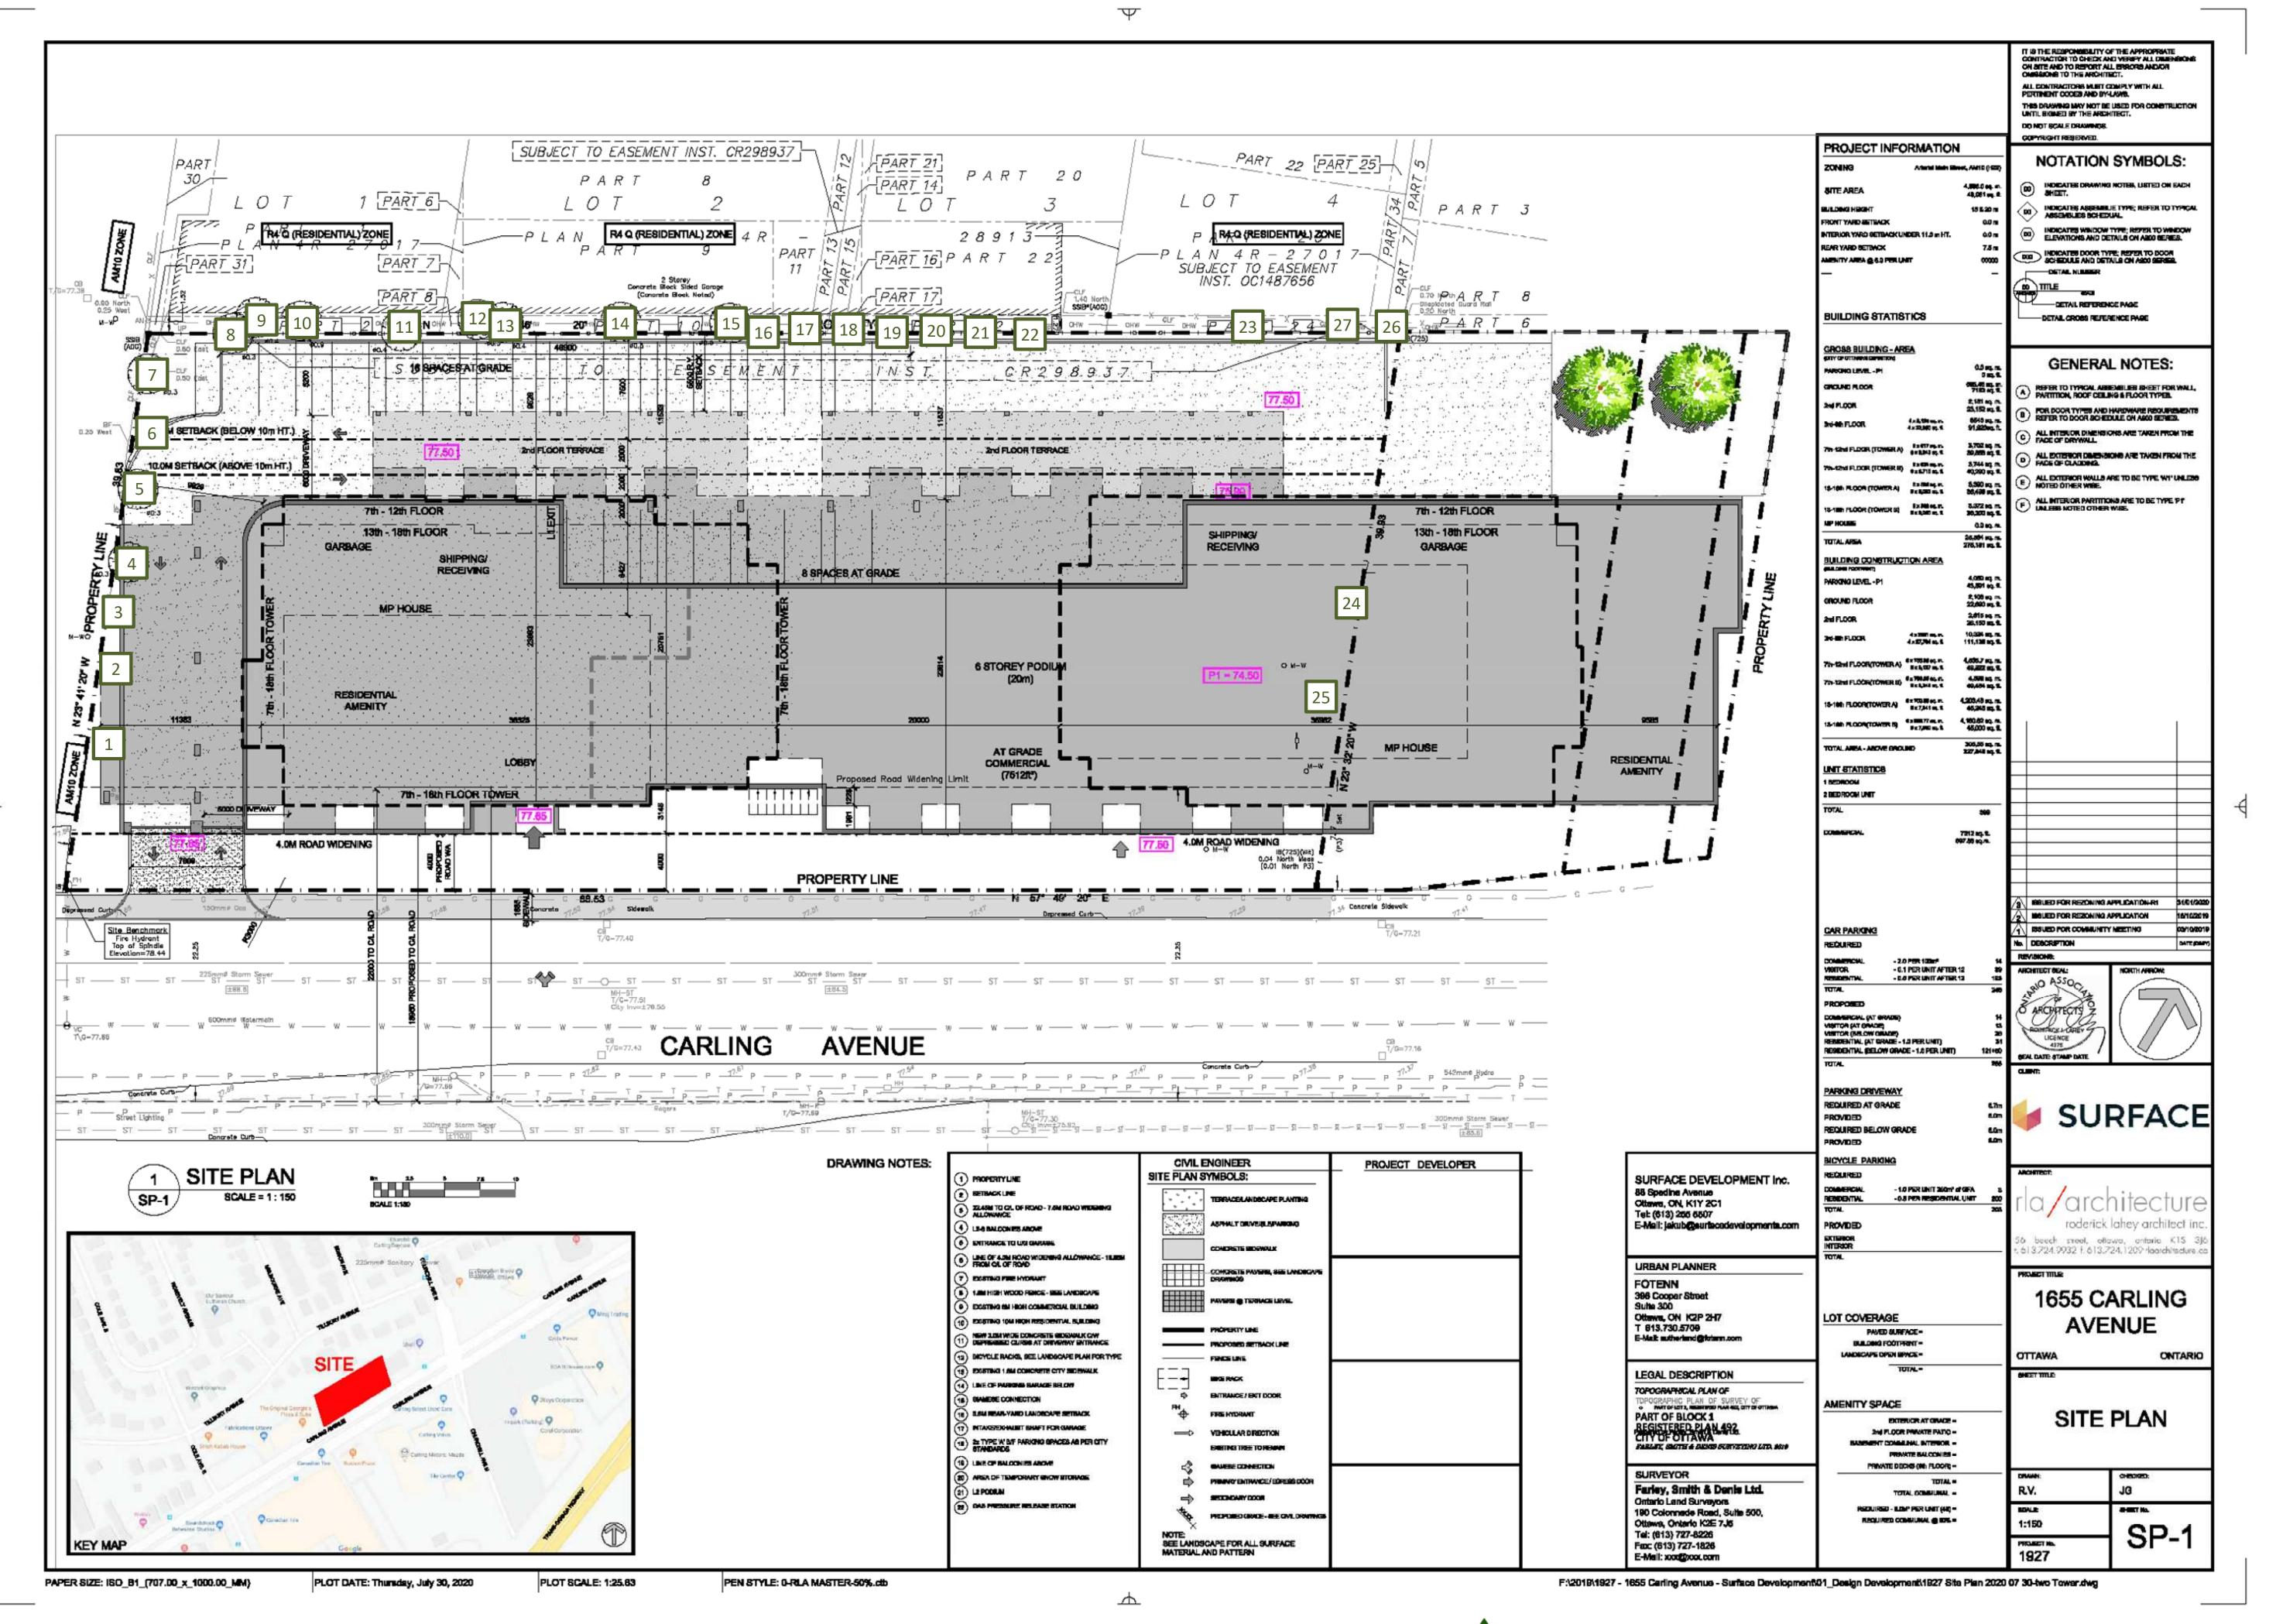
Tree Conservation Report – 1655/1619 Carling Ave
Tree layer prepared by Dendron Forestry Services
Version 1.0, August 9, 2020

The site plan provided in this report has been supplied by RLA and the red dotted line shows the extent of excavation for the underground parking lot. The excavation will extend to the property line along the north and west side, compromising the root systems for all trees along these edges and removal is recommended for all the trees on site. Note that some along the northern property line are jointly owned with neighbours on Tillbury who should be contacted prior to removal.
