November 20, 2020

RE: TREE CONSERVATION REPORT FOR 2830 CARLING AVENUE, OTTAWA

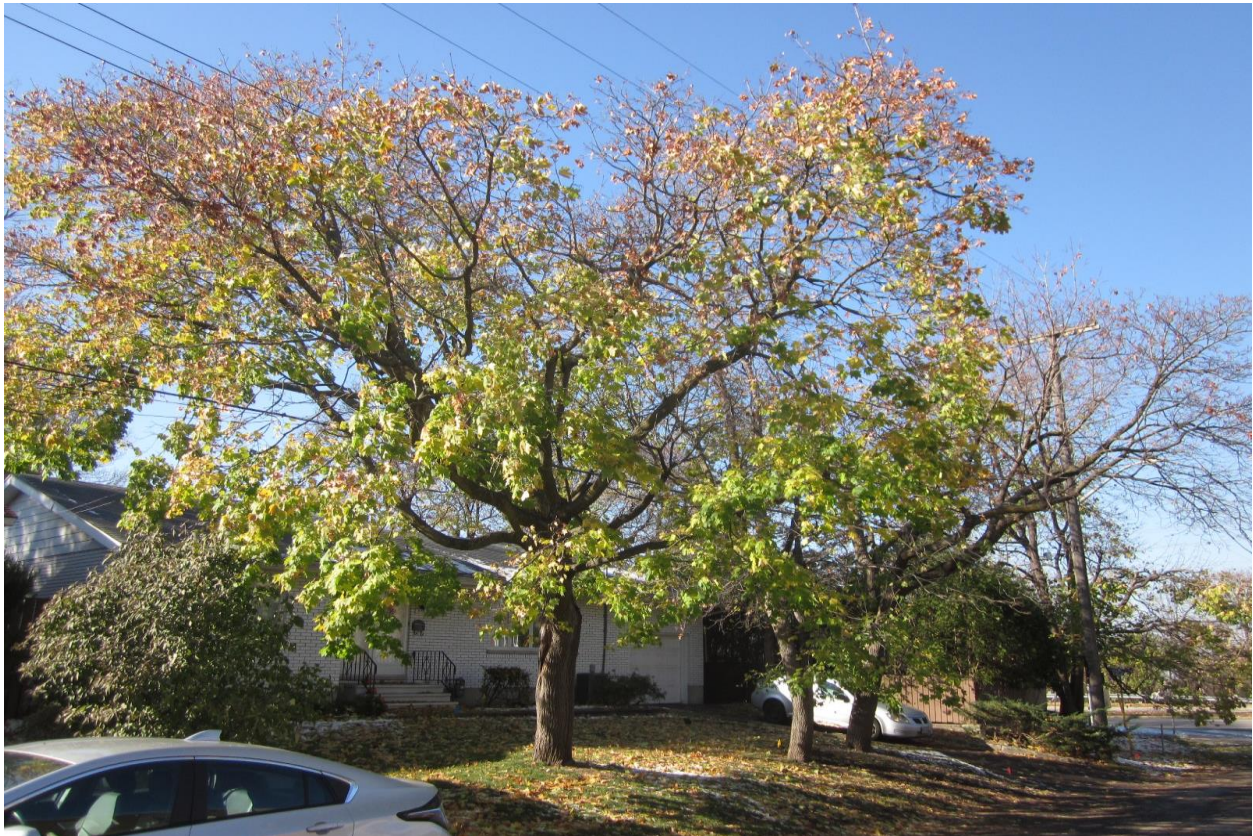
Tree No.	Tree species	Condition (VP→E)	DBH ¹ (cm)	Owner -ship	Age class, tree condition notes & preservation status (to be removed or preserved and protected)
1	Norway maple (<i>Acer platanoides</i>)	Poor	53.2	City	Mature; heavily pruned from overhead Hydro lines; introduced invasive species; to be removed

2	Norway maple	Poor	38.1	City	Mature; heavily pruned from overhead Hydro lines; co-dominant stems at 1.5m from grade; top of east stem dead (topped); moderately divergent towards northwest; to be removed
3	Norway maple	Poor	46.8	City	Mature; heavily pruned from overhead Hydro lines; strongly divergent towards northeast; to be removed
4	Juniper (<i>Juniperus</i> spp.)	Fair	29.5	Private	Overmature; upright with multiple leaders; generally symmetric; fair crown density, growth increment and needle colour; cultivar; to be removed
5	Norway maple	Poor	81.5 (at 0.2m)	City	Mature; tri-stemmed from grade; heavily pruned from overhead Hydro lines - east stem topped, three other stems divergent towards west; to be removed
6	Norway maple	Good	53.0	City	Mature; generally upright form with dominant central stem for most of height; crown asymmetric towards northeast due to influence of nearby trees; to be removed

Picture 1. Trees #1, 2, 3 and 5 (left to right) on City of Ottawa property adjacent to 2830 Carling Avenue

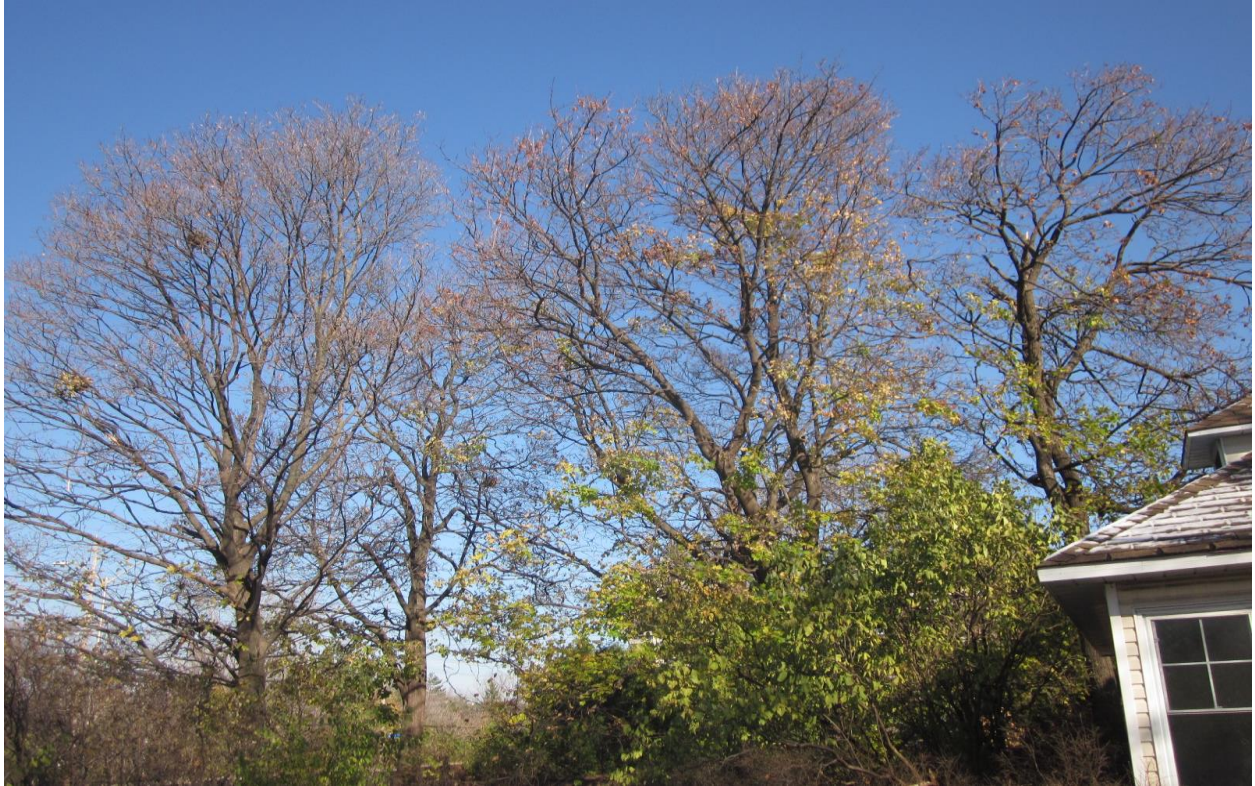
7	Norway maple	Fair	43.0	Shared	Mature; dominant central stem for half height; multiple competing leaders; crown asymmetric towards northwest - broad; to be removed
8	Norway maple	Poor	52.9	Private	Mature; divergent and completely asymmetric towards east; central stem dead and decaying at 6.5m; to be removed
9	Norway maple	Fair	35.3 & 40.0	Private	Mature; double-stemmed at 0.3m; east stem upright, west slightly divergent and heavily asymmetric towards west; to be removed
10	Norway maple	Poor	41.3	Private	Mature; central upright stem to 6.5m with co-dominant leaders; asymmetric towards south due to influence of nearby trees; east side of crown with major deadwood; to be removed

Picture 2. Trees #7, 6, 8, 9 and 10 (left to right) on or adjacent to 2830 Carling Avenue

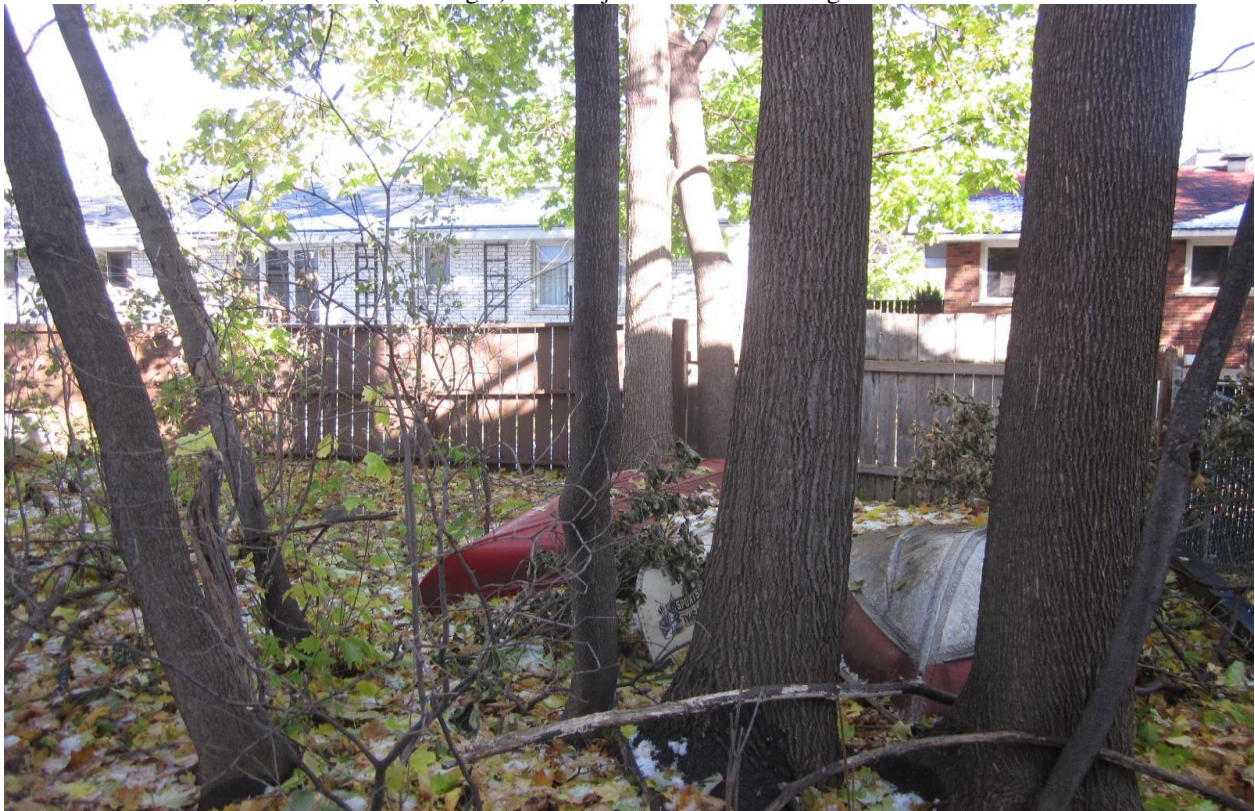
11	White elm (<i>Ulmus americana</i>)	Good	34.6	Neighbour	Mature; central upright to 6.5m with divergent leaders; no outward signs Dutch elm disease (<i>Ophiostoma ulmi/novo-ulmi</i>); native species; to be preserved and protected
12	Norway maple	Good	27.9	Neighbour	Mature; suppressed by tree #10; asymmetric towards north/northeast; to be preserved and protected
13	Norway maple	Fair	40.0	Neighbour	Mature; co-dominant stems at 4m with weak union; north stem bifurcates again at 5m; divergent and asymmetric towards north; to be preserved and protected
14	Norway maple	Good	38.5	Neighbour	Mature; generally upright; crown asymmetric towards southeast; to be preserved and protected
15	Silver maple (<i>Acer saccharinum</i>)	Fair	72.0	Shared	Very mature; central stem to 5m with co-dominant leaders; suppressed lateral at 3m on south side; strong primary union; decay and deadwood in laterals; native species; to be removed

Picture 3. Trees #13 and 14 (right) and 11 and 12 background) on or adjacent to 2830 Carling Avenue

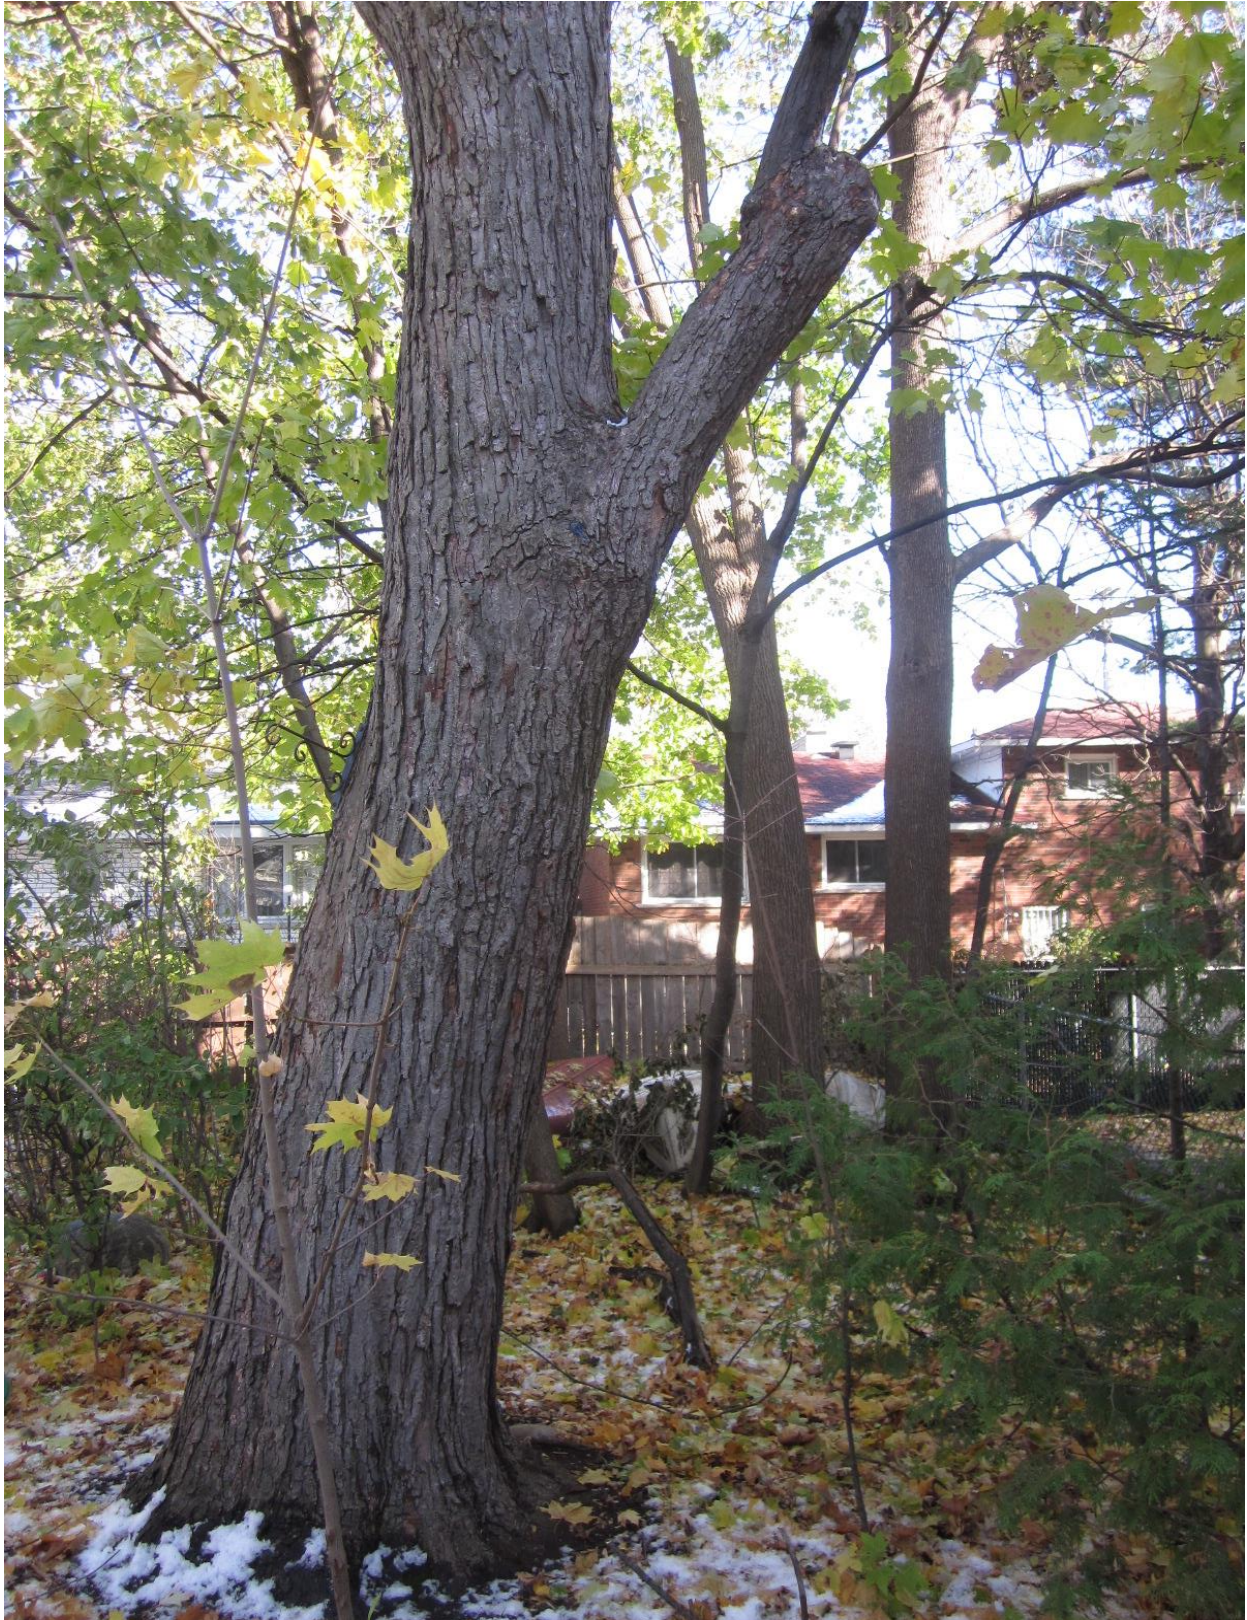
Picture 4. Trees #15 (foreground) and #13 and 14 (background) shared with or adjacent to 2830 Carling Avenue
