December 15, 2020

RE: TREE CONSERVATION REPORT FOR 78-90 BEECHWOOD AVENUE & 69-93 BARRETTE STREET, OTTAWA

This report details a pre-construction Tree Conservation Report (TCR) for the above-noted cluster of properties in Ottawa. The need for this TCR is related to the proposed demolition of multiple commercial buildings along Beechwood Avenue and residential dwellings along Barrette Street, and in their place construction of a 9-storey mixed-use building with two levels underground parking.

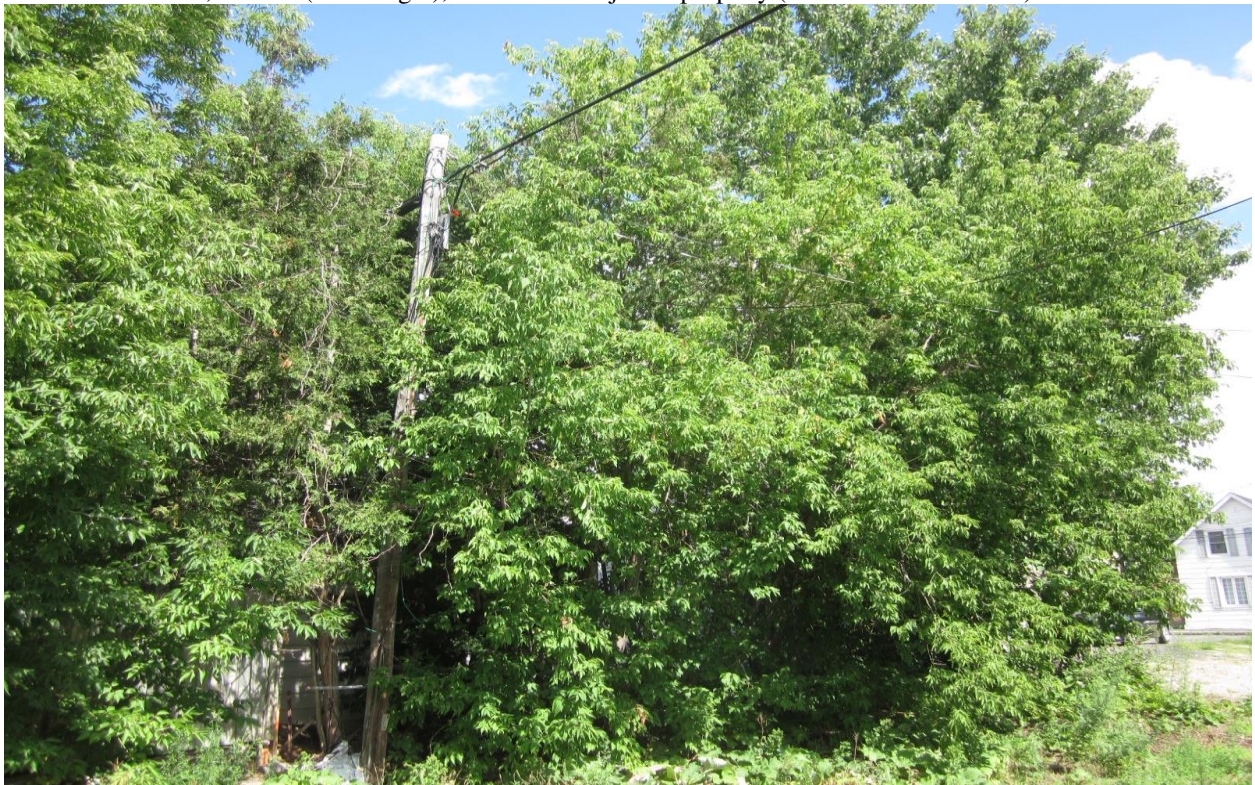
Picture 2. Same picture as above taken in July 2020

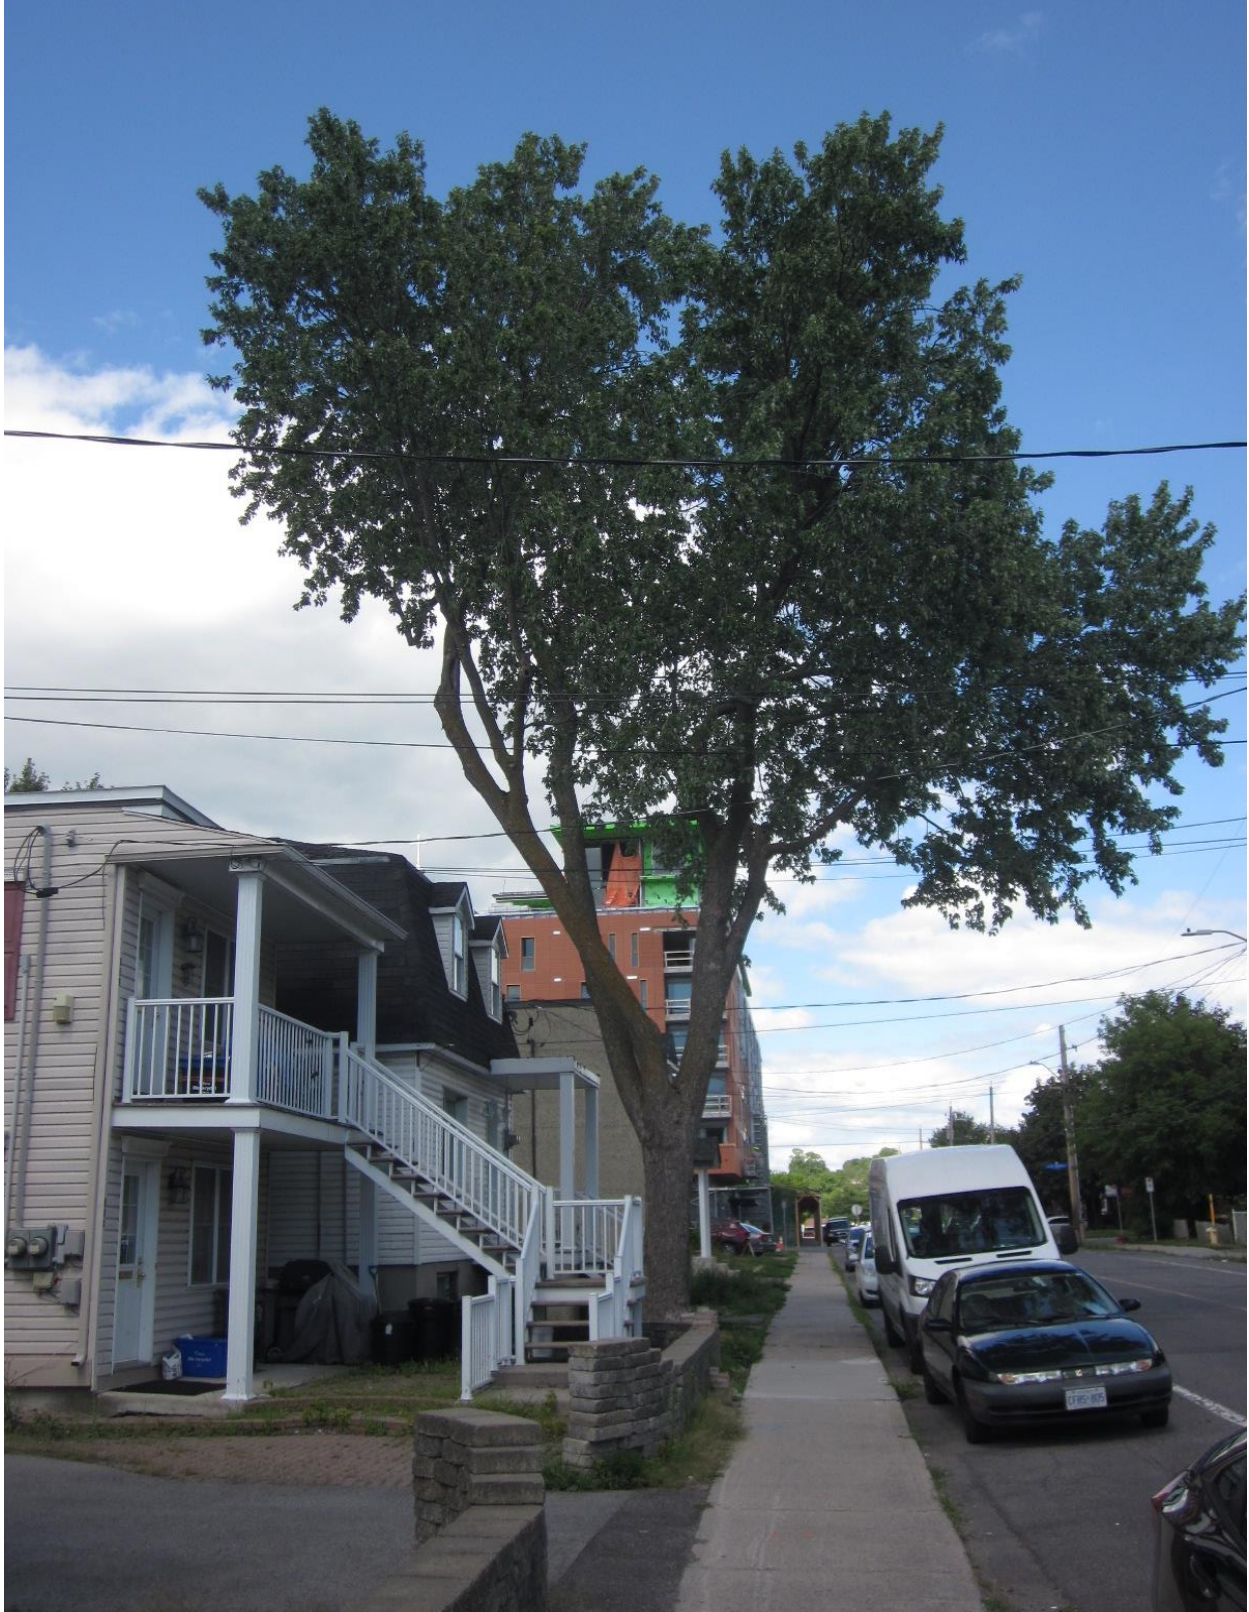
5	Silver maple	Good	64	City	Mature; tri-stemmed at 3m from grade; generally upright form due to past pruning from house and over road; very limited rooting area between foundation and sidewalk; native species; to be removed (conflicts with construction)
6	Manitoba maple	Fair	55 & 60	Private	Mature; double-stemmed from grade; crown divergent towards northwest due to past pruning from house; broad, dense crown; originated from seed; naturalized species; to be removed (conflicts with construction)

Picture 3. Tree #5 – city owned silver maple (taken July 2020)

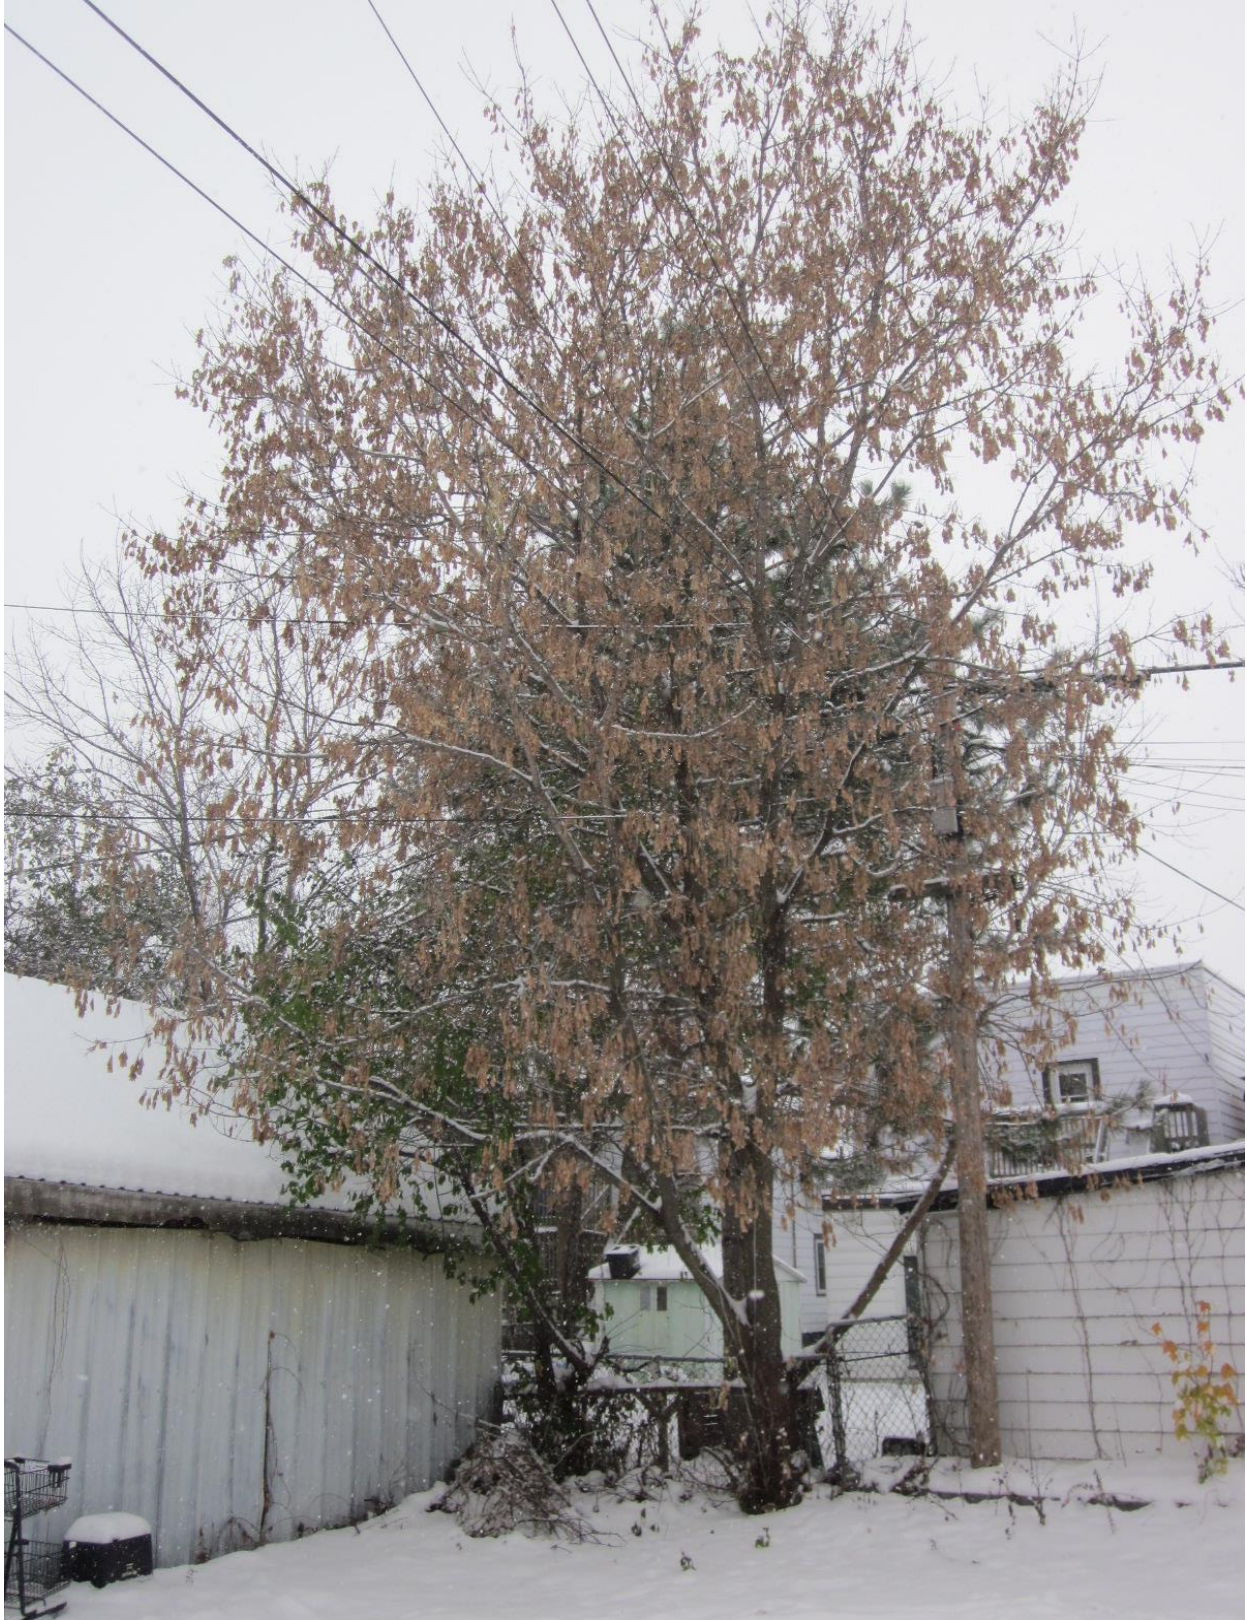
Picture 5. Manitoba maple #8 on private (subject) property (taken November 2019)
