TREE CONSERVATION REPORT

374 McArthur

Tree Conservation Report submitted
as Partial Requirements for a Site
Plan Control Application, August 31,
2020

Tree Conservation Report

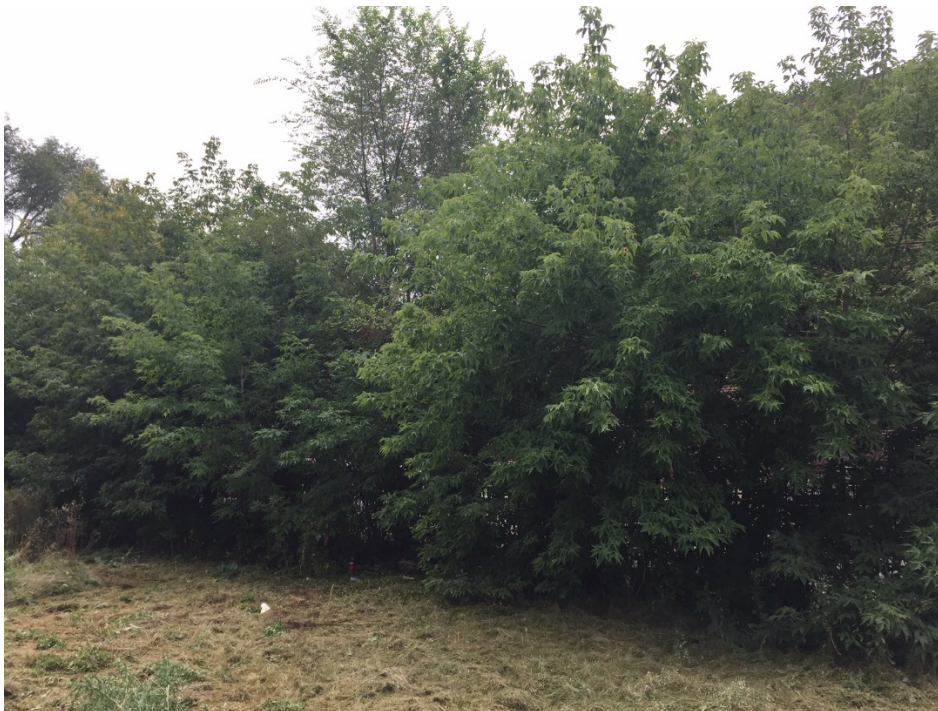
Figure 1: Manitoba maple along the west side of the property ranging in 5-10 cm

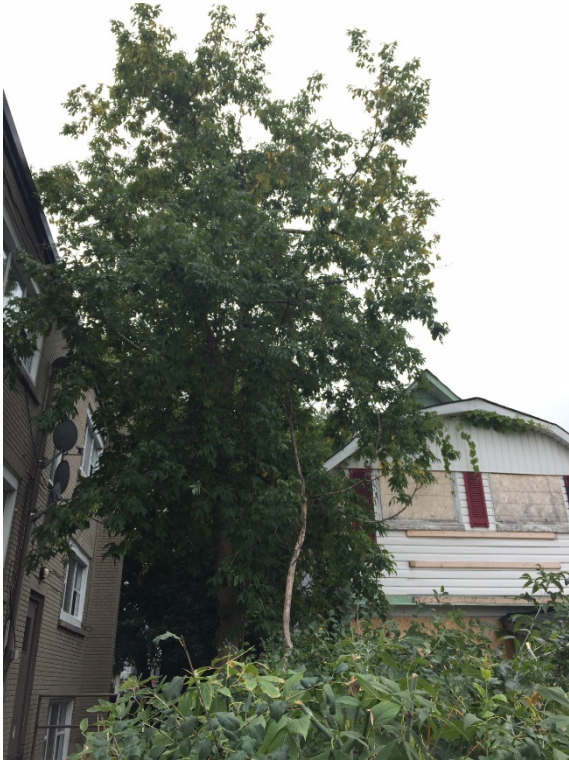
Tree ¹	Species	Diameter at breast height (dbh)	Ownership ³	Condition	Action
1	Manitoba maple (<i>Acer negundo</i>)	22 cm	Jointly owned with neighbour at 366 Brant St	Good	Removal recommended as 40% of the crown would have to be removed and excavation will be close to the base of the tree
2	Manitoba maple (<i>Acer negundo</i>)	25 cm	Jointly owned with neighbour at 366 Brant St	Fair/Good	Leaning over property; most of crown would have to be removed, excavation close to base of tree; removal recommended
3	Manitoba maple (<i>Acer negundo</i>)	18 cm	Jointly owned with neighbour at 366 Brant St	Fair/Good	Leaning over property; most of crown would have to be removed, excavation close to base of tree; removal recommended
4	Manitoba maple (<i>Acer negundo</i>)	12 cm	Jointly owned with neighbour at 366 Brant St	Fair/Good	Leaning over property; most of crown would have to be removed, excavation close to base of tree; removal recommended

Figure 2: Tree 1 - Manitoba maple right beside excavation and where new building will be

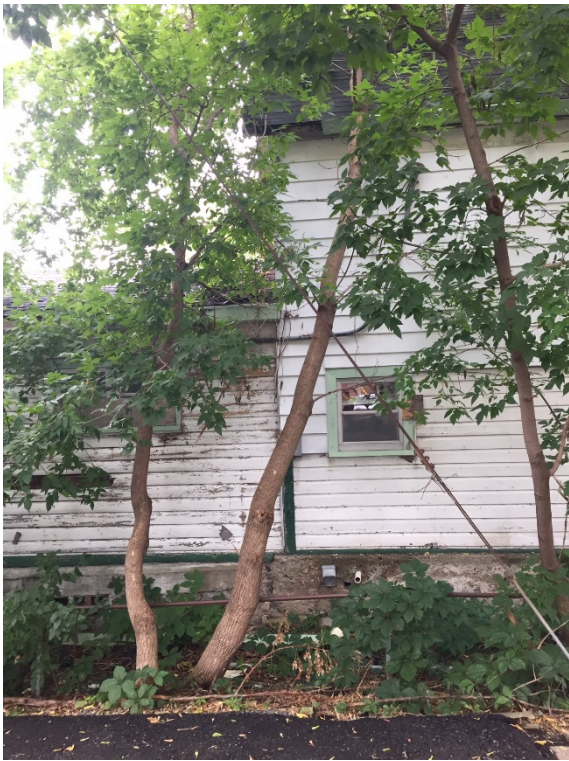
Figure 3: Tres 2-4 - Manitoba maple on property line

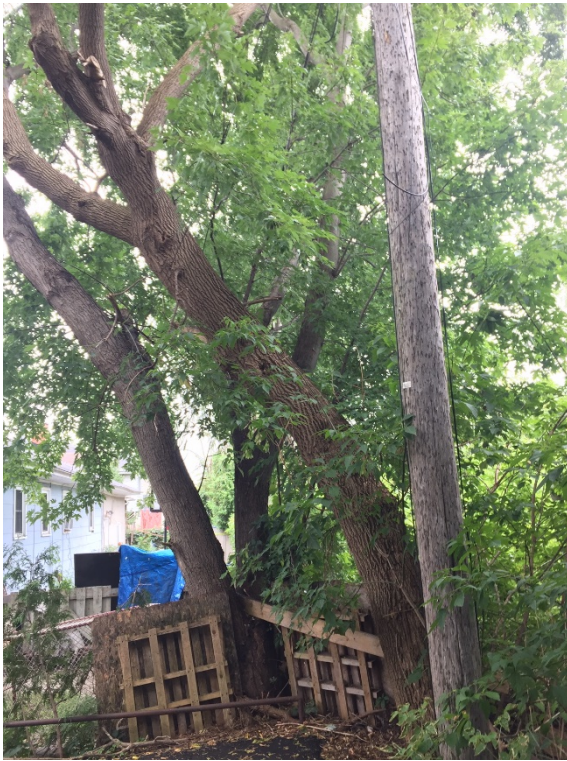
5	Manitoba maple (<i>Acer negundo</i>)	48 cm	Neighbour at 366 Brant	Fair	Excavation will come close to base of tree – consider removal
6	Silver maple (<i>Acer saccharinum</i>)	42, 33 cm	Neighbour at 372 Brant	Fair	Excavation will come close to base of tree – retain and protect as much of root system as possible
7	Silver maple (<i>Acer saccharinum</i>)	24 cm	Private	Good	Excavation will come close to base of tree – removal recommended
8	Eastern white cedar (<i>Thuja occidentalis</i>)	24, 22, 22, 21	Jointly owned with neighbour at 372 Brant	Good	Excavation will come close to base of tree – removal recommended
9	Manitoba maple (<i>Acer negundo</i>)	13 cm	Private	Fair; pruned by hydro	Within the zone of excavation – removal recommended
10	Silver maple (<i>Acer saccharinum</i>)	20 cm	Private	Good	Within the zone of excavation – removal recommended
11	Silver maple (<i>Acer saccharinum</i>)	22 cm	Private	Good	Within the zone of excavation – removal recommended

Figure 4: Trees 5 and 6: Manitoba maple and silver maple on neighbouring property close to the property line

- Avoid tearing of the roots. If the roots do tear, they should be pruned with a clean cut to increase the likelihood of sealing properly and reduce the risk of pathogens from entering the tree.
- Roots should not be left exposed and be covered with soil as quickly as possible, or temporarily with a moist, organic material such as mulch and/or burlap
- The trees should be watered during dry summer months to reduce stress they will encounter from the laneway construction

Those trees that are retained on neighbouring property (5 and 6) should be monitored after excavation to ensure that main roots that would affect the structural integrity of the tree have not been severed that would result in an increased risk of failure.

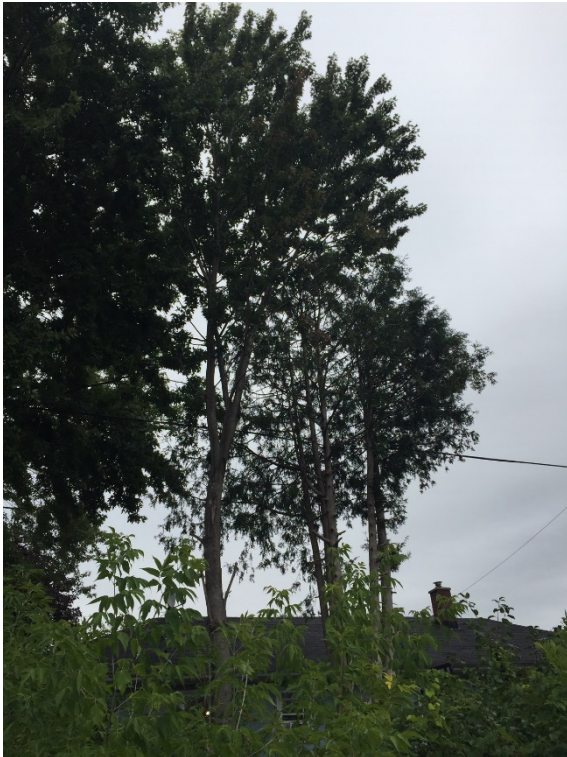
Figure 5: Trees 7 and 8 - Silver maple and clump of eastern white cedar along the property line

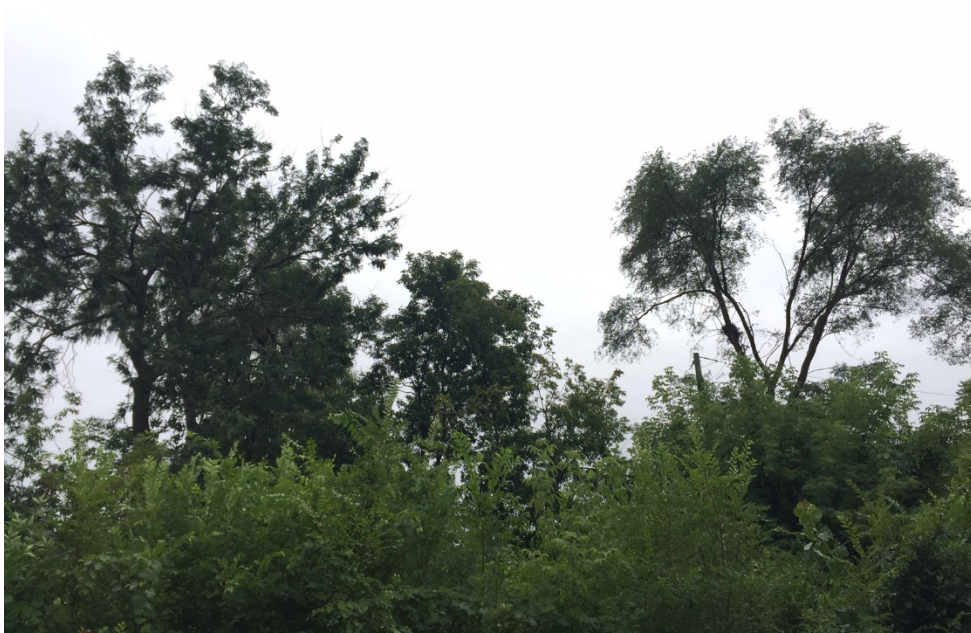
Figure 6: Trees along the back of the property
