RE: Subject Property 21 Huntmar Drive, Kanata/Ottawa, K2S0P6, Butternut on Adjacent Property
BHA Report Number: 708-001
Date(s) of Butternut health assessment: September 26, 27, 2019

Attachment 1: Butternut Health Assessor's Report

Property description: 21 Huntmar Drive, Kanata/Ottawa, K2S0P6
 BHA Report Number: 001
 Date(s) of Butternut health assessment: September 26, 27, 2019
 Date BHA Report prepared: October 10, 2019

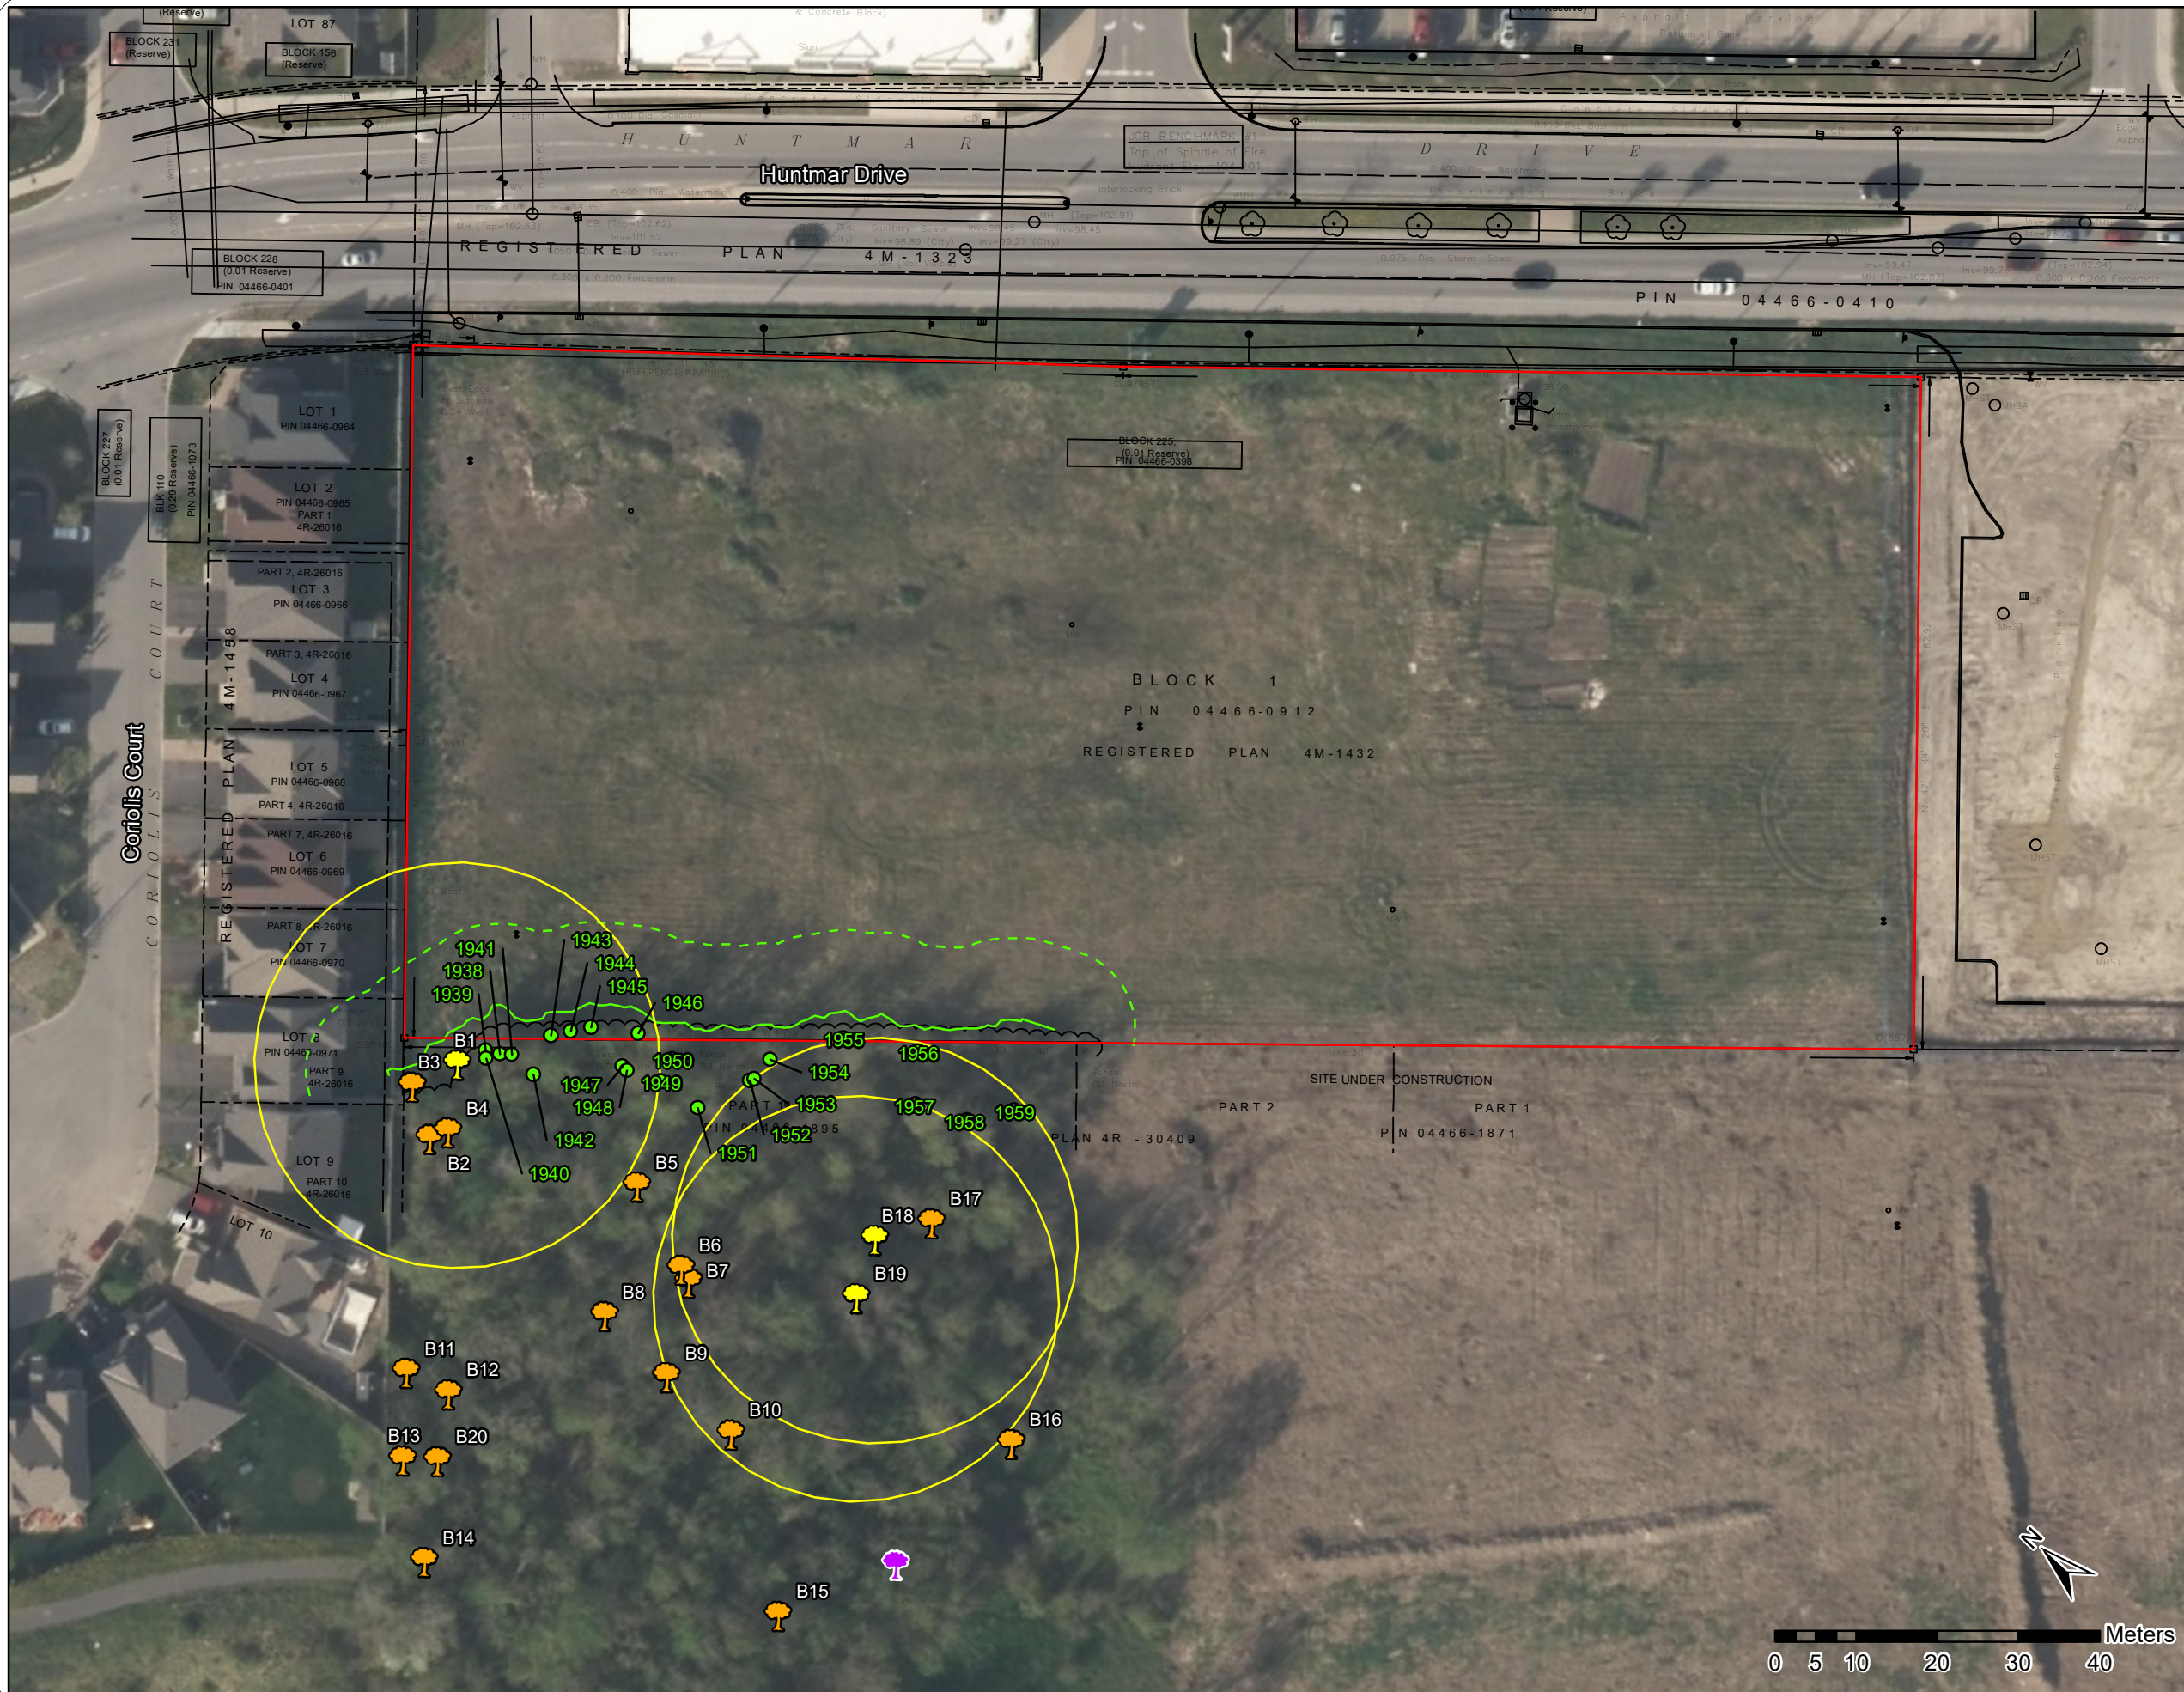
Attachment 4: Figure Illustrating Butternut Locations

A total of 20 Butternut trees were surveyed beyond the subject property limits to a distance of 50 metres (Butternut regulation zone). Seventeen (17) of the Butternut have been assessed as Category 1, three (3) were assessed as Category 2, and none (0) were assessed as Category 3. Two of the Category 2 trees are situated at a distance of 25 metres from the subject property such that there is no reasonable expectation that they would be killed, harmed, or taken by activities within the subject property. However, one of the Category 2 trees is approximately 3 metres from the subject property boundary. Although this tree will be protected from harm with implementation of a 10m buffer from the tree’s dripline, consultation with MECP is required to

confirm whether an *Endangered Species Act* permit is required. Note that even with the implementation of a 10 metre buffer, proposed works will fall within the 50 metre regulation zone. Please note that additional consultation with MECP may be required should the 10 metre protection buffer be revised.
