April 1, 2021

**RE: TREE CONSERVATION REPORT - 101, 101(A) AND 103 SCHNEIDER ROAD, OTTAWA**

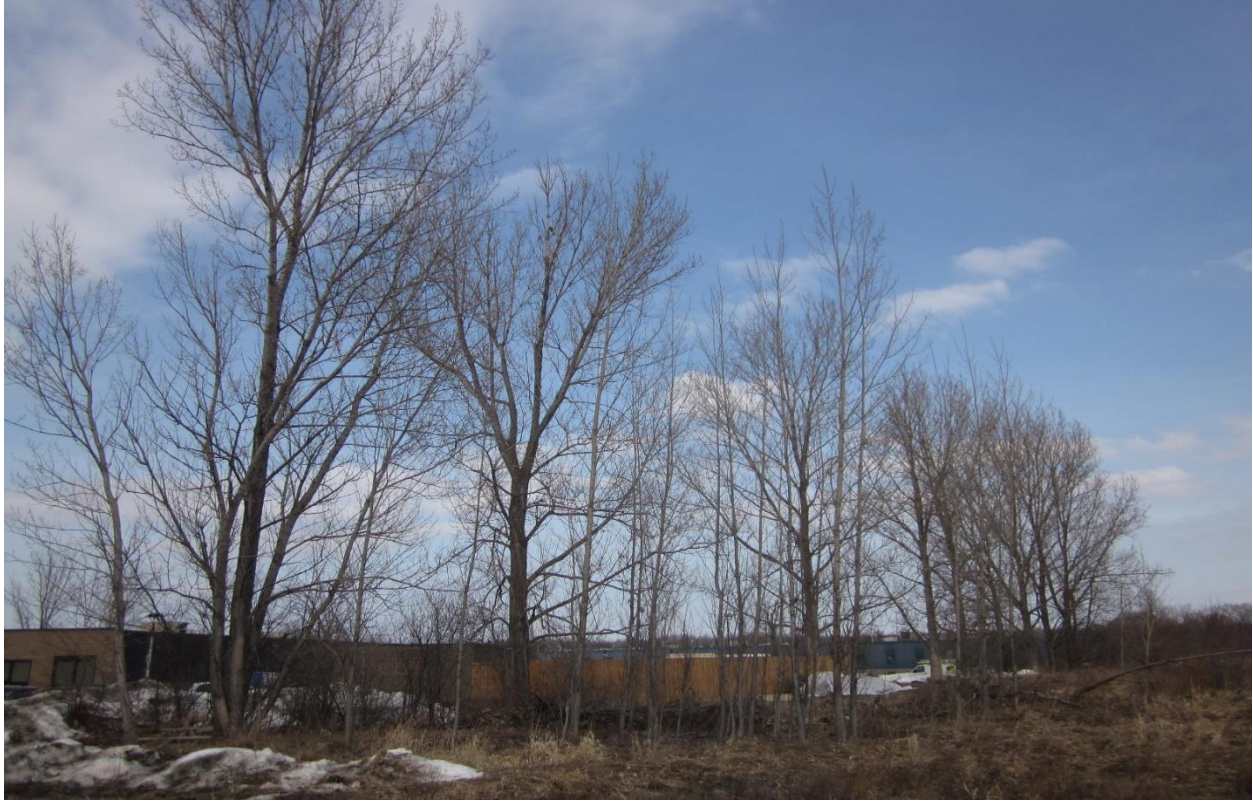
Tree No.	Tree species	Condition (VP→E)	DBH <sup>1</sup> (cm)	Owner -ship	Age class, tree condition notes & <b>preservation status</b> (to be removed or preserved and protected)
1	Cottonwood ( <i>Populus deltoides</i> )	Fair	53	Neighbour/ Private	Mature; multi-stemmed from grade – central, dominant stem with suppressed basal stems; “wooded area” on survey is root sprouts on subject property (10cm average); native species; <b>wooded area to be removed</b> (conflicts with new loading zone)
2	Cottonwood	Good	79	Neighbour	Mature; central dominant stem with co-dominant leaders at 10m; <b>to be preserved and protected</b>
3	Cottonwood	Good	86	Neighbour	Mature; central dominant stem with co-dominant leaders at 10m; broad, open-grown crown; <b>to be preserved and protected</b>
4	Cottonwood	Good	89	Neighbour	Mature; central dominant stem with co-dominant leaders at 12m and competing lateral at 10m on west; <b>to be preserved and protected</b>

5	Cottonwood	Good	79	Neighbour	Mature; central dominant stem with co-dominant leaders at 10m; crown asymmetric towards east due to influence of tree #4; <b>to be preserved and protected</b>
6	Cottonwood	Good	18	Private	Maturing; root sprout from nearby parent tree; very good growth increment; <b>to be removed</b> (conflicts with proposed new laneway)
7	Cottonwood	Good	95	Neighbour	Mature; central dominant stem with co-dominant leaders and competing lateral at 10m; crown asymmetric towards west due to influence of tree #8; <b>to be removed</b> (conflicts with proposed new truck access)
8	Cottonwood	Fair	67	Neighbour	Mature; upright, central dominant stem for most of height due to influence of trees #7 and 9; suppressed lateral at 8m towards north; <b>to be removed</b> (conflicts with proposed new truck access)

Picture 1. Neighbouring trees #1-9 located at 105 Schneider Road

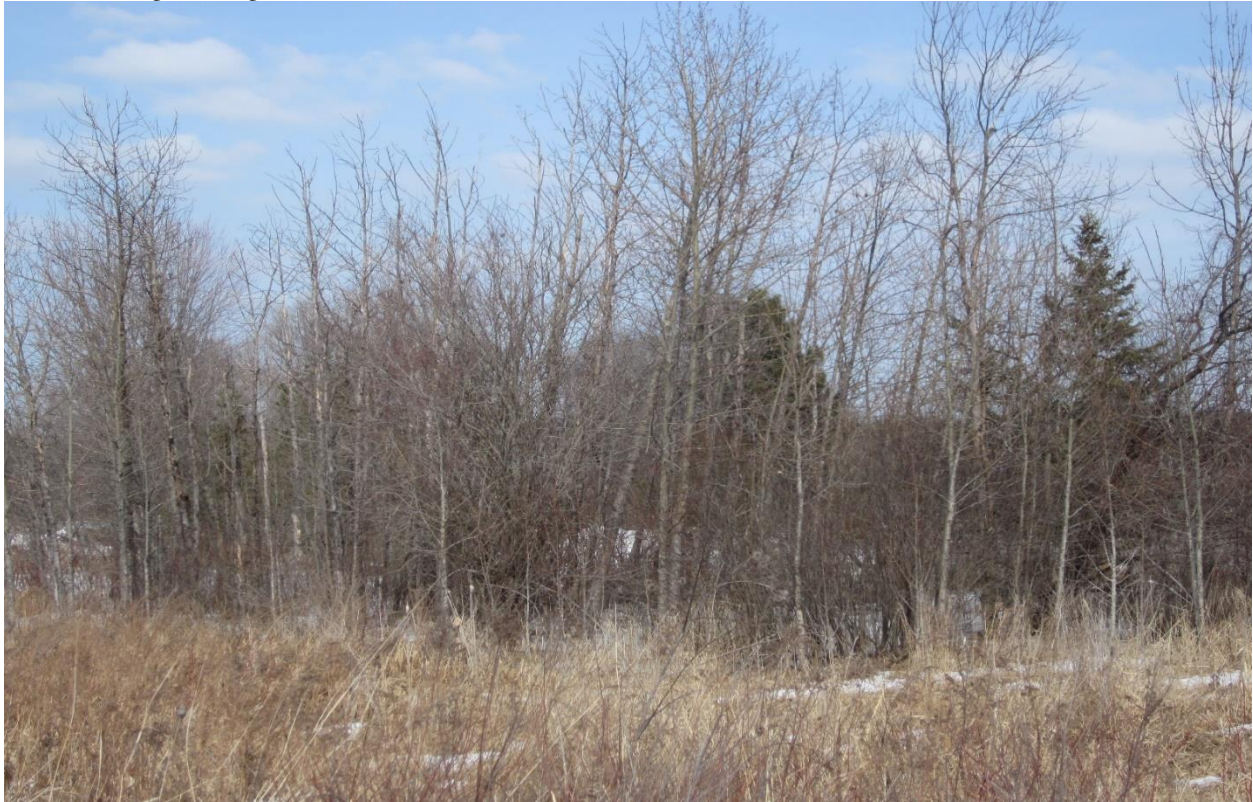
Picture 2. Tree grouping #12 at 101, 101(A) and 103 Schneider Road

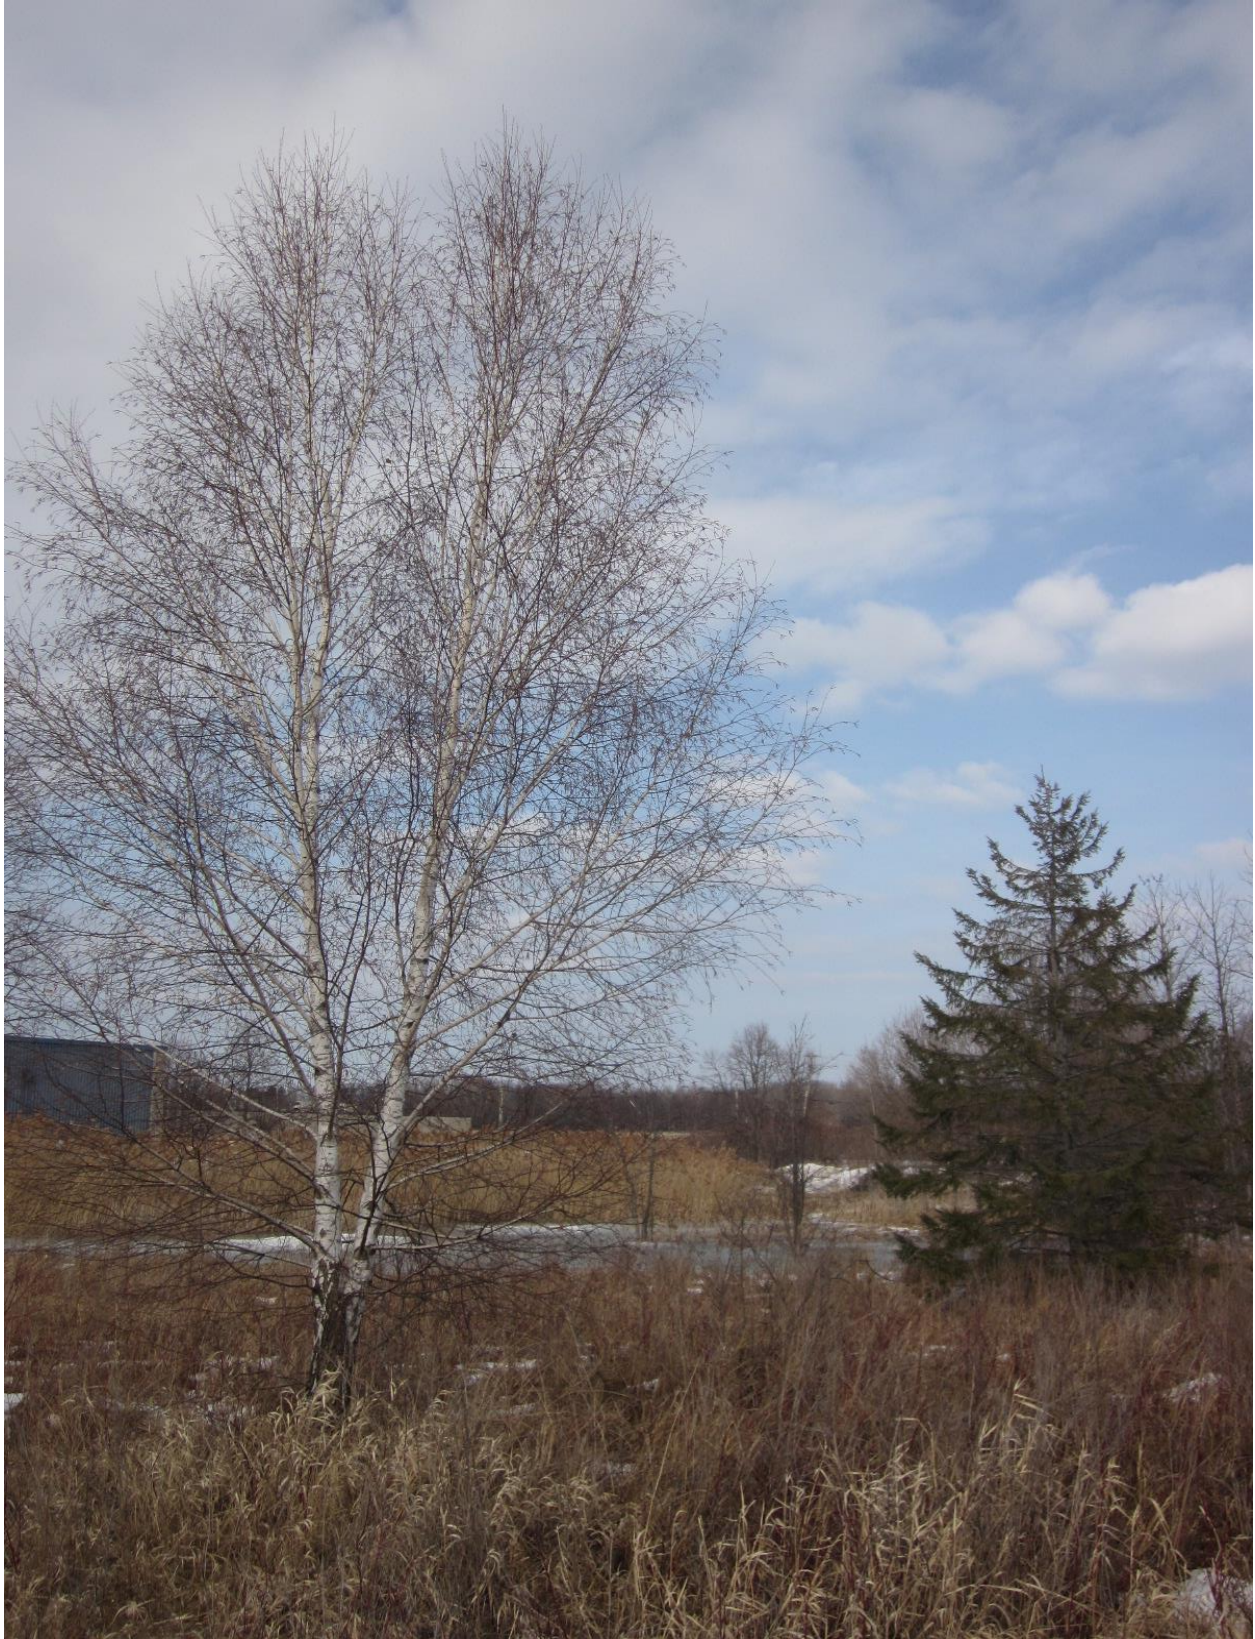
9	Cottonwood	Fair	96	Neighbour	Very mature; co-dominant stems at 7m with suppressed laterals starting at 4m; crown asymmetric towards southeast due to influence of tree #8 and second cottonwood further on neighbouring property; <b>to be preserved and protected</b>
10	White birch ( <i>Betula papyrifera</i> )	Very good	25 (at 1m)	Private	Mature; double-stemmed at 1.5m from grade; dense, symmetric crown; good growth increment; native species; <b>to be removed</b> (conflicts with proposed new loading zone)
11	White spruce ( <i>Picea glauca</i> )	Fair	33	Private	Mature; fair crown density, growth increment and needle colour; native species; <b>to be removed</b> (conflicts with proposed new loading zone)
12	Cottonwood, willow ( <i>Salix</i> spp.) & ash ( <i>Fraxinus</i> spp.)	Poor	+/-15 avg.	Private	Maturing; low wet area; saturated soil leading death of some cottonwood; ash dead or declining due to emerald ash borer ( <i>Agrilus planipennis</i> ); all native species; <b>to be removed</b> (conflicts with storm sewer connection, overflow spillway and grade changes )

Picture 3. Trees #10 and 11 at 101, 101(A) and 103 Schneider Road

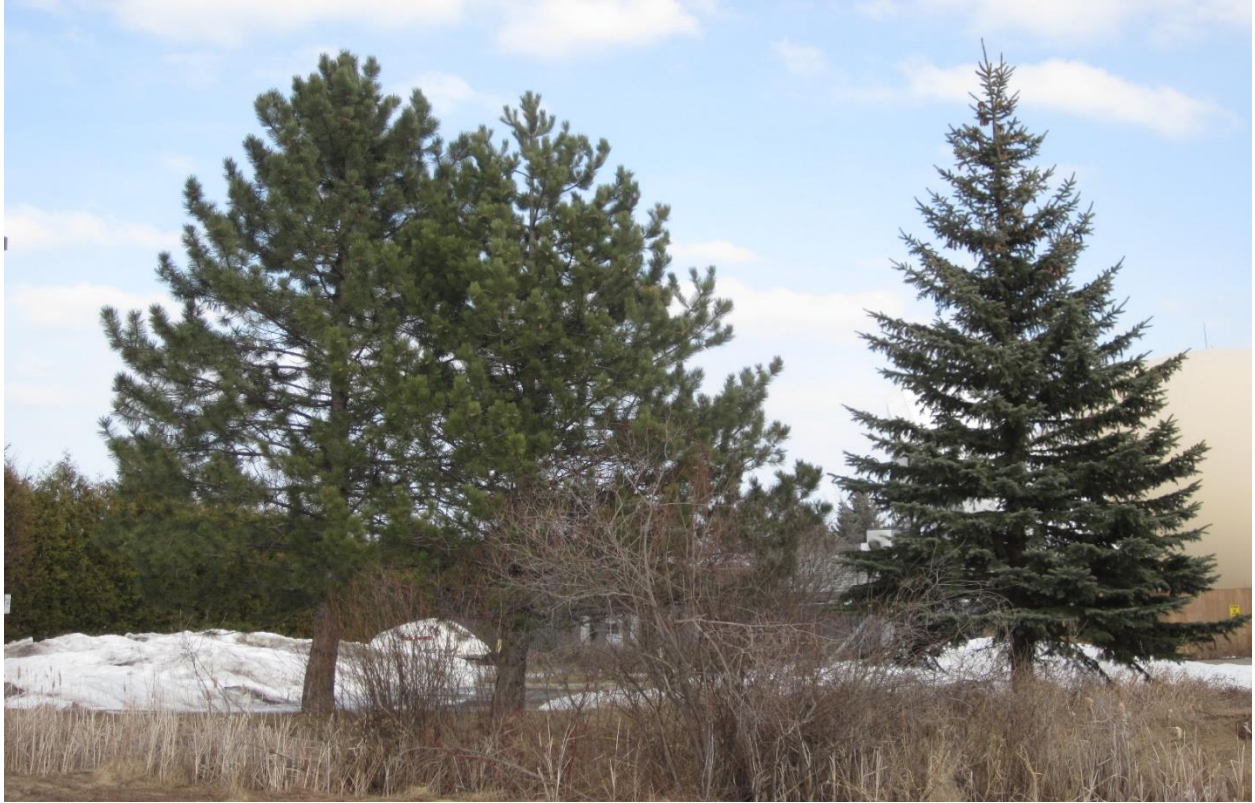
13	White spruce	Good	23	Shared	Maturing; good crown density, growth increment and needle colour; <b>to be preserved and protected</b>
14	Little-leaf linden ( <i>Tilia cordata</i> )	Good	34	Neighbour	Maturing; typical teardrop-shaped crown form; dense, symmetric crown; good growth increment; introduced species; <b>to be preserved and protected</b>
15	Austrian pine ( <i>Pinus nigra</i> )	Good	34	Shared	Maturing; good crown density, growth increment and needle colour; introduced species; <b>to be preserved and protected</b>
16	Austrian pine	Good	37	Neighbour	Maturing; upright, generally symmetric crown; good crown density, growth increment and needle colour; <b>to be preserved and protected</b>

17	Austrian pine	Good	34	Neighbour	Maturing; upright, generally symmetric crown; good crown density, growth increment and needle colour; <b>to be preserved and protected</b>
18	Colorado blue spruce ( <i>Picea pungens</i> var. <i>glauca</i> )	Very good	24	Neighbour	Maturing; symmetric crown; very good crown density, growth increment and needle colour; introduced species; <b>to be preserved and protected</b>
19	Austrian pine	Fair	28	Shared	Maturing; central stem with sweep in lower bole; crown asymmetric due to influence of trees #20 and 21; good crown density, growth increment and needle colour; <b>to be preserved and protected</b>
20	Austrian pine	Good	34	Neighbour	Maturing; crown asymmetric due to influence of trees #19 and 21; good crown density, growth increment and needle colour; <b>to be preserved and protected</b>
21	Austrian pine	Good	37	Neighbour	Maturing; crown asymmetric due to influence of trees #19 and 20; good crown density, growth increment and needle colour; <b>to be preserved and protected</b>

Picture 4. Trees #16, 17 and 18 (left to right) at 101, 101(A) and 103 Schneider Road

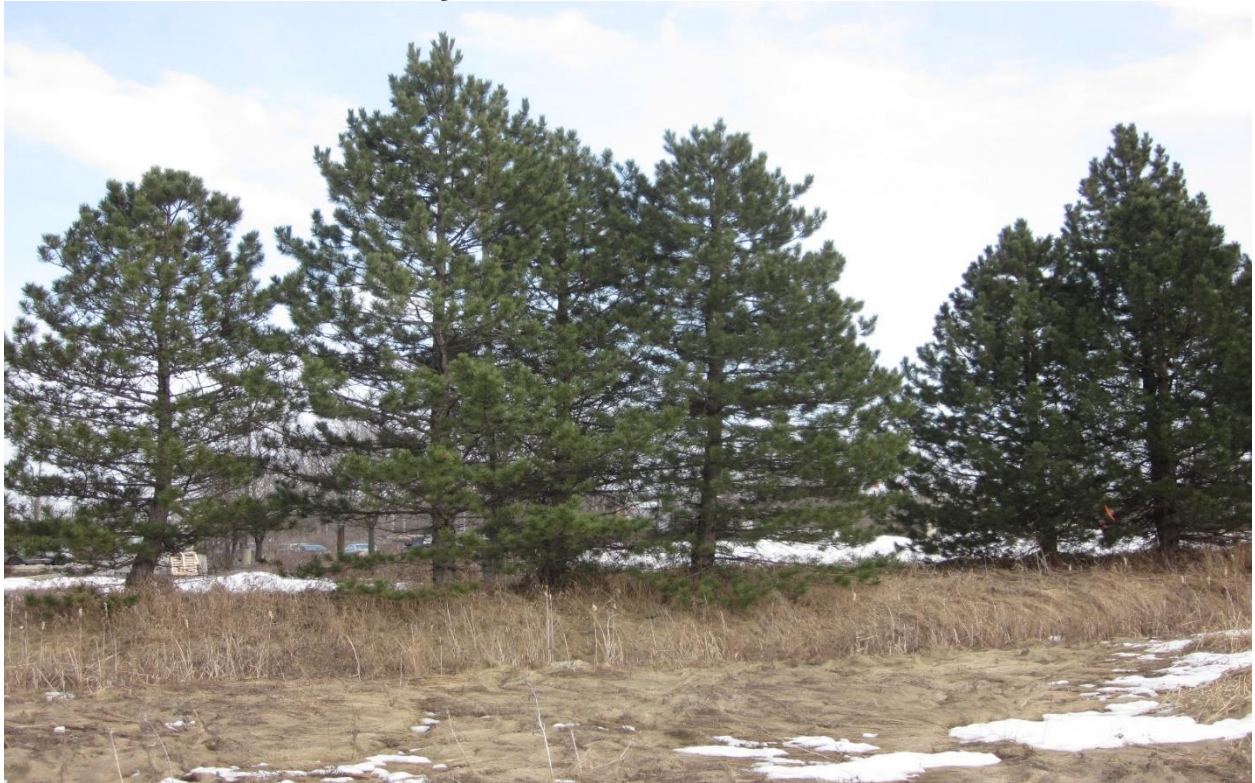
22	Austrian pine	Good	22 avg.	Neighbour	Maturing; double-stemmed at 1m; good crown density, growth increment and needle colour; <b>to be preserved and protected</b>
23	Austrian pine	Good	+/-25 avg.	Neighbour	Group of three maturing trees; crowns asymmetric due to intercompetition between trees for sunlight; good crown density, growth increment and needle colour; <b>to be preserved and protected</b>

Picture 5. Trees #19-23 (left to right) at 101, 101(A) and 103 Schneider Road
