URBAN FORESTRY & FOREST MANAGEMENT CONSULTING

April 1, 2021

# RE: TREE CONSERVATION REPORT - 101, 101(A) AND 103 SCHNEIDER ROAD, OTTAWA

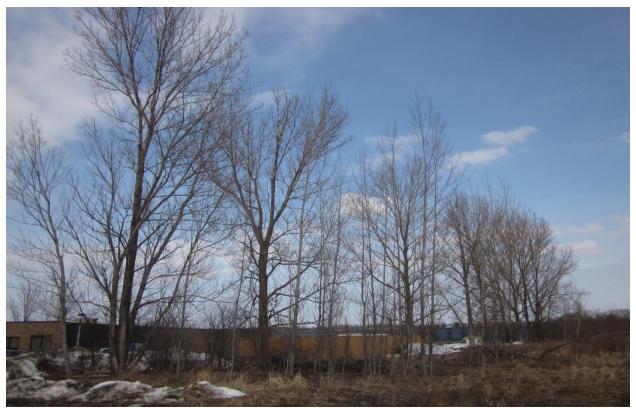
Tree		Condition	DBH <sup>1</sup>	Owner	Aga aloss trae condition notes &
	Tree species				Age class, tree condition notes &
No.		$(VP \rightarrow E)$	(cm)	-ship	preservation status (to be removed
1	C 44 1	г.	52	NT 1	or preserved and protected)
1	Cottonwood	Fair	53	Neigh-	Mature; multi-stemmed from grade –
	(Populus			bour/	central, dominant stem with
	deltoides)			Private	suppressed basal stems; "wooded
					area" on survey is root sprouts on
					subject property (10cm average);
					native species; wooded area to be
					removed (conflicts with new loading
					zone)
2	Cottonwood	Good	79	Neigh-	Mature; central dominant stem with
				bour	co-dominant leaders at 10m; <b>to be</b>
					preserved and protected
3	Cottonwood	Good	86	Neigh-	Mature; central dominant stem with
				bour	co-dominant leaders at 10m; broad,
					open-grown crown; to be preserved
					and protected
4	Cottonwood	Good	89	Neigh-	Mature; central dominant stem with

bour	co-dominant leaders at 12m and
					competing lateral at 10m on west; <b>to</b>
					be preserved and protected
5	Cottonwood	Good	79	Neigh-	Mature; central dominant stem with
				bour	co-dominant leaders at 10m; crown
					asymmetric towards east due to
					influence of tree #4; to be preserved
					and protected
6	Cottonwood	Good	18	Private	Maturing; root sprout from nearby
					parent tree; very good growth
					increment; to be removed (conflicts
					with proposed new laneway)
7	Cottonwood	Good	95	Neigh-	Mature; central dominant stem with
				bour	co-dominant leaders and competing
					lateral at 10m; crown asymmetric
					towards west due to influence of tree

#8; to be removed (conflicts with
					proposed new truck access)
8	Cottonwood	Fair	67	Neigh-	Mature; upright, central dominant
				bour	stem for most of height due to
					influence of trees #7 and 9;
					suppressed lateral at 8m towards
					north; to be removed (conflicts with
					proposed new truck access)

Picture 1. Neighbouring trees #1-9 located at 105 Schneider Road

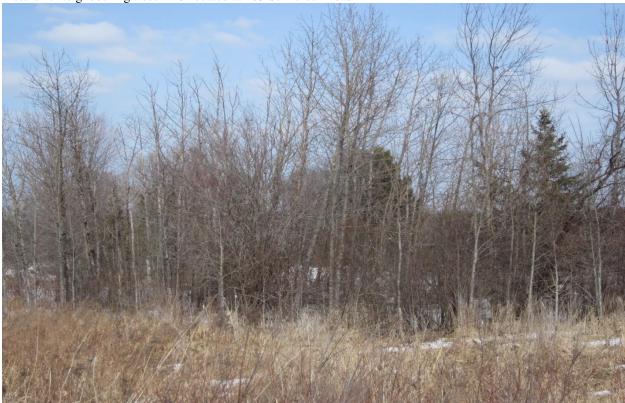
-	with proposed new loading zone)
11	White spruce	Fair	33	Private	Mature; fair crown density, growth
	(Picea glauca)				increment and needle colour; native
					species; to be removed (conflicts
					with proposed new loading zone)
12	Cottonwood,	Poor	+/-15	Private	Maturing; low wet area; saturated soil
	willow (Salix		avg.		leading death of some cottonwood;
	spp.) & ash				ash dead or declining due to emerald
	(Fraxinus spp.)				ash borer (Agrilus planipennis); all
					native species; to be preserved and
					protected
13	White spruce	Good	23	Shared	Maturing; good crown density,
					growth increment and needle colour;
					to be preserved and protected
14	Little-leaf	Good	34	Neigh-	Maturing; typical teardrop-shaped
	linden			bour	crown form; dense, symmetric
	(Tilia cordata)				crown; good growth increment;
					introduced species; to be preserved
					and protected
15	Austrian pine	Good	34	Shared	Maturing; good crown density,

Picture 2. Tree grouping #12 at 101, 101(A) and 103 Schneider Road

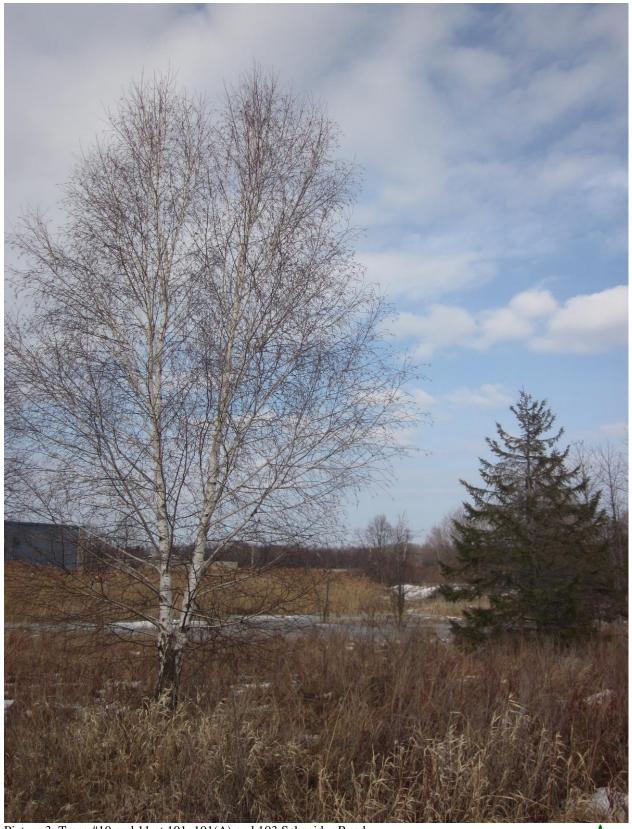
1.0			~~ /	5.1	preserved and protected
10	White birch	Very good	25 (at	Private	Mature; double-stemmed at 1.5m
	(Betula		1m)		from grade; dense, symmetric crown;
	papyrifera)				good growth increment; native
					species; to be removed (conflicts

Picture 3. Trees #10 and 11 at 101, 101(A) and 103 Schneider Road

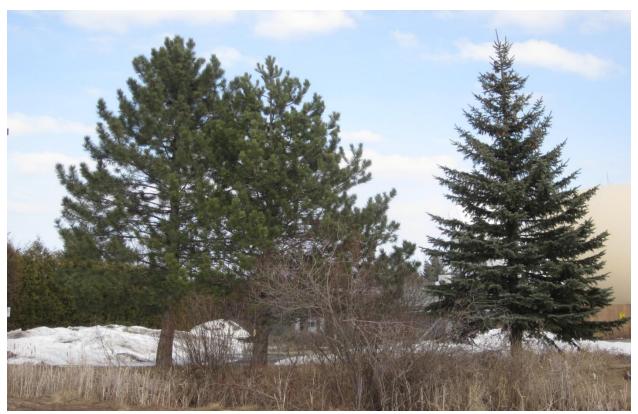
(Pinus nigra)				growth increment and needle colour;
					introduced species; to be preserved
					and protected
16	Austrian pine	Good	37	Neigh-	Maturing; upright, generally
				bour	symmetric crown; good crown
					density, growth increment and needle
					colour; to be preserved and
					protected
17	Austrian pine	Good	34	Neigh-	Maturing; upright, generally
	·			bour	symmetric crown; good crown
					density, growth increment and needle
					colour; to be preserved and
					protected
	l .	ı	1	1

Picture 4. Trees #16, 17 and 18 (left to right) at 101, 101(A) and 103 Schneider Road

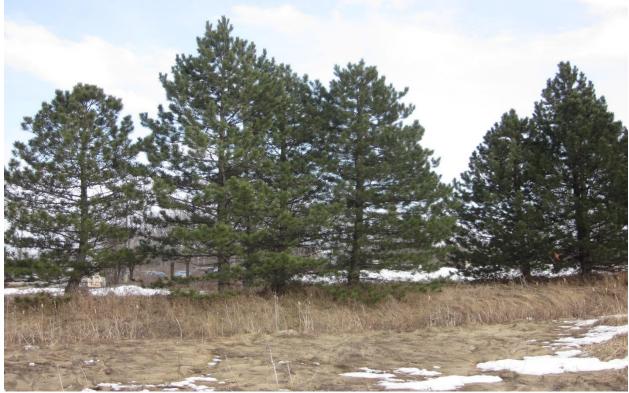
. Coll t		2.4		3.5
	Very good	24	_	Maturing; symmetric crown; very
•			bour	good crown density, growth
pungens var.				increment and needle colour;
glauca)				introduced species; to be preserved
				and protected
Austrian pine	Fair	28	Shared	Maturing; central stem with sweep in
				lower bole; crown asymmetric due to
				influence of trees #20 and 21; good
				crown density, growth increment and
				needle colour; to be preserved and
				protected
Austrian pine	Good	34	Neigh-	Maturing; crown asymmetric due to
			bour	influence of trees #19 and 21; good
				crown density, growth increment and
				needle colour; to be preserved and
				protected
Austrian pine	Good	37	Neigh-	Maturing; crown asymmetric due to
			bour	influence of trees #19 and 20; good
				crown density, growth increment and
				needle colour; to be preserved and
				protected
Austrian pine	Good	22	Neigh-	Maturing; double-stemmed at 1m;
		avg.	bour	good crown density, growth

increment and needle colour; to be
				preserved and protected
Austrian pine	Good	+/-25	Neigh-	Group of three maturing trees;
		avg.	bour	crowns asymmetric due to
				intercompetition between trees for
				sunlight; good crown density, growth
				increment and needle colour; to be
				preserved and protected
	Colorado blue spruce (Picea pungens var. glauca)  Austrian pine  Austrian pine  Austrian pine	Colorado blue spruce (Picea pungens var. glauca)  Austrian pine  Fair  Austrian pine  Good  Austrian pine  Good  Austrian pine  Good	Colorado blue spruce (Picea pungens var. glauca)Very good24Austrian pineFair28Austrian pineGood34Austrian pineGood37Austrian pineGood22 avg.Austrian pineGood+/-25	Colorado blue spruce (Picea pungens var. glauca)Very good24Neigh- bourAustrian pineFair28SharedAustrian pineGood34Neigh- bourAustrian pineGood37Neigh- bourAustrian pineGood22 avg.Neigh- bourAustrian pineGood+/-25Neigh-Austrian pineGood+/-25Neigh-

Picture 5. Trees #19-23 (left to right) at 101, 101(A) and 103 Schneider Road
