Project:  
**Gladstone and Loretta**  
 OTTAWA, ONTARIO

Drawing:  
**TREE CONSERVATION REPORT**

Scale:	1:250	Date:	04 OCT 2018
Design By:	QL	Drawn By:	QL
Project Number:	1987-01	Sheet Number:	TCR 1.0

Scale: 1:250	Date: 04 OCT 2018
Design By: QL	Drawn By: QL
Project Number: 1987-01	Sheet Number: TCR 1.1

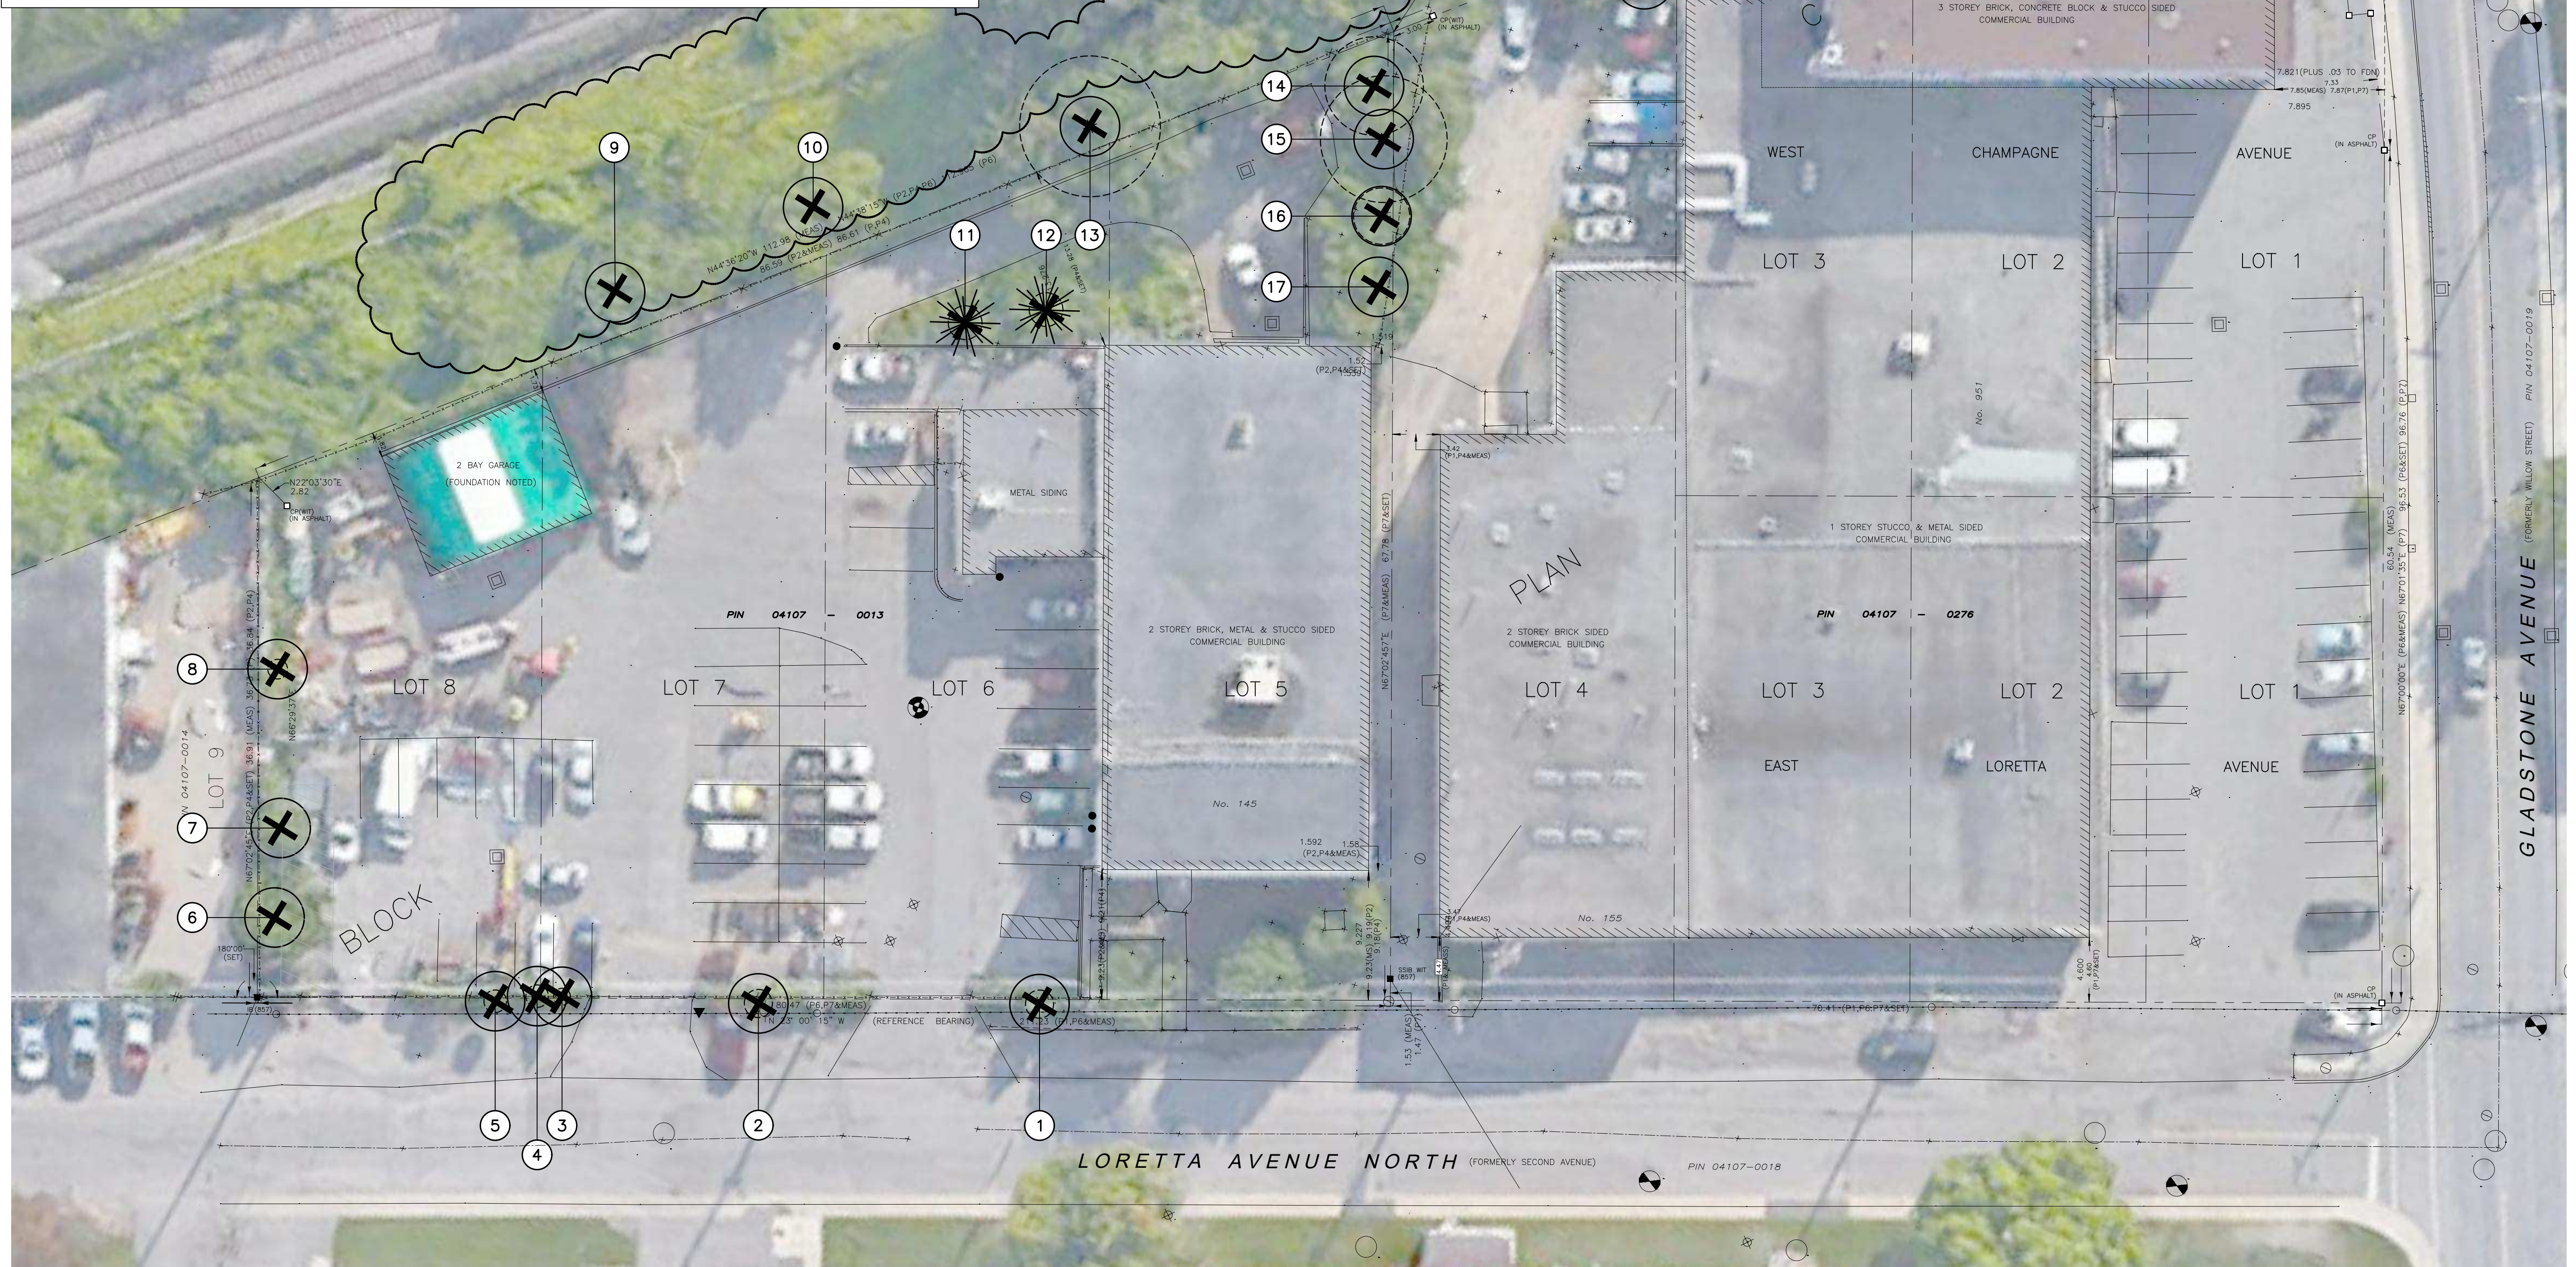
Tree #	Botanical Name	Common Name	Caliper (cm)	Condition	High Quality Tree	Rare Tree	Comments	To Be Preserved
1	<i>Syringa reticulata</i>	Japanese Tree Lilac	10	Good	NO	NO	City Owned, Symmetrical Canopy	NO
2	<i>Syringa reticulata</i>	Japanese Tree Lilac	10	Good	NO	NO	City Owned, Symmetrical Canopy	NO
3	<i>Syringa reticulata</i>	Japanese Tree Lilac	6	Poor	NO	NO	City Owned, Asymmetrical Canopy, Die-back 40% @ canopy, Leaning, Broken trunk @ base	NO
4	<i>Syringa reticulata</i>	Japanese Tree Lilac	8	Moderate	NO	NO	City Owned, Symmetrical Canopy, Die-back 20% @ canopy, Broken limbs	NO
5	<i>Syringa reticulata</i>	Japanese Tree Lilac	8	Moderate	NO	NO	City Owned, Asymmetrical Canopy, Die-back 10% @ canopy, Broken limbs	NO
6				Dead				
7				Dead				
8	<i>Acer negundo</i>	Manitoba Maple	7	Moderate	NO	NO	Private Owned, Symmetrical Canopy, Pruned lower stems, Co-dominant leaders 2 @ 2.0m	NO
9				Dead				
10				Dead

11	<i>Tsuga canadensis</i>	Eastern Hemlock	12	Good	NO	NO	Private Owned, Symmetrical Canopy	NO
12	<i>Tsuga canadensis</i>	Eastern Hemlock	12	Good	NO	NO	Private Owned, Symmetrical Canopy	NO
13	<i>Acer negundo</i>	Manitoba Maple	50, 40, 30	Moderate	NO	NO	Private Owned, Symmetrical Canopy, Die-back 5% @ canopy, 3 stem, Significant invasive vines	NO
14	<i>Acer negundo</i>	Manitoba Maple	35	Poor	NO	NO	Private Owned, Asymmetrical Canopy, Die-back 75% @ canopy, Broken limbs, Poor branch angle, Significant invasive vines	NO
15	<i>Acer negundo</i>	Manitoba Maple	45	Poor	NO	NO	Private Owned, Asymmetrical Canopy, Die-back 75% @ canopy, Poor branch angle, Leaning, Significant invasive vines	NO
16	<i>Acer negundo</i>	Manitoba Maple	15, 20	Moderate	NO	NO	Private Owned, Asymmetrical Canopy, 4 stem	NO
17				Dead				
18	<i>Acer negundo</i>	Manitoba Maple	15, 20	Poor	NO	NO	Private Owned, Symmetrical Canopy, Die-back 20% @ canopy, Broken limbs, 5 stem, Leaning	NO

19	<i>Ulmus parvifolia</i>	Chinese Elm	9	Good	NO	NO	Private Owned, Symmetrical Canopy, Co-dominant 2 @ 0.5m	NO
20	<i>Populus deltoides</i>	Cottonwood	~45	Moderate	NO	NO	City Owned, Symmetrical Canopy	NO
21	<i>Acer negundo</i>	Manitoba Maple	varies	Poor	NO	NO	City Owned, Asymmetrical Canopy, Significant invasive vines	NO

THIS IS AN EXISTING COMMERCIAL SITE USED PRIMARILY AS BUSINESS SPACE FOR MULTIPLE TENANTS. MUCH OF THE SITE IS CURRENTLY OCCUPIED BY ASPHALT PARKING LOT. THE MAJORITY OF TREES ON SITE ARE AT THE PERIMETER EDGES. WITH THE EXCEPTION OF THE STREET TREES ALONG LORETTA AVE, MOST TREES HAVE ESTABLISHED POORLY AND ARE ILL SITUATED ALONG FENCE LINES OR DIRECTLY AT RETAINING WALLS.

THE LINEAR LANDSCAPE AREA NORTHEAST OF THE SITE RUNS ADJACENT TO THE EXISTING O-TRAIN TRACKS. THIS AREA IS SEPARATED FROM THE COMMERCIAL PROPERTIES WITH CHAIN LINK FENCE AT THE TOP OF A SLOPE. THE AREA IS DENSE WITH INVASIVE PLANTS SUCH AS MANITOBA MAPLE, WILD GRAPE VINE AND VIRGINIA CREEPER. THE AREA HAS A GREAT DEAL OF DEAD TREES AND MISCELLANEOUS DEBRIS MAKING THE AREA DIFFICULT TO ACCESS.

THE SITE LACKS SIGNIFICANT TREES OF VALUE. THE PRESENT TREES OFFER LITTLE BENEFIT TO THE SITE IN TERMS OF ECOLOGY, CHARACTER, OR SHADE VALUE. THE GENERAL CONDITION OF THE SITE'S TREES ARE POOR WITH A DECLINING STATE OF HEALTH.
