June 30, 2021

RE: TREE CONSERVATION REPORT FOR 180 KANATA AVENUE, OTTAWA

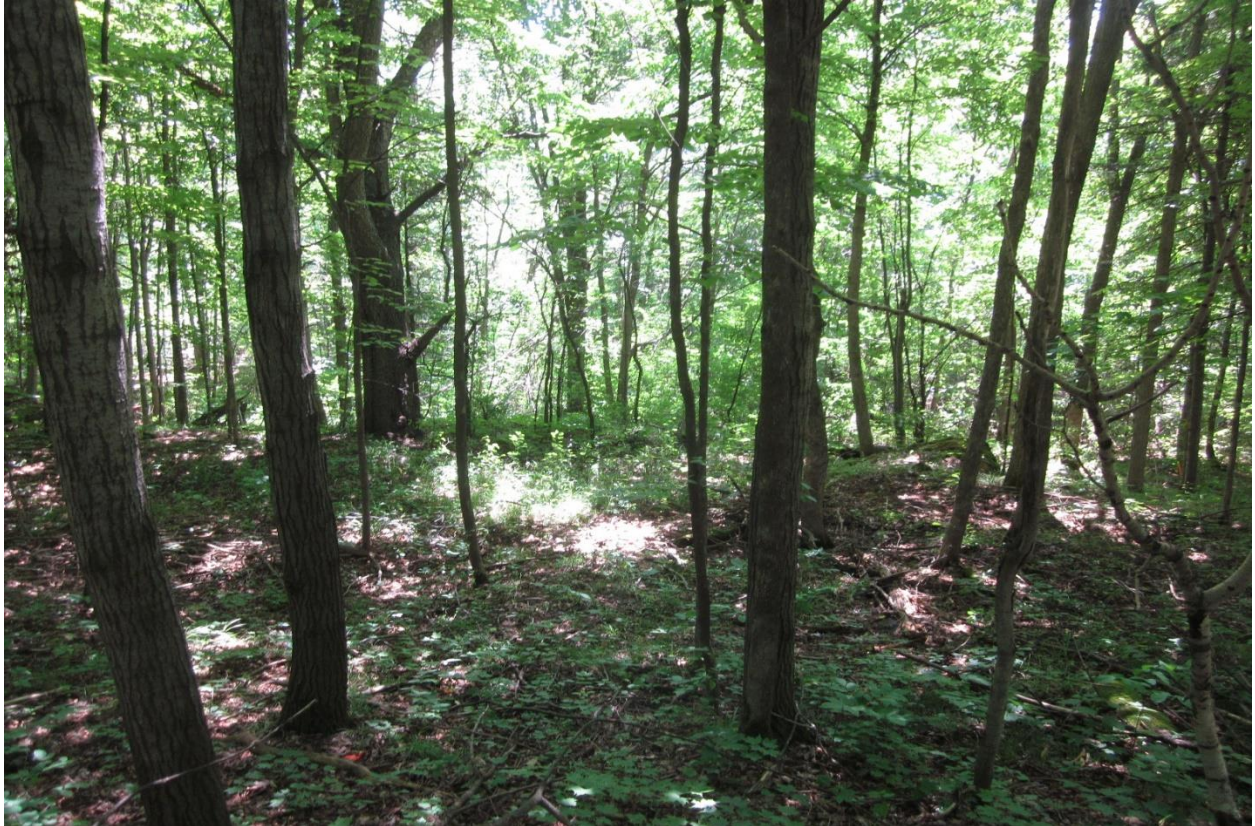
Picture 1. Typical over- and understory conditions at 180 Kanata Avenue property (looking southeastward)

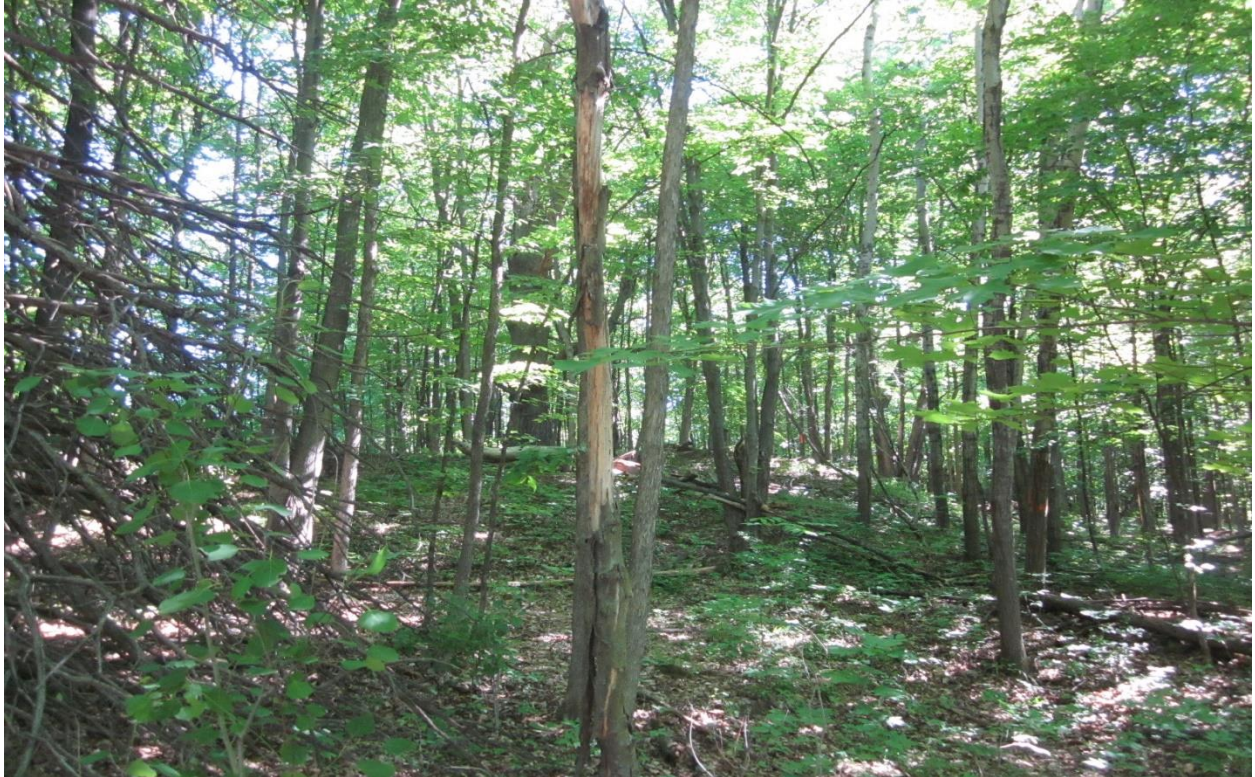
Picture 2. Typical over- and understory conditions at 180 Kanata Avenue property (looking northeastward)

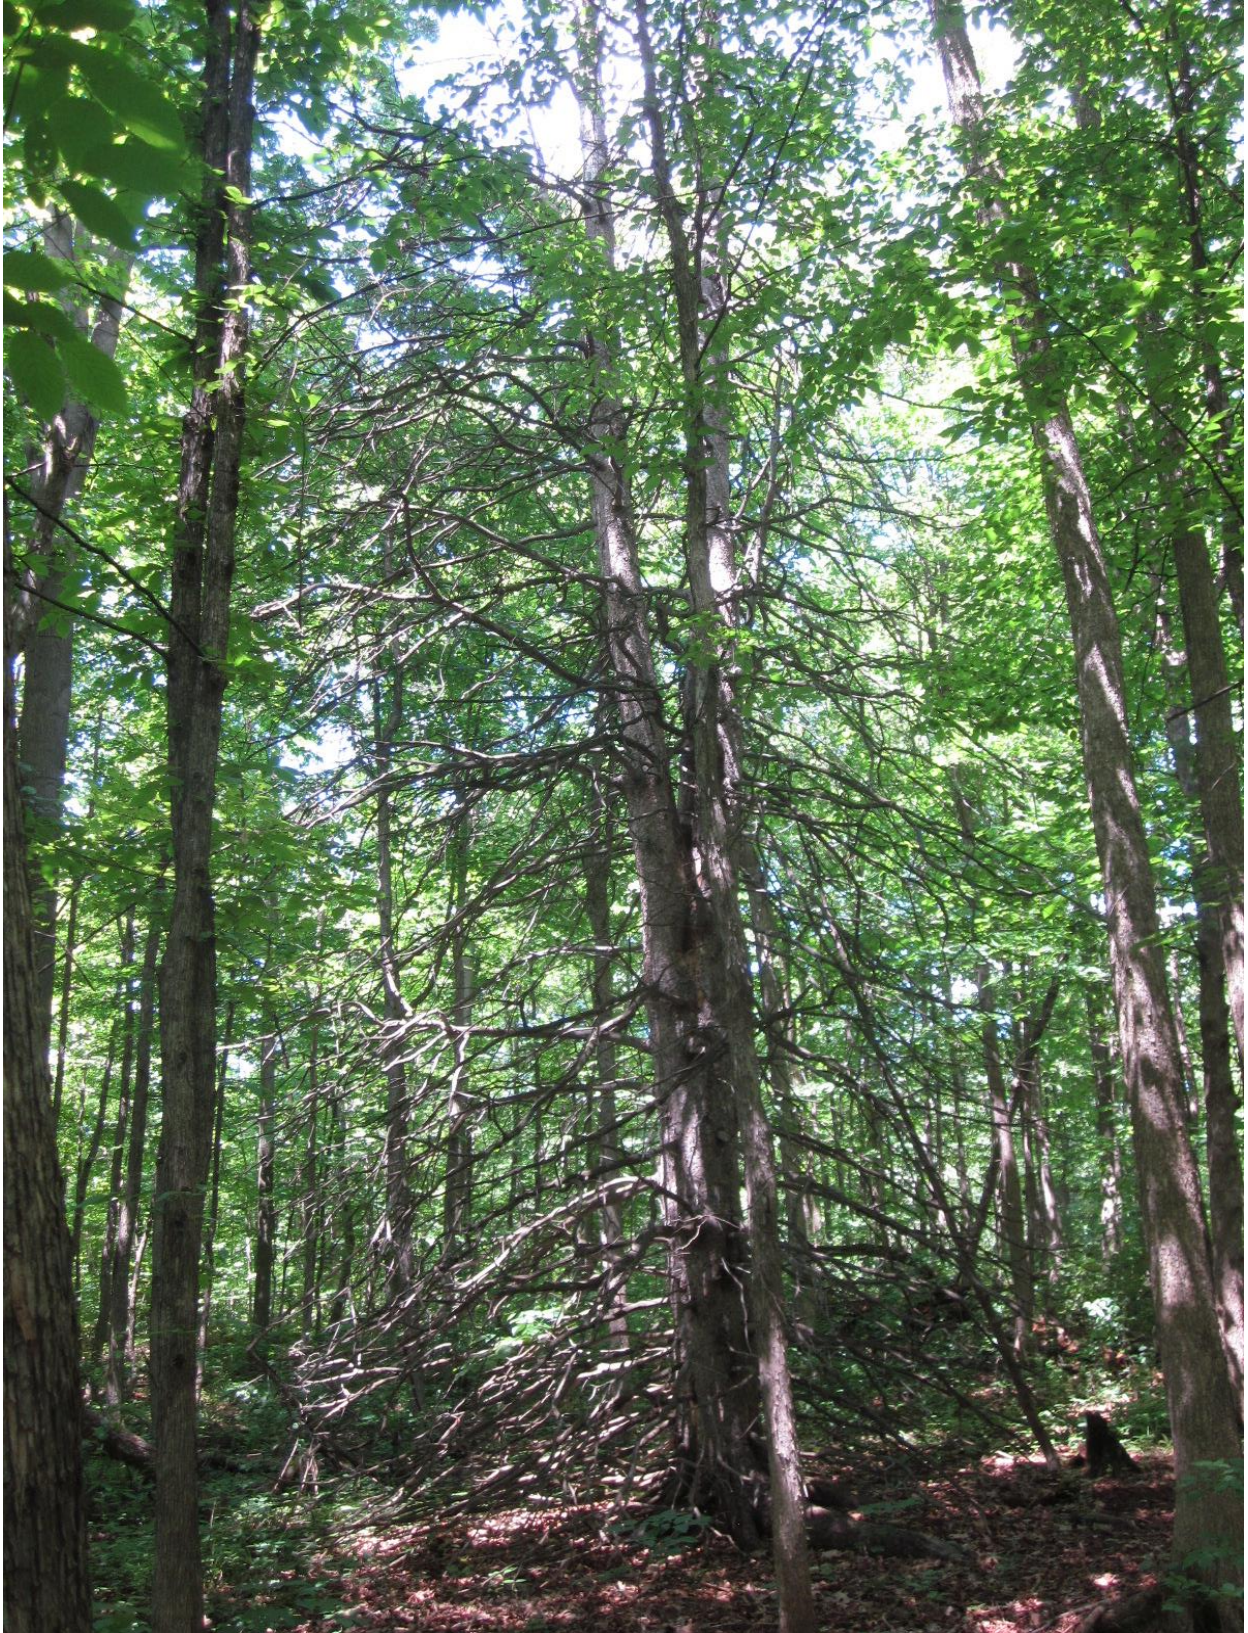
Their diminished presence is one negative consequence to a lack of forest disturbance. White pine seeds require exposed mineral soil for germination, cedars need openings in the canopy for sufficient sunlight and soil moisture (through interception of precipitation) and white spruce seeds will have trouble penetrating the thick litter layer beneath a deciduous stand. Consequently, although trees of seed bearing age are present, no regeneration of the three coniferous species was found in the understory.

Picture 3. Recently dead veteran white spruce at 180 Kanata Avenue property

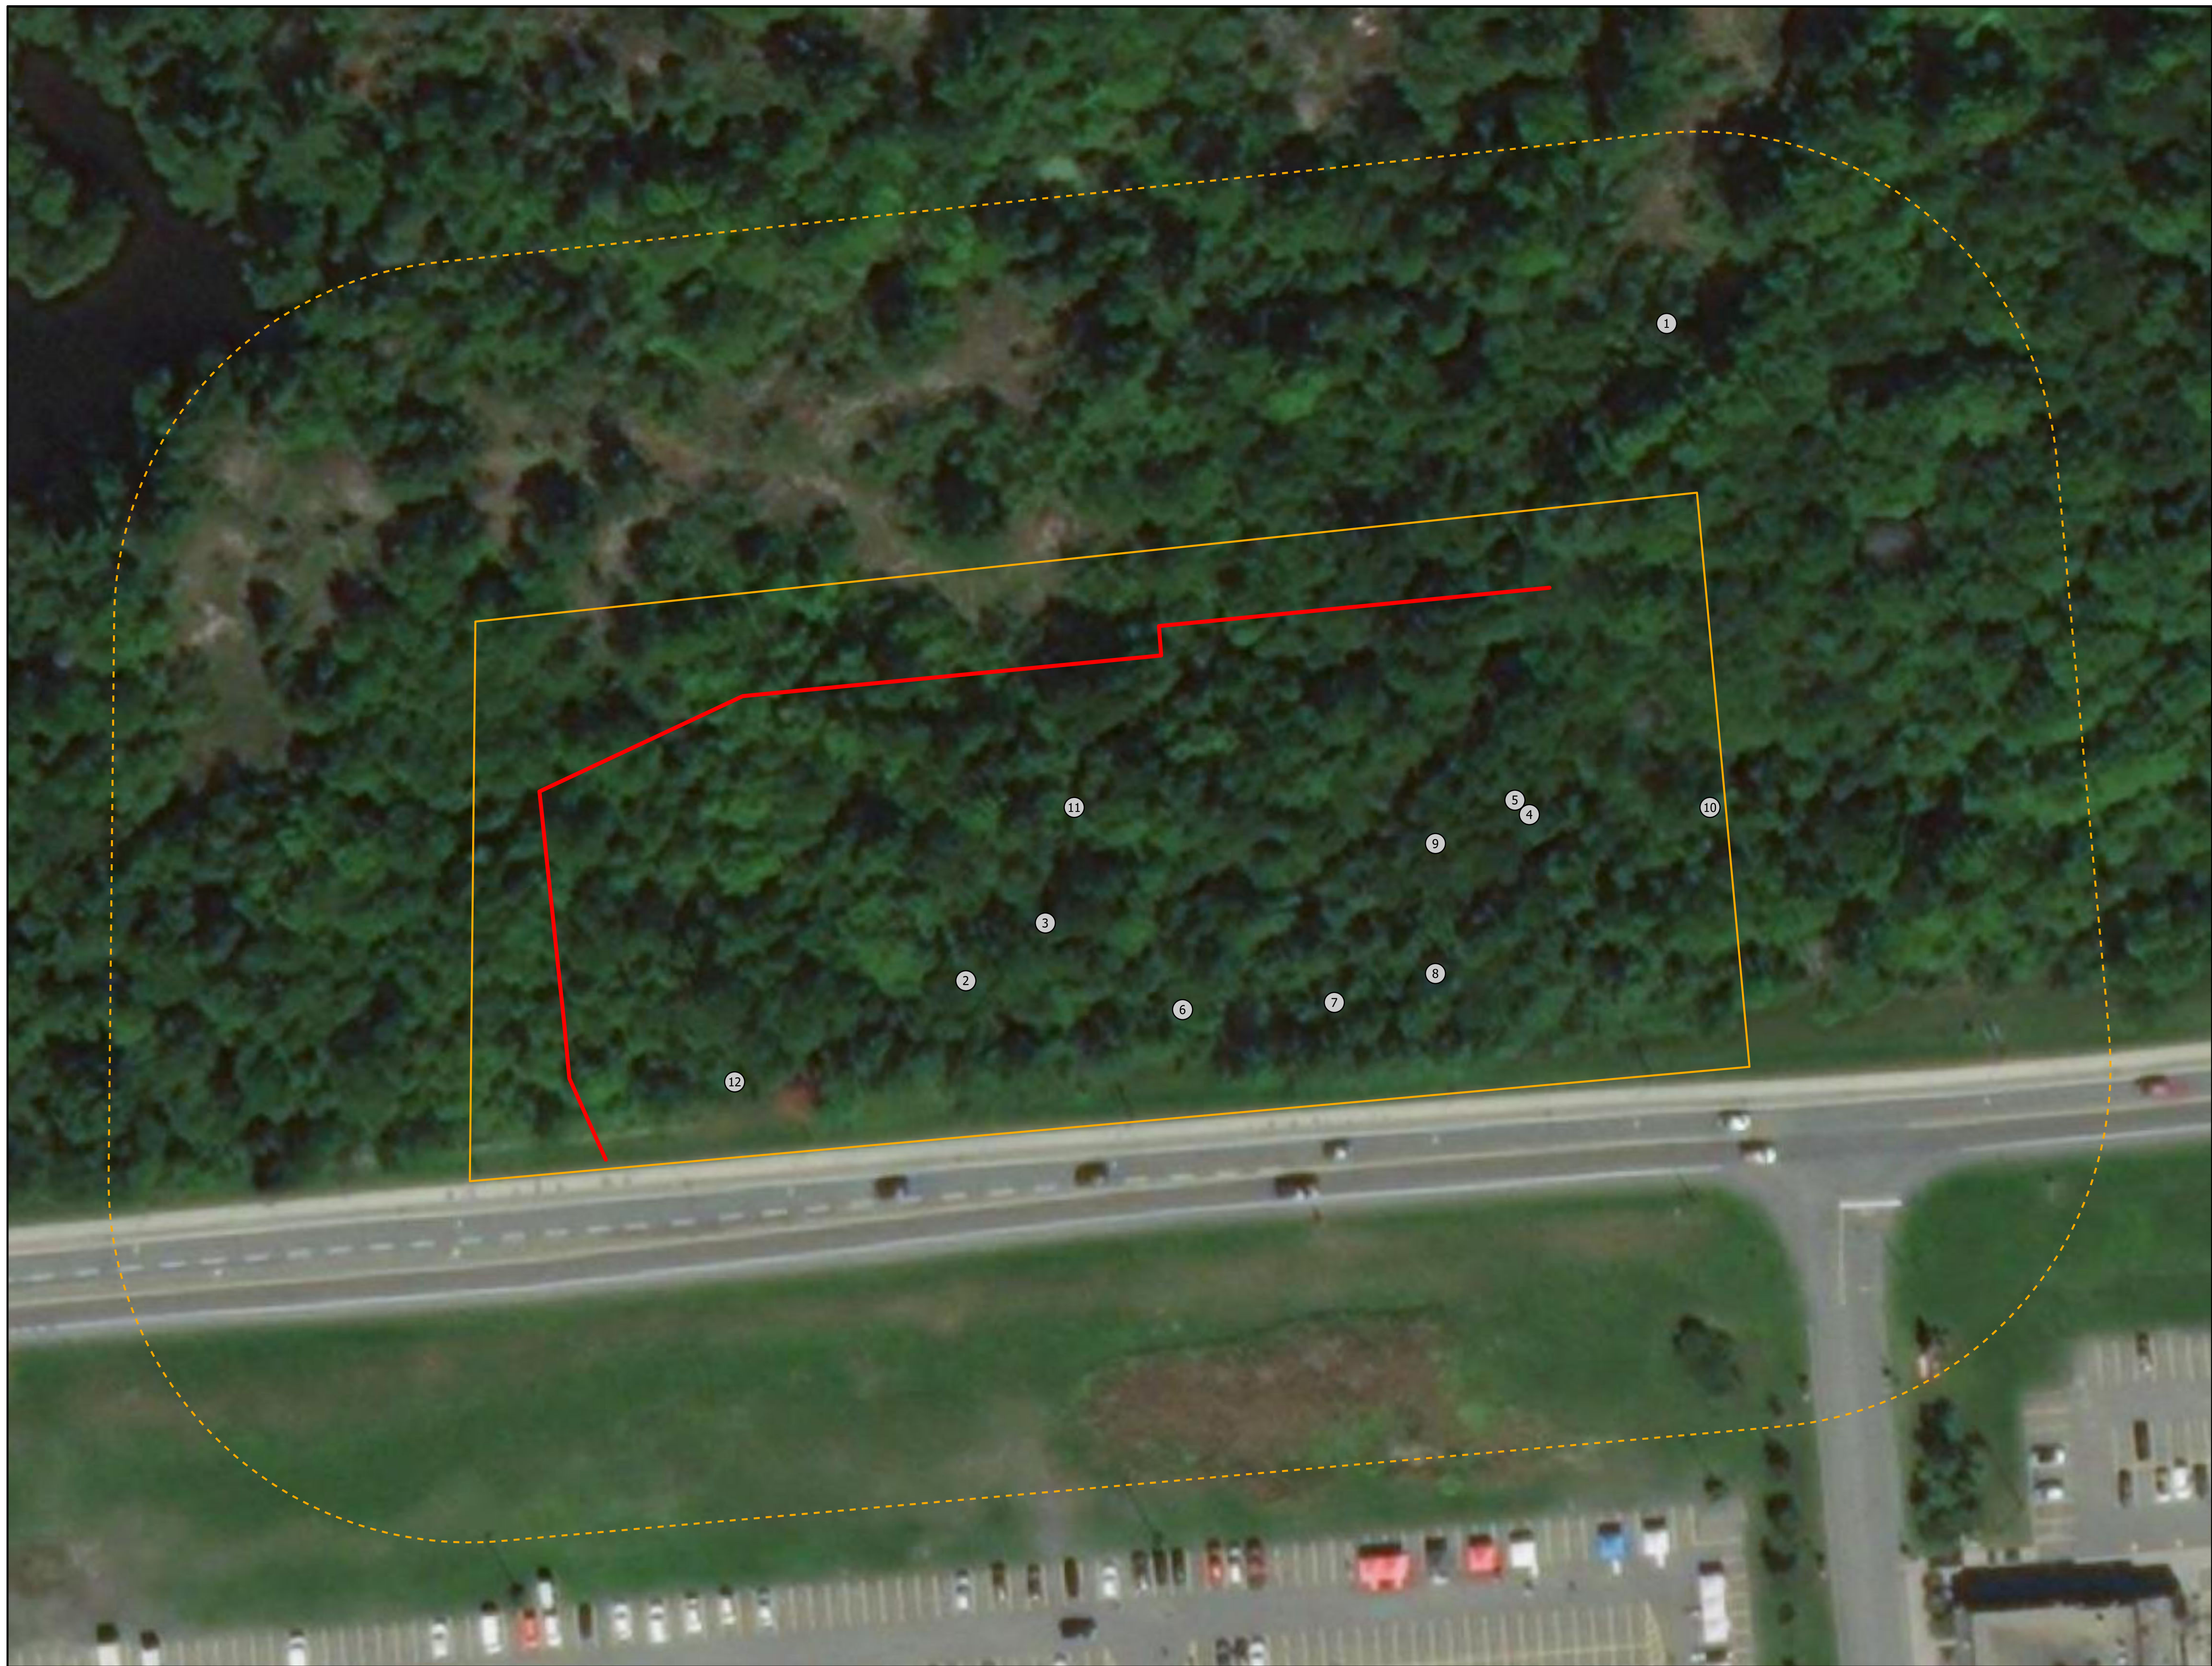
DRAWING: Locations of Butternut

A total of twelve butternuts (*Juglans cinerea*) were found on or within 50m of the subject property. This tree species is listed as endangered under the Province of Ontario's Endangered Species Act (2007) and so is protected from harm. Through the completion of a butternut health assessment all twelve trees were determined to be Category 1 (*i.e.* non-retainable). This assessment was sent to the Ontario Ministry of Environment, Conservation and Parks in June 2021.

Given the layout of the proposed development and parking below grade, and the relatively small area of the subject property, there are very limited opportunities for the conservation of existing trees. In particular, the need for substantial grade changes (via blasting due to the presence of extensive rock) precludes large scale tree conservation. Instead, tree retention will be limited to the margins of the property – in particular along the northern and western property lines (see tree conservation plan included on page 9 of this report).
