TREE CONSERVATION REPORT

18 Louisa Street, Ottawa, Ontario

May 26, 2021

revised August 09, 2024

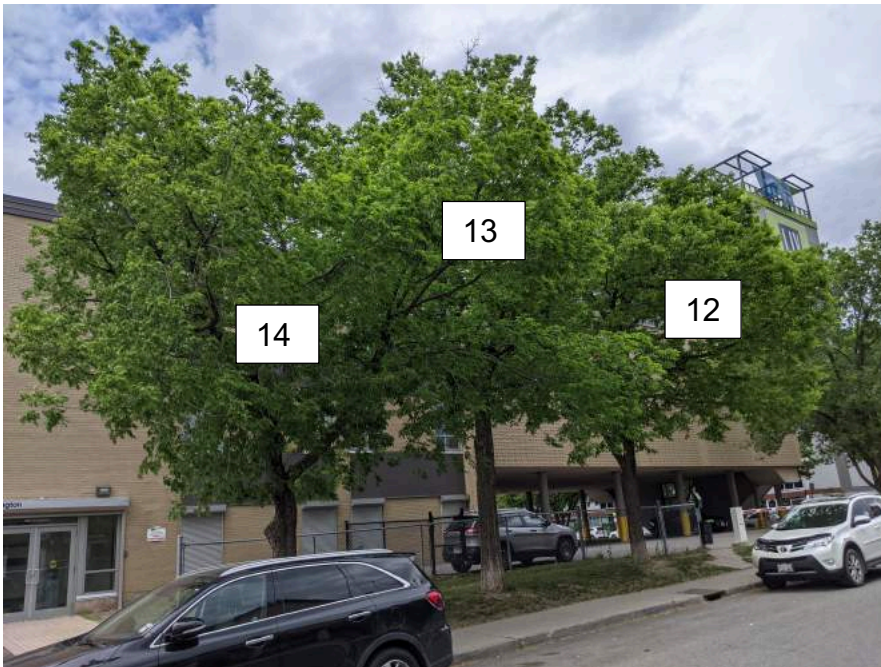
Trees #12, 13, 14 will be impacted by the proposed development (transformer location and access drive). These are Ash trees and do not appear to have received inoculation against Emerald Ash Borer. As the initial inventory was conducted in the winter, overall canopy condition was impossible to determine. However, as Figure 1 shows, all the Ash trees

appear to be in overall good condition as of May 26th, 2021. The roots on all three trees are slightly girdled, but canopies appear to be full and lush.

Figure 2 Picture of Ash trees on May 26, 2021.

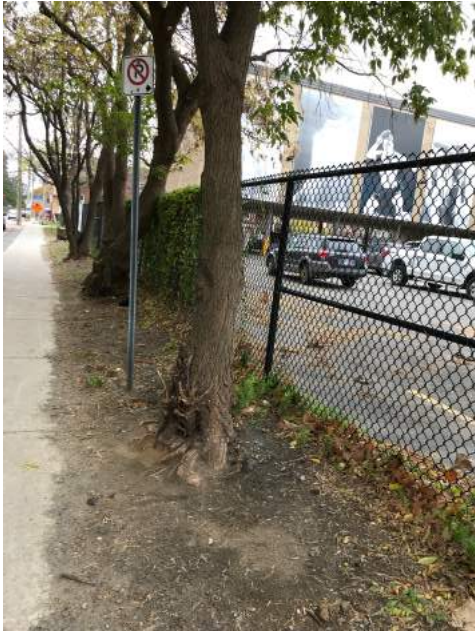
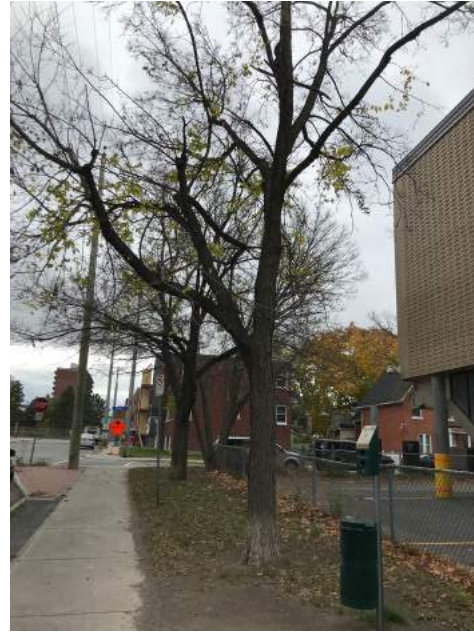
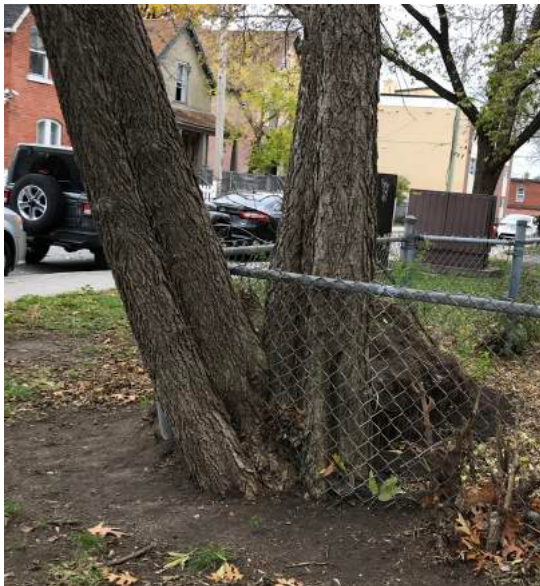
Trees # 1-11 are in direct conflict with the proposed development. According to the proposed site plan, the parking garage extends to the property line on all sides. Therefore, all trees are scheduled to be removed. The majority of these trees were in fair to poor condition, as shown in Figure 2 below (*updated November 10, 2021*).

Figure 2-4: poor growth habit of Manitoba Maple and Ash along Bell Street, canopy pruned for overhead hydro

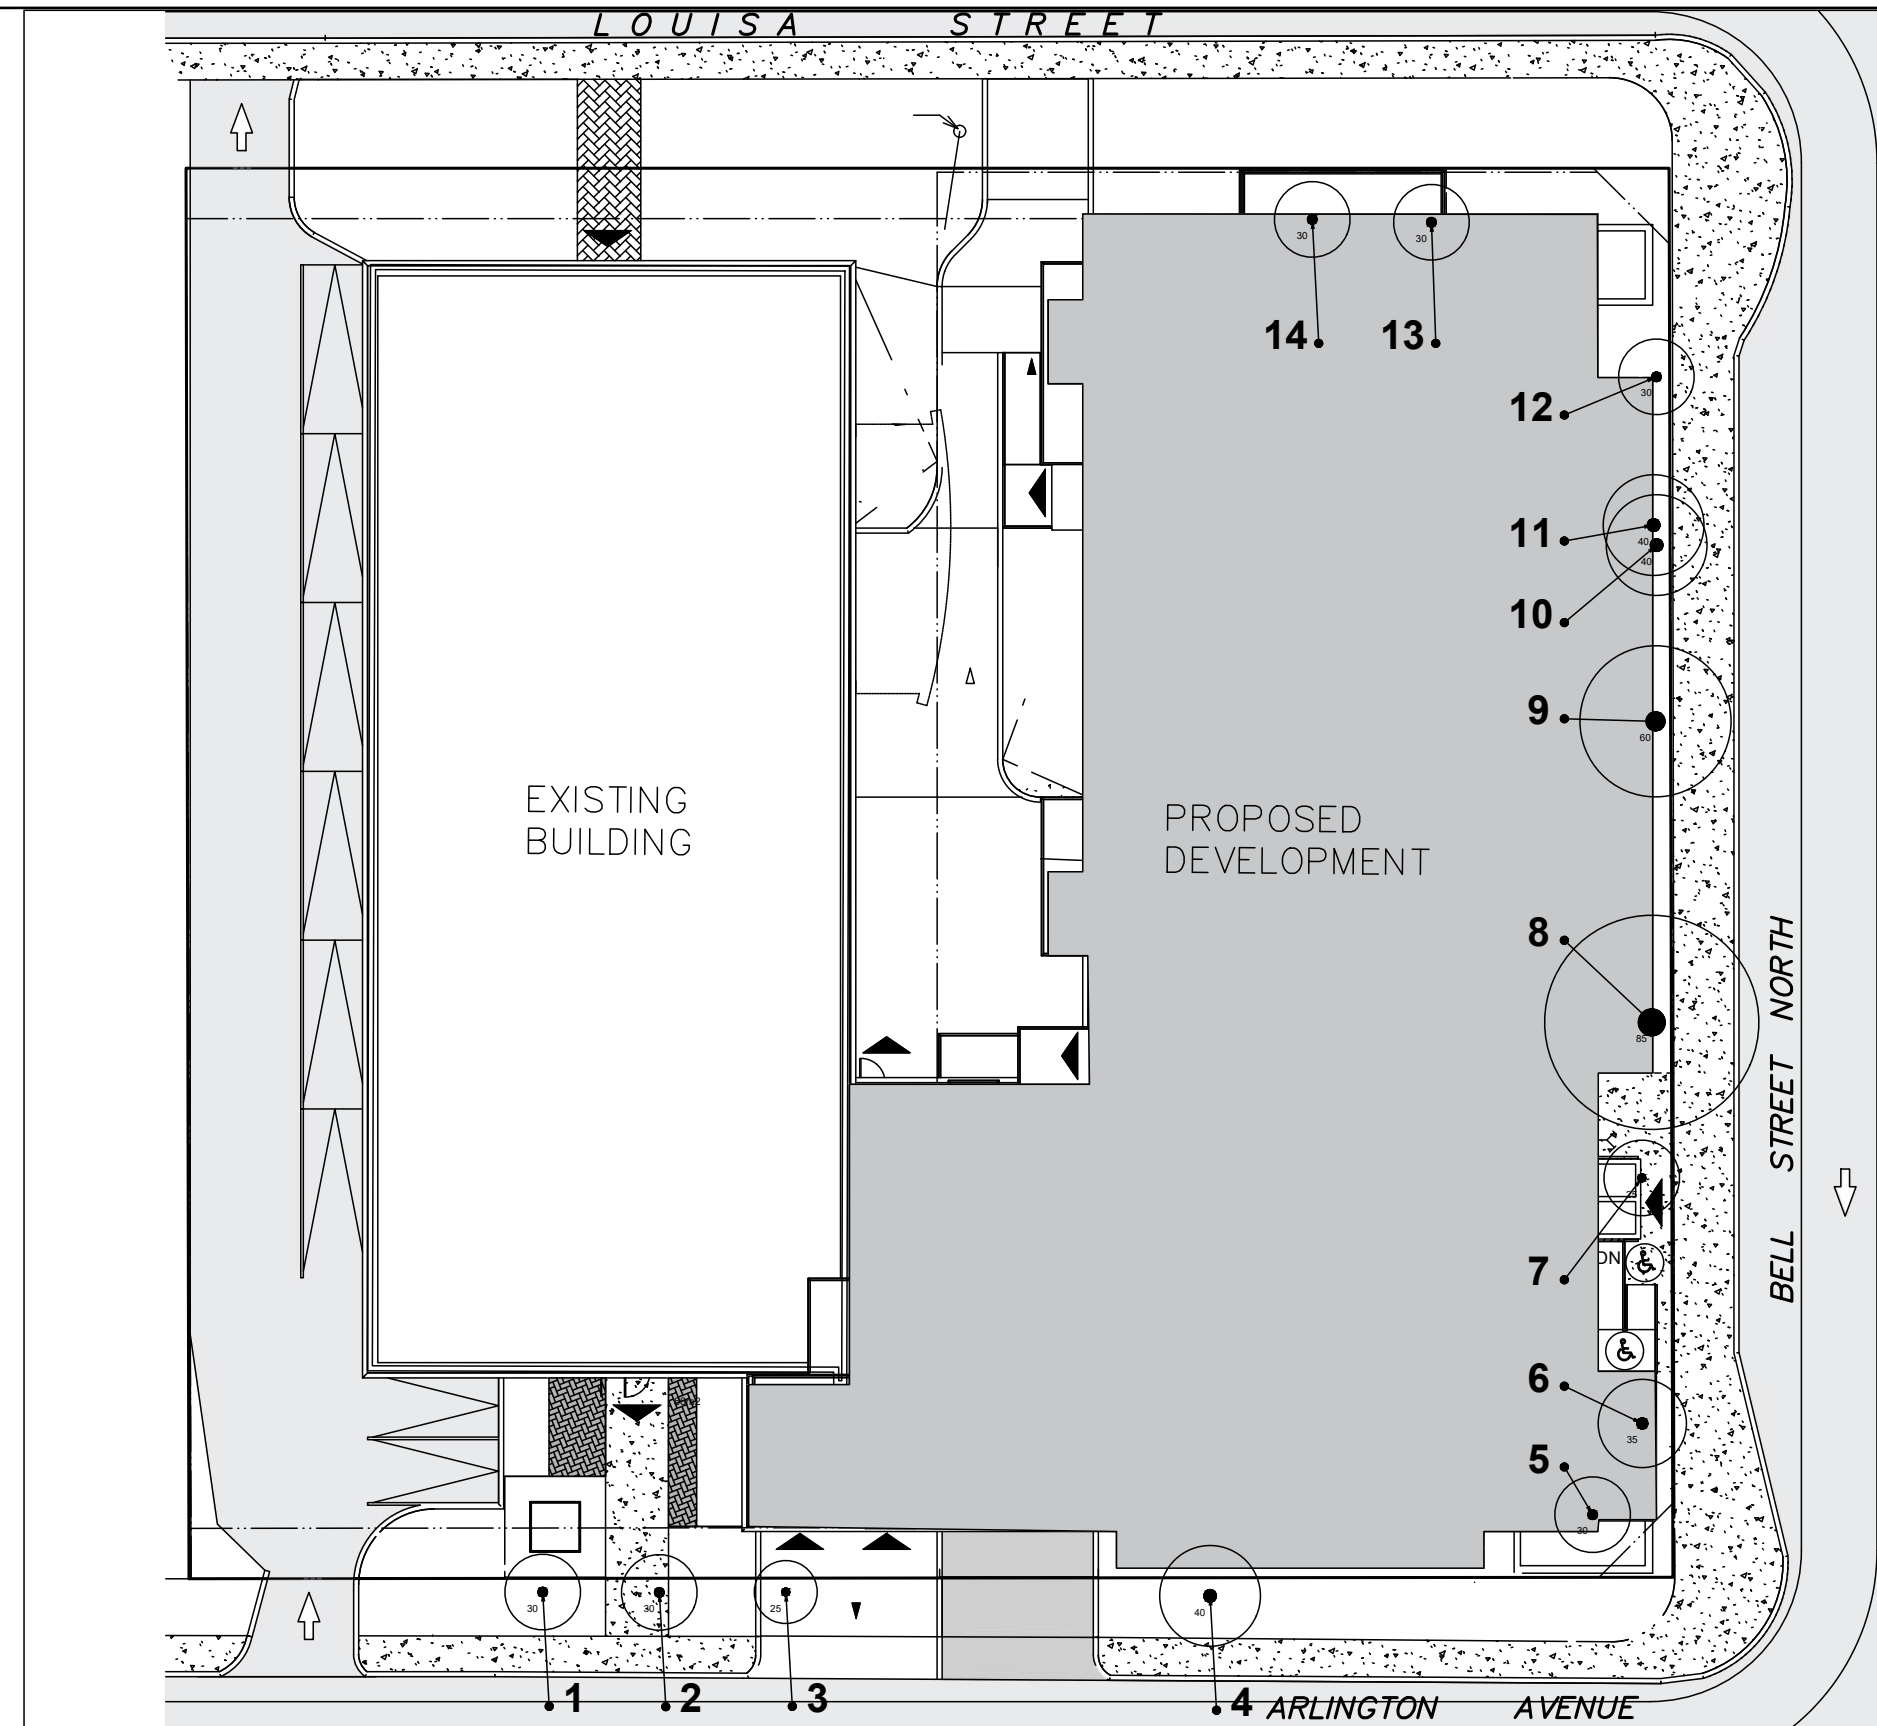
drawing
MAP # 1 - CURRENT VEGETATION

PLANT ID #	SIZE DBH* / ht. (m)	Private (P), City (C), Adjacent (A)	BOTANICAL NAME	COMMON NAME	DISTINCTIVE TREE**	CONDITION	ACTION	COMMENTS
1	0.37	P	<i>Fraxinus ssp</i>	Ash ssp.	✓	Fair-Good	REMOVE	Minor decay and suckering occurring at base of trunk.
2	0.36	P	<i>Fraxinus ssp</i>	Ash ssp.		Fair	REMOVE	Minor decay and suckering occurring at base of trunk. Significant deadwood in upper canopy.
3	0.33	P	<i>Acer negundo</i>	Manitoba Maple	✓	Fair	REMOVE	Suckering occurring at base of trunk.
4	0.37	P	<i>Acer negundo</i>	Manitoba Maple	✓	Poor	REMOVE	Suckering occurring at base of trunk. Steel sign pole and chainlink fence ingrown into trunk at base. Significant deadwood in upper canopy. Suboptimal branch structure with 2 codominant stems at 3m.
5	0.39	P	<i>Acer negundo</i>	Manitoba Maple	✓	Poor	REMOVE	Suckering occurring at base of trunk. Steel sign pole and chainlink fence ingrown into trunk at base. Significant deadwood in upper canopy. Decay across half of trunk diameter. Existing conflict with overhead power lines. Suboptimal branch structure with 2 codominant stems at 1m.

6	0.5	P	<i>Acer negundo</i>	Manitoba Maple	✓	Fair	REMOVE	Suboptimal branch structure with 6 codominant stems at 0.5m.
7	0.85	P	<i>Acer negundo</i>	Manitoba Maple	N/A	N/A	Removed	Removed by city forces (2021). Suckering occurring at base of trunk. Steel sign pole and chainlink fence ingrown into trunk at base. Existing conflict with overhead power lines. Suboptimal branch structure with 5 codominant stems at 0.5m.
8	0.25	P	<i>Fraxinus ssp</i>	Ash ssp.		Fair-Good	REMOVE	Wounds in branches of upper canopy.
9	0.35	P	<i>Fraxinus ssp</i>	Ash ssp.	✓	Fair-Good	REMOVE	Wounds in branches of upper canopy. Suboptimal branch structure with 2 codominant stems at 2m.
10	4 x 0.3	P	<i>Fraxinus ssp</i>	Ash ssp.	✓	Fair	REMOVE	Chainlink fence ingrown at trunk base. Multistem (4) at base.
11	0.48	C	<i>Fraxinus ssp</i>	Ash ssp.	✓	Fair	REMOVE	Large wounds in one of codominant stems. Suboptimal branch structure with 2 codominant stems at 2m.

12	0.25	C	<i>Fraxinus ssp</i>	Ash ssp.		Fair	REMOVE	Suboptimal branch structure with 2 codominant stems at 2m.
13	0.3	C	<i>Fraxinus ssp</i>	Ash ssp.	✓	Fair	REMOVE	Minor wounds due to pruning. Slightly unbalanced crown.
14	0.3	C	<i>Fraxinus ssp</i>	Ash ssp.	✓	Fair	REMOVE	Unbalanced crown towards sidewalk wide due to heavy pruning.
A	0.35	A	<i>Fraxinus ssp</i>	Ash ssp.	✓	Fair	REMAIN	Suckering occurring at base. Potential conflict with overhead power lines. Unbalanced crown towards sidewalk side due to heavy pruning.
B	0.2	A	<i>Acer negundo</i>	Manitoba Maple		Fair	REMAIN	Existing conflict with chainlink fence and pole. Potential conflict with overhead wires in <5 years. Otherwise good form with strong leader.
