TREE CONSERVATION REPORT

18 Louisa Street, Ottawa, Ontario

May 26, 2021

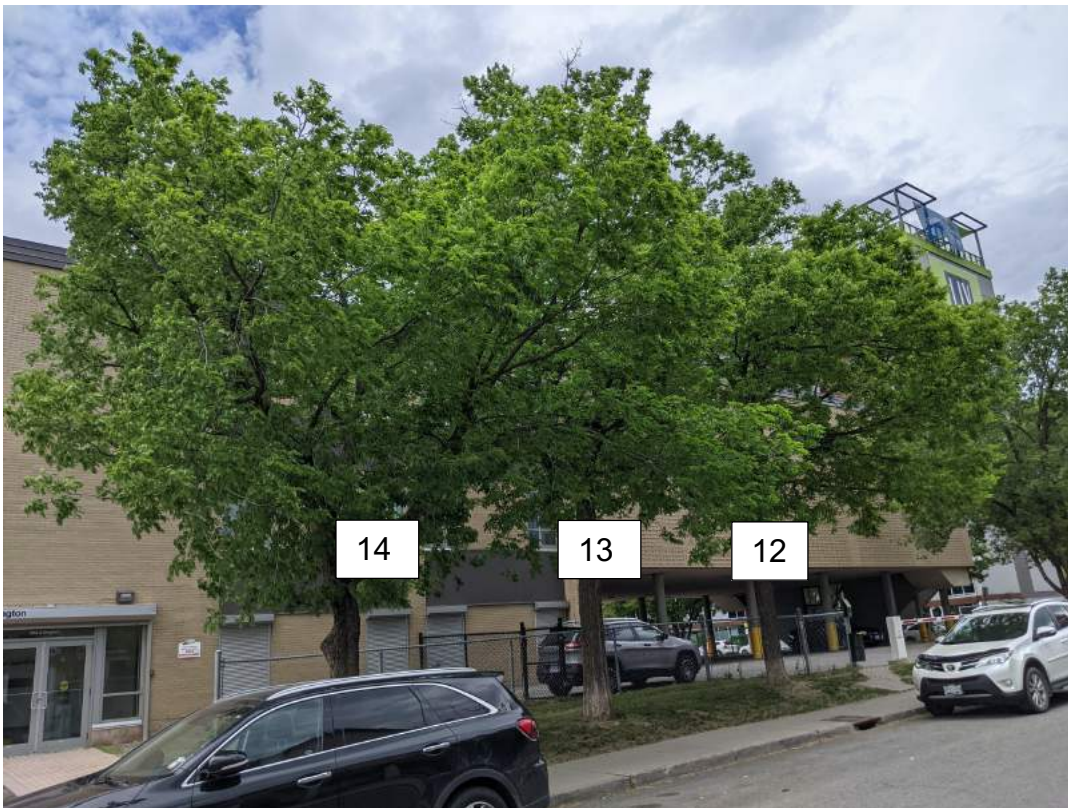
Trees #12, 13, 14 will not be impacted by the proposed development. These are Ash trees and do not appear to have received inoculation against Emerald Ash Borer. As the initial inventory was conducted in the winter, overall canopy condition was impossible to determine. However, as Figure 1 shows, all the Ash trees appear to be in overall good condition as of May 26th, 2021. The roots on all three trees are slightly girdled, but canopies appear to be full and lush.

Figure 1 Picture of Ash trees on May 26, 2021.

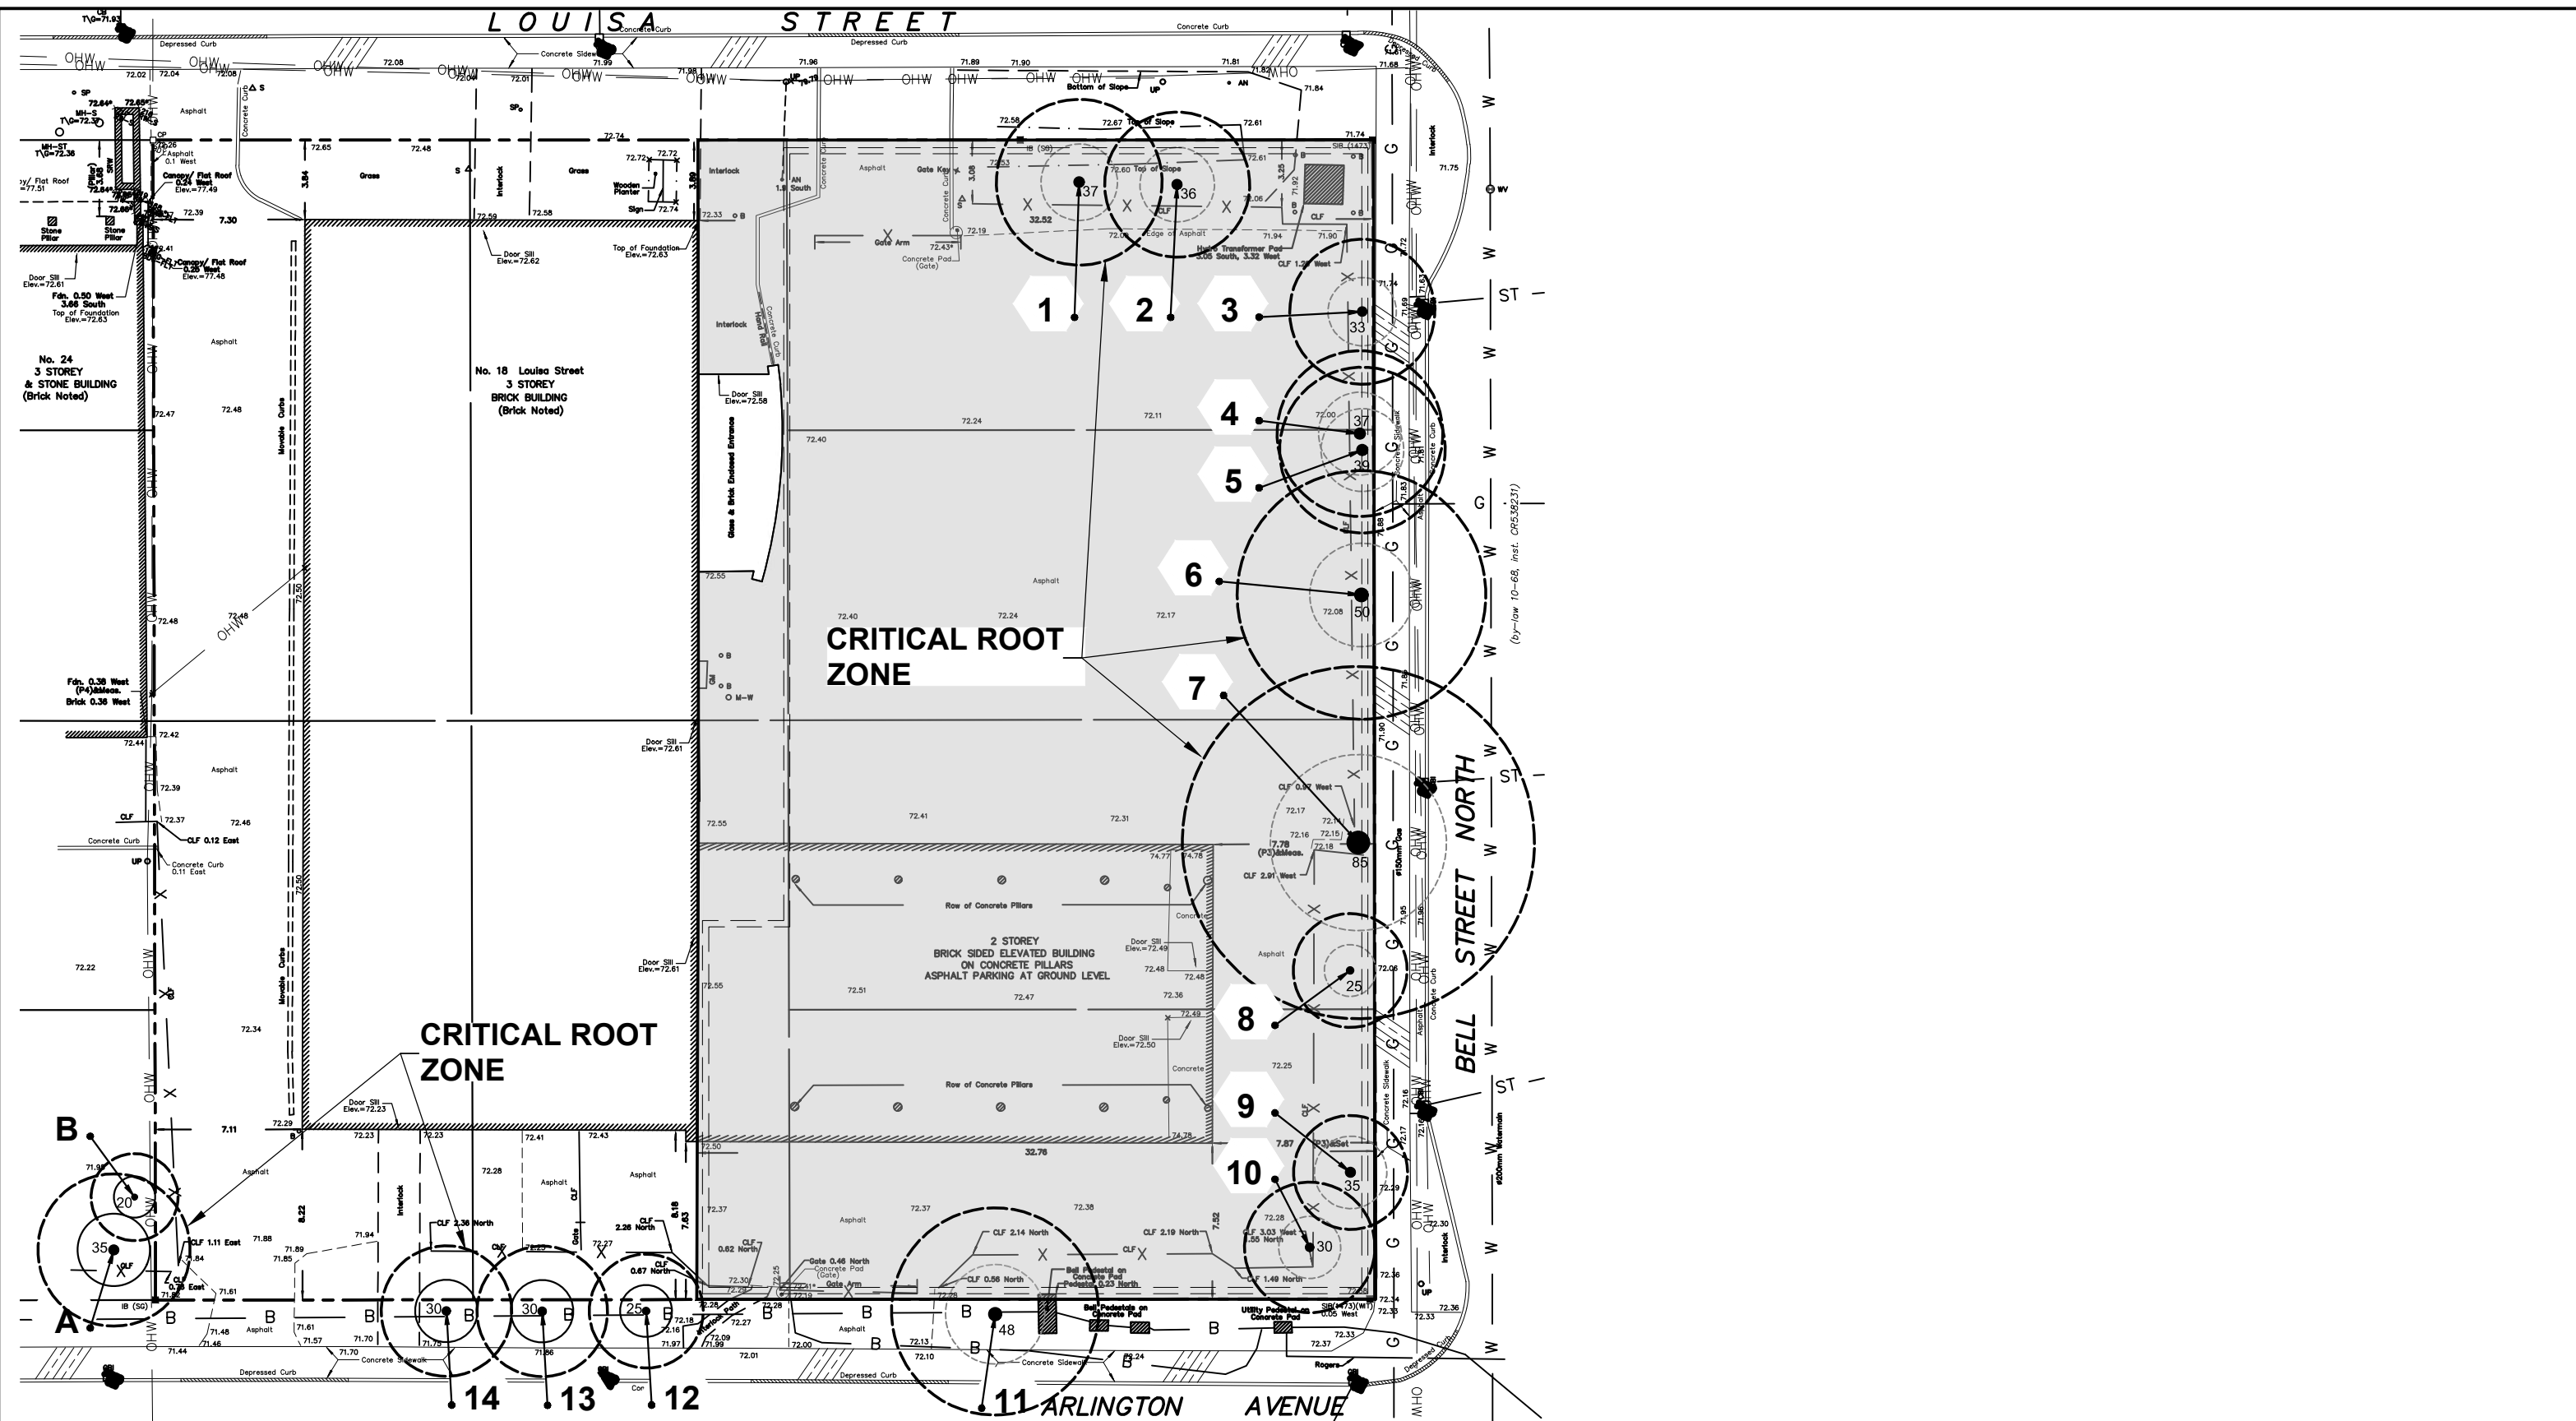
drawing **MAP # 1 - CURRENT VEGETATION**

PLANT ID #	SIZE DBH* / ht. (m)	Private (P), City (C), Adjacent (A)	BOTANICAL NAME	COMMON NAME	DISTINCTIVE TREE**	CONDITION	ACTION	COMMENTS
1	0.37	C	<i>Fraxinus ssp</i>	Ash ssp.	✓	Good	REMOVE	Minor decay and suckering occuring at base of trunk.
2	0.36	C	<i>Fraxinus ssp</i>	Ash ssp.	✓	Fair	REMOVE	Minor decay and suckering occuring at base of trunk. Significant deadwood in upper canopy.
3	0.33	C	<i>Acer negundo</i>	Manitoba Maple	✓	Fair	REMOVE	Suckering occuring at base of trunk.
4	0.37	C	<i>Acer negundo</i>	Manitoba Maple	✓	Poor	REMOVE	Suckering occuring at base of trunk. Steel sign pole and chainlink fence ingrown into trunk at base. Significant deadwood in upper canopy. Suboptimal branch structure with 2 codominant stems at 3m.
5	0.39	C	<i>Acer negundo</i>	Manitoba Maple	✓	Poor	REMOVE	Suckering occuring at base of trunk. Steel sign pole and chainlink fence ingrown into trunk at base. Significant deadwood in upper canopy. Decay across half of trunk diameter. Existing conflict with overhead power lines. Suboptimal branch structure with 2 codominant stems at 1m.

6	0.5	C	<i>Acer negundo</i>	Manitoba Maple	✓	Fair	REMOVE	Suboptimal branch structure with 6 codominant stems at 0.5m.
7	0.85	C	<i>Acer negundo</i>	Manitoba Maple	✓	Poor	REMOVE	Suckering occuring at base of trunk. Steel sign pole and chainlink fence ingrown into trunk at base. Existing conflict with overhead power lines. Suboptimal branch structure with 5 codominant stems at 0.5m.
8	0.25	C	<i>Fraxinus ssp</i>	Ash ssp.		Good	REMOVE	Wounds in branches of upper canopy.
9	0.35	C	<i>Fraxinus ssp</i>	Ash ssp.	✓	Good	REMOVE	Wounds in branches of upper canopy. Suboptimal branch structure with 2 codominant stems at 2m.
10	4 x 0.3	C	<i>Fraxinus ssp</i>	Ash ssp.	✓	Fair	REMOVE	Chainlink fence ingrown at trunk base. Multistem (4) at base.
11	0.48	C	<i>Fraxinus ssp</i>	Ash ssp.	✓	Fair	REMOVE	Large wounds in one of codominant stems. Suboptimal branch structure with 2 codominant stems at 2m.
12	0.25	C	<i>Fraxinus ssp</i>	Ash ssp.		Good	REMAIN	Suboptimal branch structure with 2 codominant stems at 2m.

13	0.3	C	<i>Fraxinus ssp</i>	Ash ssp.	✓	Good	REMAIN	Minor wounds due to pruning. Slightly unbalanced crown.
14	0.3	C	<i>Fraxinus ssp</i>	Ash ssp.	✓	Good	REMAIN	Unbalanced crown towards sidewalk wide due to heavy pruning.
A	0.35	A	<i>Fraxinus ssp</i>	Ash ssp.	✓	Fair	REMAIN	Suckering occuring at base. Potential conflict with overhead power lines. Unbalanced crown towards sidewalk side due to heavy pruning.
B	0.2	A	<i>Acer negundo</i>	Manitoba Maple		Fair	REMAIN	Existing conflict with chainlink fence and pole. Potential conflict with overhead wires in <5 years. Otherwise good form with strong leader.
