URBAN FORESTRY & FOREST MANAGEMENT CONSULTING

August 30, 2021

RE: TREE CONSERVATION REPORT FOR 2571 LANCASTER ROAD, OTTAWA

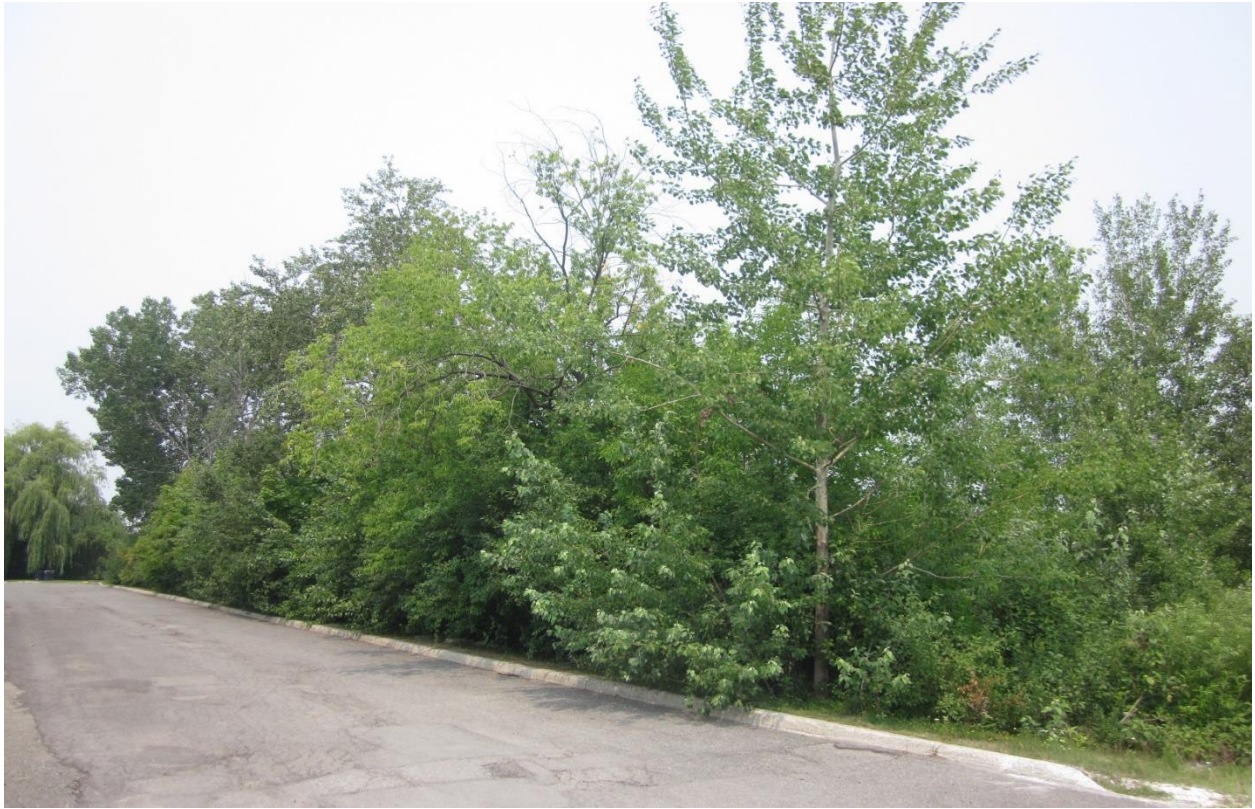
Tree No.	Tree species	Condition (VP→E)	DBH ¹ (cm)	Owner -ship	Age class, tree condition notes & preservation status (to be removed or preserved and protected)
1	Eastern cottonwood (<i>Populus deltoides</i>)	Good	43	Private	Maturing; central dominant stem with suppressed laterals starting at 2m from grade; native species; to be removed
2	Russian-olive (<i>Elaeagnus angustifolia</i>)	Fair	30	Private	Mature; co-dominant leaders; divergent; introduced invasive species; to be removed
3	Manitoba maple (<i>Acer negundo</i>)	Fair	35	Private	Mature; divergent form; originated from seed; naturalized species; to be removed
4	Balsam poplar (<i>Populus balsamifera</i>)	Fair	30	Private	Maturing; upright form; competing leaders; native species; to be removed
5	Balsam poplar	Fair	25	Private	Maturing; upright form; competing leaders; to be removed
6	Eastern cottonwood	Good	76	Private	Mature; central stem with competing lateral on east at 4m and suppressed at 2.5m on west; to be removed

Picture 1. Trees #3 - 6 (right to left) at 2571 Lancaster Road

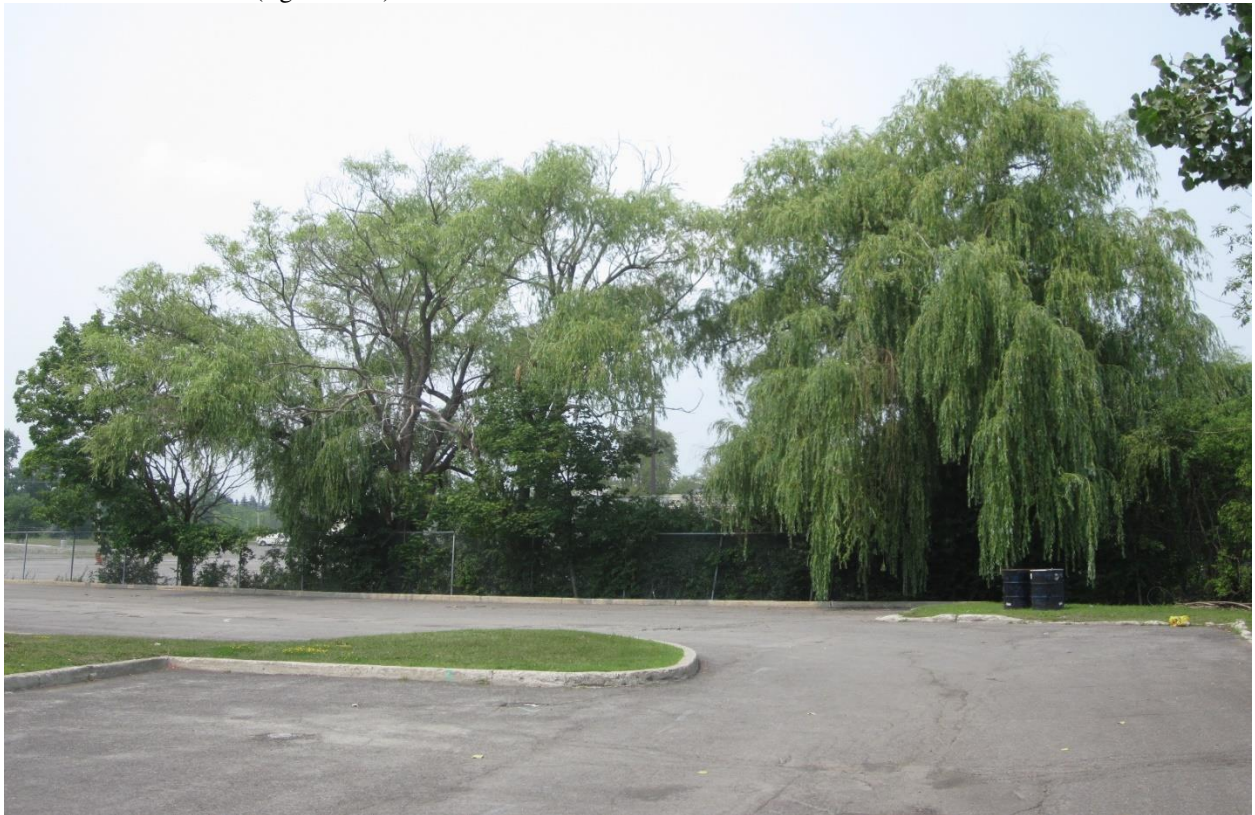
7	Golden weeping willow (<i>Salix alba</i> var. <i>vitellina</i>)	Very poor	>100	Neighbour	Overmature; double-stemmed from grade; north stem topped at +/-10m, south stem multi-stemmed at 2m – one dead, one broken; tree is senescent; cultivar; to be preserved and protected (but should be pruned from over 2571)
8	Golden weeping willow	Poor	+/-60	Neighbour	Mature; tri-stemmed at 1m – one dead towards 2571, one broken and hung up in crown; to be preserved and protected (but should be pruned from over 2571)
9	Golden weeping willow	Poor	+/-100	Neighbour	Overmature; multiple co-dominant stems at 2.5m – one dead towards 2571; to be preserved and protected (but should be pruned from over 2571)
10	Norway maple (<i>Acer platanoides</i>)	Poor	+/-40	Neighbour	Mature; central stem dead, lateral towards south now dominant; introduced invasive species; to be preserved and protected

Picture 2. Neighbouring trees #7 - 10 (right to left) at 2571 Lancaster Road

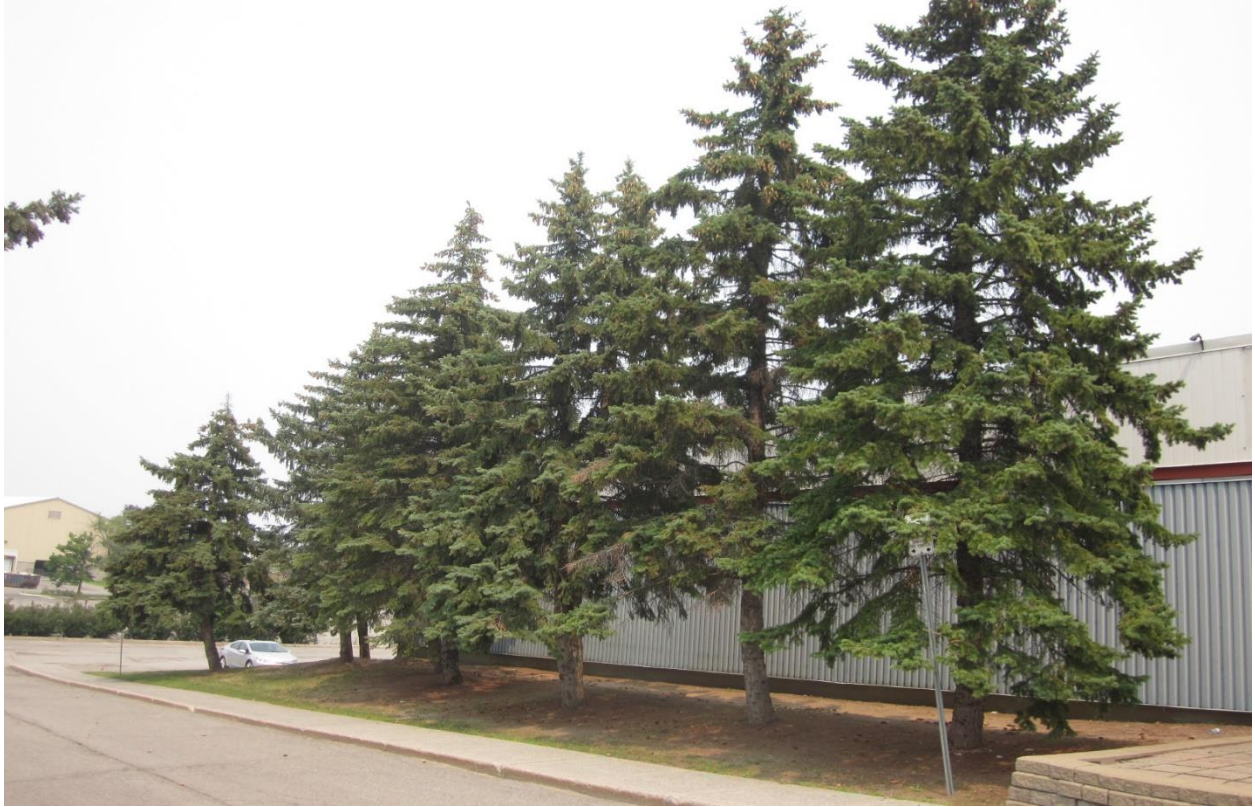
11	Colorado spruce (<i>Picea pungens</i>)	Poor	32	Private	Mature; leader dead; fair crown density, growth increment and needle colour below; restricted rooting area; introduced species; to be removed
12	Colorado spruce	Poor	30	Private	Mature; leader dead; fair density, increment and colour below; restricted rooting area; to be removed
13	Colorado spruce	Good	26	Private	Mature; narrow, upright form; good density, increment and colour; to be removed
14	Colorado spruce	Good	34	Private	Mature; lower crown asymmetric; good density, increment and colour; to be removed
15	Colorado spruce	Fair	35	Private	Mature; planting ropes still present; poor density, fair increment and colour; to be removed
16	Colorado spruce	Fair	25	Private	Mature; lower crown asymmetric; fair density, good increment and colour; to be removed
17	Colorado spruce	Good	32	Private	Mature; lower crown thin due to intercompetition for sunlight; good density, increment and colour above; to be removed

28	Red maple (<i>Acer rubrum</i>)	Fair	23	Private	Mature; thin crown with chlorotic foliage; very restricted and compacted rooting area; fair density, increment and colour; native species; to be removed
29	Colorado spruce	Fair	34 (at 0.2m)	Private	Mature; tri-stemmed at 0.7m - central stem with two competing laterals; fair density, increment and colour; restricted rooting area; to be removed
30	Colorado spruce	Fair	35 (at 1m)	Private	Mature; double stemmed at 1.4m; scattered dead branches due to cytospora canker; fair density, good increment and colour; to be removed

Picture 3. Trees #28 - 11 (right to left) at 2571 Lancaster Road

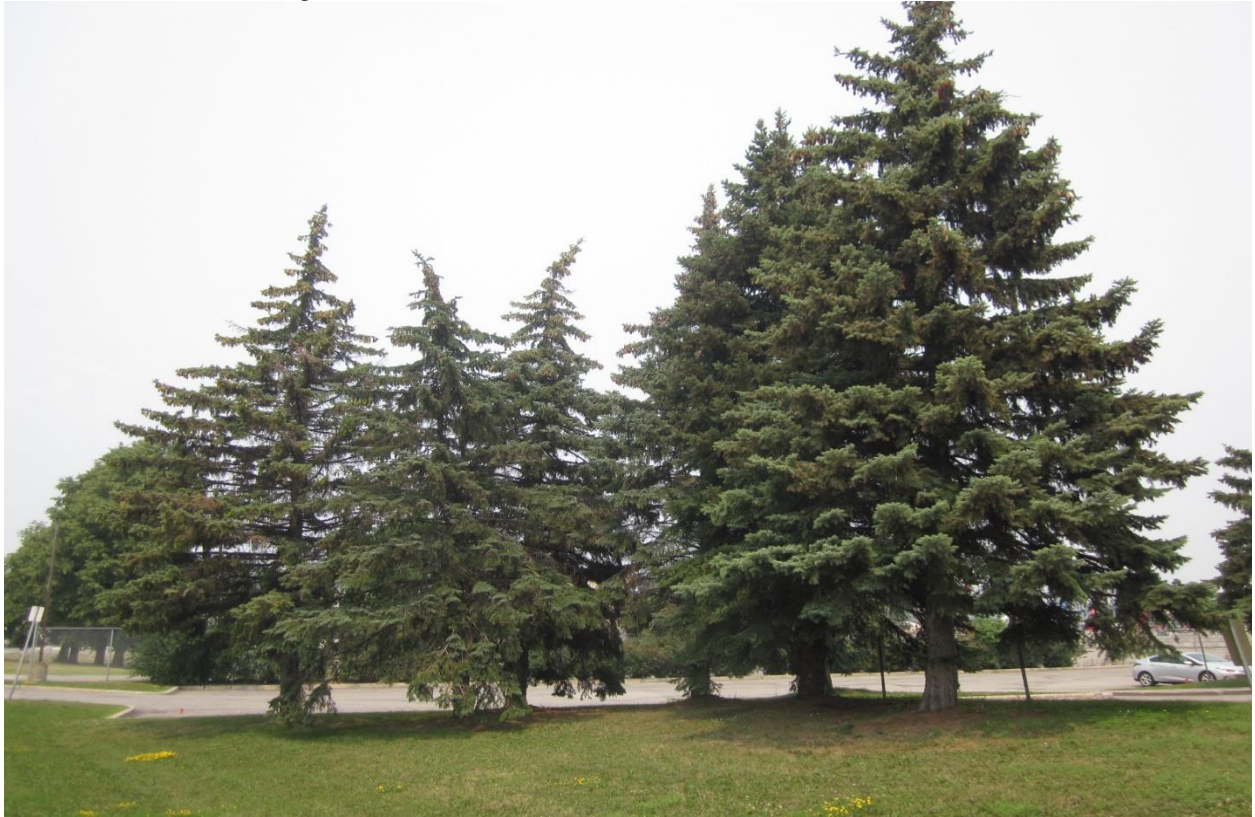
18	Colorado spruce	Fair	31	Private	Mature; fair crown density, growth increment and needle colour; restricted rooting area; to be removed
19	Colorado spruce	Fair	29	Private	Mature; fair crown density, growth increment and needle colour; restricted rooting area; to be removed
20	Colorado spruce	Fair	35 (at 0.5m)	Private	Mature; double stemmed at 1.4m; lower crown thin due to intercompetition; good density, increment and colour above; to be removed
21	Colorado spruce	Fair	31	Private	Mature; lower crown thin due to intercompetition; good density, increment and colour above; to be removed

22	Colorado spruce	Fair	33 (at 0.5m)	Private	Mature; double stemmed at 1.3m; fair density, increment and colour; restricted rooting area; to be removed
23	Colorado spruce	Fair	30	Private	Mature; fair density, increment and colour; scattered dead branches due to Cytospora canker (<i>Cytospora kunzei</i> var. <i>picea</i>); restricted rooting area; to be removed
24	Colorado spruce	Good	29	Private	Mature; good density, increment and colour; restricted rooting area; to be removed
25	Colorado spruce	Poor	22	Private	Mature; leader dead; many scattered dead branches due to cytospora canker; poor density, fair increment and colour; restricted rooting area; to be removed
26	Colorado spruce	Fair	23 & 25	Private	Mature; double stemmed at grade; good density, increment and colour; lower crown asymmetric; fair density, increment and colour; to be removed
27	Colorado spruce	Fair	34	Private	Mature; co-dominant leaders at 4m; many scattered dead branches due to cytospora canker; poor density, fair increment and colour; to be removed

Picture 4. Trees #27 - 15 (right to left) at 2571 Lancaster Road

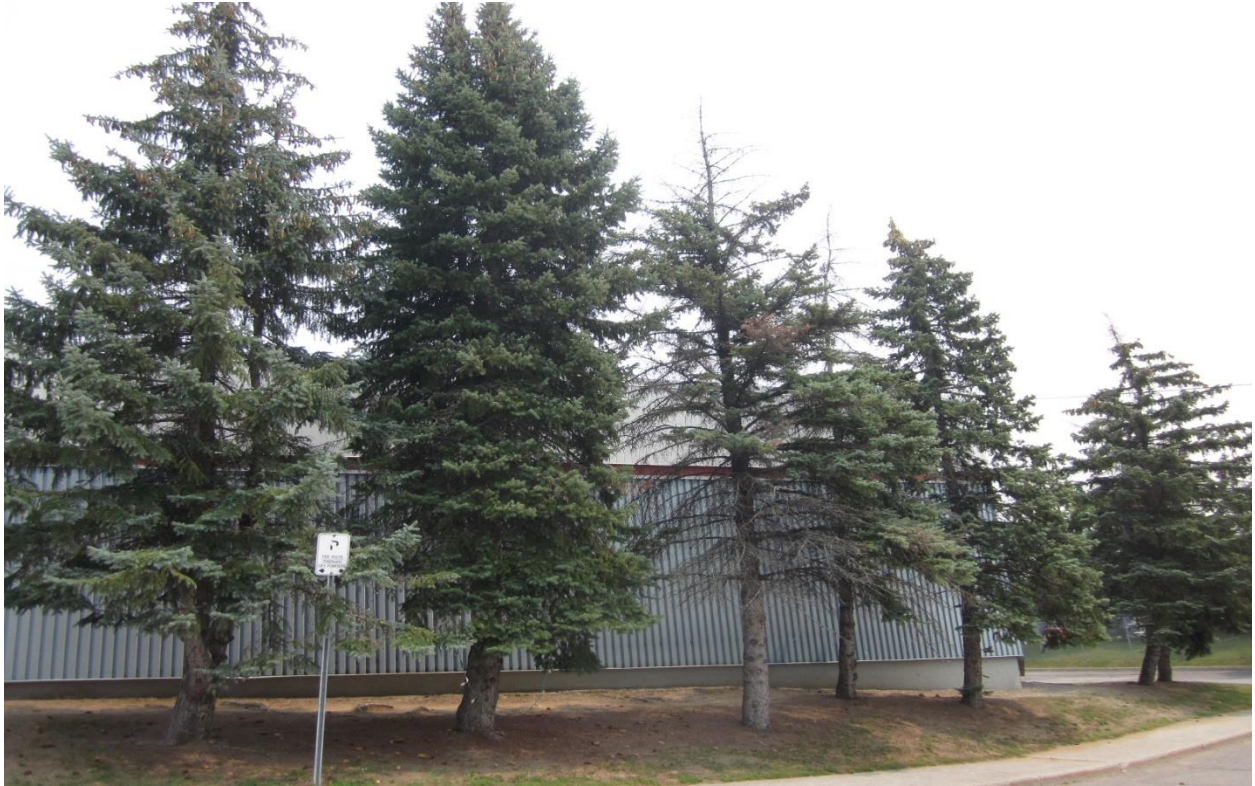
31	Colorado spruce	Poor	30	Private	Mature; very poor density (only holding 50 percent living foliage), fair increment and colour; restricted rooting area; to be removed
32	Colorado spruce	Fair	27	Private	Mature; fair density, increment and colour; crown asymmetric; restricted rooting area; to be removed
33	Colorado spruce	Fair	30	Private	Mature; leader dead; fair density, increment and colour; divergent towards southwest; to be removed
34	Colorado spruce	Poor	26	Private	Mature; leader dead; many scattered dead branches due to cytospora canker; poor density, fair increment and colour; to be removed
35	White elm (<i>Ulmus americana</i>)	Good	54	City	Mature; tri-dominant stems at 3m; lower crown asymmetric towards southwest; no outward signs of Dutch elm disease (<i>Ophiostoma novo-ulmi</i>); native species; to be preserved and protected
36	Norway maple	Fair	+/-30	Neighbour	Mature; single dominant stem for most of height; crown asymmetric towards southeast; to be preserved and protected

Picture 5. Trees #29 - 34 (left to right) at 2571 Lancaster Road

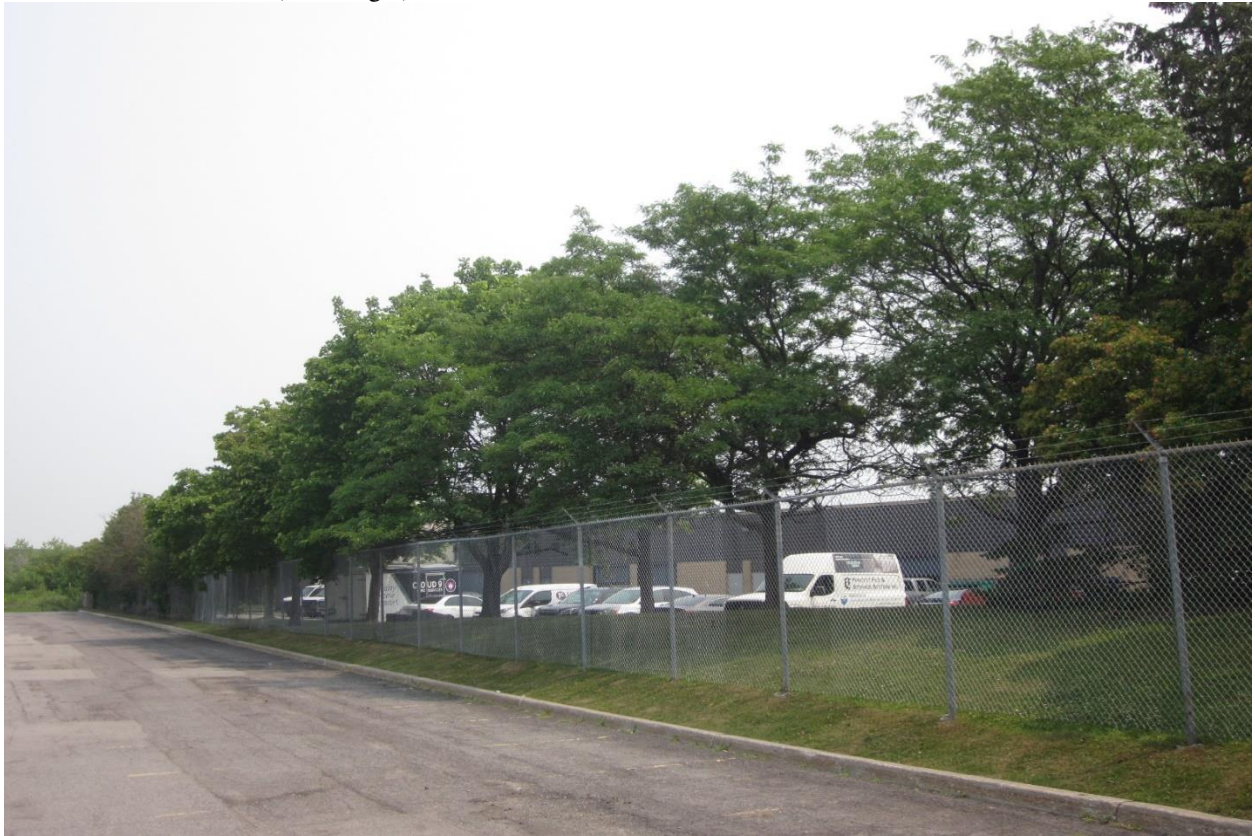
37	Manitoba maple	Dead	+/-70	Neighbour	Mature; has grown through chain link fence; recommended for removal (hazardous)
38	Norway maple	Fair	+/-40	Neighbour	Mature; central stem with two competing laterals at 1.5 and 2m on south; to be preserved and protected
39	Honey-locust (<i>Gleditsia triacanthos</i>)	Good	+/-40	Neighbour	Mature; co-dominant leaders at 3m with competing laterals at 2m, broad, asymmetric crown towards south; introduced species; to be preserved and protected
40	Honey-locust	Fair	+/-30	Neighbour	Mature; central stem with competing laterals starting at 1.5m; generally symmetric crown; to be preserved and protected

41	Honey-locust	Fair	+/-25	Neighbour	Mature; asymmetric towards southeast/southwest due to shading from nearby maple; physical injury to lower crown from piling of snow; to be preserved and protected
42	Norway maple	Fair	+/-50	Neighbour	Mature; central stem with competing laterals on south and west; physical injury to lower crown from piling of snow; to be preserved and protected
43	Norway maple	Poor	+/-30	Neighbour	Mature; central stem dead, lateral on northwest now dominant; physical injury to stem and lower crown from piling of snow; to be preserved and protected
44	Norway maple	Poor	+/-25	Neighbour	Mature; branch cluster at 2m – central stem dead, laterals dominant; to be preserved and protected
45	Norway maple	Fair	+/-25	Neighbour	Mature; co-dominant stems at 2m with two suppressed stems; generally upright form; physical injury to stem and lower crown from piling of snow; to be preserved and protected

46	Norway maple	Fair	+/-25	Neighbour	Mature; co-dominant stems at 3m – central with competing lateral on southeast; to be preserved and protected
47	White cedar (<i>Thuja occidentalis</i>)	Poor - Fair	+/10	Neighbour	Mature; hedge form; seeded deciduous trees and restricted rooting area causing trees to decline; native species; to be preserved and protected
48	Ash species (<i>Fraxinus</i> spp.)	Dead	31	Shared	Mature; dead due to emerald ash borer (<i>Agrilus planipennis</i>); native species; recommended for removal (hazardous)

Picture 6. Neighbouring trees #39 - 47 (right to far left) at 2571 Lancaster Road

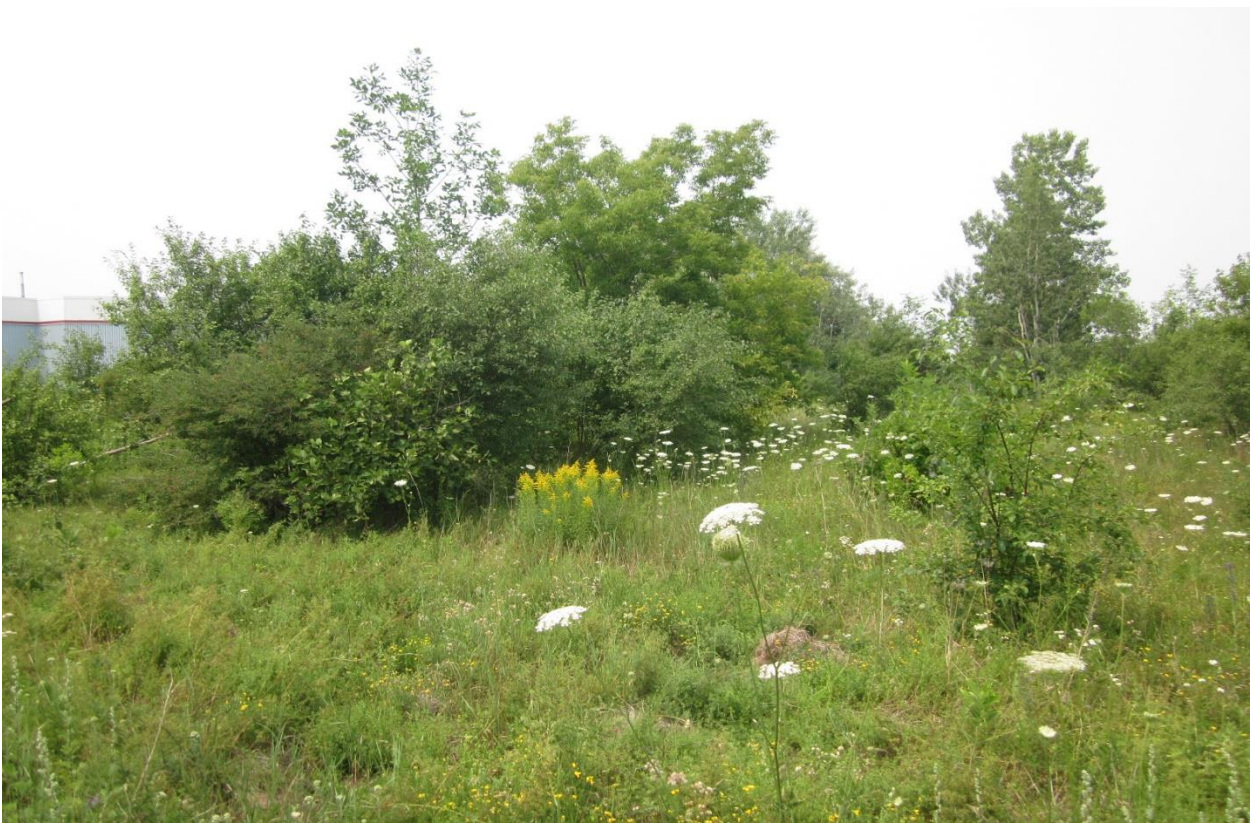
Treed Area No.	Tree species	Condition (VP→E)	DBH ¹ (cm)	Owner -ship	Age class, tree condition notes & preservation status (to be removed or preserved and protected)
49	Mixed species: ash (<i>Fraxinus</i> spp.), willow, white elm, Manitoba and amur maple (<i>Acer tataricum</i> subsp. <i>ginnala</i>), trembling aspen (<i>Populus tremuloides</i>)	Good to Poor	>10	Private	Immature to maturing; tree composition primarily trembling aspen and ash (45 and 35 percent respectively by stem count) - aspen generally in good condition, ash mostly infested with emerald ash borer; shrub layer mainly buckthorn (<i>Rhamnus</i> spp.), ash, dogwood (<i>Cornus</i> spp.) and honeysuckle (<i>Lonicera</i> spp.); entire area to be cleared of vegetation

Picture 7. Typical conditions within previous railway ROW at 2571 Lancaster Road (looking northwestward)

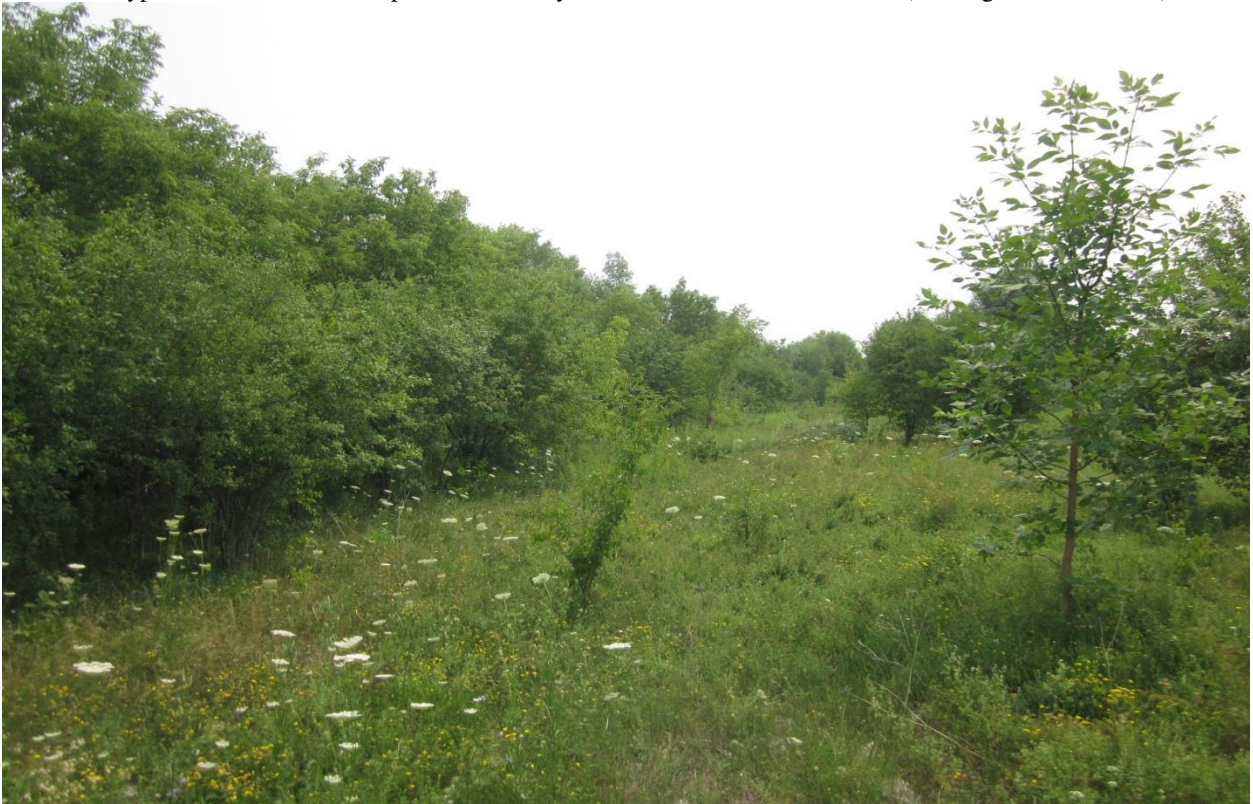
Picture 8. Typical conditions within previous railway ROW at 2571 Lancaster Road (looking southeastward)
