TREE CONSERVATION REPORT

Preliminary report for 1983 Carling Ave

Tree Conservation Report submitted as Partial
Requirements for a Site Plan Control Application

Address: 1983 Carling Ave

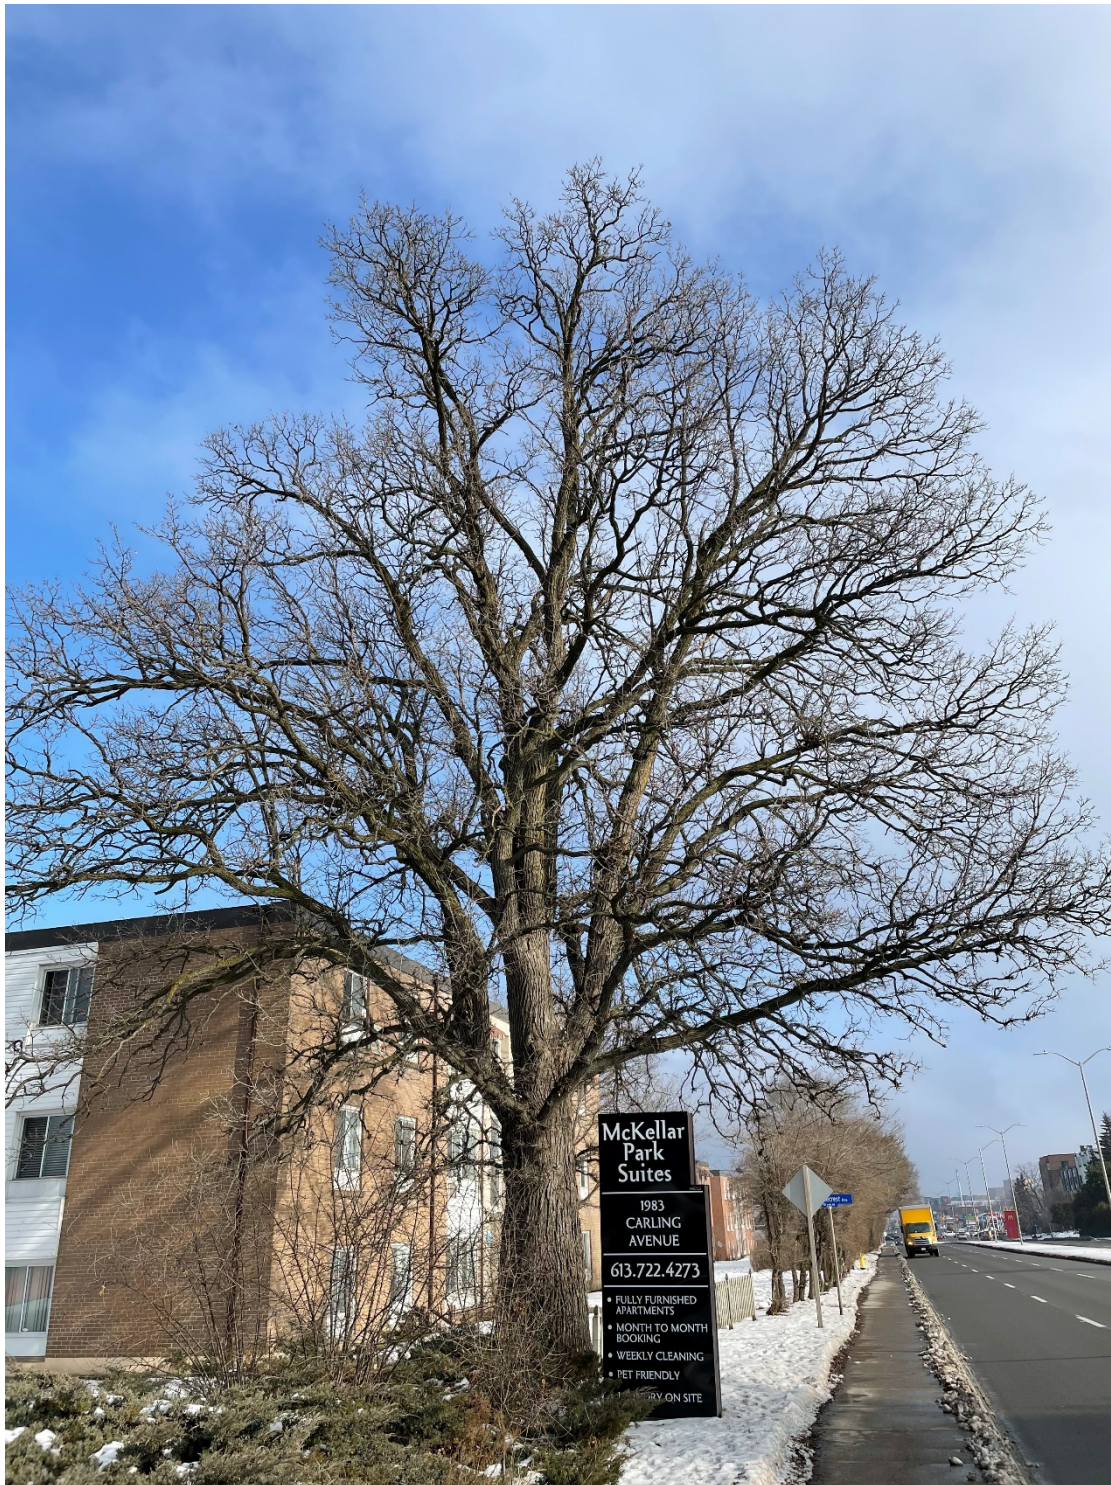
The large bur oak located close to the sidewalk and along Carling avenue is the tree of concern that will be most impacted by the proposed development. This tree has a diameter of 111 cm, and its root system likely extends at least 11 m in all directions, except for where there is infrastructure such as the road and building. Although the tree appears in good health, it does have some health concerns to note. The crown is extensive, but since this tree is overhanging a major thoroughfare, it has been damaged by salt spray which is visible along the south side. Also, there is a large cavity at the base of the tree that measures 80 cm long; 15 cm wide; and 40 cm deep. A metal rod was inserted and extended past the cavity wall an additional 30 cm. Therefore, the decay and cavity extend 70 cm into the trunk at the widest point. The extent of decay is over 1 m up the tree in the centre of the decay column – the 1 m rod did not reach the end. These observations on decay were made using tools for a basic assessment. To understand better the extent of internal decay in this tree, a Level 3 risk assessment would be required using an advanced technique such as sonic topography or resistance drilling. These tools can map out the decay in the stem at different heights up the trunk and are relatively non-invasive. Combining these results with a good understanding of the dynamics of how internal decay impacts large oak trees would help to assess the structural integrity of the tree. Although extensive decay can give the impression of structural weakness, this may not always be the case. Trees can learn to adapt to weaknesses by refocusing their growth on strengthening their stem and reducing the crown weight naturally.

Figure 1: Large bur oak along Carling, facing east

Based on the initial site plan provided by the client, the proposed building will be approximately 3.5 m from the trunk of the tree. When adding in the space required to construct this building, the excavation extends to approximately 2.5 m from the trunk. Looking at the existing critical root zone, approximately 30% of the potential rooting area would be removed as part of this development. However, most of this potential rooting area is currently covered by asphalt, and it is possible that there are not many roots under this surface, especially if it has been resurfaced. Mitigating any damage to the roots will be important to reducing the impact of the construction to the tree. Recommended mitigation measures include:

- Avoid tearing of the roots prior to the excavation. If the roots do tear, they should be pruned with a clean cut to increase the likelihood of sealing properly and reduce the risk of pathogens from entering the tree.
- Roots should not be left exposed and be covered with soil as quickly as possible, or temporarily with a moist, organic material such as mulch and/or burlap
- The tree should be watered during dry summer months to reduce stress it will encounter from the construction

Those branches that are in conflict with the new building will also need to be pruned back. When pruning this tree, balancing the weight should be factored in while considering the root loss. Reducing the crown in response to root loss should be done only to improve stability and otherwise be kept at a minimum to reduce the stress response by the tree. Other mitigations factors could help to reduce the stress response by the tree including:

- Ensure the remaining root zone is well protected during all construction by following the protection measures below
- Mulching the rooting area with 5-10 cm of quick-decomposing mulch (e.g. hardwood)

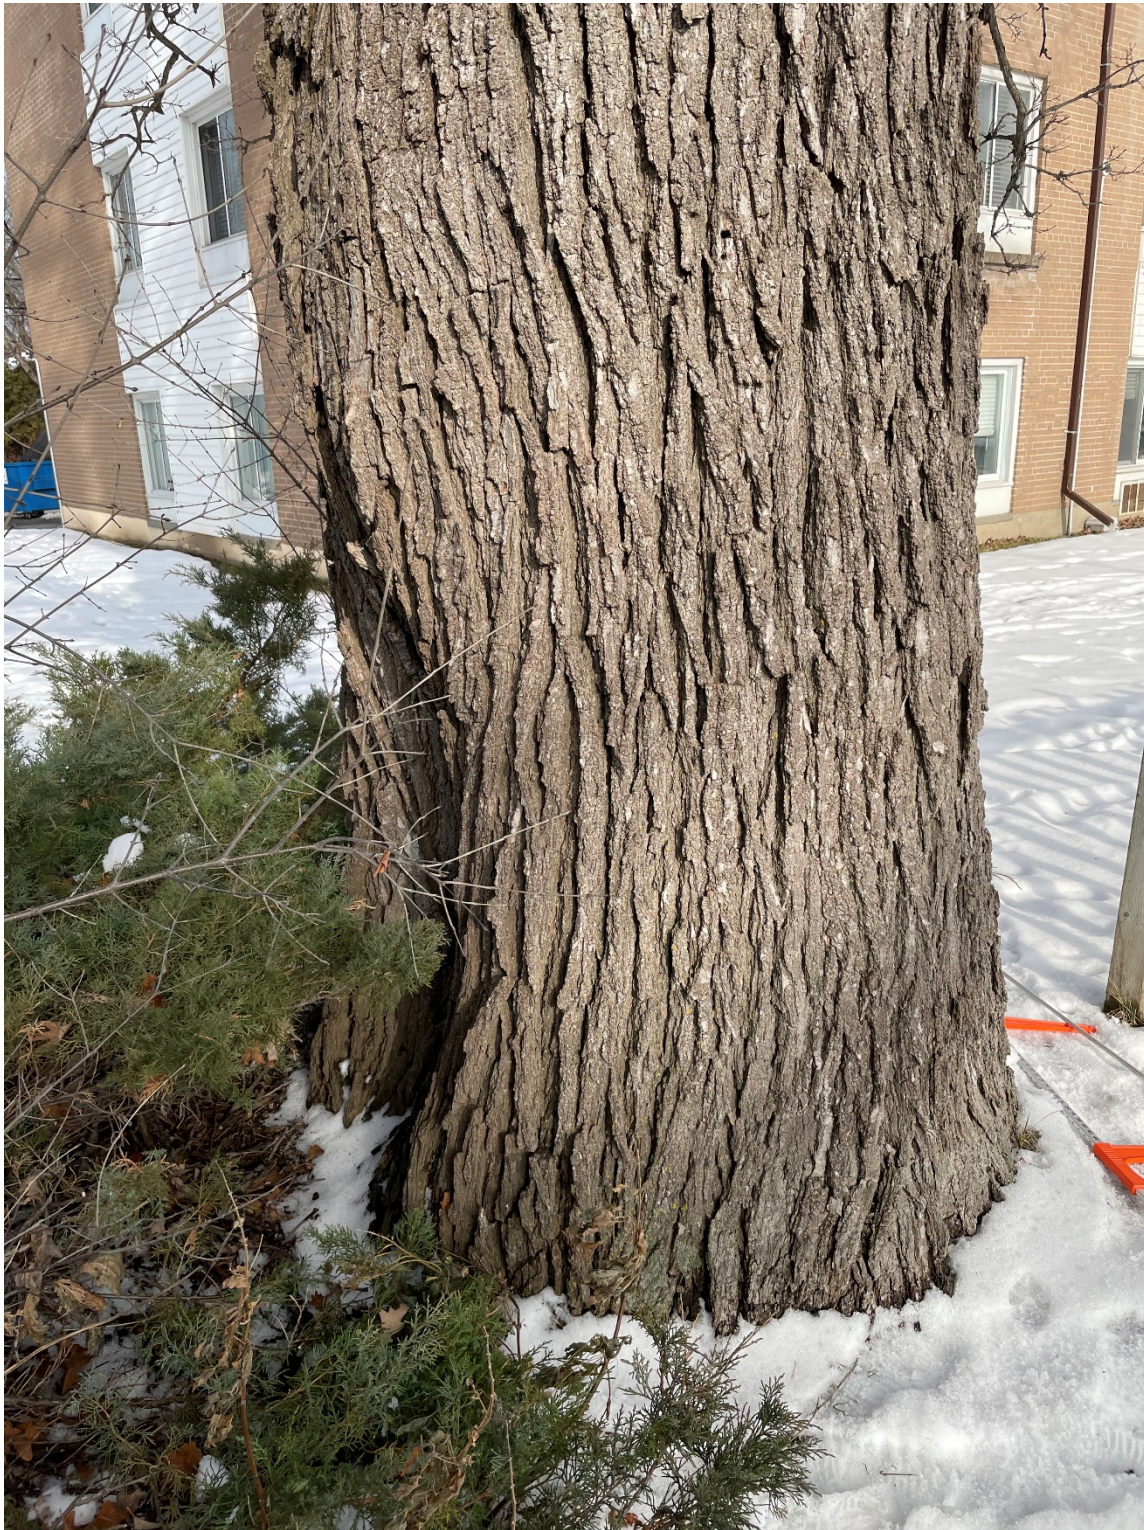
Figure 2: Wound at base of trunk along the west side
