TREE CONSERVATION REPORT

1983 Carling Ave

Tree Conservation Report submitted as Partial
Requirements for a Site Plan Control Application

January 28, 2022

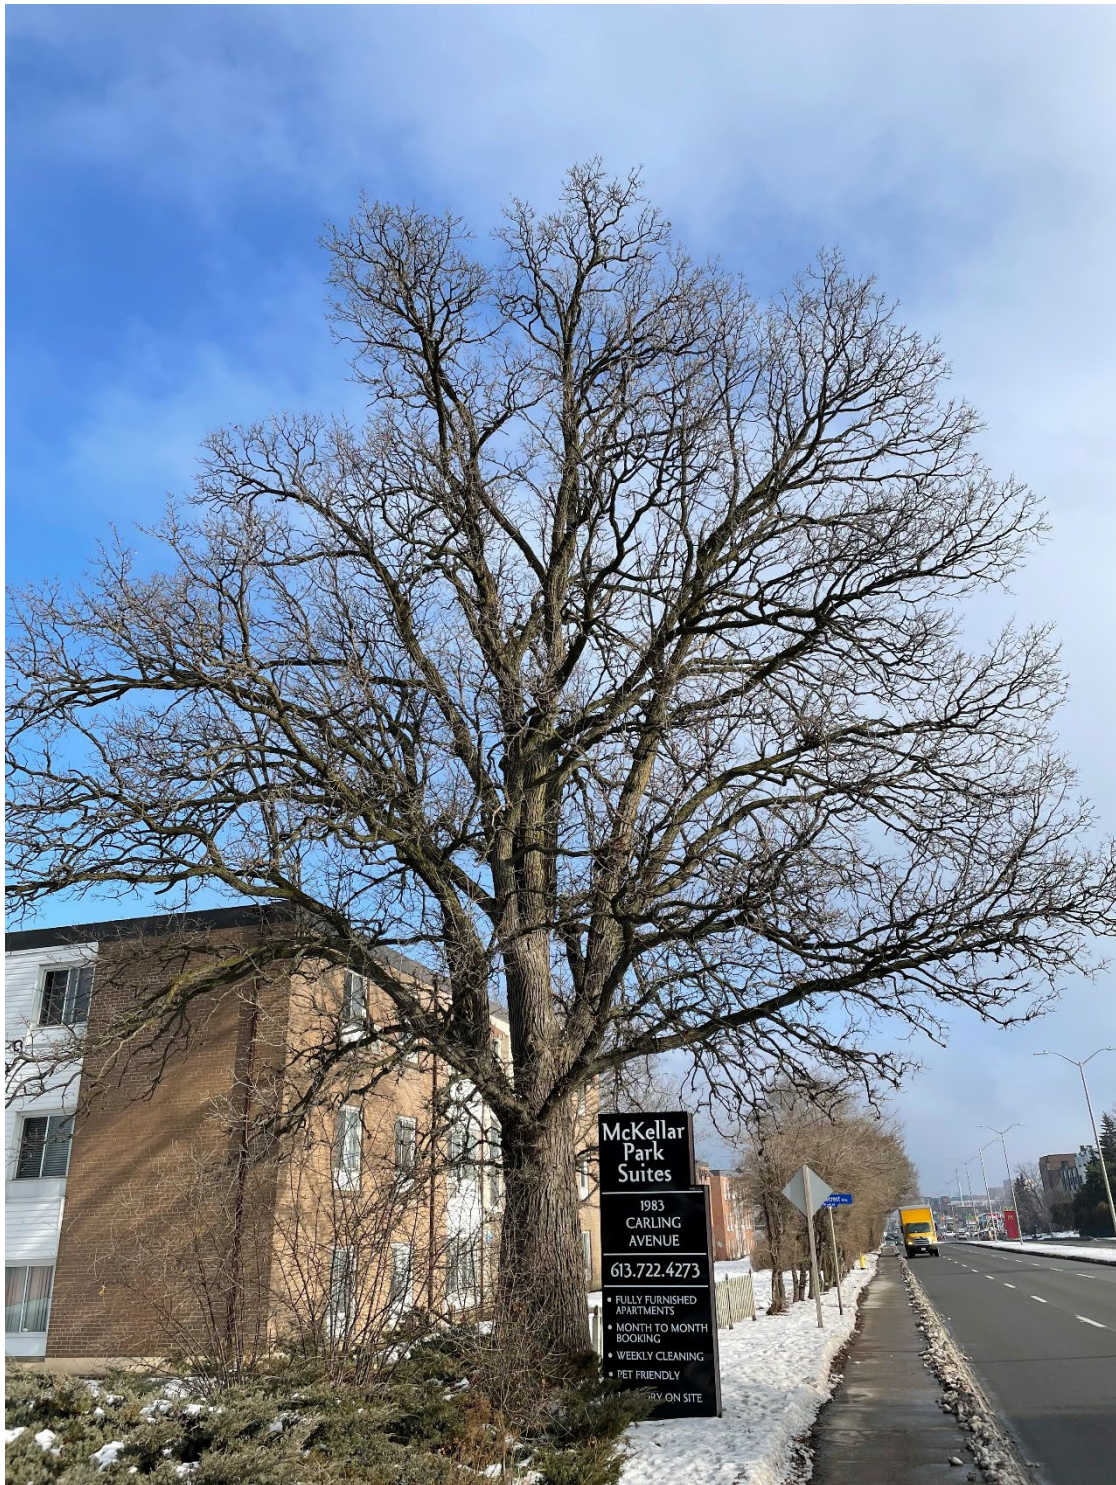
The large bur oak located close to the sidewalk and along Carling Avenue is the tree of concern that will be most impacted by the proposed development. This tree has a diameter of 111 cm, and its root system likely extends at least 11 m in all directions, except for where there is infrastructure such as the road and building. Although the tree appears in good health, it does have some health concerns to note. The crown is extensive, but since this tree is overhanging a major thoroughfare, it has been damaged by salt spray which is visible along the south side. Also, there is a large cavity at the base of the tree that measures 80 cm long; 15 cm wide; and 40 cm deep. A metal rod was inserted and extended past the cavity wall an additional 30 cm. Therefore, the decay and cavity extend 70 cm into the trunk at the widest point. The extent of decay is over 1 m up the tree in the centre of the decay column – the 1 m rod did not reach the end. These observations on decay were made using tools for a basic assessment. To understand better the extent of internal decay in this tree, a Level 3 risk assessment would be required using an advanced technique such as sonic topography or resistance drilling. These tools can map out the decay in the stem at different heights up the trunk and are relatively non-invasive. Combining these results with a good understanding of the dynamics of how internal decay impacts large oak trees would help to assess the structural integrity of the tree. Although extensive decay can give the impression of structural weakness, this may not always be the case. Trees can learn to adapt to weaknesses by refocusing their growth on strengthening their stem and reducing the crown weight naturally.

Figure 1: Large bur oak along Carling, facing east

Based on the impacts to the tree as noted above, tree removal is the recommended option.

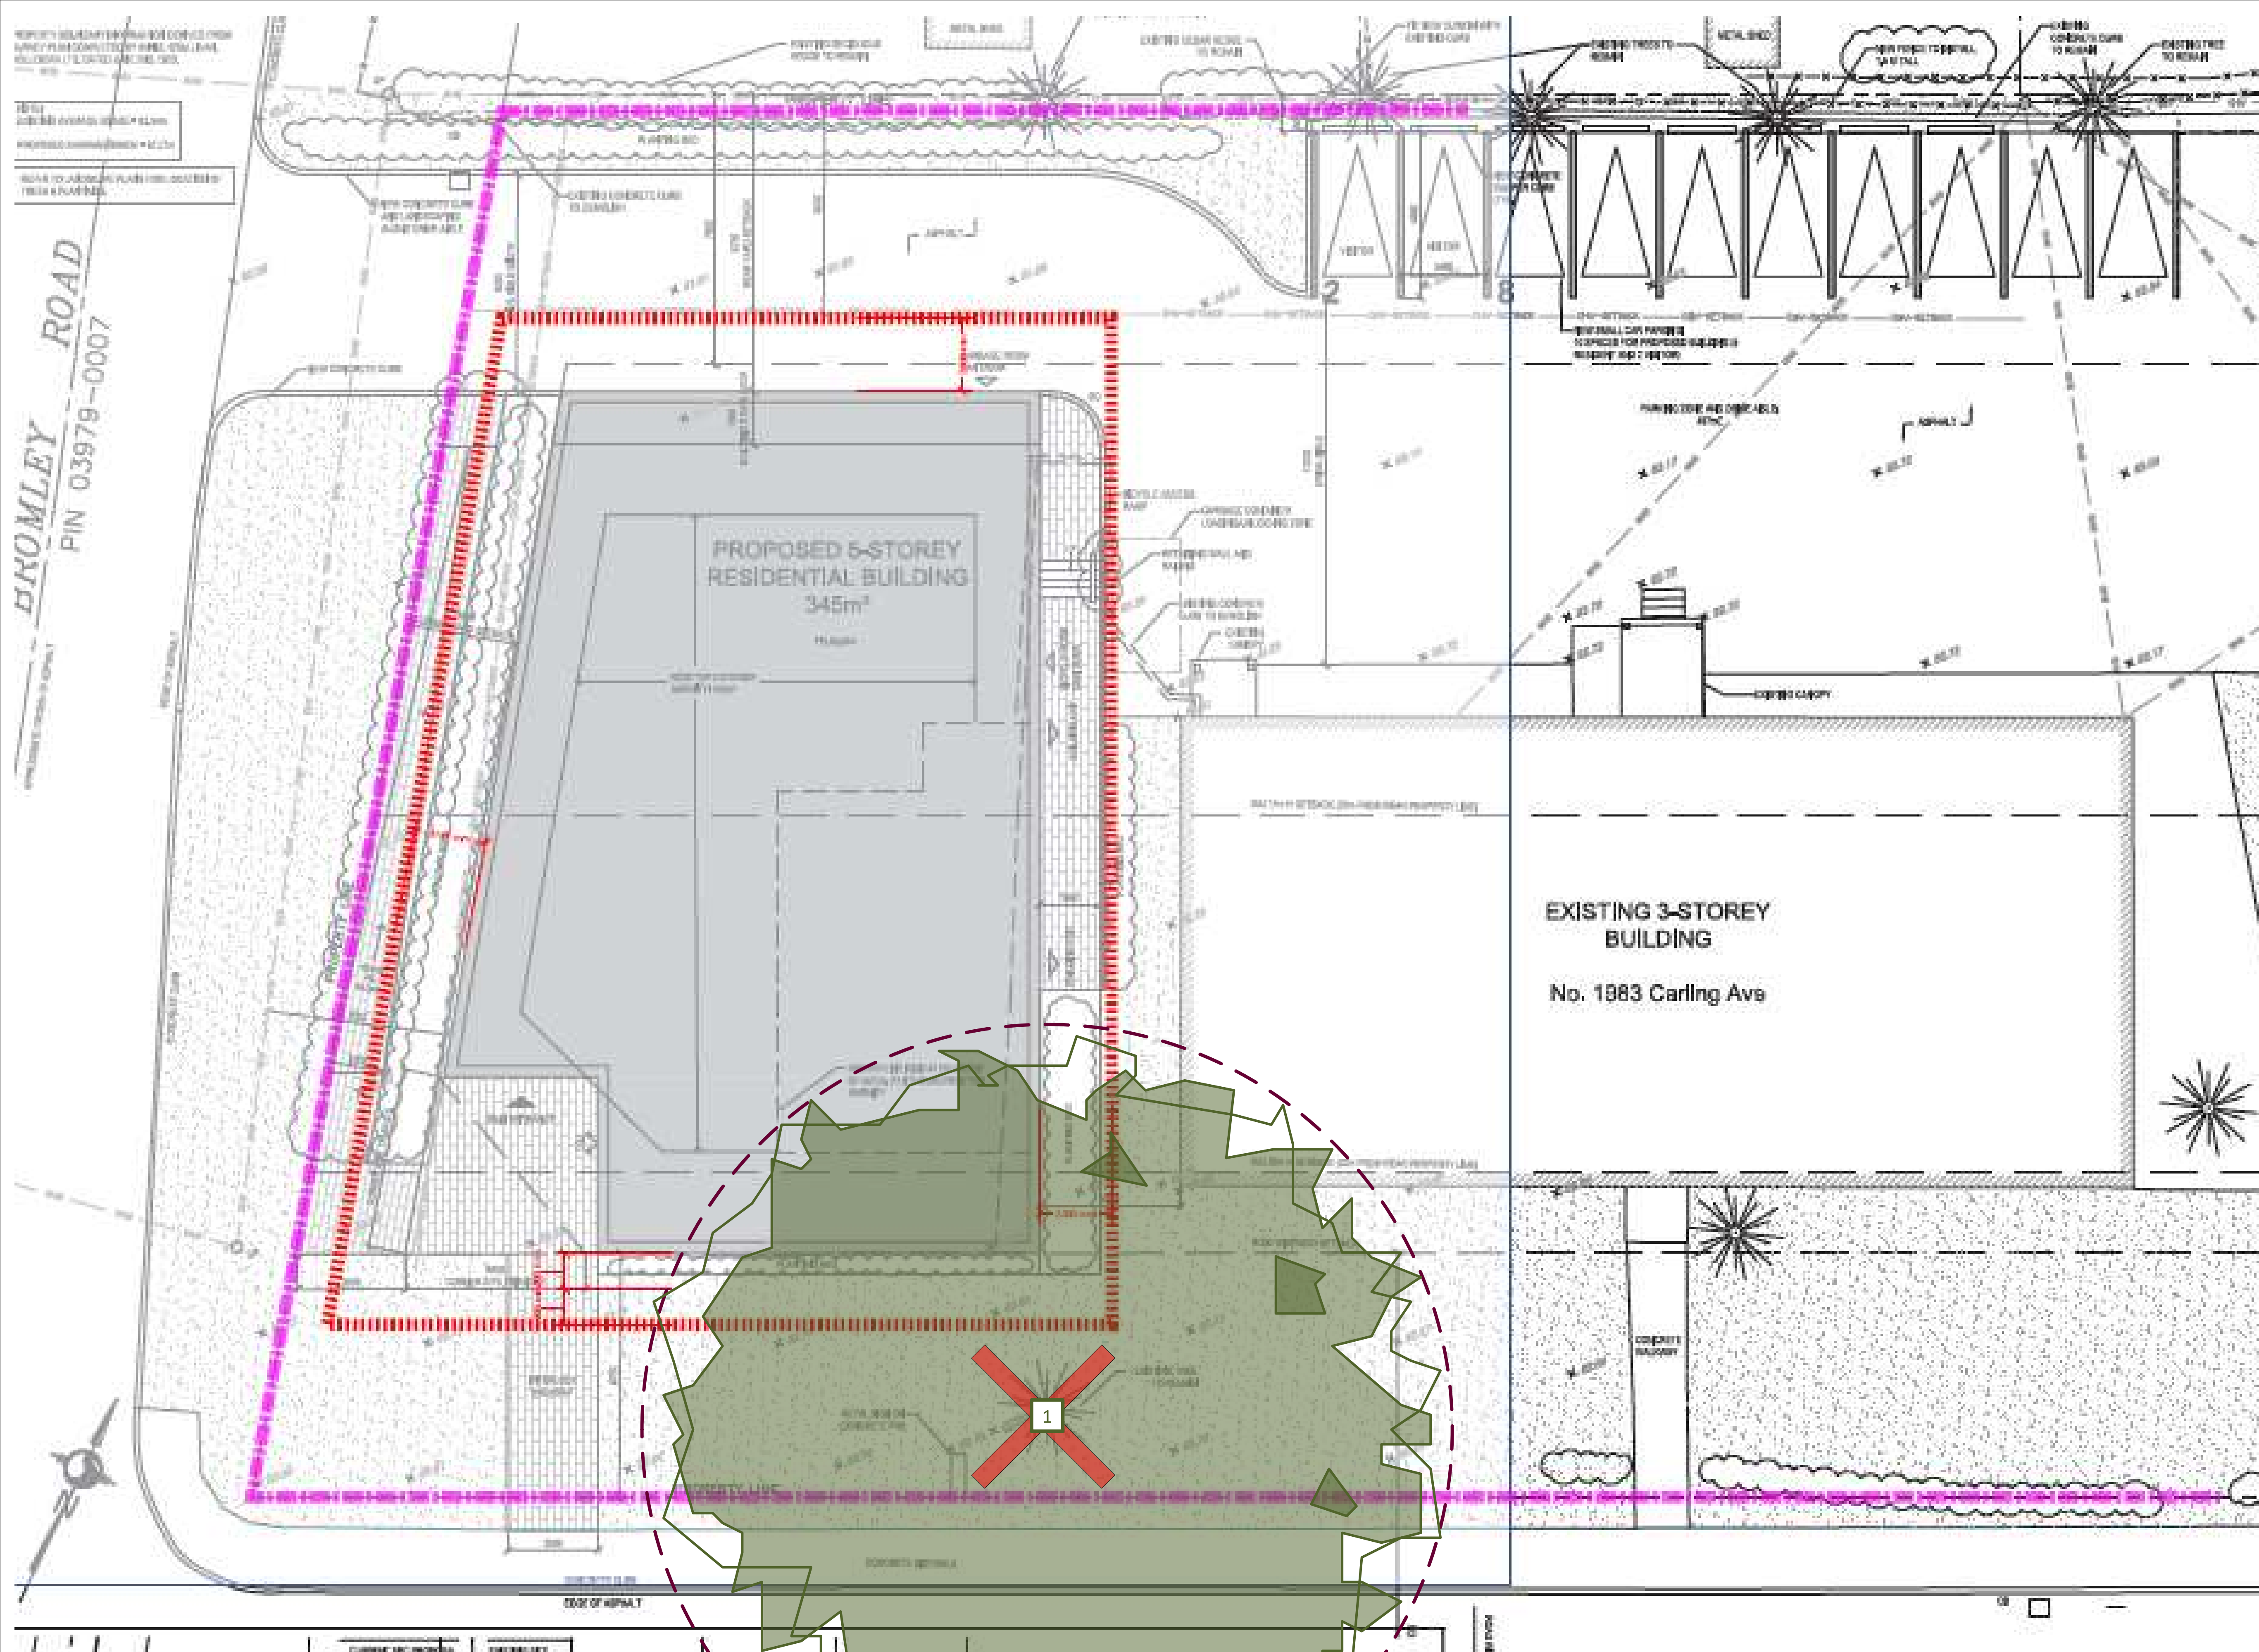
Tree Conservation Report – 1983 Carling Ave
 Proposed Development and Conserved Vegetation (excavation zone)
 Tree layer prepared by Dendron Forestry Services
 Version 1.0, January 27, 2022
 For more information, please contact info@dendronforestry.ca

- 1) Excavation zone (refer to Proposed Development and Conserved Vegetation (excavation zone) map): The excavation will extend well into the critical root zone as well as the static root zone to less than 2 m from the edge of the tree. A large portion of the critical root zone will be lost during the excavation which would impact both the long-term viability of the tree and possibly the structural integrity.
